| Housebuilder Name: Elivia Homes - The Woodlands. | | | Date: 16/05/2025 |
| Site Name: Reeds Lane, Sayers Common. | | | Weather: 23 °C Dry |
| Postcode: BN6 9JG. | | Surveyor: Adam McDermott (TGPV) | |

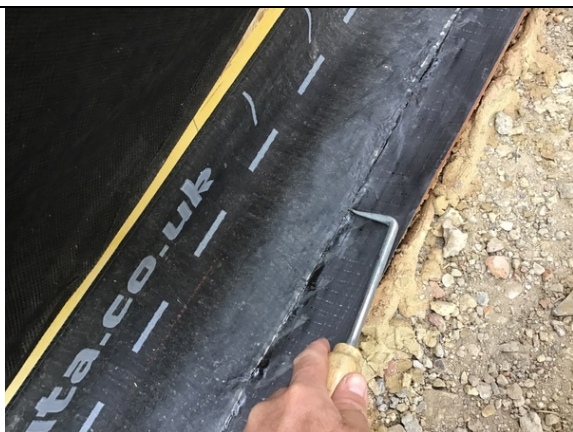
Probe testing all hand welded membrane laps in plots 6 & 7.

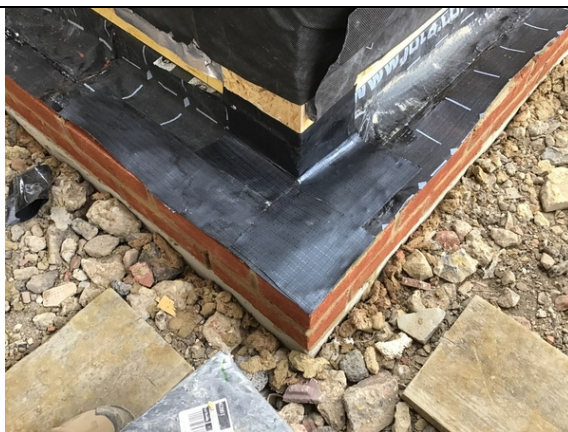
Corner detailing in plots 6 & 7.

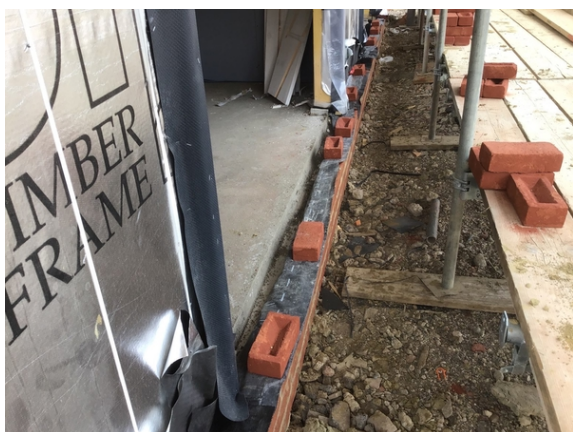
Overview of the extended membrane to the back elevation of plots 8 & 9.

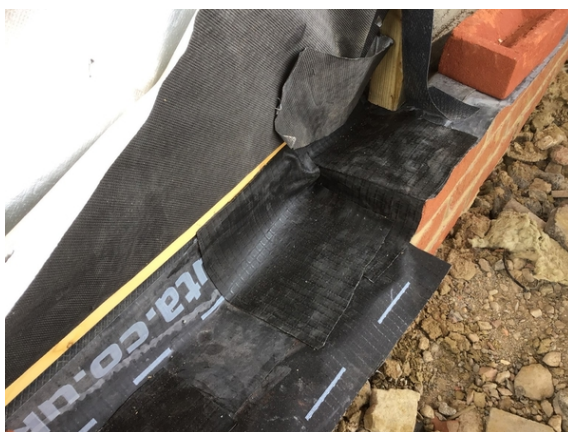
Detailing work to the back of the door threshold in plot 8.

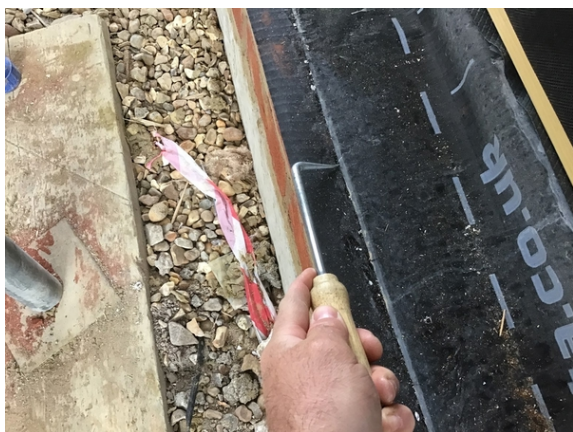
Probe testing the hand welded extended membrane around the perimeter of plot 9.

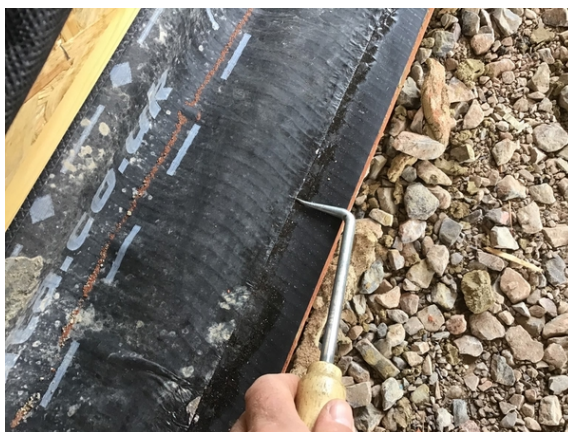
Probe testing all hand welded membrane laps on plot 10.

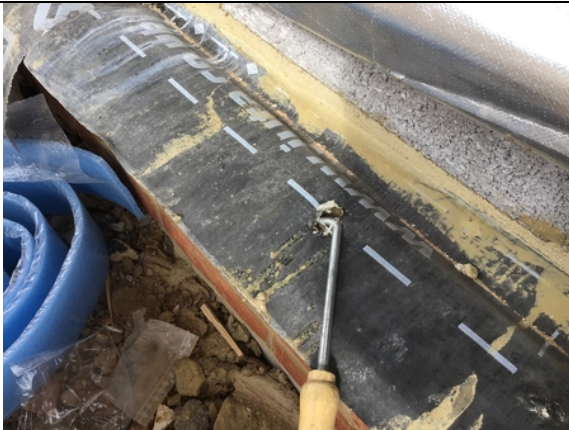
Hole found upon our inspection to plot 10.

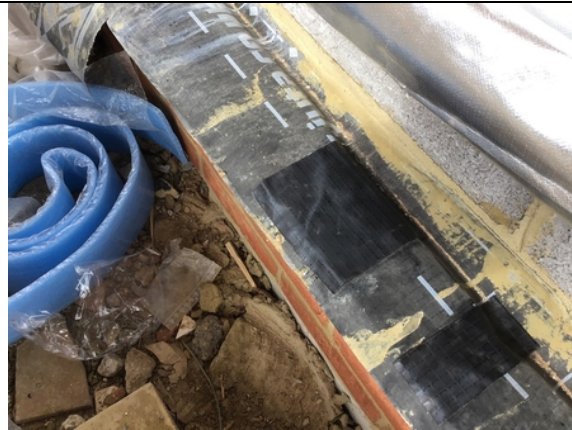
Repaired hole in membrane using Juta GP1 SAM to plot 10.

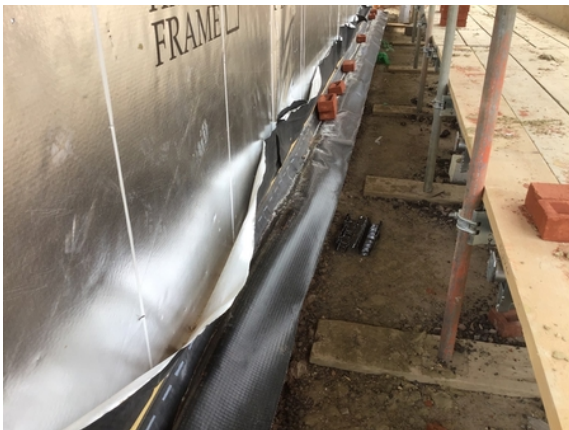
Overview of the extended Juta GP1 gas membrane that has been hand welded to the previously installed gas membrane which now spans the perimeter cavity wall across plot 11.

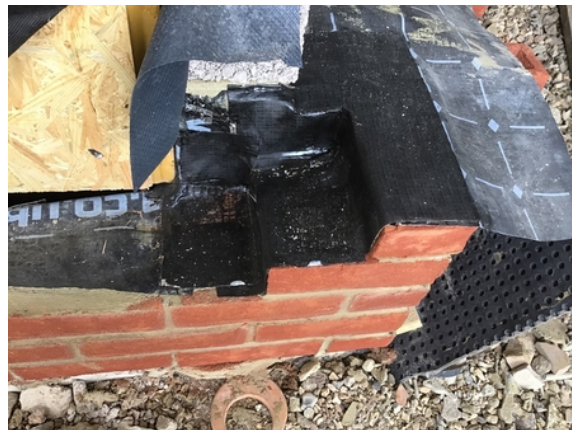
Detailing work to the extended perimeter membrane to plot 11.

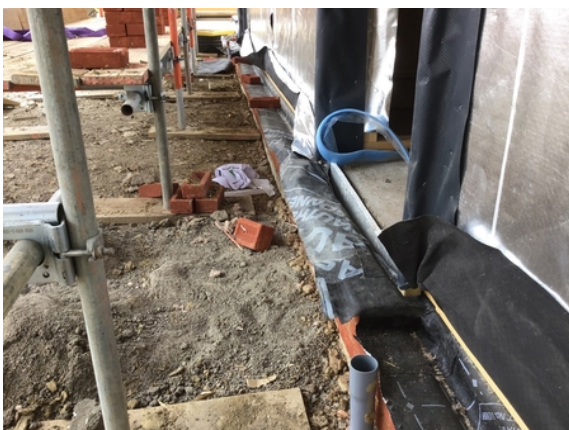
Overview of the extended Juta GP1 gas membrane that has been hand welded to the previously installed gas membrane which now spans the perimeter cavity wall across the front elevation of plots 12 & 13.

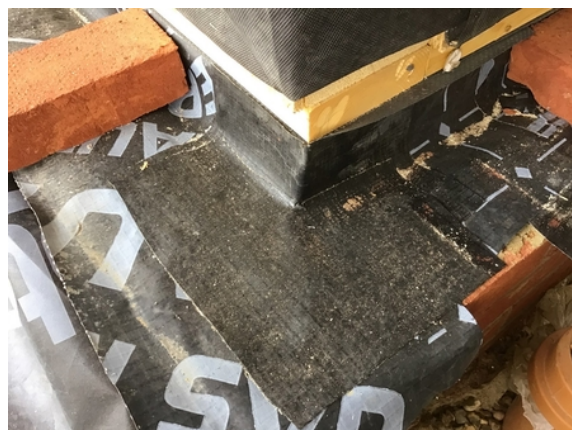
Corner detailing work to plot 12.

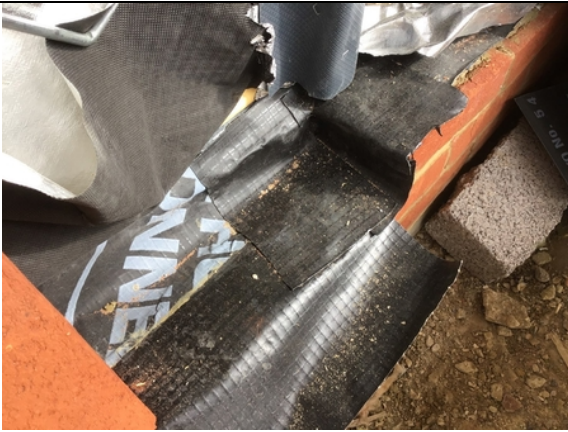
Door threshold detailing at the back of plot 13.

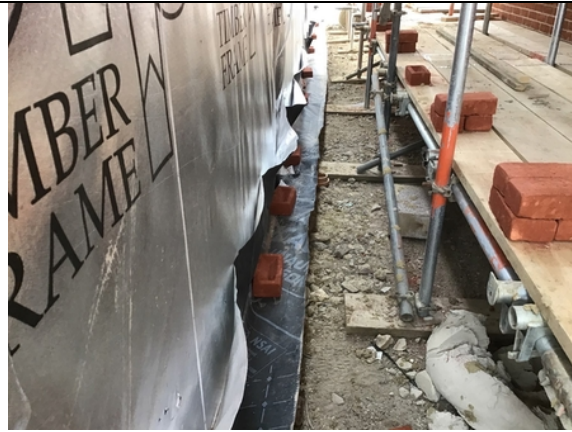
Overview of the extended Juta GP1 gas membrane that has been hand welded to the previously installed gas membrane which now spans the perimeter cavity wall across plots 14 & 15.

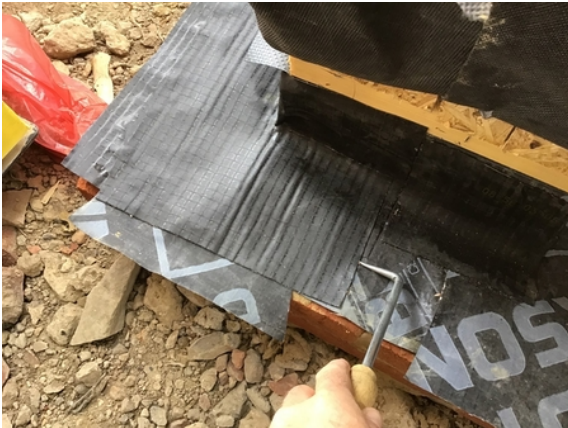
Probe testing the corner detailing in plots 14 & 15.

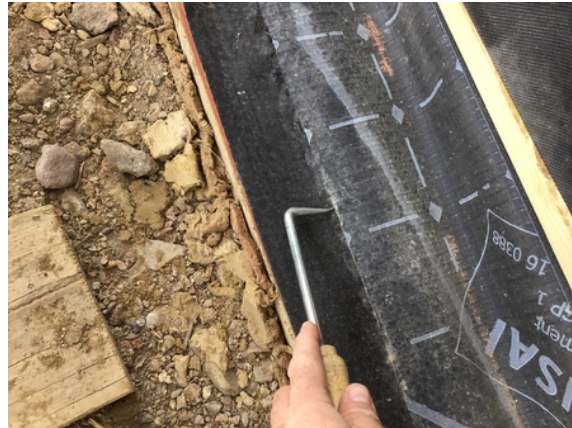
Probe testing all hand welded membrane laps in plots 14 & 15.

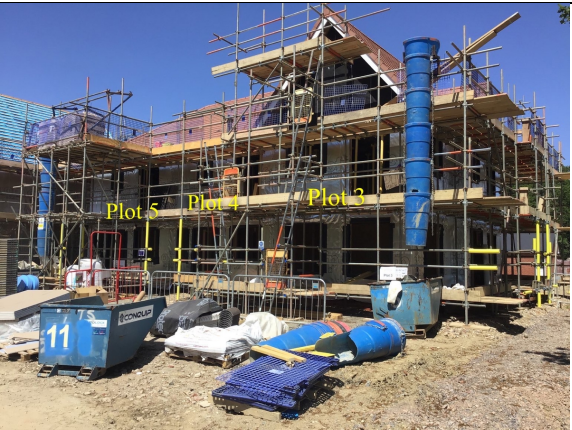
A general overview of plots 3,4 & 5.

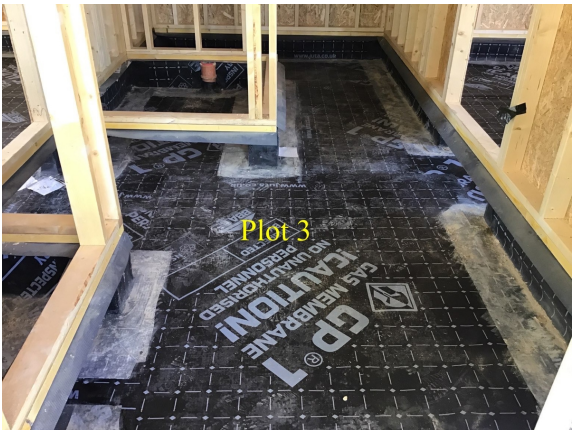
Overview of the Juta GP1 gas membrane installed as an infill in plot 3.

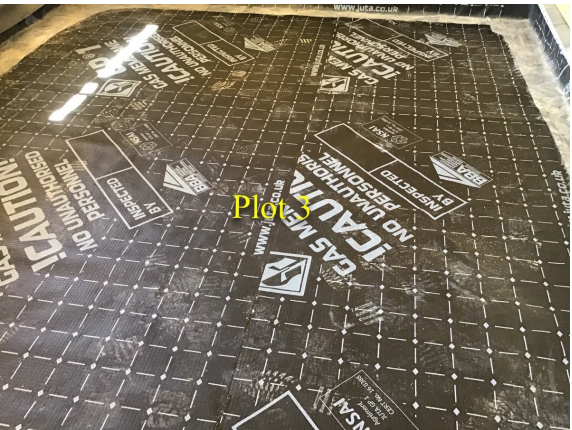
Overview of the Juta GP1 gas membrane installed as an infill in plot 3.
