## Foul and Surface Water Drainage Report

**Prince Albert, Copthorne**

**Westcoast Developments Ltd**

Reference **C3261**

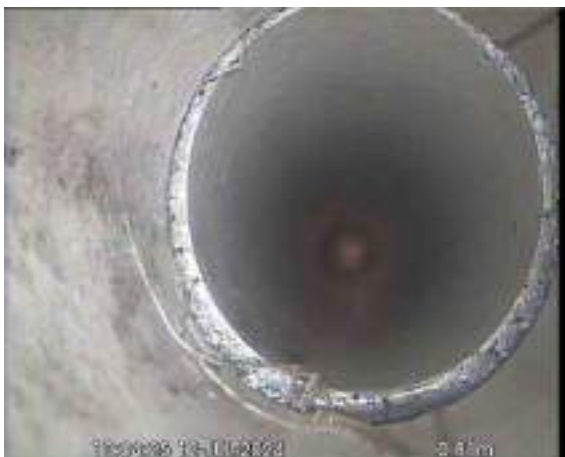
GULLYX\_b10122b8-1f1f-4b61-85ad-1d1dd839dd63\_20240725\_090208\_797.jpg, 00:01:01, 0.81 m  
Crack, circumferential at joint from 6 o'clock to 9 o'clock

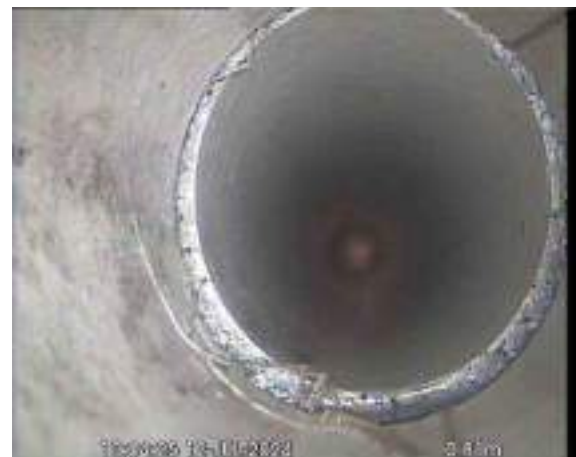
GULLYX\_497c7feb-53ee-44b1-89dc-872bd2b7a9cf\_20240725\_090218\_006.jpg, 00:01:01, 0.81 m  
Roots, fine at joint

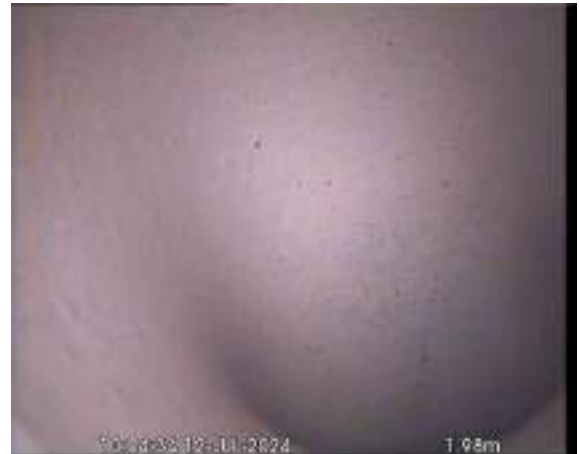
GULLYX\_be408751-b267-4dcb-87b2-47920da53df0\_20240725\_090226\_317.jpg, 00:01:01, 0.81 m  
Joint displaced, medium

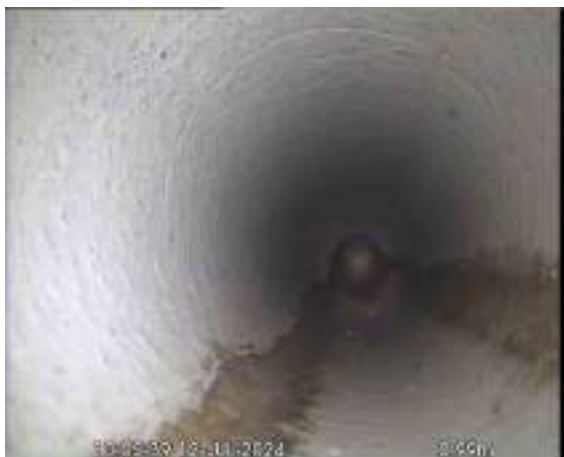
W\_CX\_b0b5a396-c87b-44df-b524-f6ae86763abc\_20240725\_090413\_863.jpg, 00:00:37, 0.99 m  
Crack, circumferential from 9 o'clock to 3 o'clock

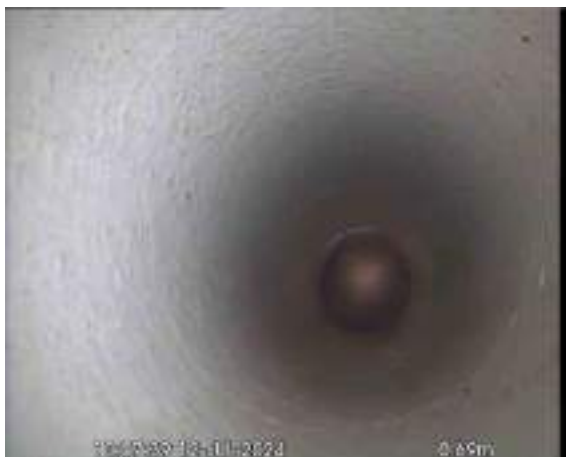
W\_CX\_6de99cdf-b413-404c-b955-bd55d3022d42\_20240725\_090601\_206.jpg, 00:00:31, 0.69 m  
Crack, circumferential from 3 o'clock to 8 o'clock

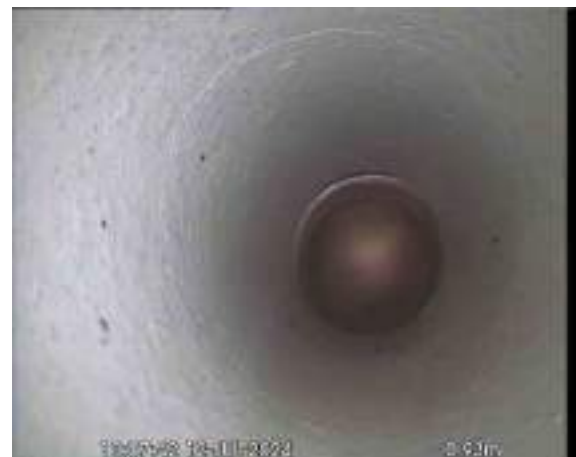
W\_CX\_9fa16cc0-0598-4ab2-b04a-1bd0e0447c7d\_20240725\_090647\_708.jpg, 00:00:34, 0.93 m  
Crack, circumferential from 9 o'clock to 3 o'clock

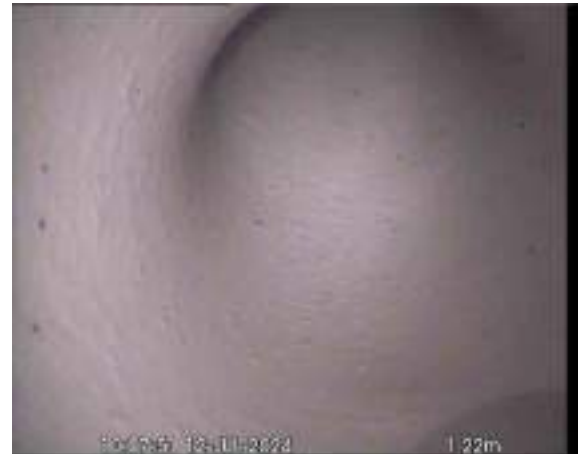
W\_CX\_1865770f-a7a0-438a-95c3-9da68d53db4d\_20240725\_090701\_492.jpg, 00:00:39, 1.13 m  
Joint displaced, medium

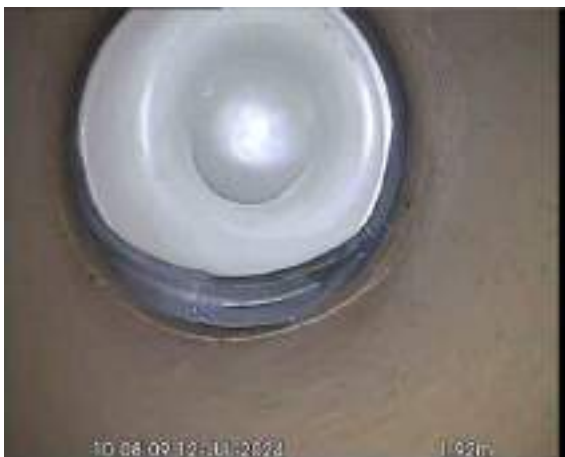
W\_CX\_140950e0-f4b9-4fa9-b1b6-8f3dc2314eb6\_20240725\_090748\_590.jpg, 00:01:01, 1.92 m  
Crack, circumferential at joint from 12 o'clock to 12 o'clock

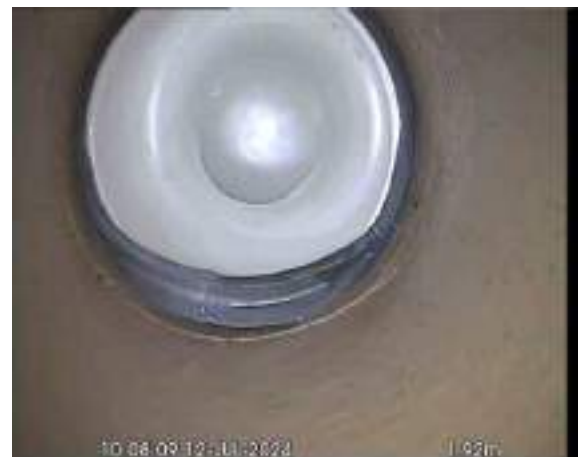
W\_CX\_dc0dc9d8-5d35-437e-89b2-f803bfeb8fe8\_20240725\_090809\_548.jpg, 00:01:01, 1.92 m  
Sealing ring intruding, intruding but not hanging from 4 o'clock to 8 o'clock, (ON PAN CONNECTOR)

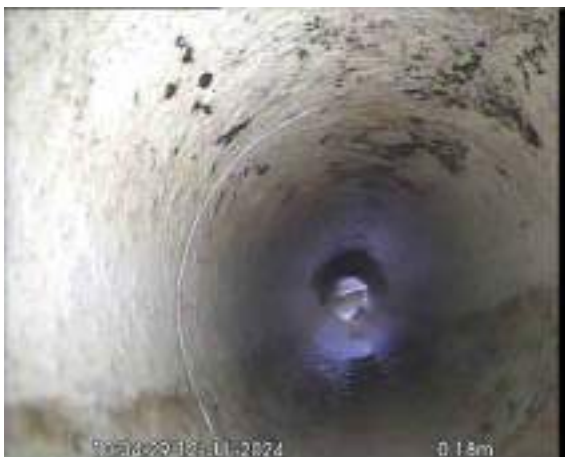
MH1X\_97e7b7b8-20ed-4a65-9726-8e0e94167fbc\_20240725\_090948\_059.jpg, 00:00:28, 0.18 m  
Crack, circumferential from 6 o'clock to 12 o'clock

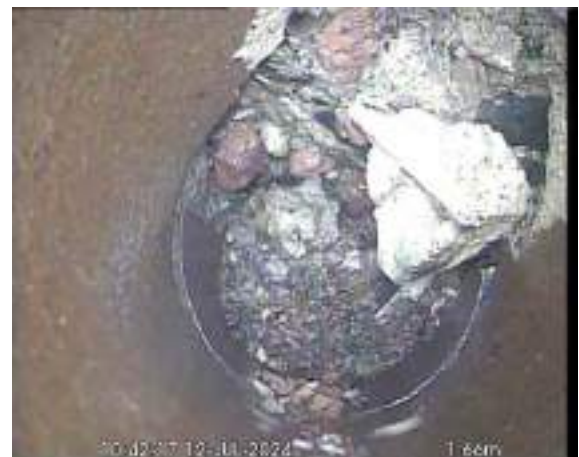
REDUNDANTX\_29814b43-2bf2-411c-83a3-7448b2e32080\_2  
0240725\_091151\_156.jpg, 00:00:47, 1.66 m  
Broken pipe from 10 o'clock to 3 o'clock

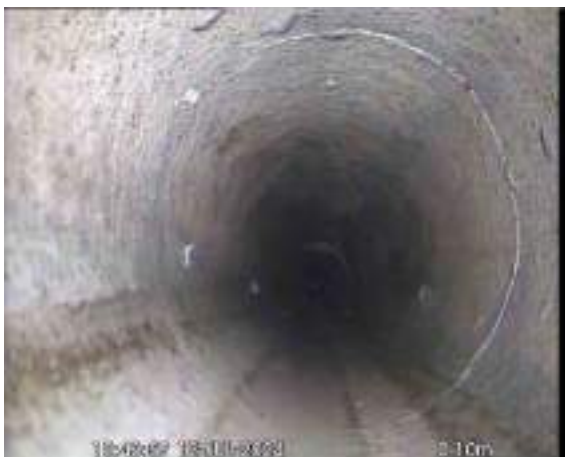
MH6X\_d2fe370d-baf2-4429-b37e-bc117d0a8e8e\_20240725\_091559\_829.jpg, 00:00:23, 0.10 m  
Fracture, circumferential from 11 o'clock to 5 o'clock

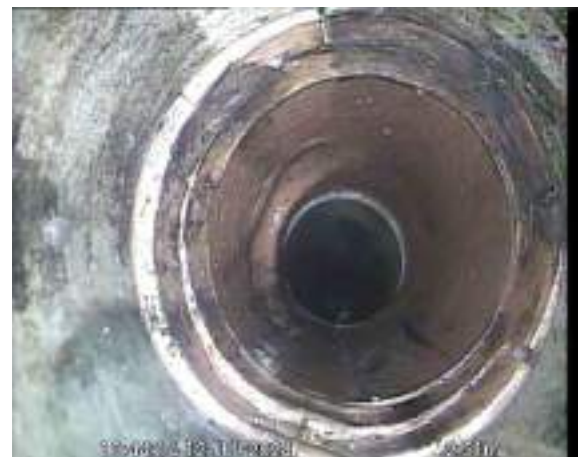
MH6X\_5b7b7237-2ba3-4cba-86aa-fcb1f22d1ecc\_20240725\_092232\_813.jpg, 00:00:41, 2.51 m  
Fracture, multiple at joint from 12 o'clock to 12 o'clock

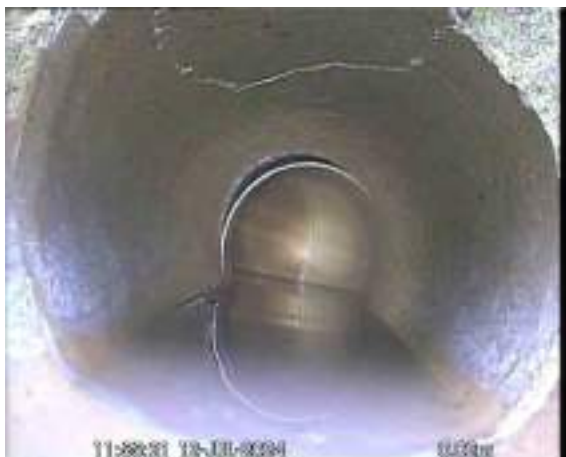
MH2X\_71538d31-1645-4ac7-b3ba-3a632e838191\_20240725\_092525\_584.jpg, 00:00:35, 0.02 m  
Crack, circumferential from 10 o'clock to 2 o'clock

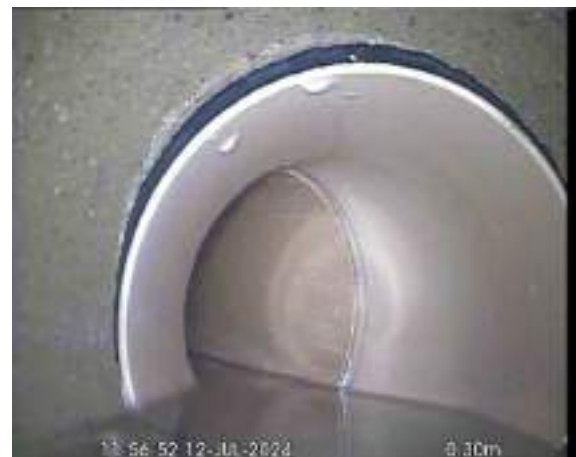
MH2X\_9e3848a9-2aef-4403-9dc0-06a55e9cccf0\_20240725\_092609\_653.jpg, 00:00:56, 0.30 m  
Joint displaced, medium

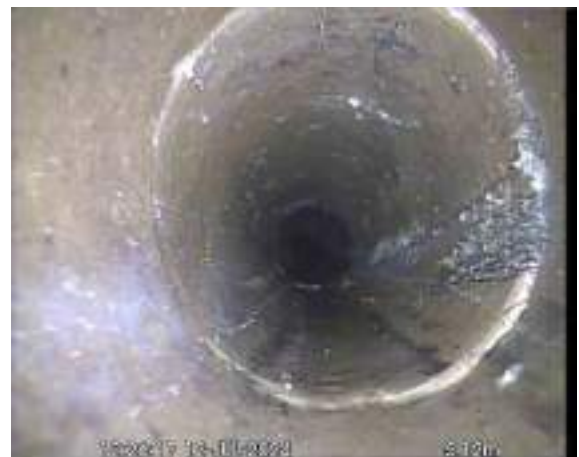
MH5X\_109efa46-164d-464f-96dd-18bcad47188e\_20240725\_094816\_811.jpg, 00:01:44, 5.12 m  
Roots, fine at joint

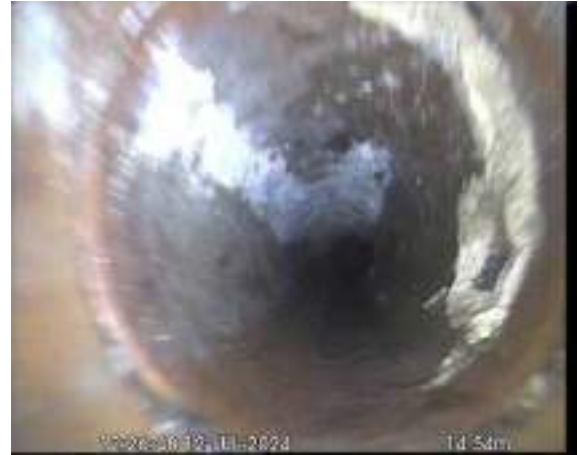
MH5X\_b9529b71-08d6-4df3-a0ef-83327201d51f\_20240725\_094926\_931.jpg, 00:02:15, 14.54 m  
Hole in drain or sewer at 4 o'clock

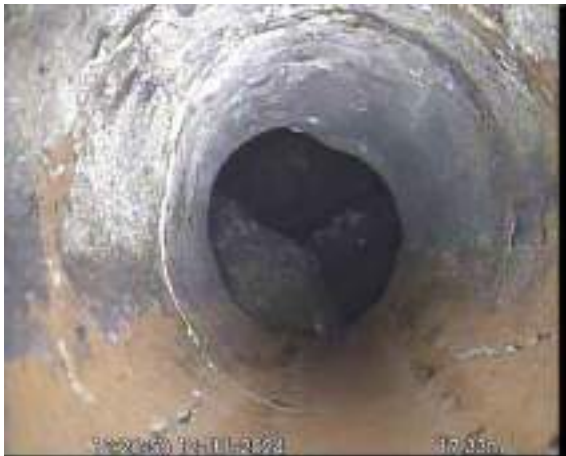
MH5X\_245e56e0-af60-4cc5-9251-72fe8d11e2b2\_20240725\_094946\_179.jpg, 00:02:23, 17.33 m  
Fracture, multiple from 12 o'clock to 12 o'clock

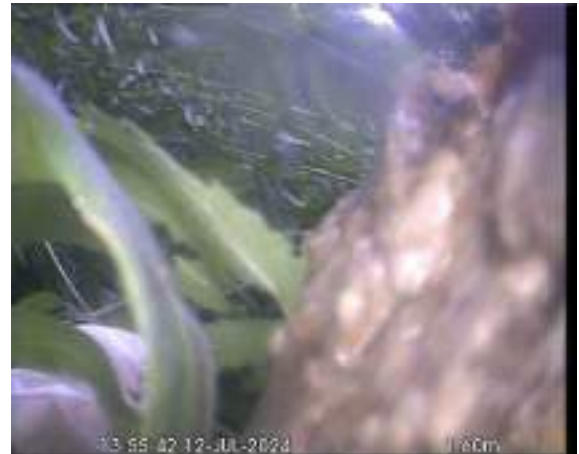
SVPX\_9d8768b1-86dd-4d7b-b136-613c52434c58\_20240725\_095530\_137.jpg, 00:01:28, 1.60 m  
Survey abandoned, S/A - OPEN PIPE - SOIL VENT PIPE NOT CONNECTED UP

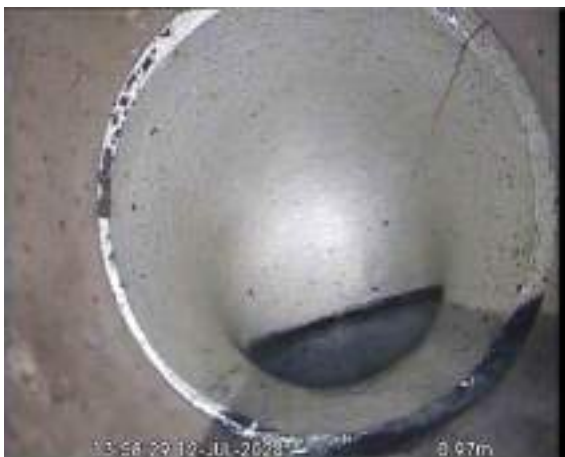
GULLYX\_36dc49d5-3dc1-4da4-862e-24eaa0b586df\_20240725\_100014\_047.jpg, 00:00:24, 0.97 m  
Crack, longitudinal at joint at 2 o'clock

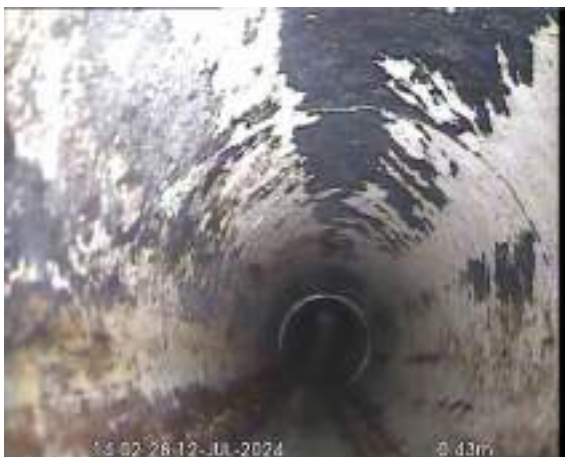
GULLYX\_2b29d929-3dfa-4401-bebe-b29732e2f259\_20240725\_101316\_226.jpg, 00:00:39, 0.43 m  
Fracture, circumferential from 10 o'clock to 3 o'clock

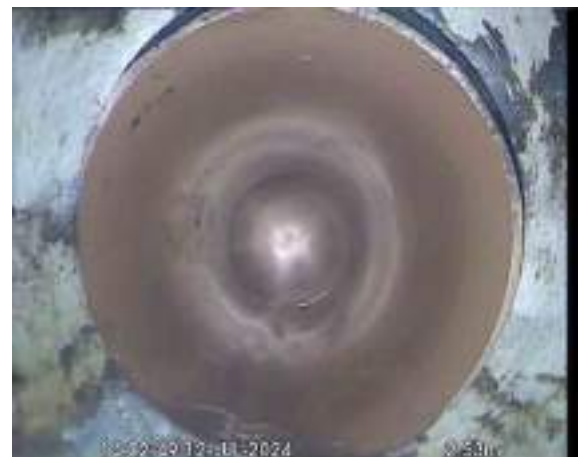
GULLYX\_a0d2ed5e-7b7e-4ae5-a077-94c7952a4929\_20240725\_101329\_585.jpg, 00:01:00, 2.53 m  
Joint displaced, medium

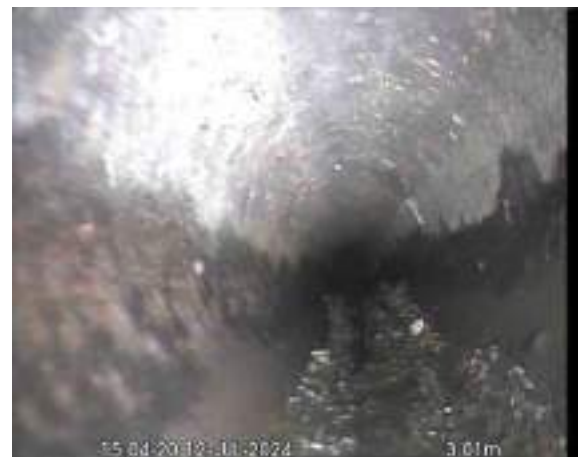
MANHOLEX\_9f739453-0b6d-4c3b-aa2f-970cef82bb99\_20240725\_102213\_871.jpg, 00:00:51, 3.01 m  
Settled deposits, fine, 5% cross-sectional area loss
