# Asbestos Reinspection Report

Job Ref No: **492967**, Account Ref No: **21707**, Contract Ref No: **70197**, Client Site Ref: **HU06**

**Nationwide Hurstpierpoint, 58 High Street, Hurstpierpoint, West Sussex, BN6 9RG**

**Title:** Re-inspection Survey to 0398-HU06

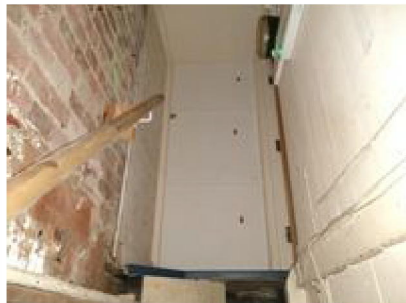
| Building | Level | Location | Item / Product Examined | Sample No. | Material Description | Fibre Type | Material Score | Extent | Risk Level Assessment | Initial Control Recommendation | Photograph |
|---|---|---|---|---|---|---|---|---|---|---|---|
| Nationwide, Hurstpierpoint | -1 | 001/ stairwell | Panels to wall | 65082-3 | Asbestos-containing cement | Chrysotile | 5 | 3 No. | R2 | Reinspect Periodically | |

| Building: Nationwide, Hurstpierpoint | | | Level: -1 | | | Location: 001/ stairwell | | | | | |
|---|---|---|---|---|---|---|---|---|---|---|---|
| Panels to wall | Asbestos-containing cement | Previously Sampled | 65082-3 | 3 No. | 2 | 1 | 1 | Chrysotile | 5 | 3 | <br>R2 |

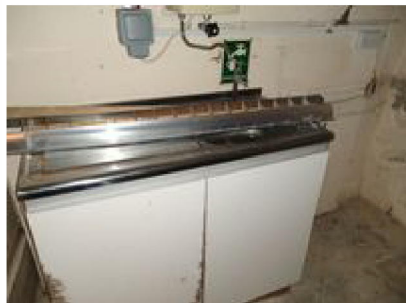
| Building | Level | Location | Item / Product Examined | Sample No. | Material Description | Fibre Type | Material Score | Extent | Risk Level Assessment | Initial Control Recommendation | Photograph |
|---|---|---|---|---|---|---|---|---|---|---|---|
| Nationwide, Hurstpierpoint | -1 | 002/ basement staff room | Sink pad | 241497-8 | Asbestos-containing bituminous product | Chrysotile | 3 | 0.1 Sqm. | R3 | Reinspect Periodically | |

| Building: Nationwide, Hurstpierpoint | | | Level: -1 | | | Location: 001/ stairwell | | | | | |
|---|---|---|---|---|---|---|---|---|---|---|---|
| Sink pad | Asbestos-containing bituminous product | Previously Sampled | 241497-8 | 0.1 Sqm. | 1 | 1 | 0 | Chrysotile | 3 | 3 | <br>R3 |

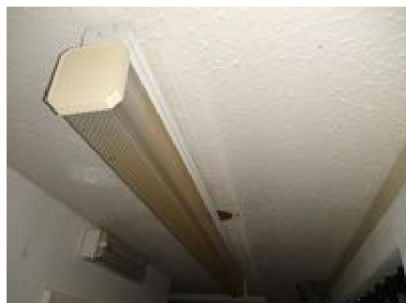
| Building | Level | Location | Item / Product Examined | Sample No. | Material Description | Fibre Type | Material Score | Extent | Risk Level Assessment | Initial Control Recommendation | Photograph |
|---|---|---|---|---|---|---|---|---|---|---|---|
| Nationwide, Hurstpierpoint | -1 | 003/ corridor | Ceiling | 241497-9 | Asbestos-containing textured coating | Chrysotile | 3 | 5 Sqm. | R3 | Reinspect Periodically | |

| Building: Nationwide, Hurstpierpoint | | | | | Level: -1 | | Location: 003/ corridor | | | | |
|---|---|---|---|---|---|---|---|---|---|---|---|
| Ceiling | Asbestos-containing textured coating | Previously Sampled | 241497-9 | 5 Sqm. | 1 | 1 | 0 | Chrysotile | 3 | 3 | |

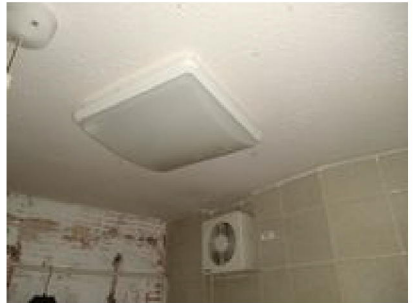
| Building | Level | Location | Item / Product Examined | Sample No. | Material Description | Fibre Type | Material Score | Extent | Risk Level Assessment | Initial Control Recommendation | Photograph |
|---|---|---|---|---|---|---|---|---|---|---|---|
| Nationwide, Hurstpierpoint | -1 | 004/ wc | Ceiling | 241497-9 | Asbestos-containing textured coating | Chrysotile | 3 | 3 Sqm. | R3 | Reinspect Periodically | |

| Building: Nationwide, Hurstpierpoint | | | | | Level: -1 | | Location: 004/ wc | | | | |
|---|---|---|---|---|---|---|---|---|---|---|---|
| Ceiling | Asbestos-containing textured coating | Previously Sampled | 241497-9 | 3 Sqm. | 1 | 1 | 0 | Chrysotile | 3 | 3 | |

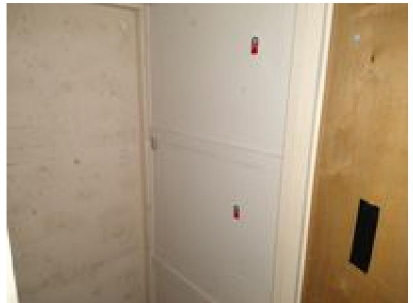
| Building | Level | Location | Item / Product Examined | Sample No. | Material Description | Fibre Type | Material Score | Extent | Risk Level Assessment | Initial Control Recommendation | Photograph |
|---|---|---|---|---|---|---|---|---|---|---|---|
| Nationwide, Hurstpierpoint | 0 | 004/ Stairwell To Basement | Wall panels | 241497-5 | Asbestos-containing cement | Chrysotile | 4 | 3 Sqm. | R3 | Reinspect Periodically | |

| Building: Nationwide, Hurstpierpoint | | | | | Level: 0 | | Location: 004/ Stairwell To Basement | | | | |
|---|---|---|---|---|---|---|---|---|---|---|---|
| Wall panels | Asbestos-containing cement | Previously Sampled | 241497-5 | 3 Sqm. | 1 | 1 | 1 | Chrysotile | 4 | 3 | |
