| <b>Housebuilder Name: Elivia Homes - The Woodlands</b> | | | <b>Date: 06/06/2025</b> |
| <b>Site Name: Reeds Lane, Sayers Common</b> | | | <b>Weather: 14 °C Showers</b> |
| <b>Postcode: BN6 9JG</b> | | <b>Surveyor: James Hall (TGPV)</b> | |

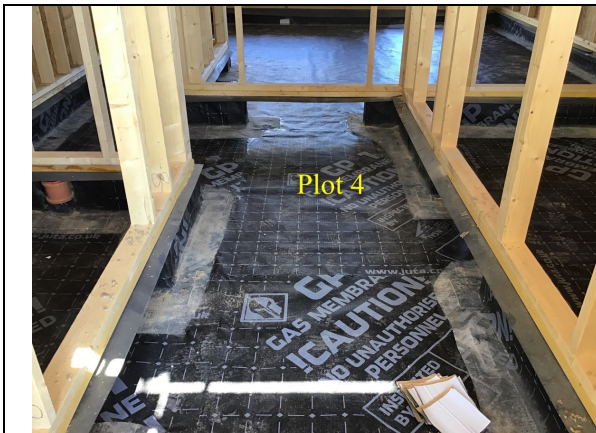
Overview of the Juta GP1 gas membrane installed as an infill in plot 4.

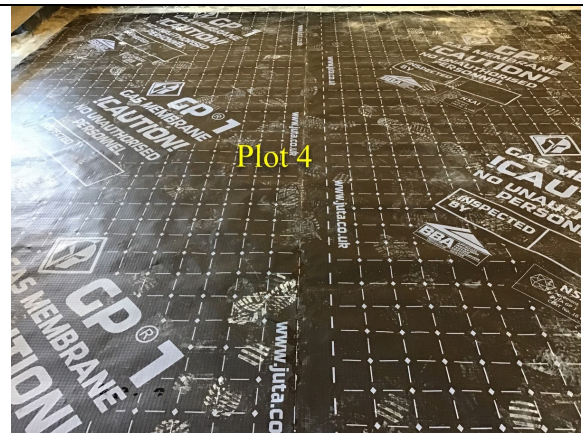
Overview of the Juta GP1 gas membrane installed as an infill in plot 4.

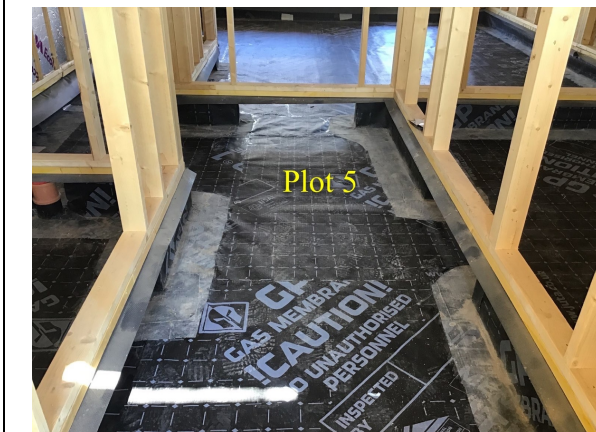
Overview of the Juta GP1 gas membrane installed as an infill in plot 5.

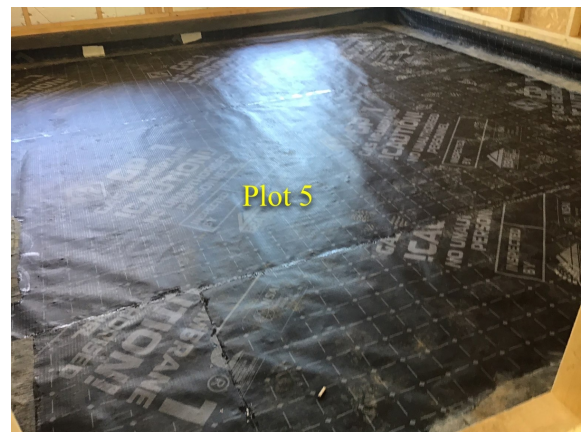
Overview of the Juta GP1 gas membrane installed as an infill in plot 5.

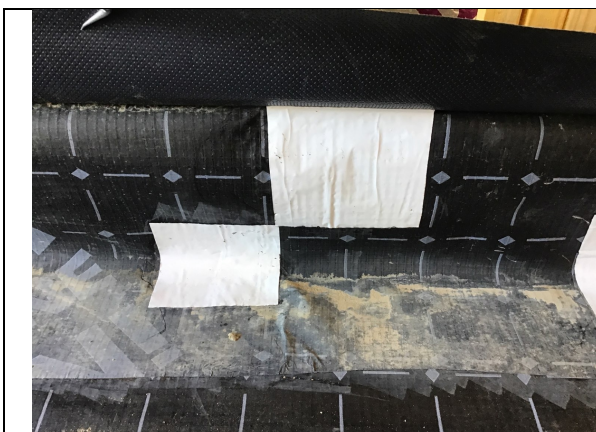
Patch repairs in plot 3.

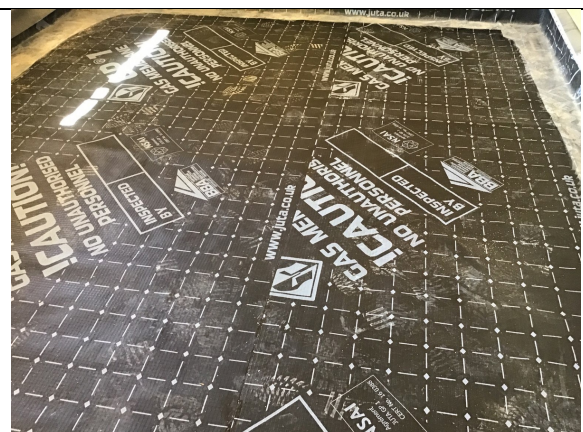
Overview of a hand welded membrane lap in plot 3.

| <b>Material Jointing Method:</b> The membrane has been overlapped sufficiently to achieve a sound joint, the joint is clean and dry and has been joined by means of hand welding with a hot air gun and neoprene roller, the width of the welded joint is a minimum of 30mm. | | | |

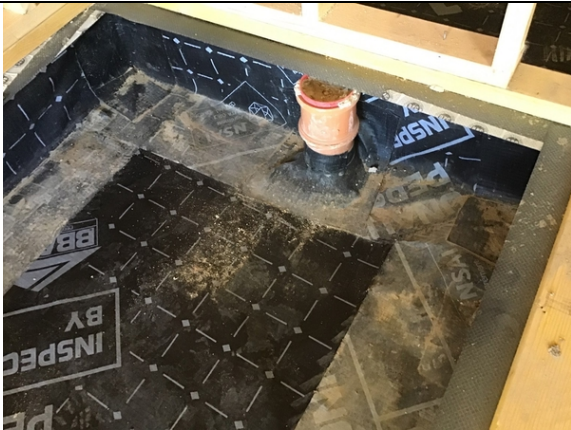
Overview of a pipe penetration detailing that has been inspected on a previous visit in plot 3.

| <b>Service Entry Seal Method:</b> The external of the pipes/ducts have been sealed using preformed tophats that have been hand welded into place, this is an approved and recognised method in CIRIA C735 | | | |

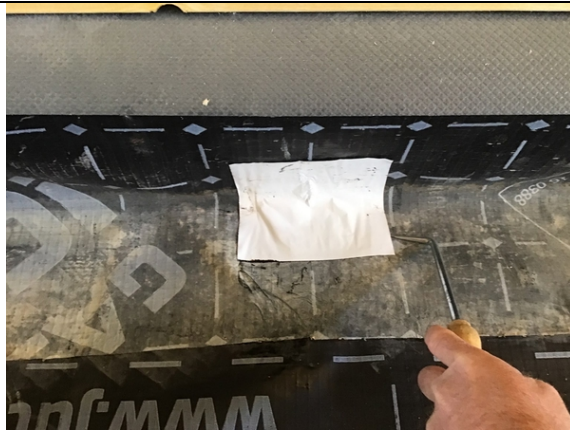
Probe testing a patch repair in plot 4.

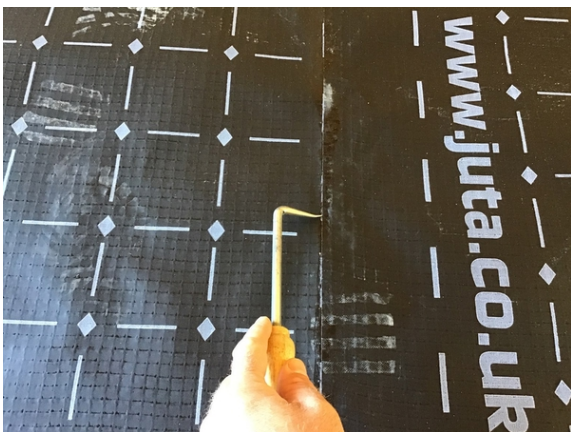
Probe testing a hand welded membrane lap in plot 4.

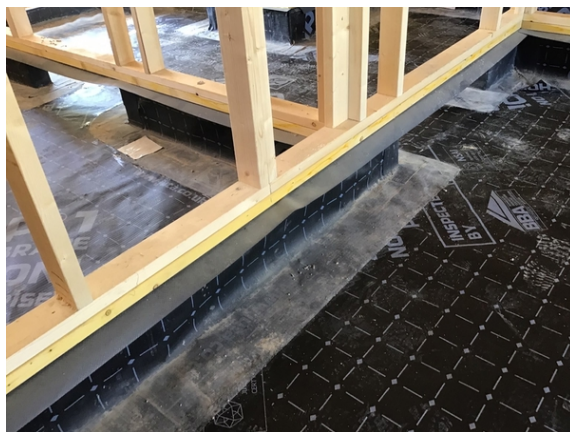
Overview of the internal wall membrane that has been hand welded to the infilled membrane in plot 4.

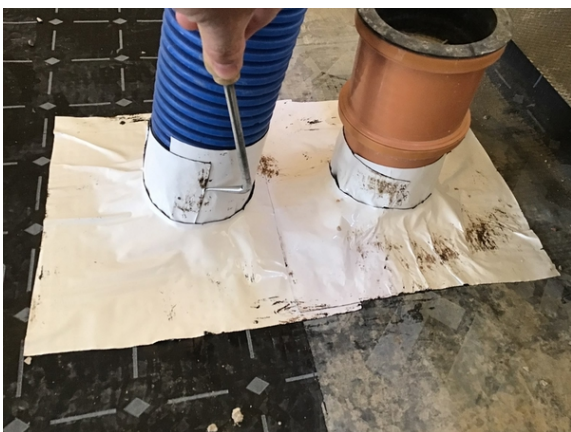
Probe testing a typical pipe penetration detail in plot 5.

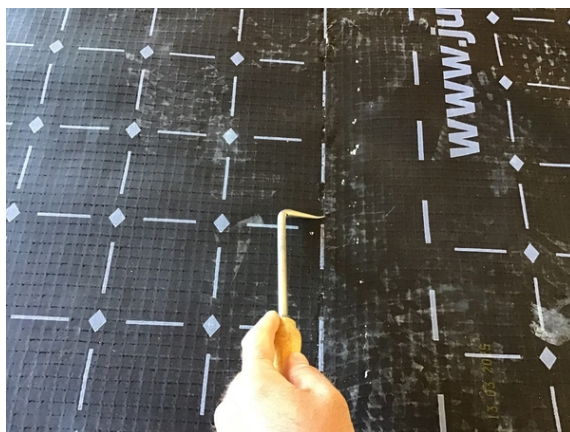
Probe testing all hand welded membrane laps in plot 5.

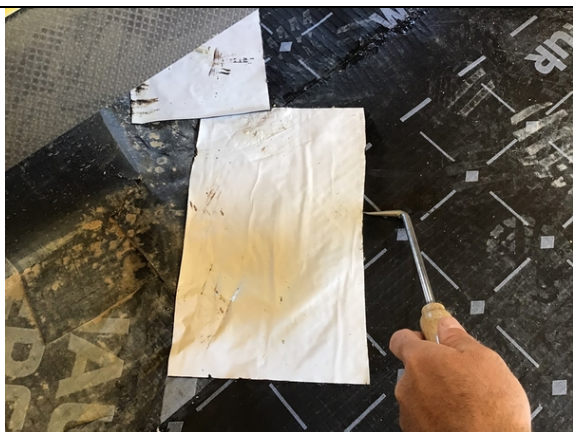
Probe testing a patch repair in plot 5.
