| Housebuilder Name: Elivia Homes - The Woodlands | | | Date: 10/06/2025 |
| Site Name: Reeds Lane, Sayers Common | | | Weather: 20 °C Dry/Overcast |
| Postcode: BN6 9JG | | Surveyor: James Hall (TGPV) | |
| Plot Number | Building Type | Extent of Inspection | Result |

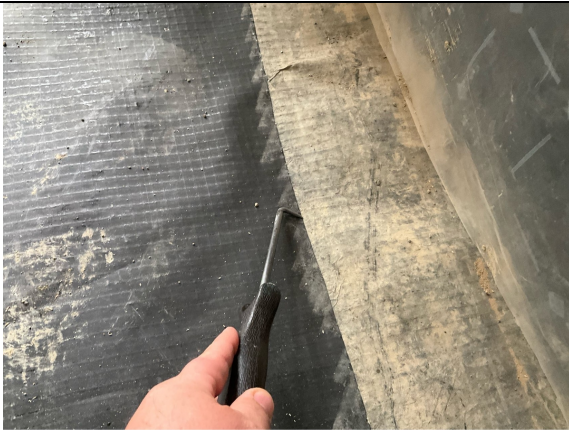
Plot 15. Probe testing along perimeter edge hand welded membrane lap joints.

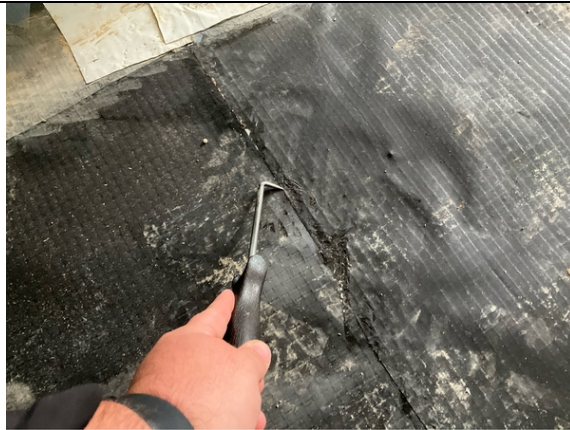
Plot 15. Probe testing along hand welded lap joints.

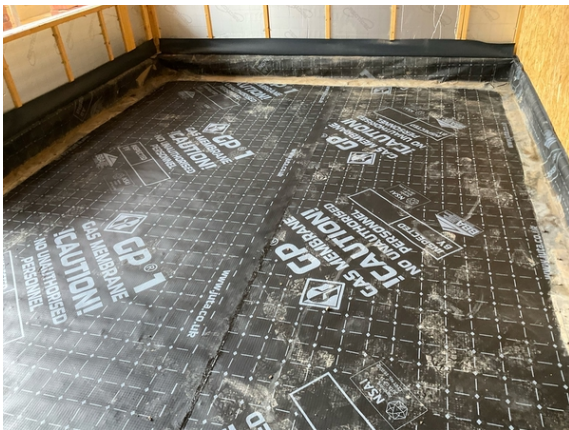
Plot 34. Overview of the Infill installation using Juta GP1.

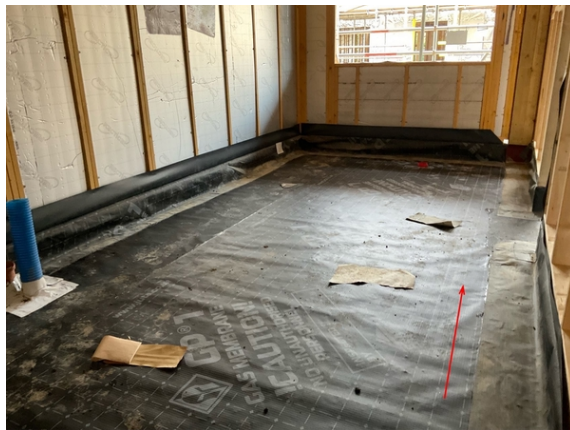
Plot 34. Overview of the Infill installation using Juta GP1.

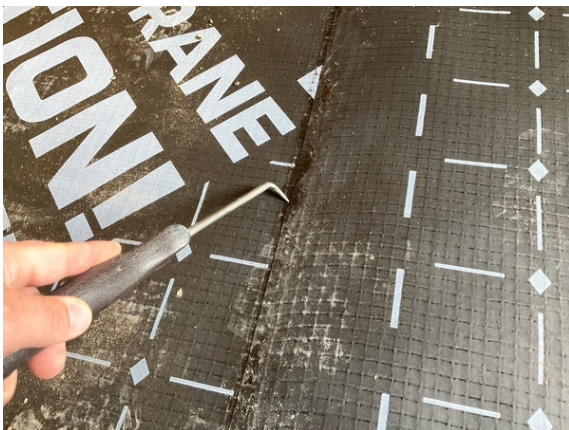
Plot 34. Probe testing along hand welded membrane lap joints.

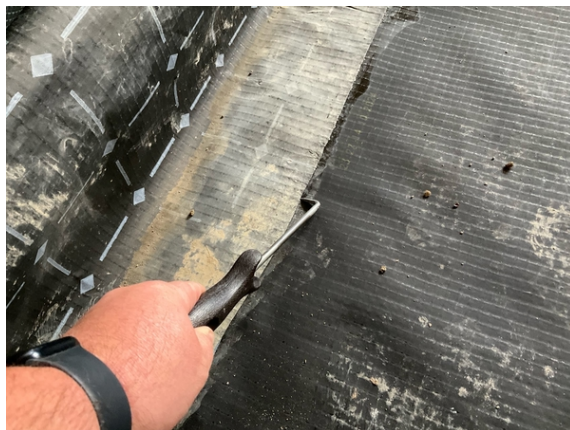
Plot 34. Probe testing along perimeter edge hand welded lap joints.

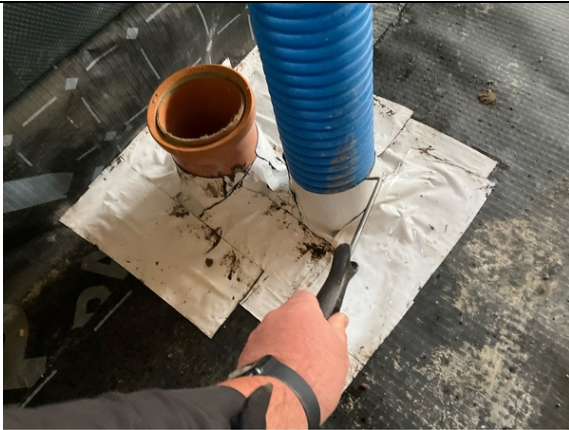
Plot 34. Probe testing to pipe penetration details.

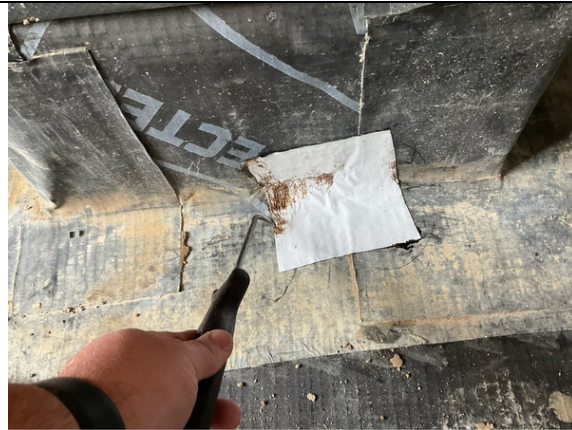
Plot 34. Probe testing to installers own CQA patch repairs.

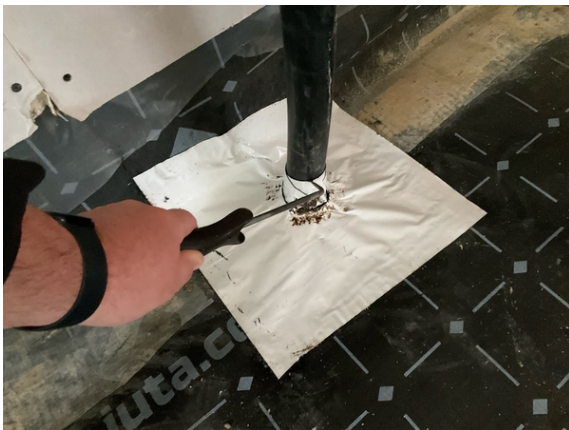
Plot 34. Probe testing to pipe penetration details.

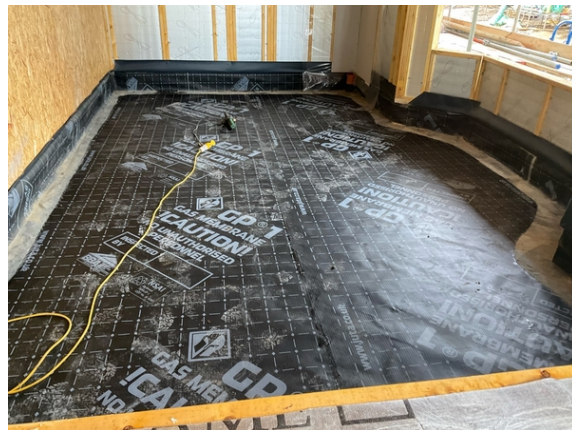
Plot 35. Overview of the Infill installation using Juta GP1.

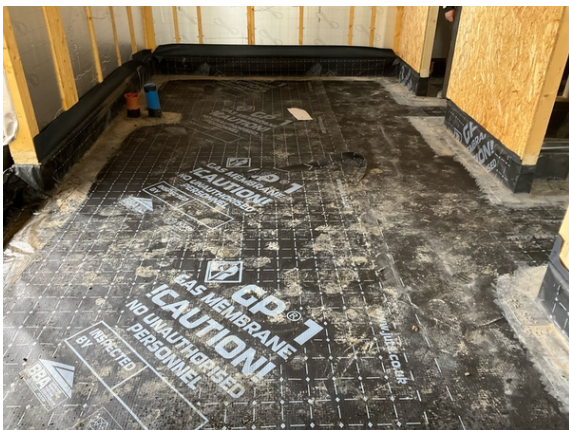
Plot 35. Overview of the Infill installation using Juta GP1.

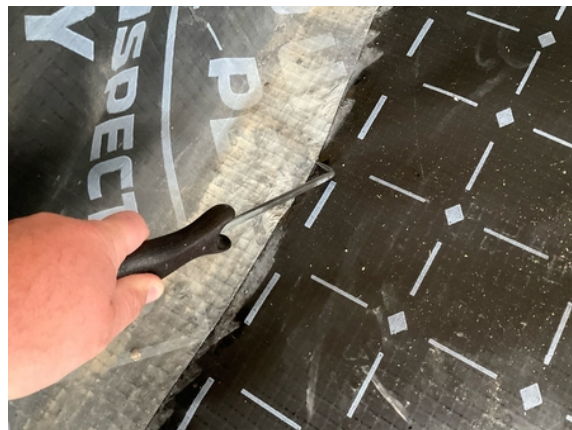
Plot 35. Probe testing along perimeter edge hand welded lap joints.

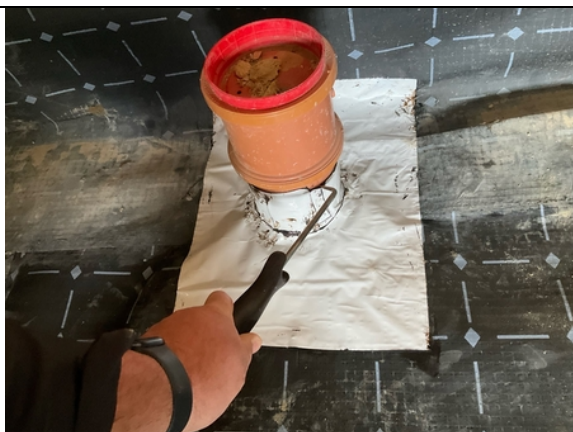
Plot 35. Probe testing to pipe penetration details.

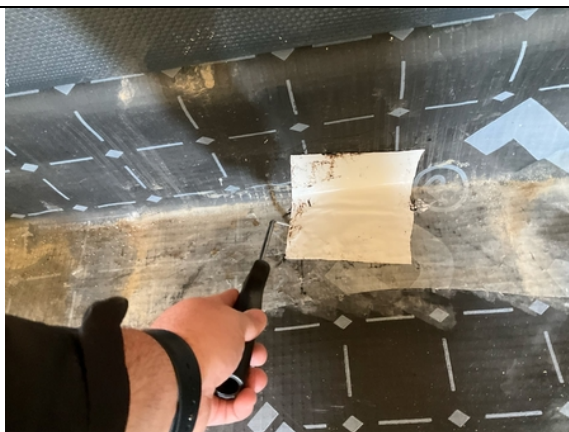
Plot 35. Probe testing to installers own CQA patch repairs.

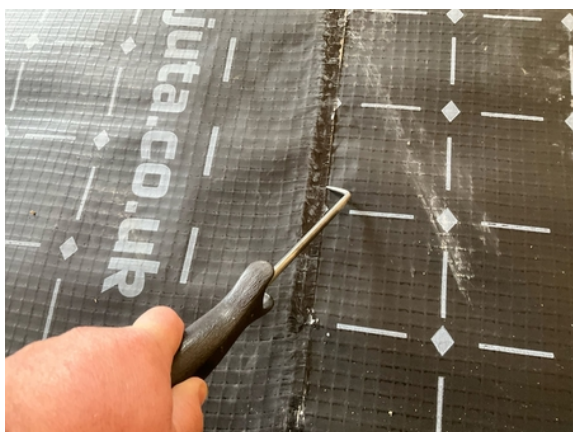
Plot 35. Probe testing along hand welded membrane lap joints.

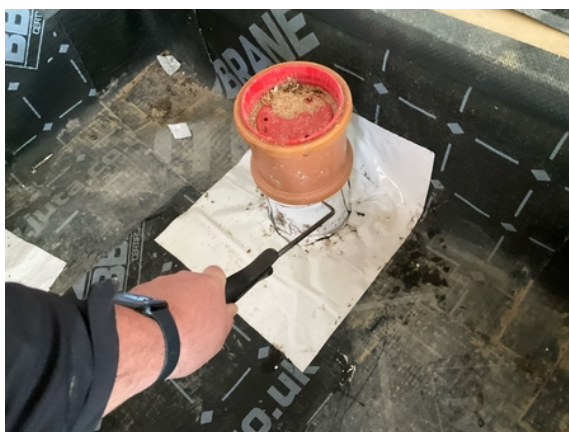
Plot 35. Probe testing to pipe penetration details.

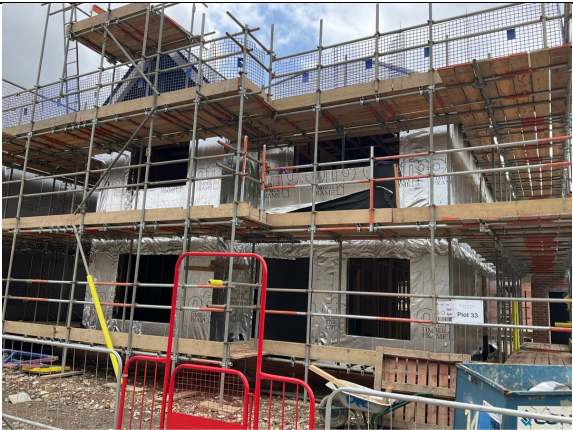
General overview of Plot 33.

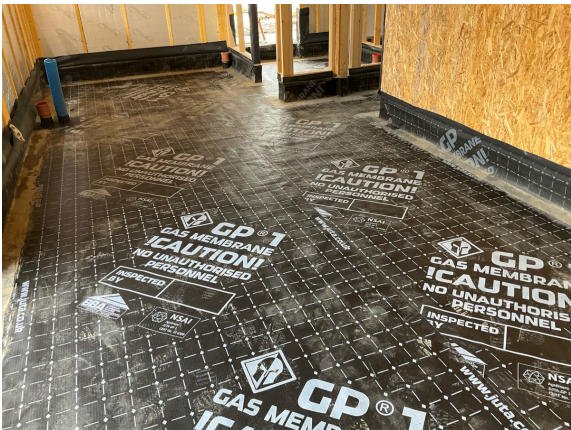
Overview of the infill installation using Juta GP1.

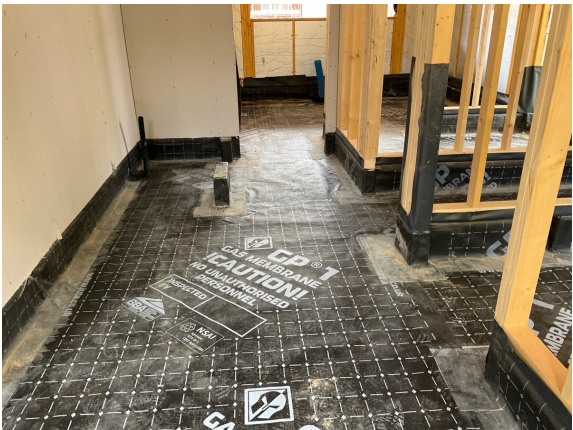
Overview of the infill installation using Juta GP1.
