### Detailing Sample Photographs

| Housebuilder Name: Elivia Homes - The Woodlands. | | | Date: 25/06/2025 |
| Site Name: Reeds Lane, Sayers Common. | | | Weather: 26 °C Dry |

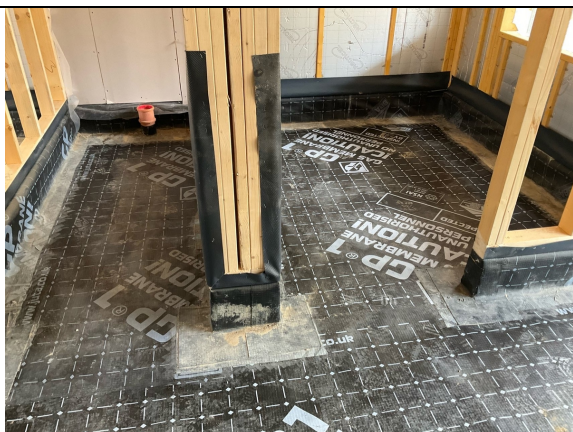
Overview of the infill installation using Juta GP1.

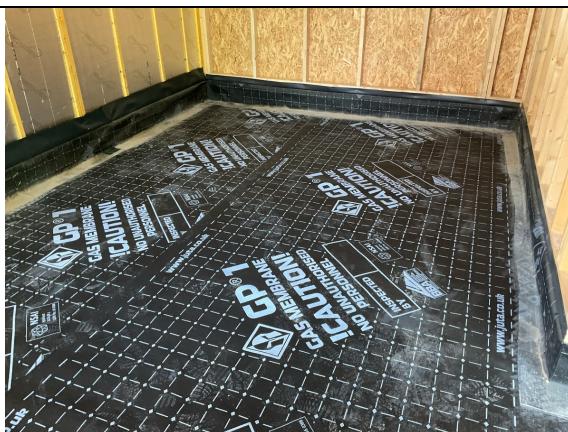
Overview of the infill installation using Juta GP1.

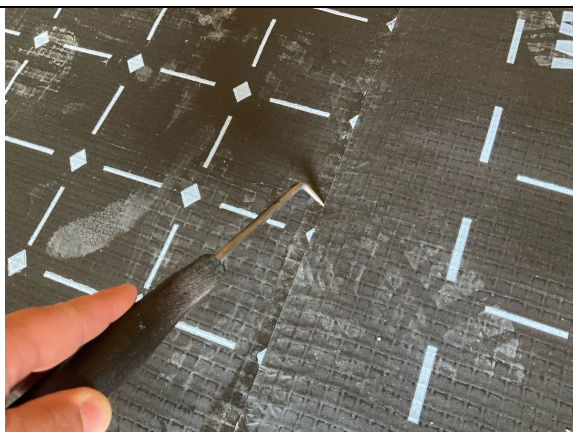
Probe testing along hand welded membrane lap joints.

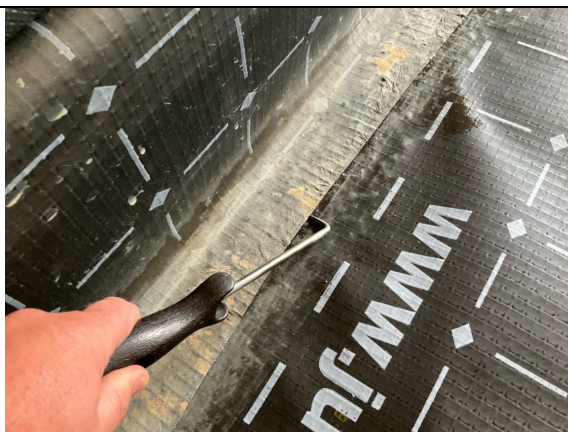
Probe testing along perimeter edge hand welded membrane lap joints.

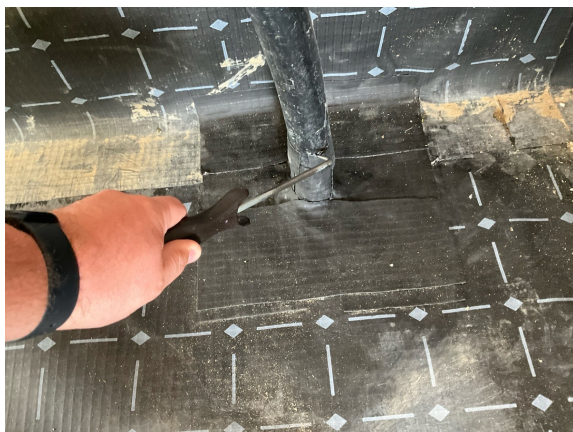
Probe testing to pipe penetration details.

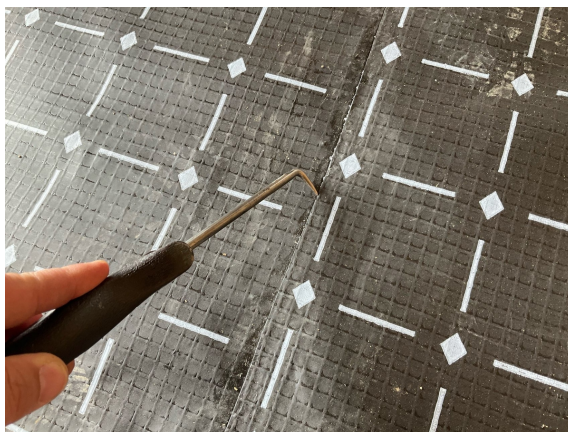
Probe testing along hand welded membrane lap joints.

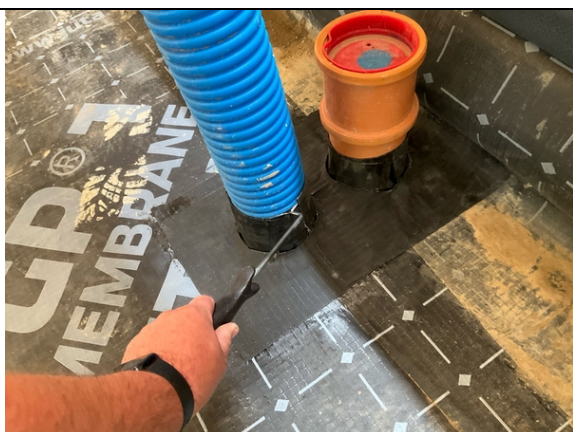
Probe testing to pipe penetration details.

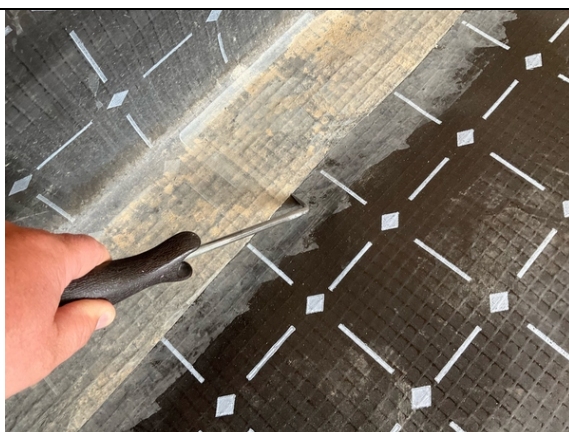
Probe testing along perimeter edge hand welded membrane lap joints.

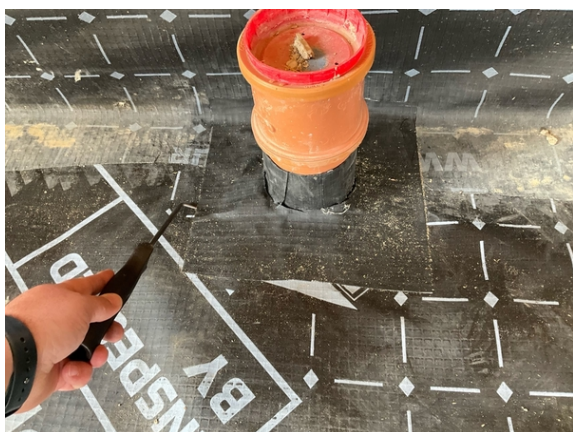
Probe testing to pipe penetration details.

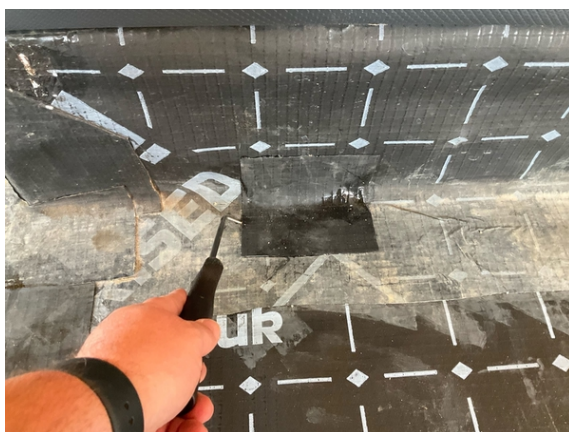
Probe testing to installers own CQA patch repairs.

| Housebuilder Name: Elivia Homes - The Woodlands. | | | Date: 25/06/2025 |
|---|---|---|---|
| 33,34,36 & 37. | No defects were recorded at the time of our inspection however MB Membranes carried out the own CQA repairs during the install. | | N/A |

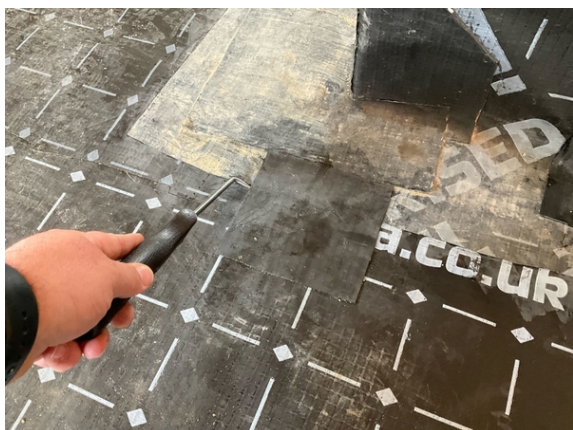
Probe testing to installers own CQA patch repairs.
