| Housebuilder Name: Elivia Homes - The Woodlands. | | | Date: 03/07/2025 |
| Site Name: Reeds Lane, Sayers Common. | | | Weather: 28 °C Dry |
| 35 & 37. | Detached. | Miscelanoues Repairs (See section 3 Defects section for details of completed repairs | Pass |

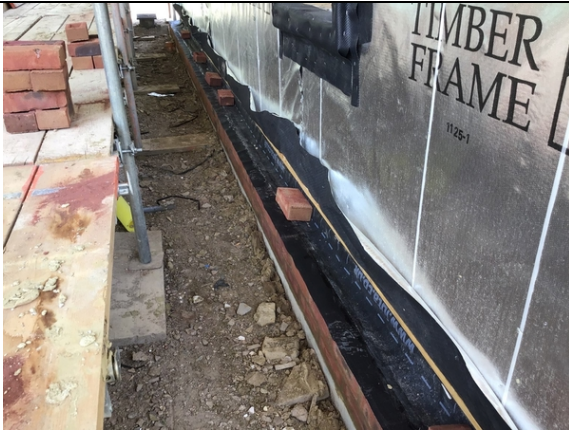
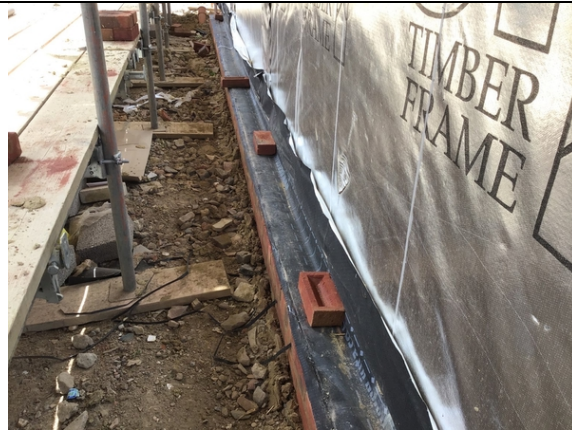
Overview of the extended membrane installation to close off the perimeter cavity on plot 36.

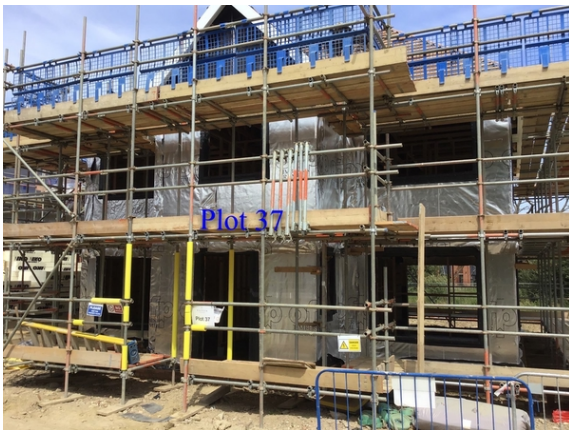
A general overview of plot 37.

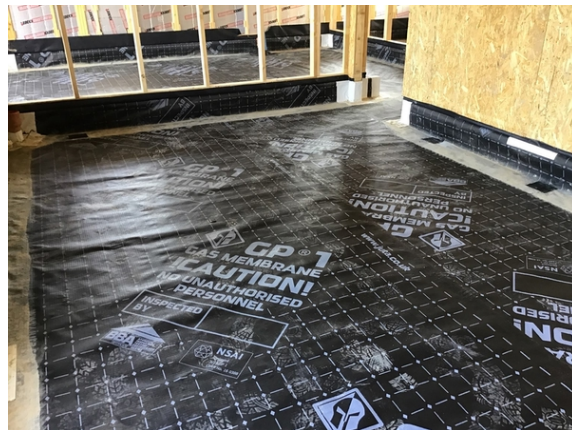
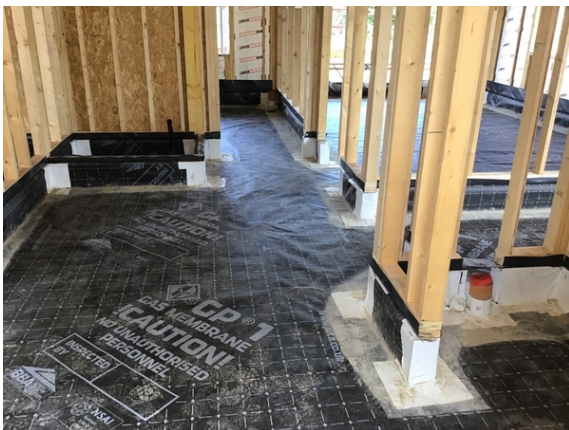
Overview of the Juta GP1 gas membrane that has been installed as an infill to plot 37.

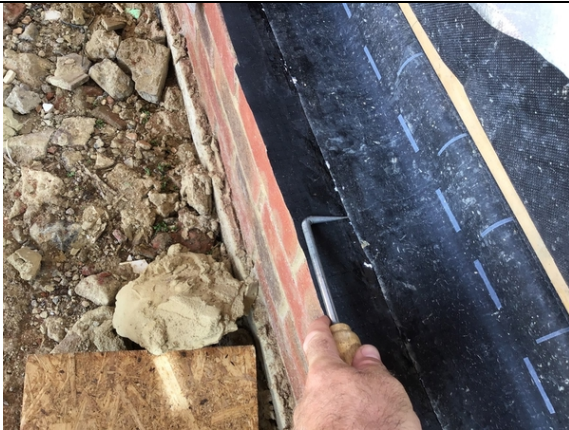
Probe testing the extended hand welded membrane lap around the perimeter of plot 33.

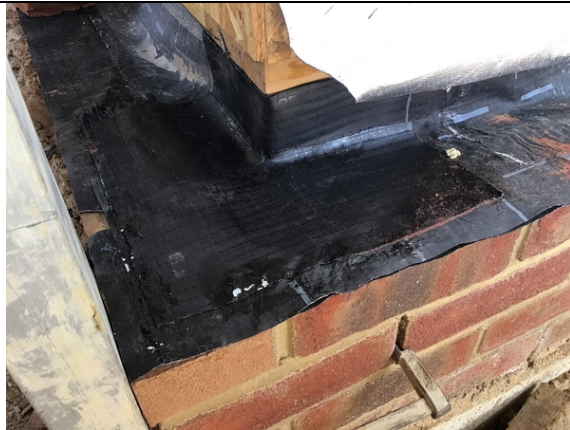
Corner detailing to plot 33.

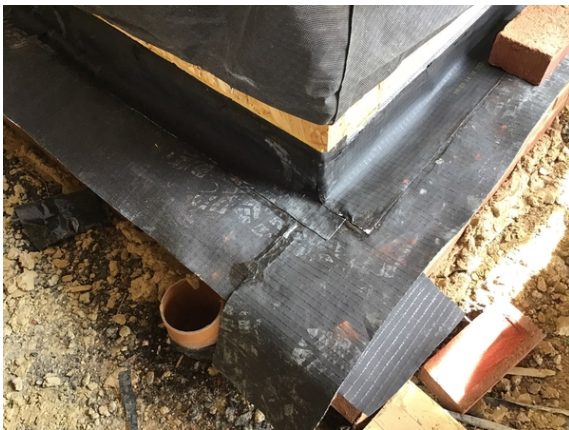
Corner detailing to plot 34.

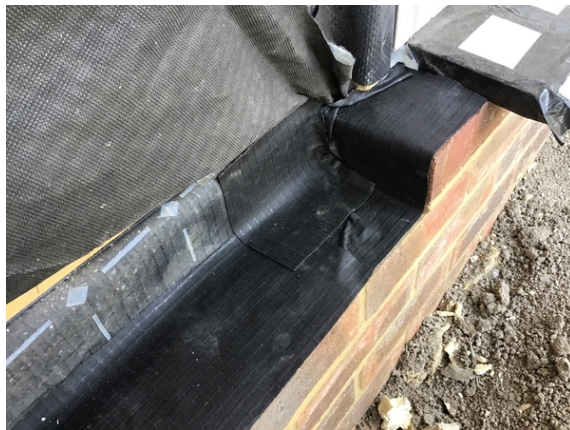
External door threshold detailing to plot 34.

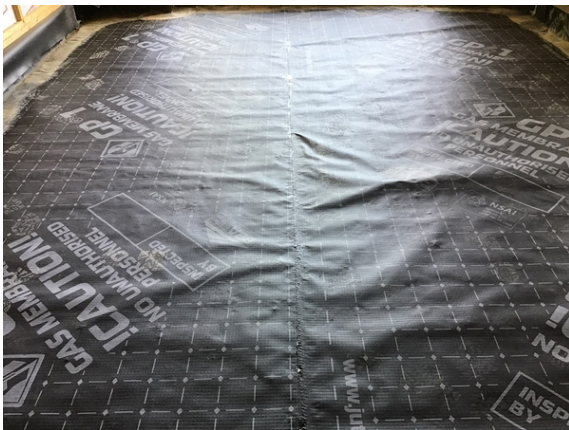
Overview of a typical hand welded membrane lap in plot 36.

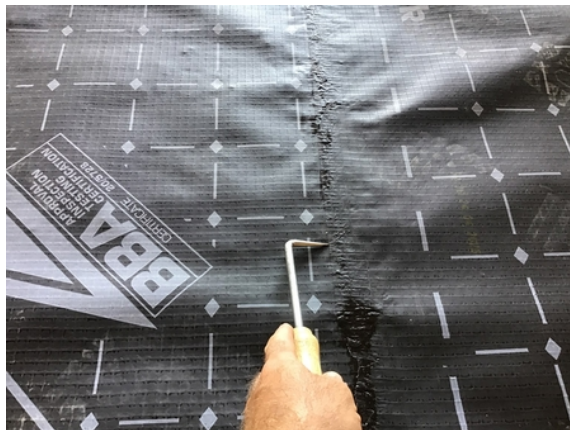
Probe testing a hand welded membrane lap in plot 36.

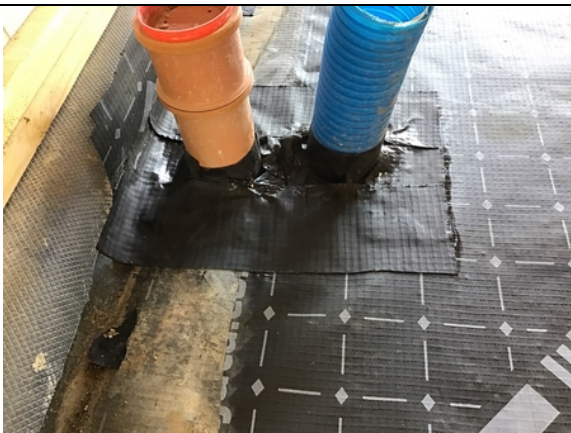
Typical double pipe penetration detailing in plot 36.

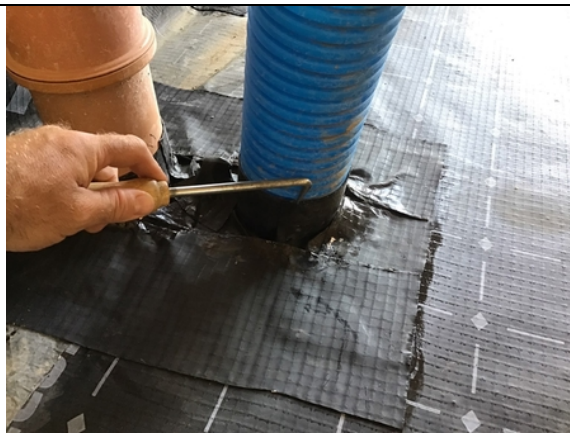
Probe testing a typical pipe penetration detail in plot 36.

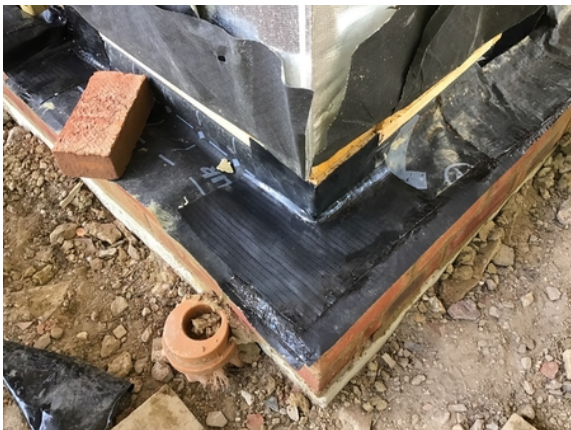
Typical corner detailing around the perimeter of plot 36.

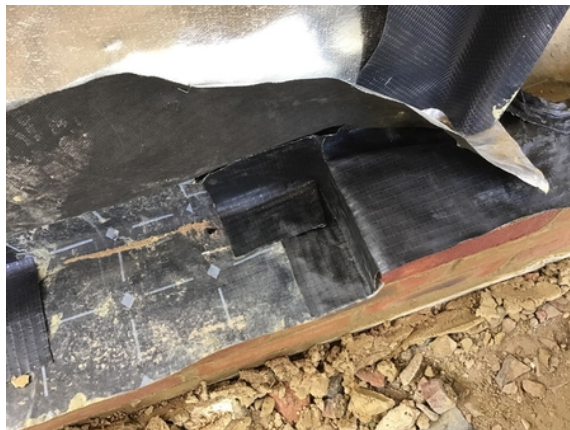
External door threshold detailing in plot 36.

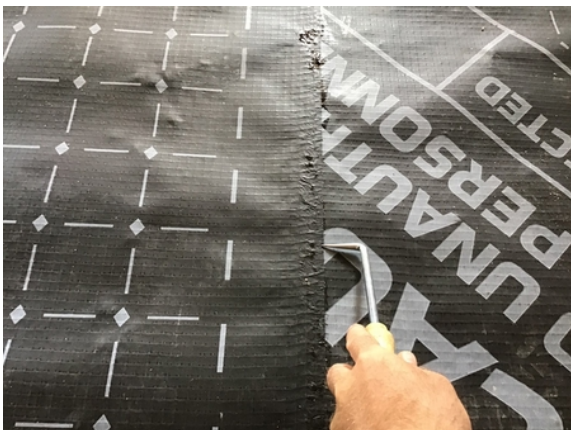
Probe testing a hand welded membrane lap in plot 37.

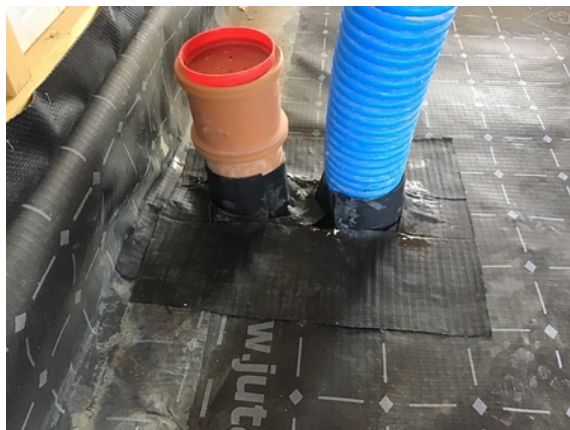
Typical double pipe penetration detailing in plot 37.

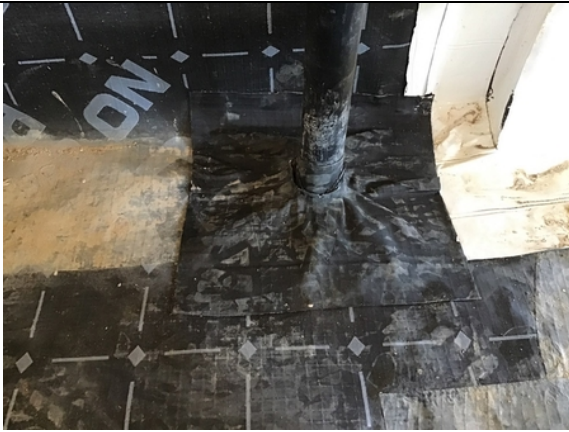
Pipe penetration detailing in plot 37.

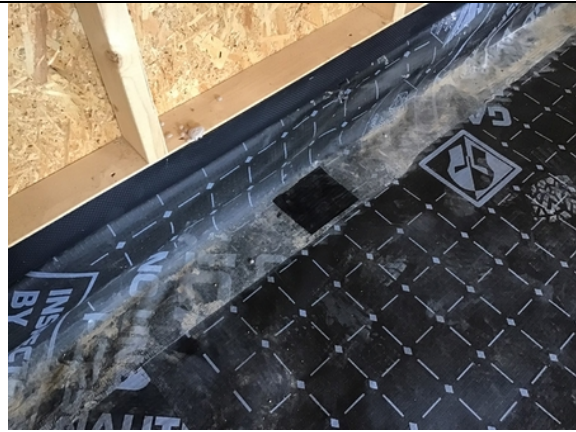
MB Membranes carried out there own CQA repairs prior to our inspection.

| Housebuilder Name: Elivia Homes - The Woodlands. | | | Date: 03/07/2025 |
|---|---|---|---|
| 35 & 37. | 1no hole was found on the perimeter membrane on plot 37 and repaired using Juta GP1 SAM by MB Membranes. | | N/A |

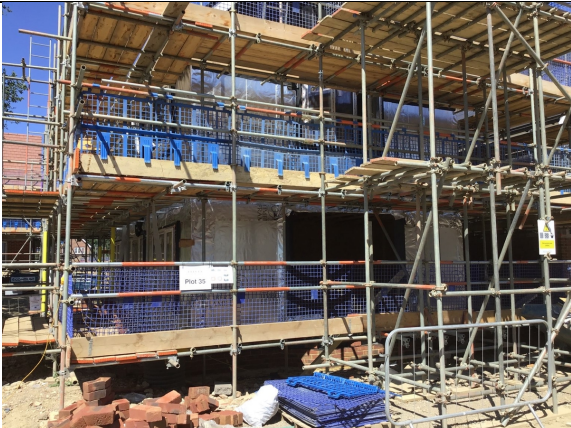
| <p>Marked up site plan.</p> | <p>A general overview of plot 35.</p> |

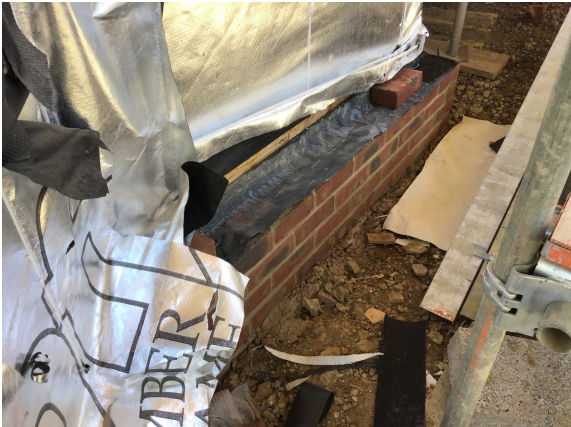
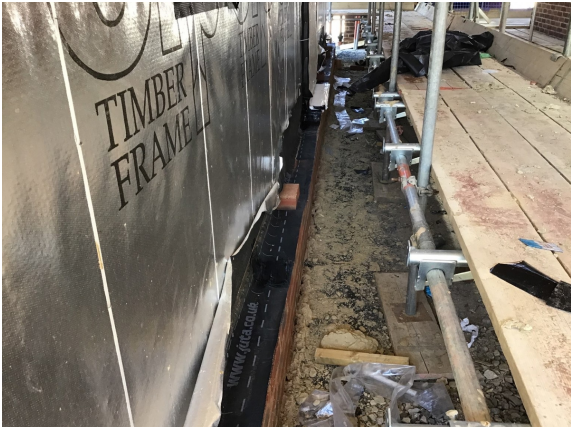
| <p>Overview of the extended membrane installation to close off the perimeter cavity on plot 35.</p> | <p>Overview of the extended membrane installation to close off the perimeter cavity on plot 35.</p> |
