| <b>Housebuilder Name: Elivia Homes - The Woodlands.</b> | | <b>Date: 12/09/2025</b> | |
| <b>Site Name: Reeds Lane, Sayers Common.</b> | | <b>Weather: 18 °C Showers</b> | |
| <b>Postcode: BN6 9JG.</b> | | <b>Surveyor: Adam McDermott (TGPV)</b> | |

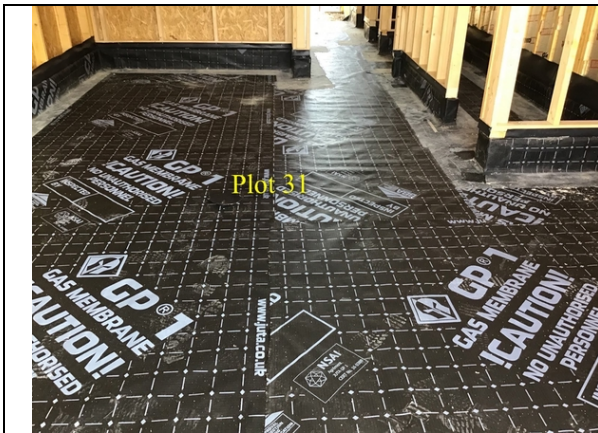
Overview of the Juta GP1 Gas Membrane that has been installed as an infill to plot 31.

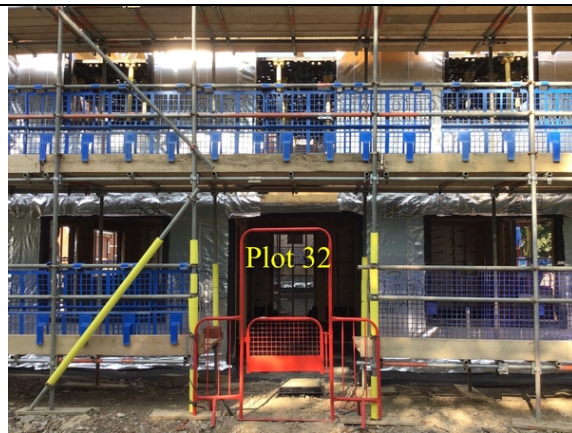
A general overview of plot 32.

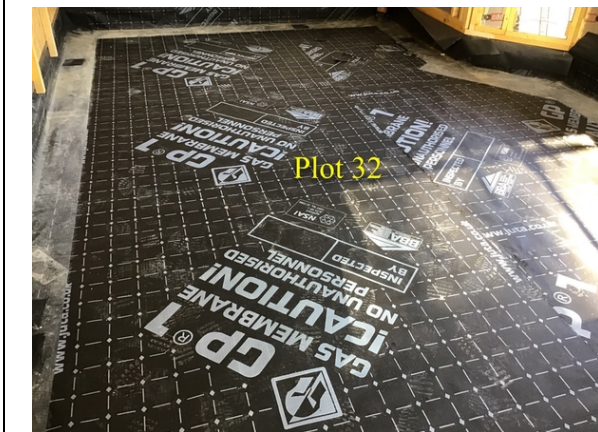
Overview of the Juta GP1 Gas Membrane that has been installed as an infill to plot 32.

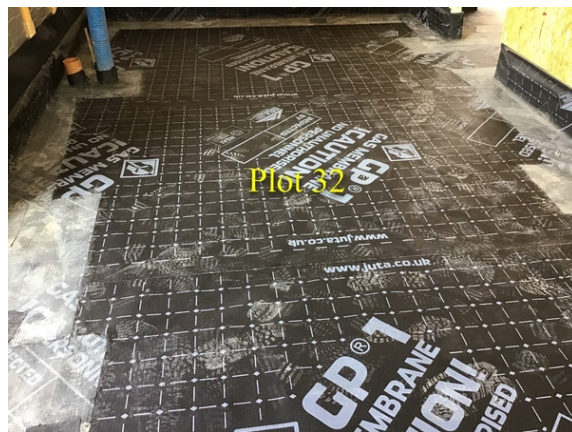
Overview of the Juta GP1 Gas Membrane that has been installed as an infill to plot 32.

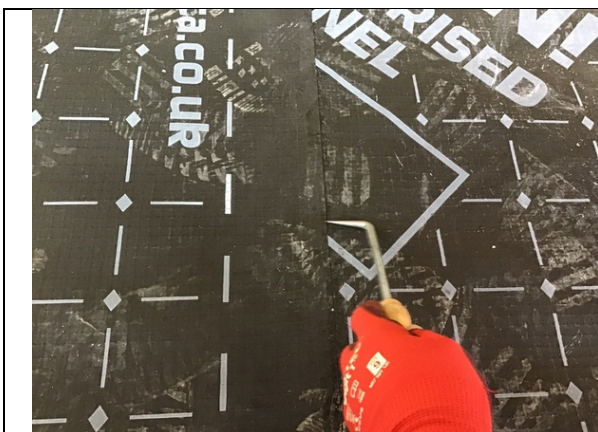
Probe testing a typical hand welded membrane lap in plot 14.

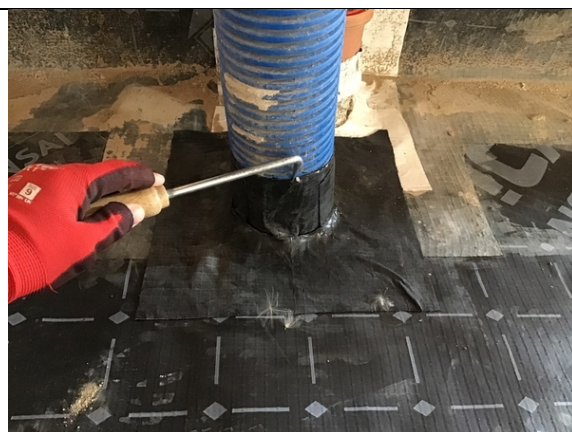
Probe testing a typical pipe penetration detail in plot 14.

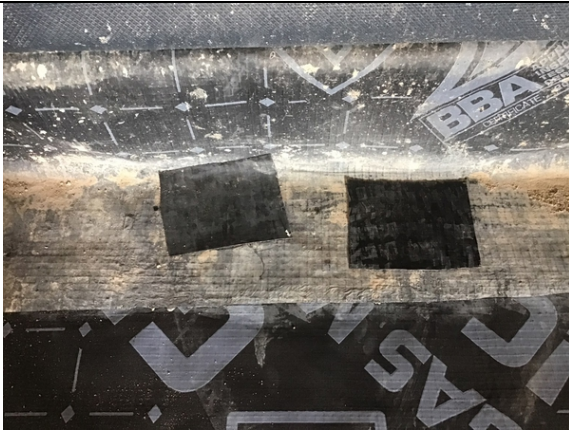
Patch repairs that were carried out by mb membranes prior to our inspection in plot 14.

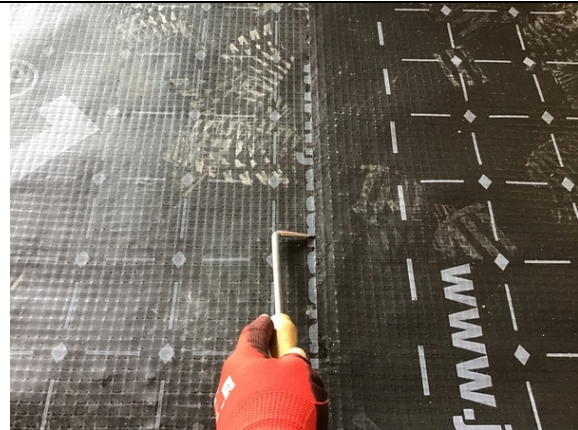
Probe testing a typical hand welded membrane lap in plot 29.

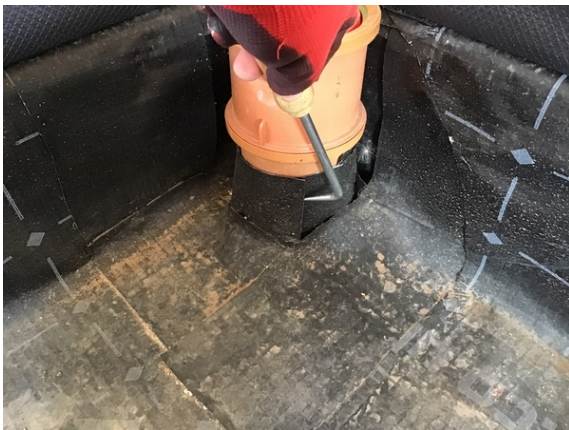
Pipe penetration detailing in plot 29.

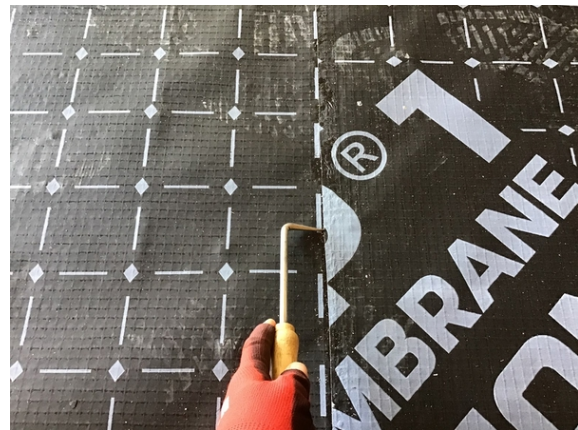
Probe testing a hand welded membrane lap in plot 30.

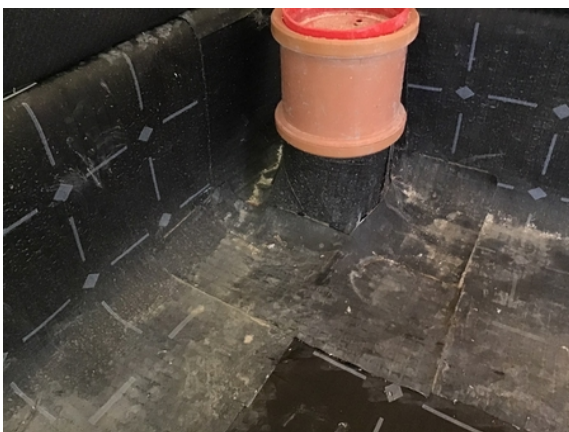
Typical pipe penetration detailing in plot 30.

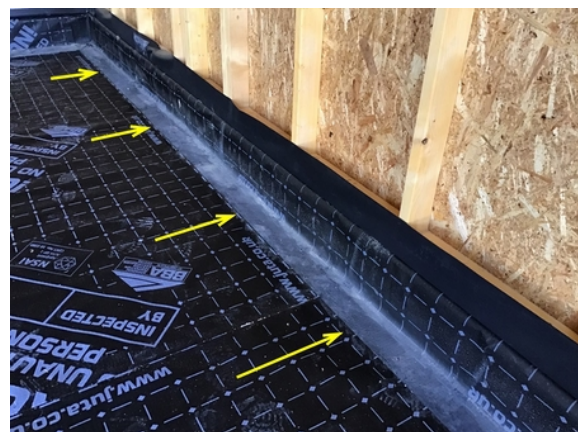
Overview of the extended membrane previously installed around the perimeter in plot 30.

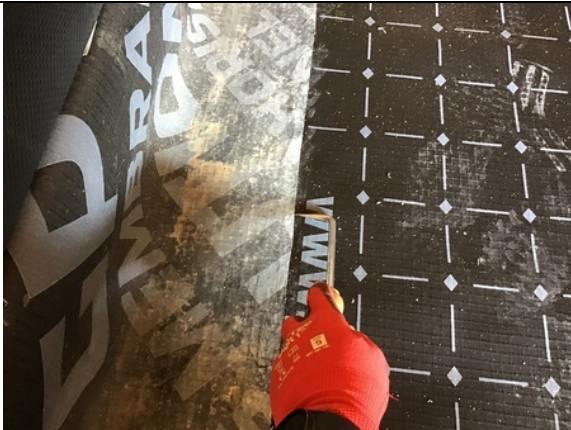
Probe testing a typical hand welded membrane lap in plot 31.

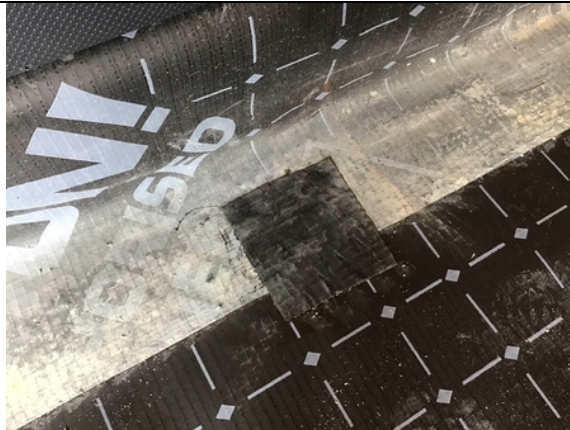
Patch repair using Juta GP1 SAM a that was completed by mb membranes prior to our inspection in plot 31.

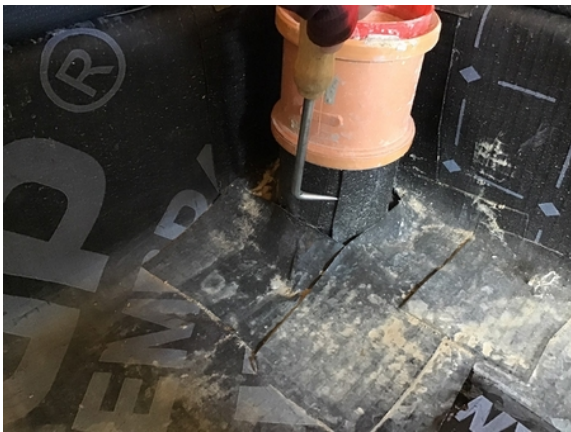
Probe testing a typical pipe penetration detail in plot 31.

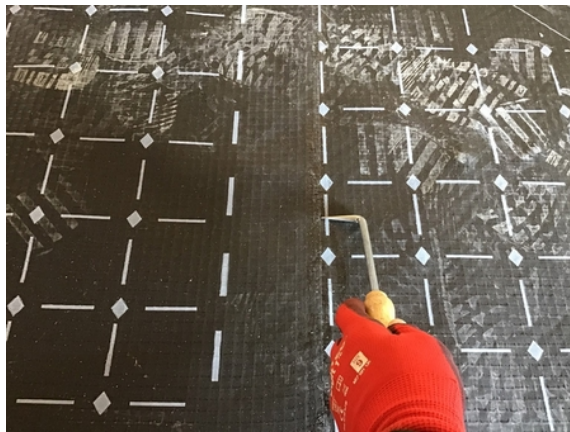
Probe testing a hand welded membrane lap in plot 32.

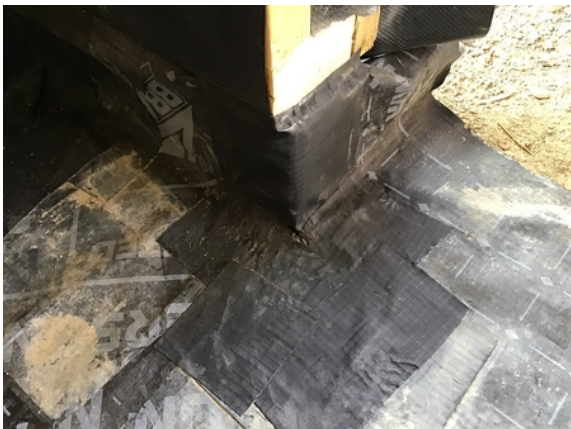
Door threshold detailing in plot 32.

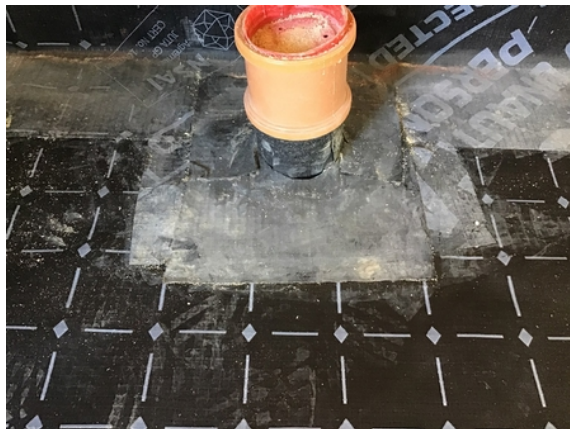
Pipe penetration detailing in plot 32.

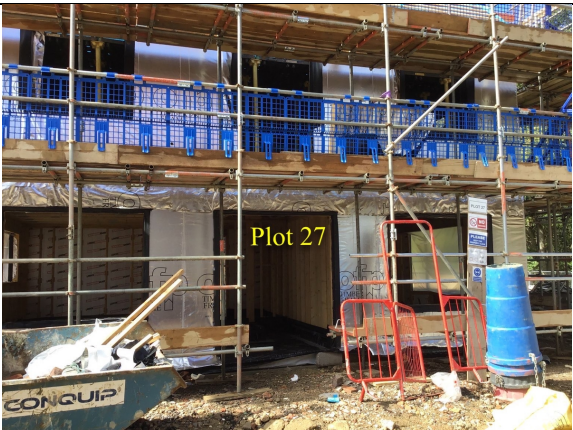
A general overview of plot 27.

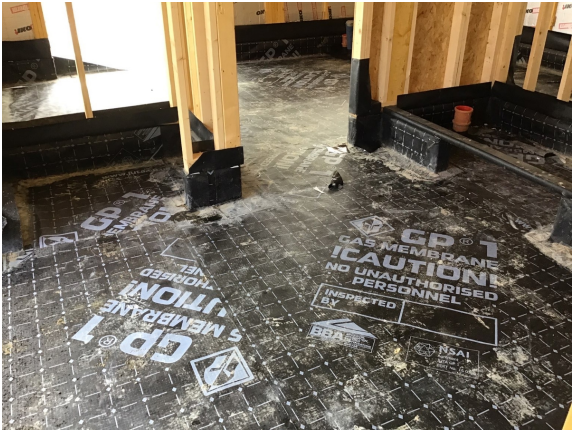
Overview of the Juta GP1 Gas Membrane that has been installed as an infill to plot 27.

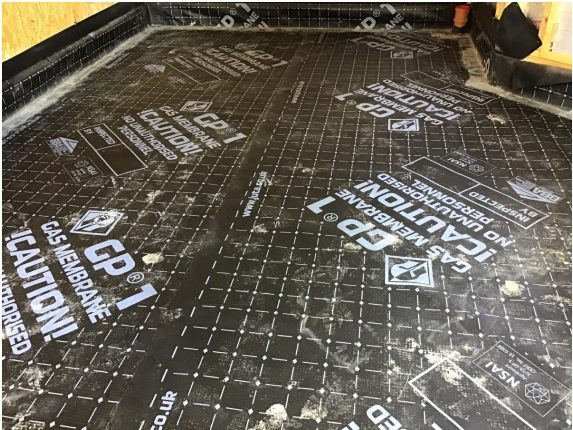
Overview of the Juta GP1 Gas Membrane that has been installed as an infill to plot 27.
