| Housebuilder Name: Elivia Homes - The Woodlands. | | | Date: 23/09/2025 |
| Site Name: Reeds Lane, Sayers Common. | | | Weather: 20 °C Dry |
| Postcode: BN6 9JG. | | Surveyor: Adam McDermott (TGPV) | |

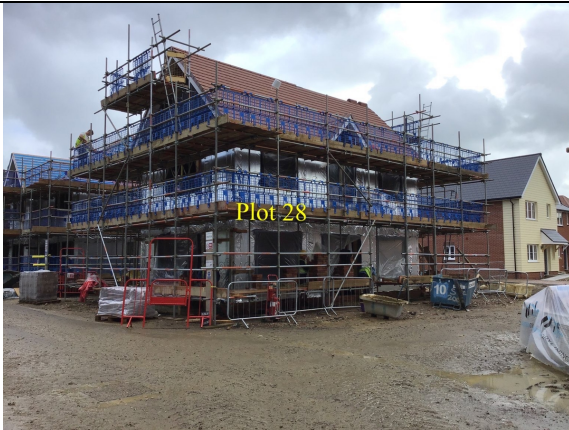
A general overview of detached plot 28.

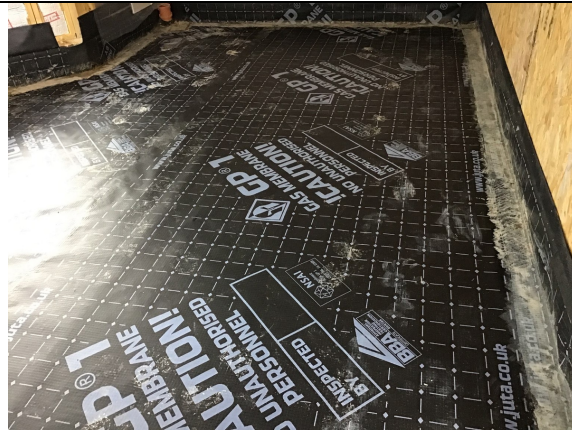
Overview of the Juta GP1 Gas Membrane that has been installed as an infill to plot 28.

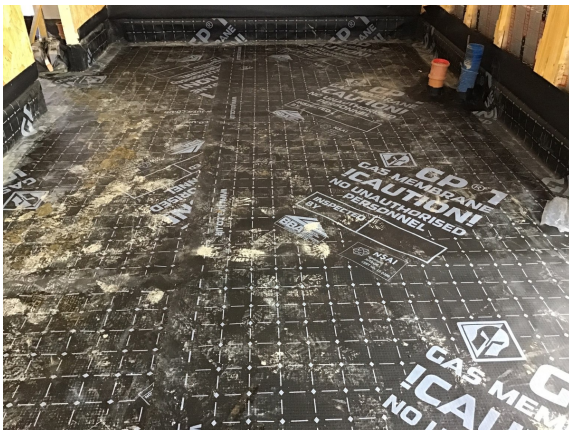
Overview of the Juta GP1 Gas Membrane that has been installed as an infill to plot 28.

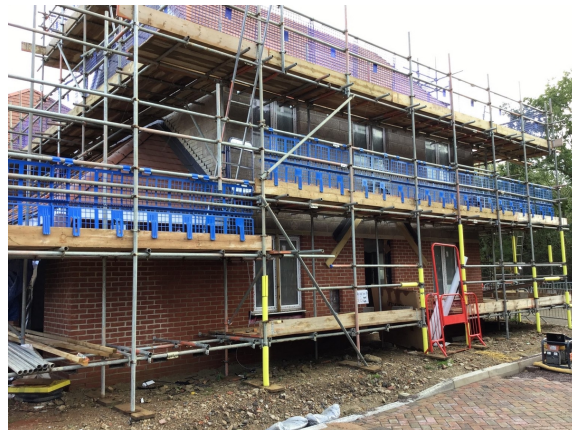
Overview of detached maisonette plots 6 & 7.

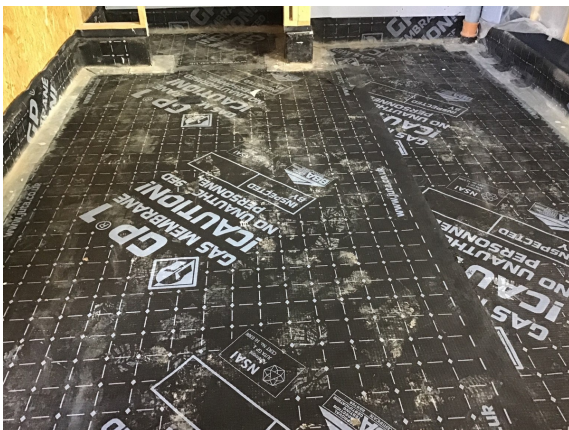
Overview of the Juta GP1 Gas Membrane that has been installed as an infill to plots 6 & 7.

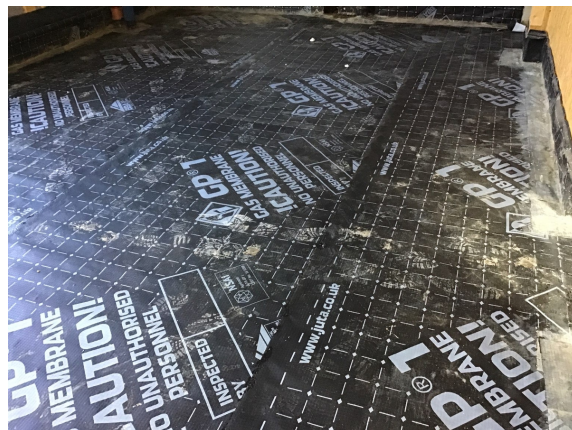
Overview of the Juta GP1 Gas Membrane that has been installed as an infill to plots 6 & 7.

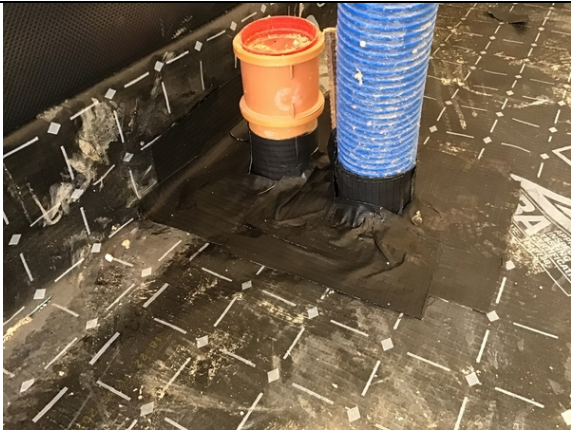
Typical double pipe penetration detailing in plot 27.

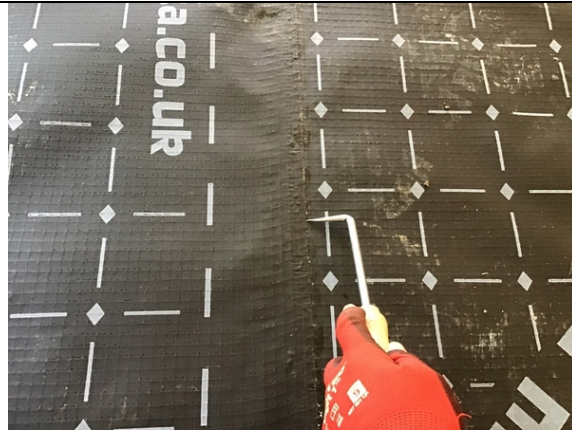
Probe testing a hand welded membrane lap in plot 27.

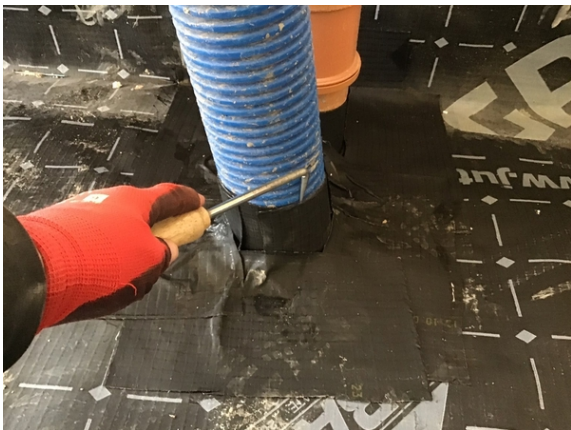
Probe testing a typical pipe penetration detail in plot 27.

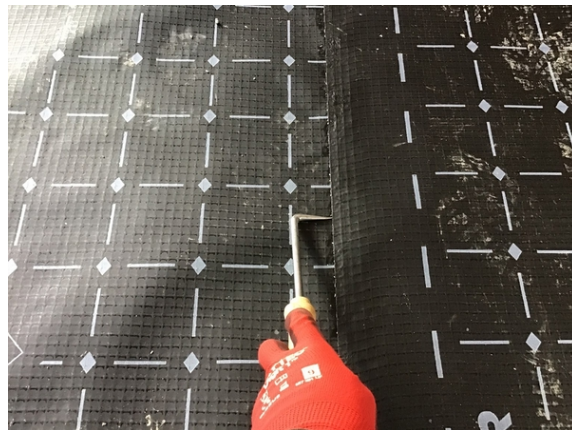
Probe testing a typical hand welded membrane lap in plot 28.

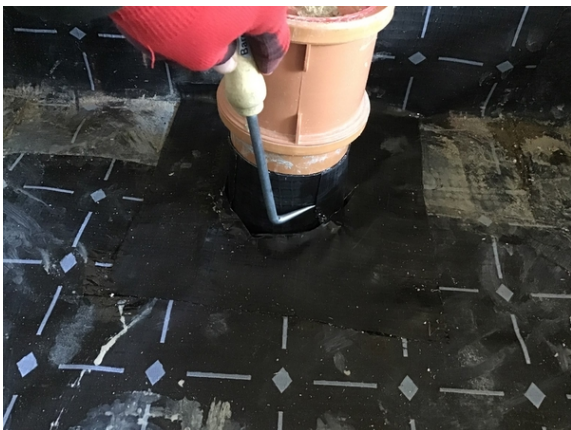
Probe testing a pipe penetration detail in plot 28.

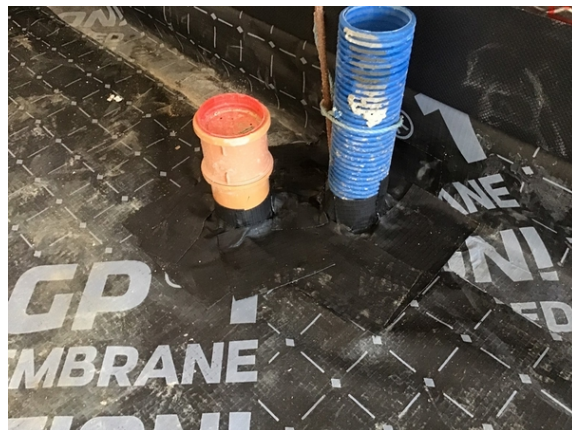
Typical double pipe penetration detailing in plot 28.

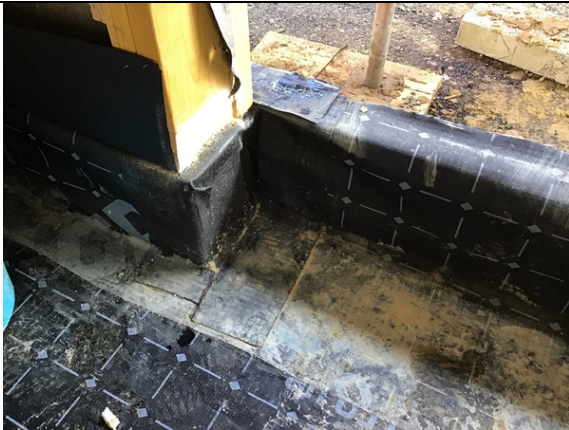
Door threshold detailing in plot 28.

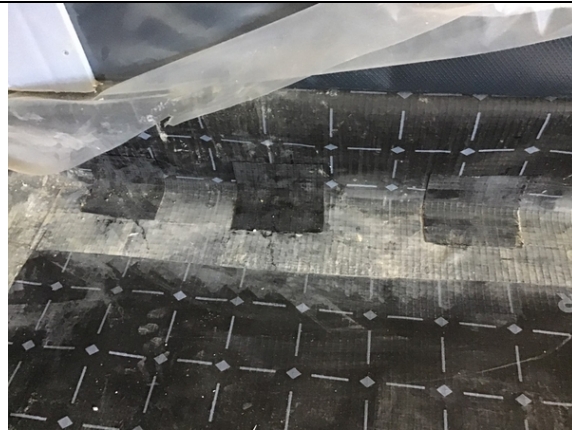
Patch repair detailing completed by mb membranes prior to our inspection in plots 6 & 7.

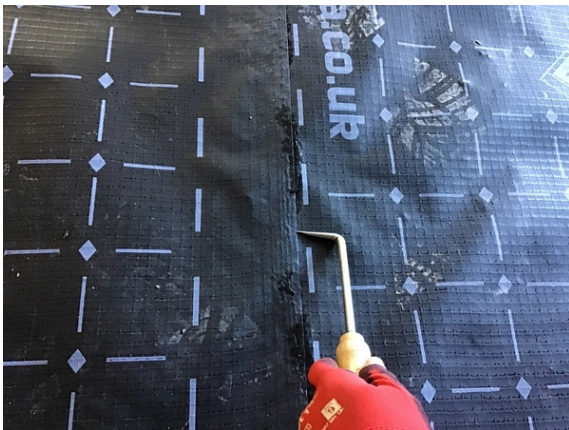
Probe testing a typical hand welded membrane lap in plots 6 & 7.

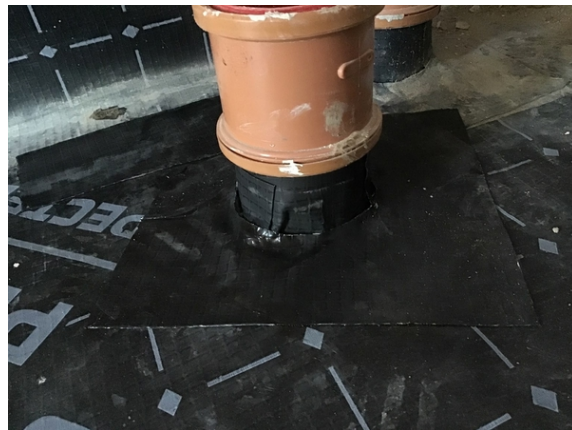
Pipe penetration detailing in plots 6 & 7.

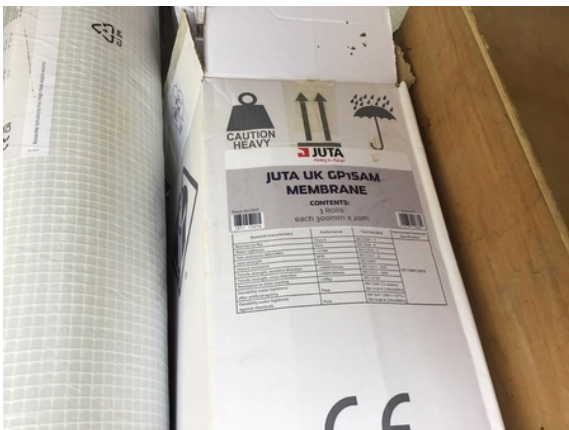
Evidence of the Juta GP1 SAM that has been used for the detailing work on this project.

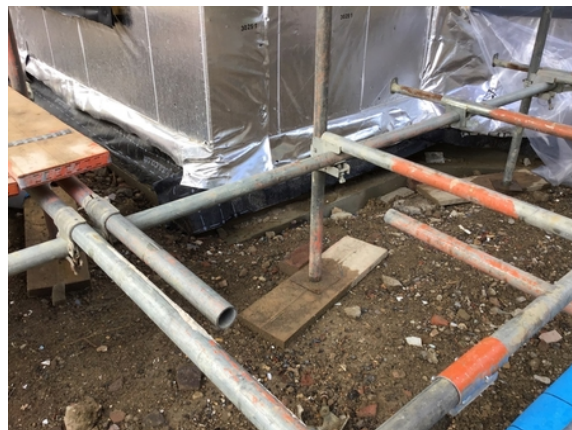
Evidence of the outer brickwork not in place to all plots noted above at the time of our inspection.
