| Housebuilder Name: Elivia Homes - The Woodlands. | | | Date: 13/11/2025 |
| Site Name: Reeds Lane, Sayers Common. | | | Weather: 15 °C Dry |
| Postcode: BN6 9JG | | Surveyor: Adam McDermott (TGPV) | |
| Plot Number | Building Type | Extent of Inspection | Result |

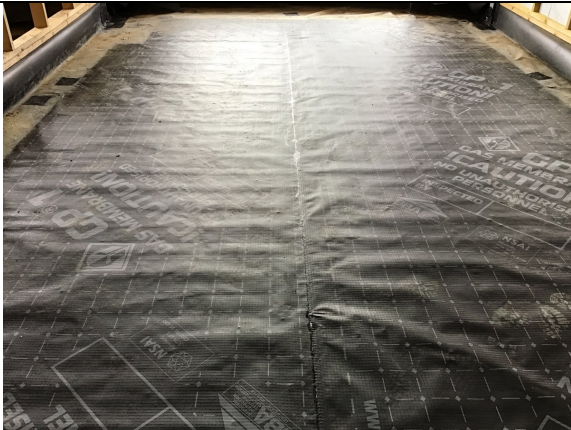
Overview of a hand welded membrane lap in plot 25.

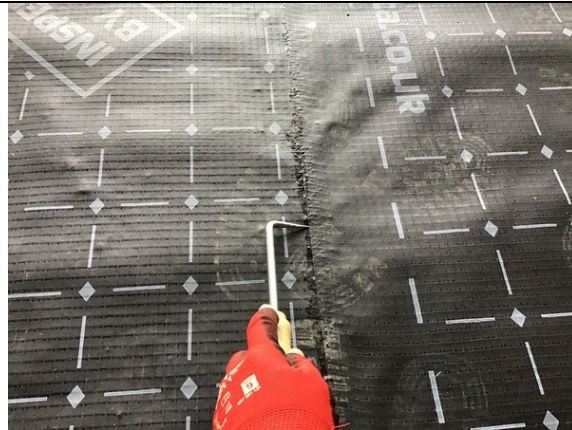
Probe testing a hand welded membrane lap in plot 25.

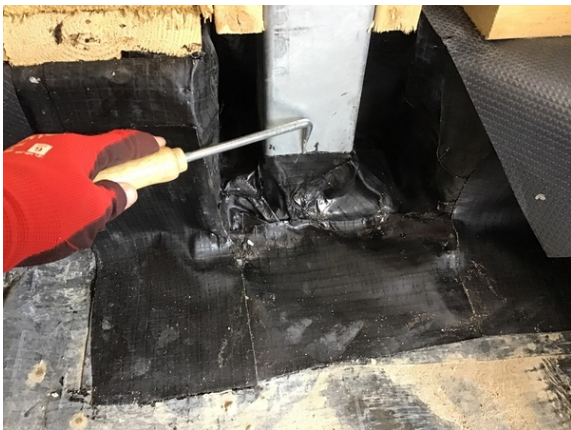
Probe testing a steel stanchion detail in plot 25.

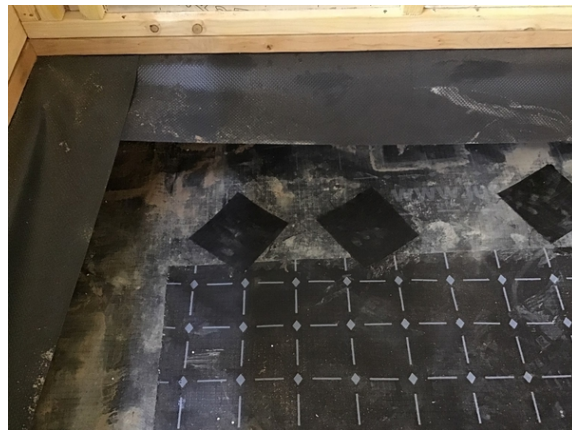
Patch repair detailing in plot 25 that was completed by mb membranes prior to our inspection.

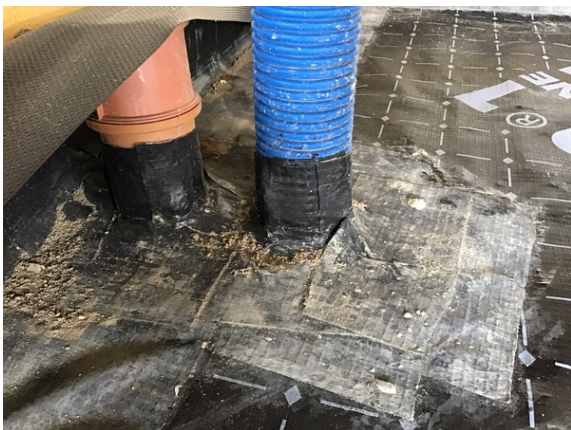
Typical pipe penetration detailing in plot 25.

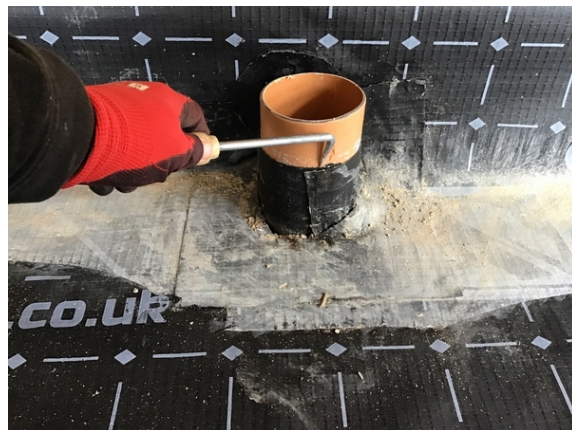
Probe testing a pipe penetration detail in plot 26.

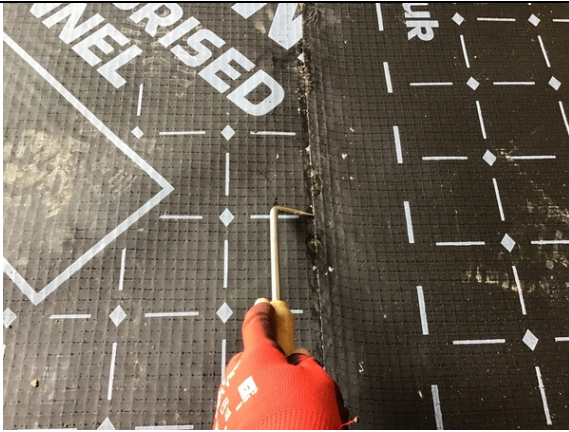
Probe testing a hand welded membrane lap in plot 26.

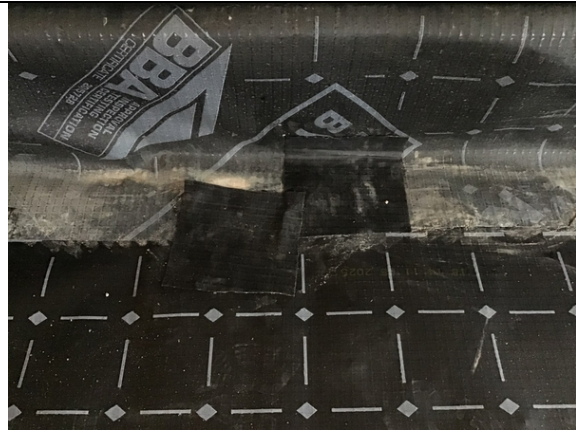
Patch repair detailing completed by mb membranes prior to our inspection in plot 26.

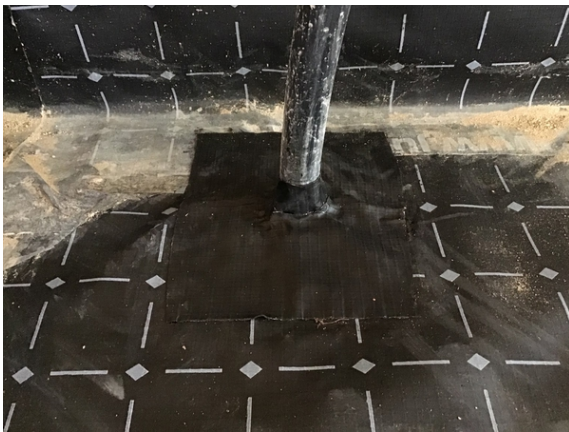
Pipe penetration detailing in plot 26.

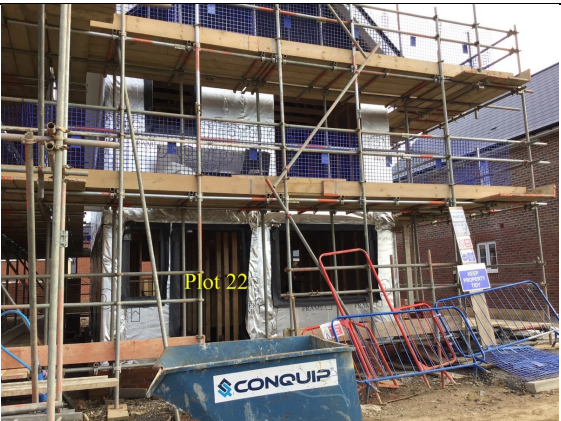
| Marked up site plan. | A general overview of detached plot 22. |

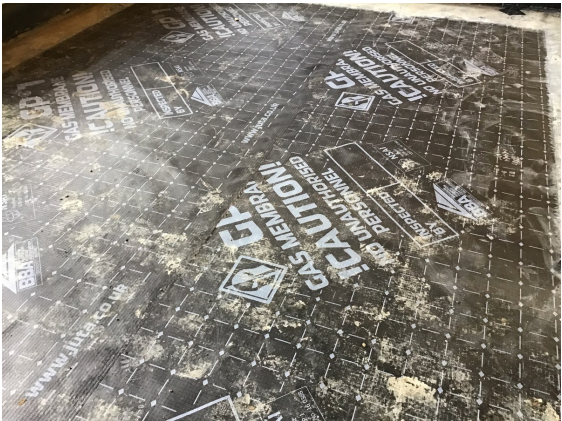
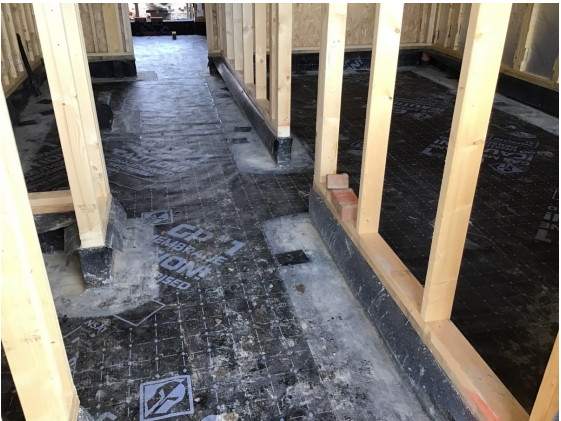
| Plot 22 infill installation overview. | Plot 22 infill installation overview. |
