### Detailing Sample Photographs

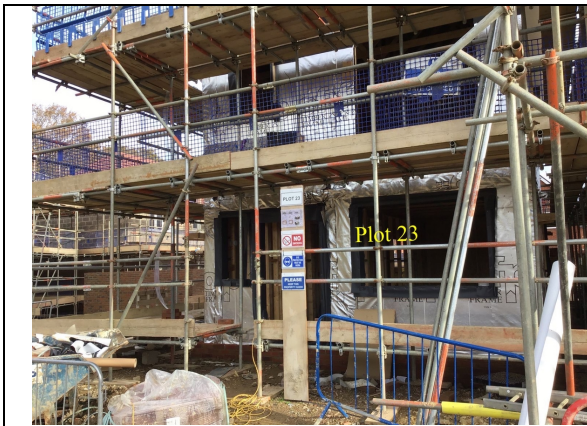
A general overview of detached plot 23.

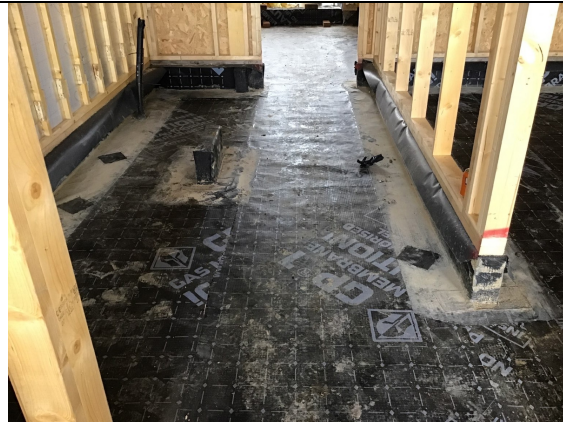
Plot 23 infill installation overview.

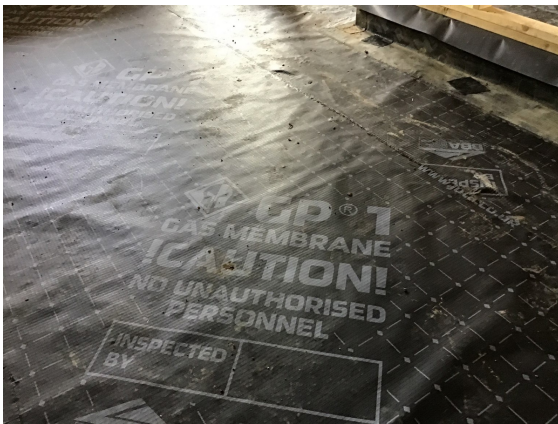
Plot 23 infill installation overview.

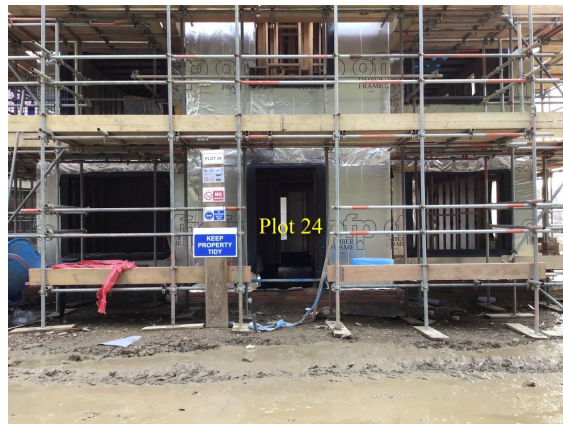
A general overview of detached plot 24.

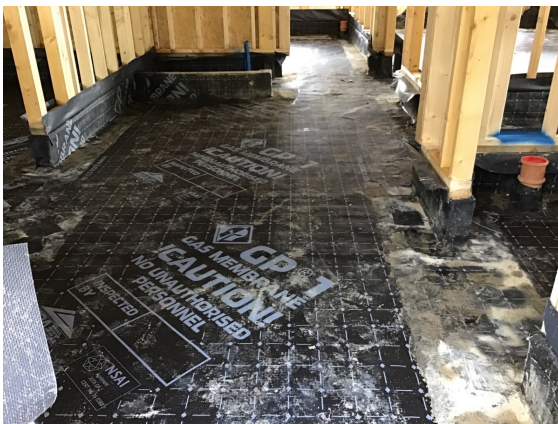
Plot 24 infill installation overview.

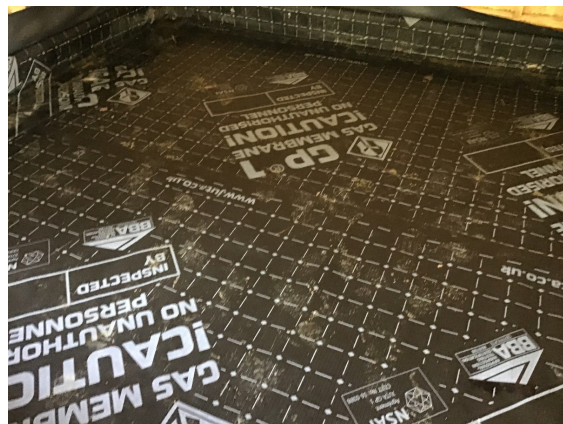
Plot 24 infill installation overview.

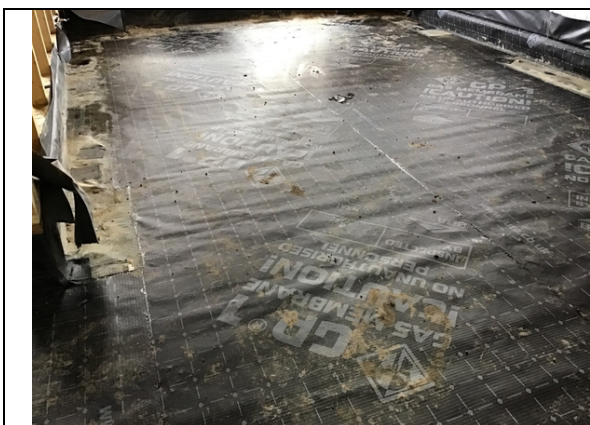
Plot 24 infill installation overview.

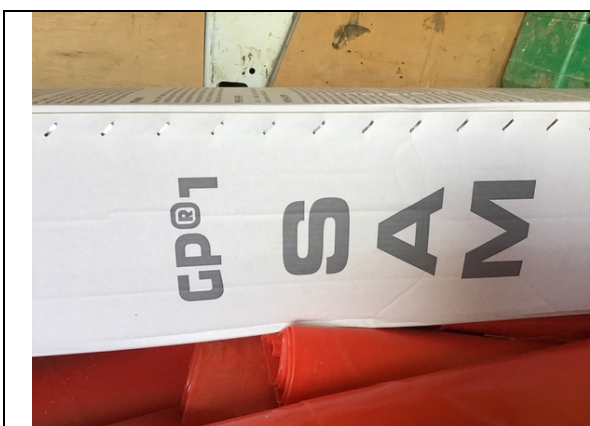
Evidence of the Juta GP1 SAM that has been used for the detailing on this project.

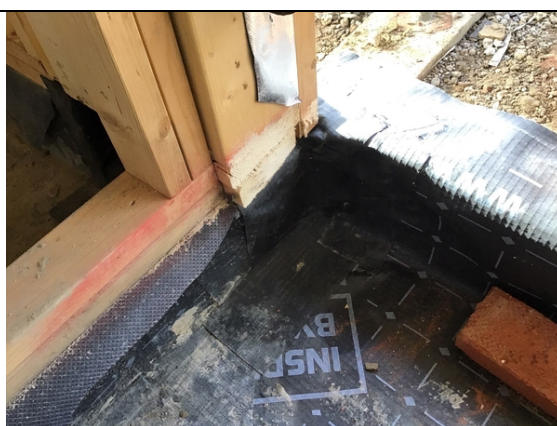
Plot 22 door threshold detailing.

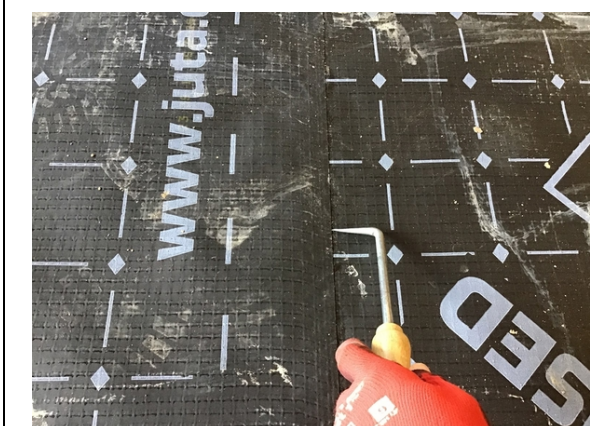
Plot 22 hand welded membrane lap testing.

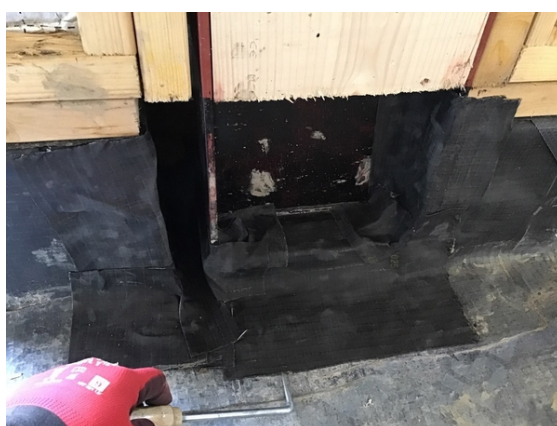
Plot 22 steel stanchion detail testing.

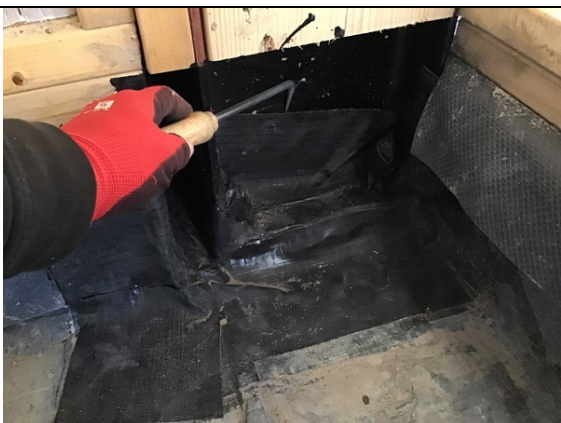
Plot 23 steel stanchion detail testing.

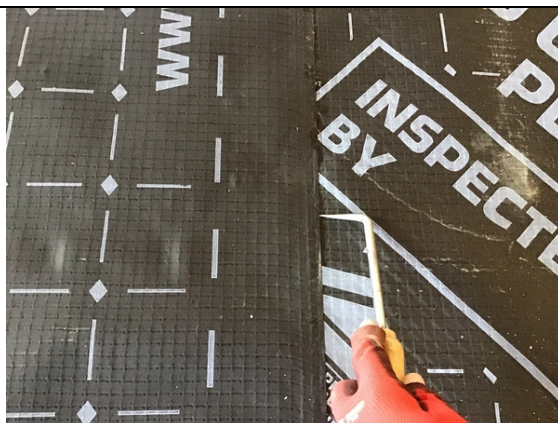
Plot 23 hand welded membrane lap testing.

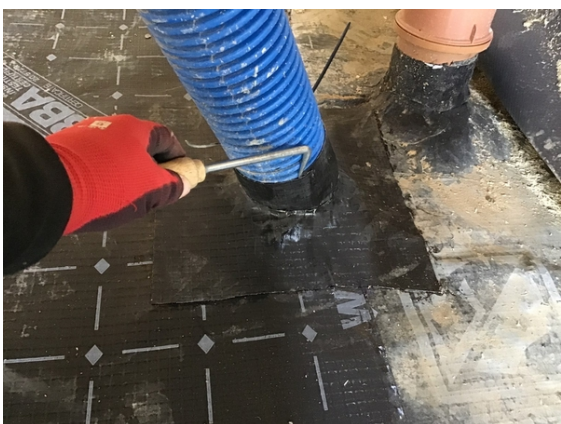
Plot 23 pipe penetration detail testing.

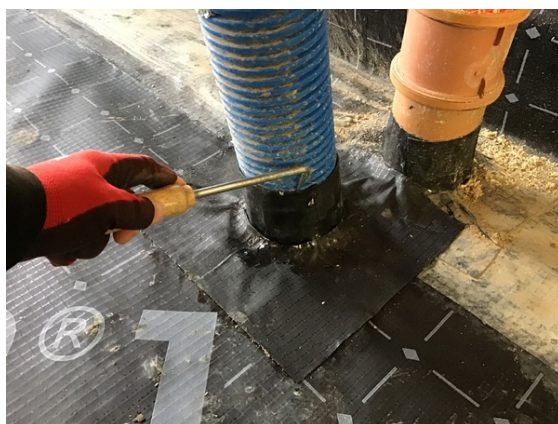
Plot 24 pipe penetration detail testing.

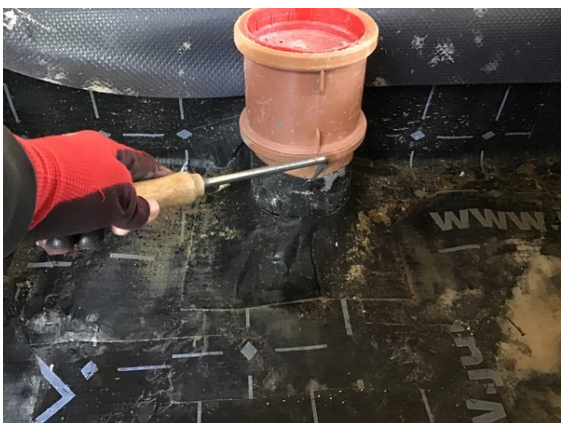
Plot 24 pipe penetration detail testing.

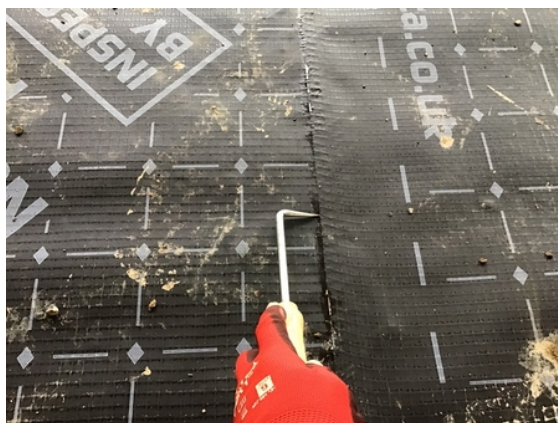
Plot 24 hand welded membrane lap testing.

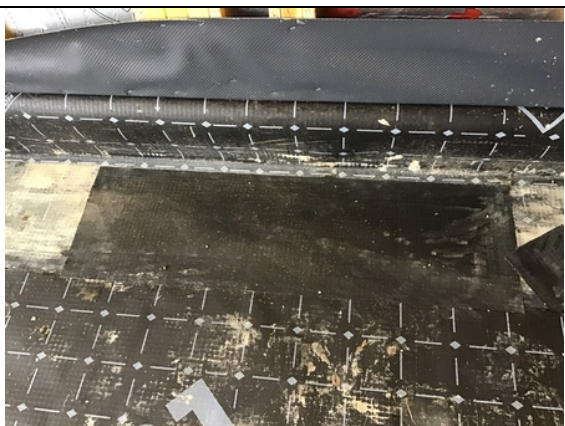
Plot 24 Juta GP1 SAM picture frame detail.
