Structural Defects (SRM 4)

Project name :
60 Keymer Rd, Hassocks

Date :
16/05/2021

Inspection report

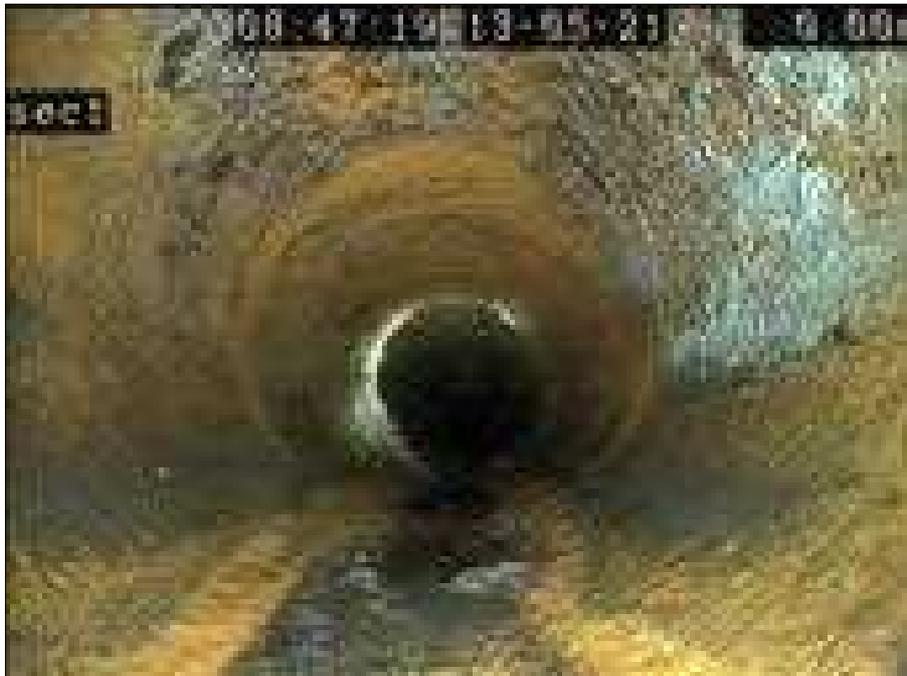
Photo: 1_1_3_A.jpg
0m, Water level, 0% of the vertical dimension

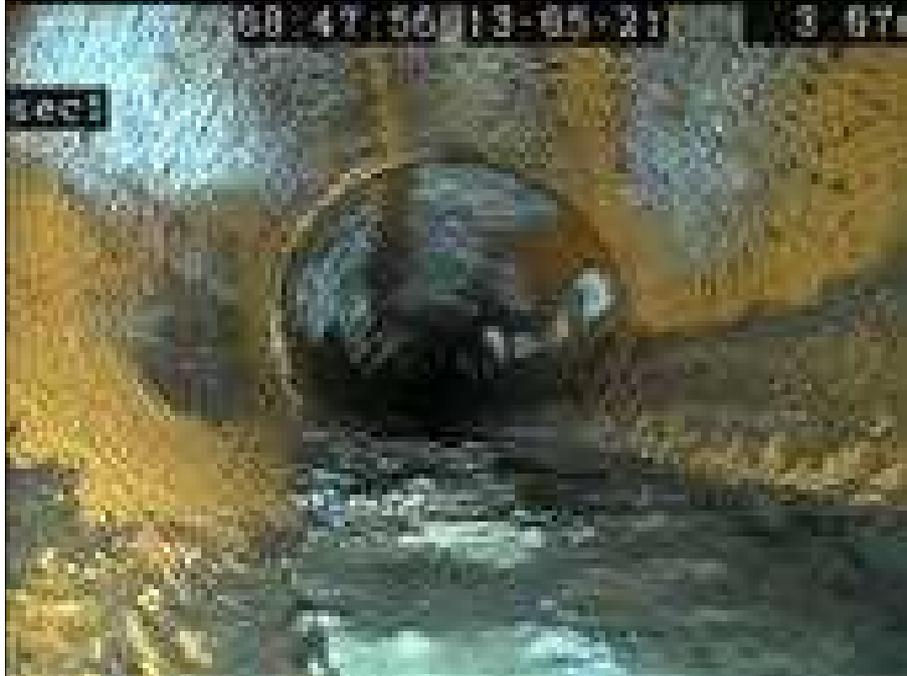
Photo: 1_1_6_A.jpg

3.1m, Attached deposits, other, from 5 to 7 o'clock, 15% cross-sectional area loss

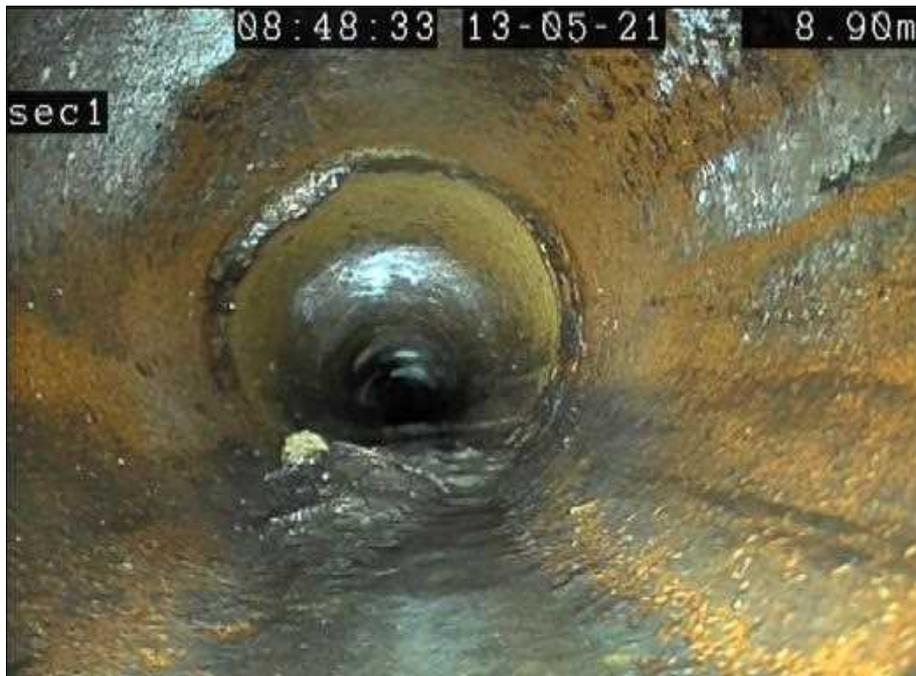
Photo: 1_1_7_A.jpg

9m, Attached deposits, other at joint, from 5 to 7 o'clock, 20% cross-sectional area loss

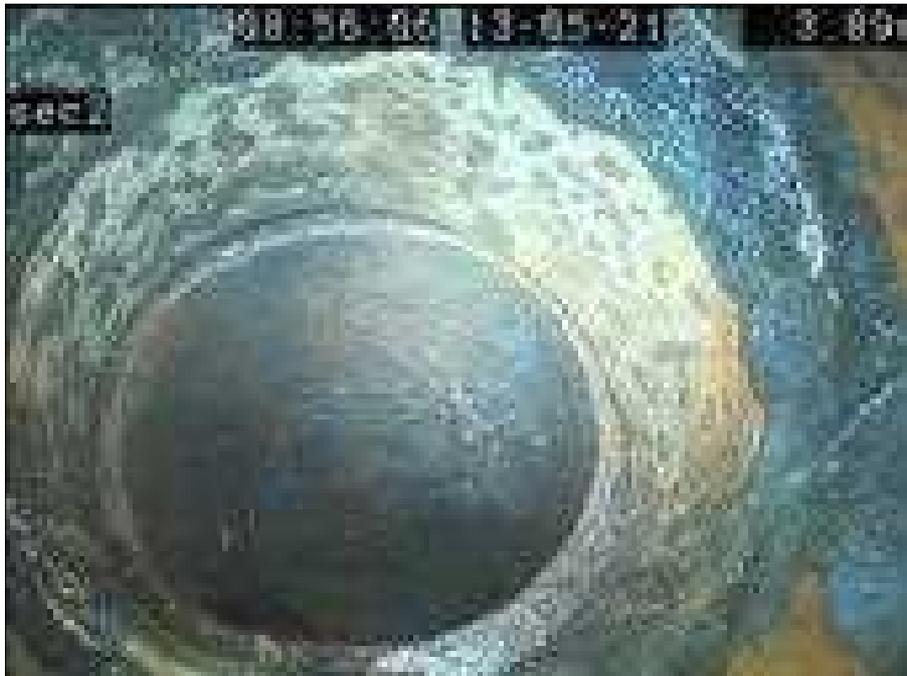
Photo: 3_3_15_A.jpg
3.9m, Joint displaced, medium

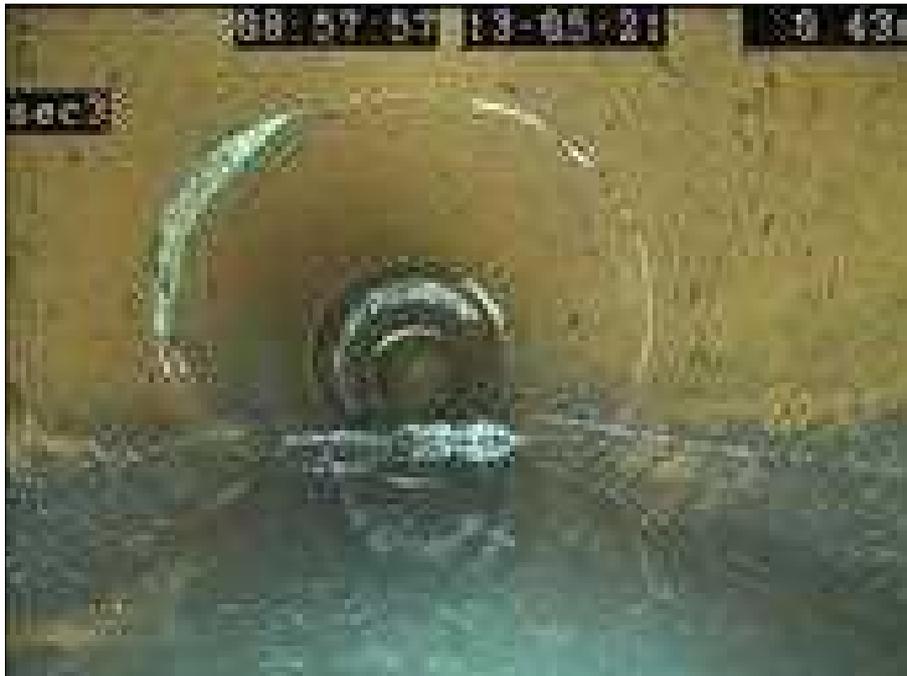
Photo: 4_4_21_A.jpg
0.4m, Fracture, circumferential, from 12 to 12 o'clock

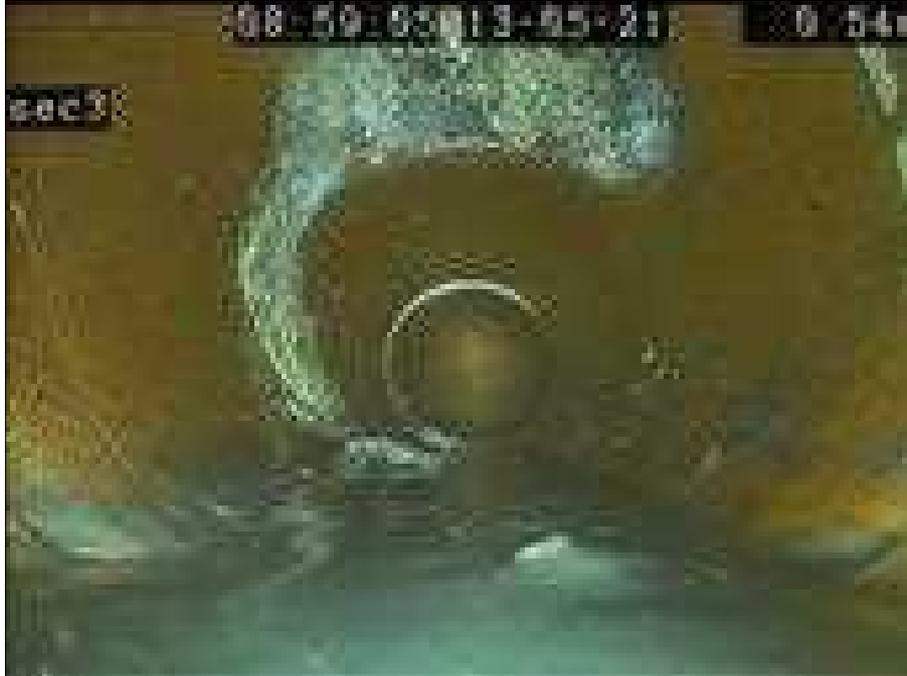
Photo: 4_4_20_A.jpg
0.7m, Junction, at 12 o'clock, diameter 100mm

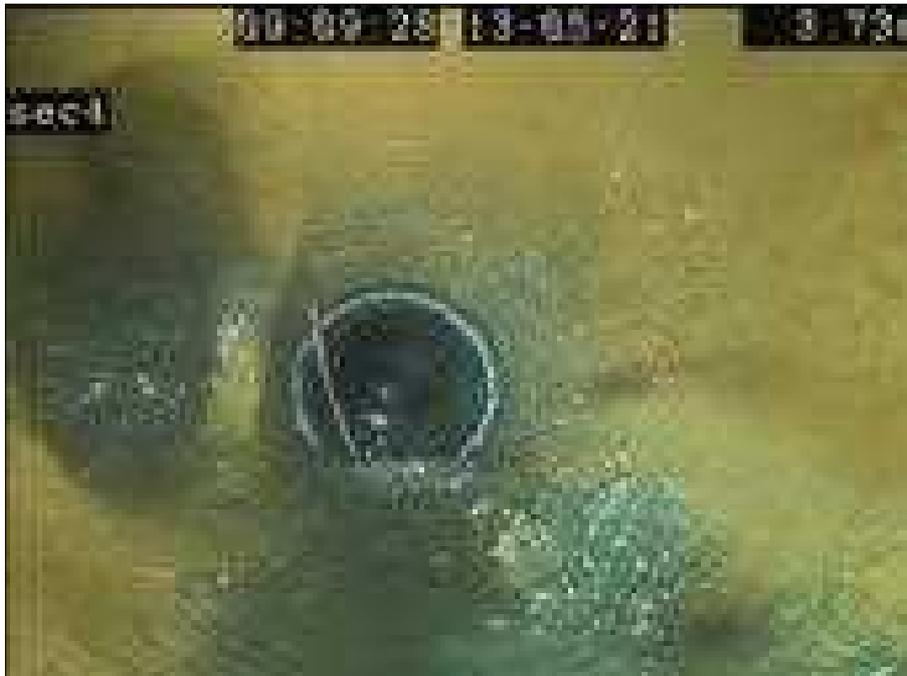
Photo: 5_5_26_A.jpg
3.7m, Junction, at 9 o'clock, diameter 100mm
