## Structural Engineering Report

**WICKENDEN MANOR, CHILLING STREET, SHARPTHORNE, EAST GRINSTEAD:**

Preliminary visual inspection report & structural appraisal of the existing stables buildings.

**Ref:** 20088  
**Date:** 31<sup>st</sup> July 2026

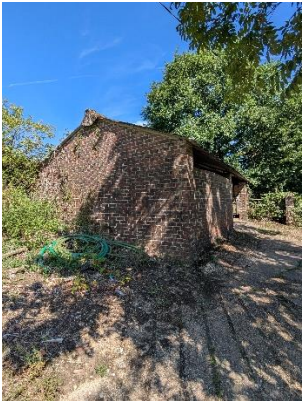
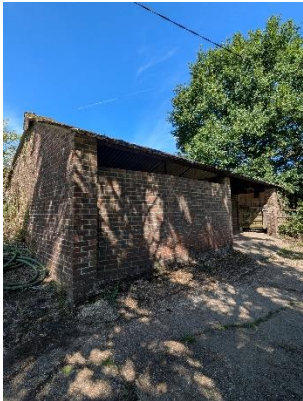
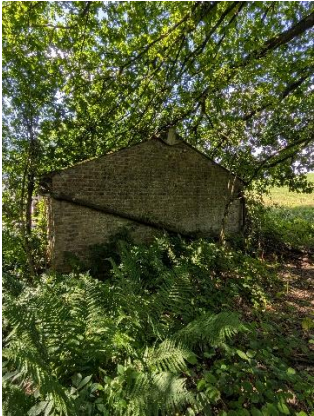
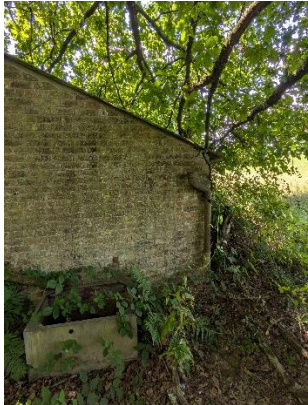
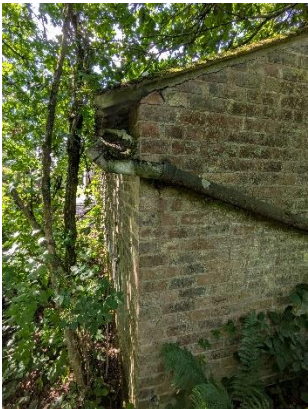
A load bearing masonry building, with a steel framed roof with steel purlins supporting corrugated cement sheet roof coverings. The ground floor was of concrete construction, sloping slightly to the east. The building was thought likely to be of mid / late 1950's construction. (Photo 1, 2, 3, 4 & 5)

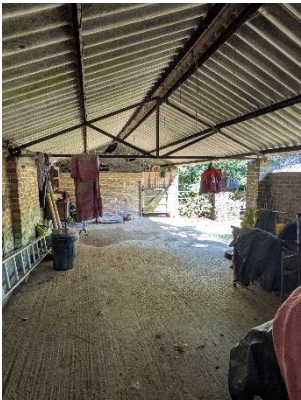
The steel roof trusses were formed using light gauge steel angle sections, welded to one another to form each truss. Steel purlins spanned between the trusses and supported the corrugated cement sheet roof. All elements of steel forming the trusses and purlins were corroded and had not been painted or otherwise maintained, likely since original construction of the building. (Photo 6).

| Photo 5 Building A east elevation | Photo 6 - Building A Roof arrangement |

The roof will need to be replaced.

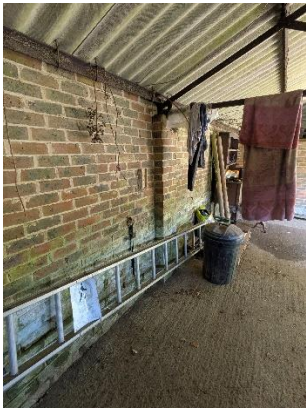
The west external wall was retaining around 800mm of ground to the west side of the building and the brickwork was noted, internally, to be wet and with damp and moisture staining. The brickwork appeared undamaged, other than the staining noted. (Photo 7).

| Photo 7 – Building A internal west elevation showing moisture penetration. | Photo 8 - Building A south east corner horizontal tapered crack. |

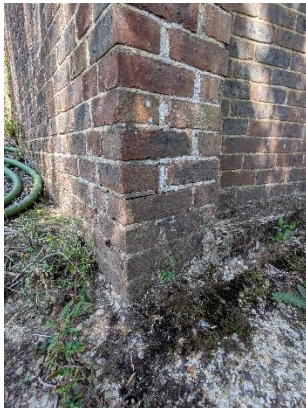
To the south east corner of the building, on the south elevation, a horizontal tapering crack was noted at around 150mm above the internal slab level and where it appeared localised downward movement of the foundation had occurred to the corner of the building. (Photo 8).

Localised downward movement of the foundations was noted to one corner of the building. This will likely require localised underpinning.

It should be possible to retain the existing external walls of the building, though it is likely, as is common with agricultural building being converted to domestic or similar use, there may be a need to underpin foundations to ensure they are of a sufficient depth to be below that of external ground levels and below the level of reduced dig for any replacement internal floor slab.

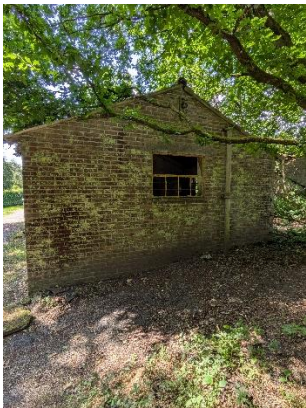
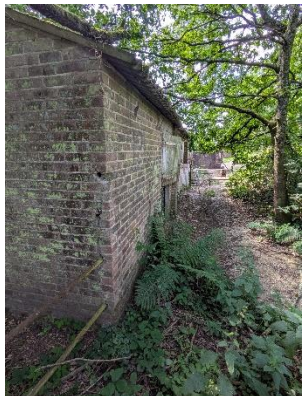
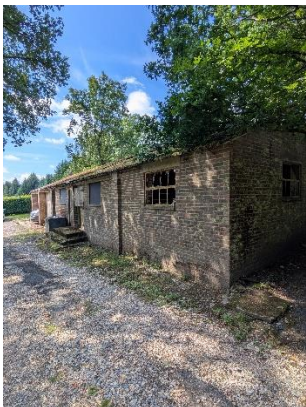
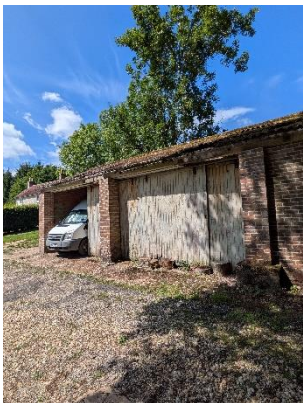
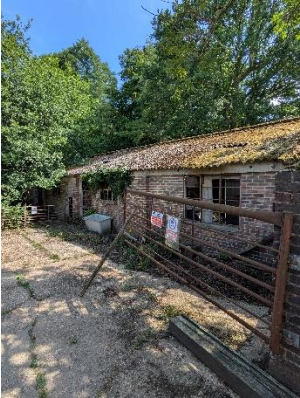
concrete eaves beams supported on precast concrete columns. It was thought likely the building had been constructed in the late 1950's or early 1960's. (Photos 9, 10, 11, 12 & 13).

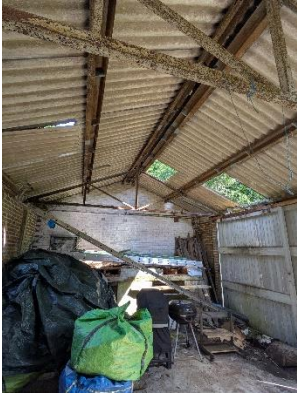
The steel roof trusses were formed using light gauge steel angle sections, welded to one another to form each truss. Steel purlins spanned between the trusses and supported the corrugated cement sheet roof. All elements of steel forming the trusses and purlins were corroded and had not been painted or otherwise maintained, likely since original construction of the building. (Photo 14)

| <p>Photo 13 – Building B west elevation.</p> | <p>Photo 14 - Building B roof arrangement.</p> |

The roof will need to be replaced.

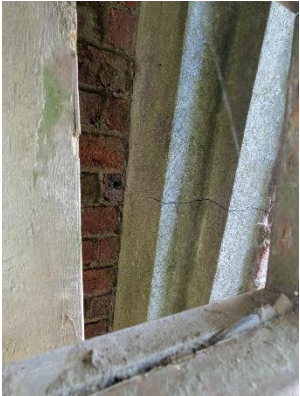
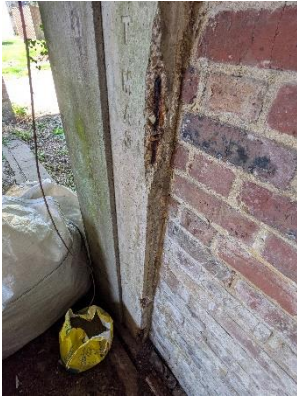
Precast concrete eaves beams spanned between precast concrete columns. Many of the precast concrete columns were noted to have been clad or encased in brickwork, though some were still exposed to the south end of the west elevation. Corrosion of reinforcement in the precast elements had resulted in spalling and damage to the concrete forming many of the elements, including the columns (where visible) and the eaves beams. (Photos 15, 16, 17 & 18).

Similarly, the precast concrete columns supporting the same were also showing signs of corrosion, possibly significantly so where encased by brick piers to the south end of the building. These elements will need to be replaced.

| <p>Photo 15 - Building B Cracked concrete precast column</p> | <p>Photo 16 - Building B cracked and corroded concrete column</p> |

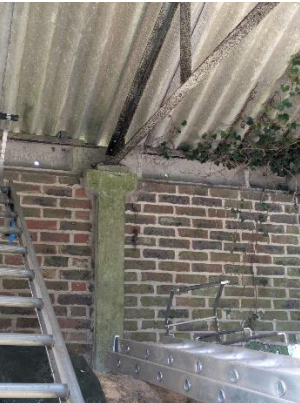
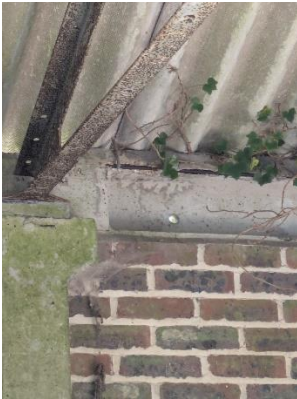
insulated composite roof construction. The concrete eaves beams showed evidence of deterioration and corrosion of reinforcement and would not be considered to be economically repairable.

| <p>Photo 17 - Building B Corroding reinforcement to eaves beam</p> | <p>Photo 18 - Building B Corroding reinforcement to eaves beam</p> |

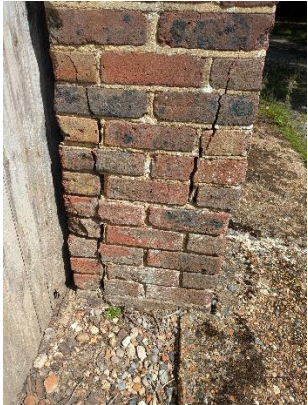
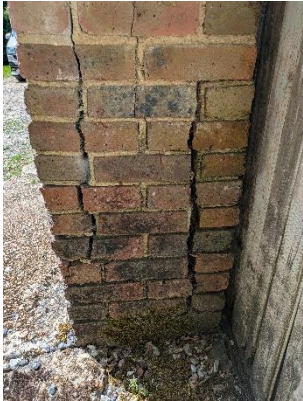
To the east elevation, at the south end of the building brick piers were present and vertical cracking was noted to the bottom sections of the piers on the two side faces and the front face of the pier. The piers appeared to be encasing precast concrete or steel columns, supporting the concrete eaves beams over the door openings to the east elevation. (Photo 19, 20 & 21).

| Photo 19 – Building B cracked brickwork around precast column. | Photo 20 - Building B cracked brickwork around precast column. |

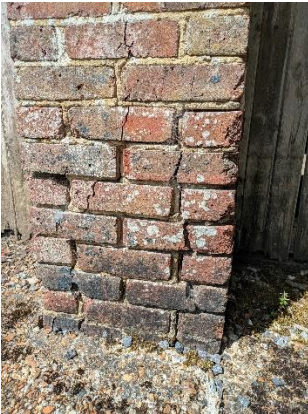
| Photo 21 - Building B cracked brickwork around precast column. | Photo 22 - Building B cast concrete block to base of pier / column |

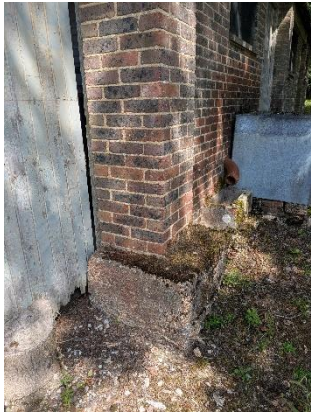
A cast concrete block or foundation was noted to the north end of the twin door openings in the east elevation of the building, possibly cast over or around the base of the original pier or precast concrete column. (Photo 22).

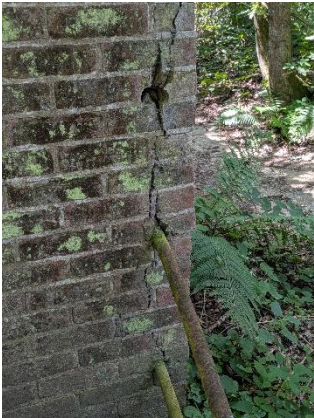
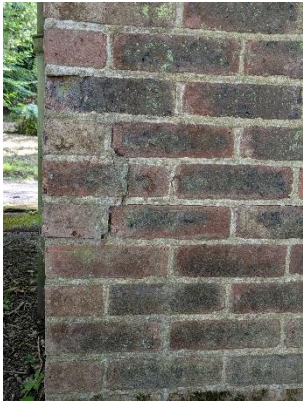
To the north west corner of the building cracking of up to 10mm wide was noted to the brickwork where embedded metal tubes were set into the brickwork and were corroding. Cracks were vertical to the north elevation and horizontal to the west elevation, running south around 0.6m. (Photo 23 & 24).

| Photo 23 - Building B Building B cracking to brickwork north west corner | Photo 24 - Building B Building B cracking to brickwork north west corner |

It is evident some damage to the masonry has occurred which will require limited remedial repair by brick stitching and possible introduction of a system of bed joint reinforcement in the damaged areas of structure, including the north east & north west corners, and possibly the north elevation under the window.

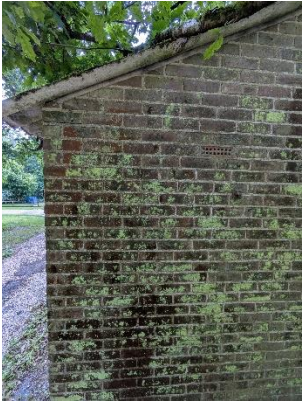
To the north east corner of the build, on the north elevation a tapered horizontal crack was present from the eaves of the east wall, extending back to the head of the window on the north elevation. (Photo 25). A tapered vertical crack was present to the sill of the north elevation window, of around 3mm wide and which extended and diminished into four brick courses below the sill. (Photo 26).

It appeared there had been some likely foundation movement to the north east corner of the building, which will likely require underpinning or some other form of foundation strengthening and stabilisation system.

| Photo 25 – Building B north east corner horizontal cracking towards window head. | Photo 26 - Building B vertical tapered crack through north elevation sill & bricks below. |
