# **North Hall Cottage**

## **Tree Report - BS5837:2012**

**October 2024**

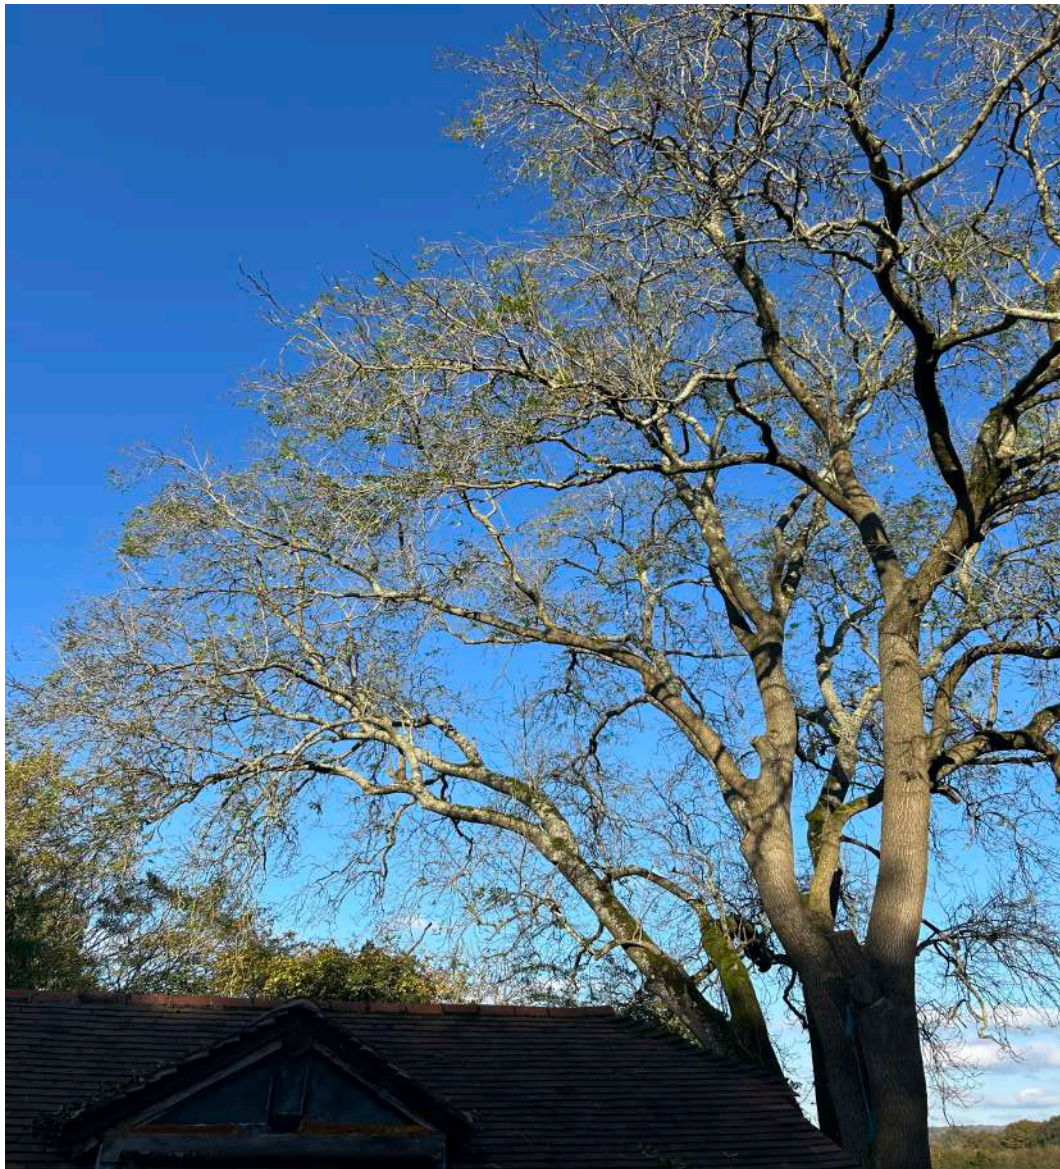
Tree T1, an impressive mature ash tree, is displaying early signs of Ash Dieback Disease (*Hymenoscyphus fraxineus*, or ADD) in its crown, with multiple minor dead branches present and a number of recent limb failures, presenting a risk to the buildings located below it.

Additionally, the tree's north-facing stems have a heavy lean, placing undue strain on the base of the tree and therefore its overall stability.

**T1** – Mature ash with building to be demolished below (Photo taken October 2024)

One tree is required to be removed before the development of the extension and after the demolition of the existing out-building.

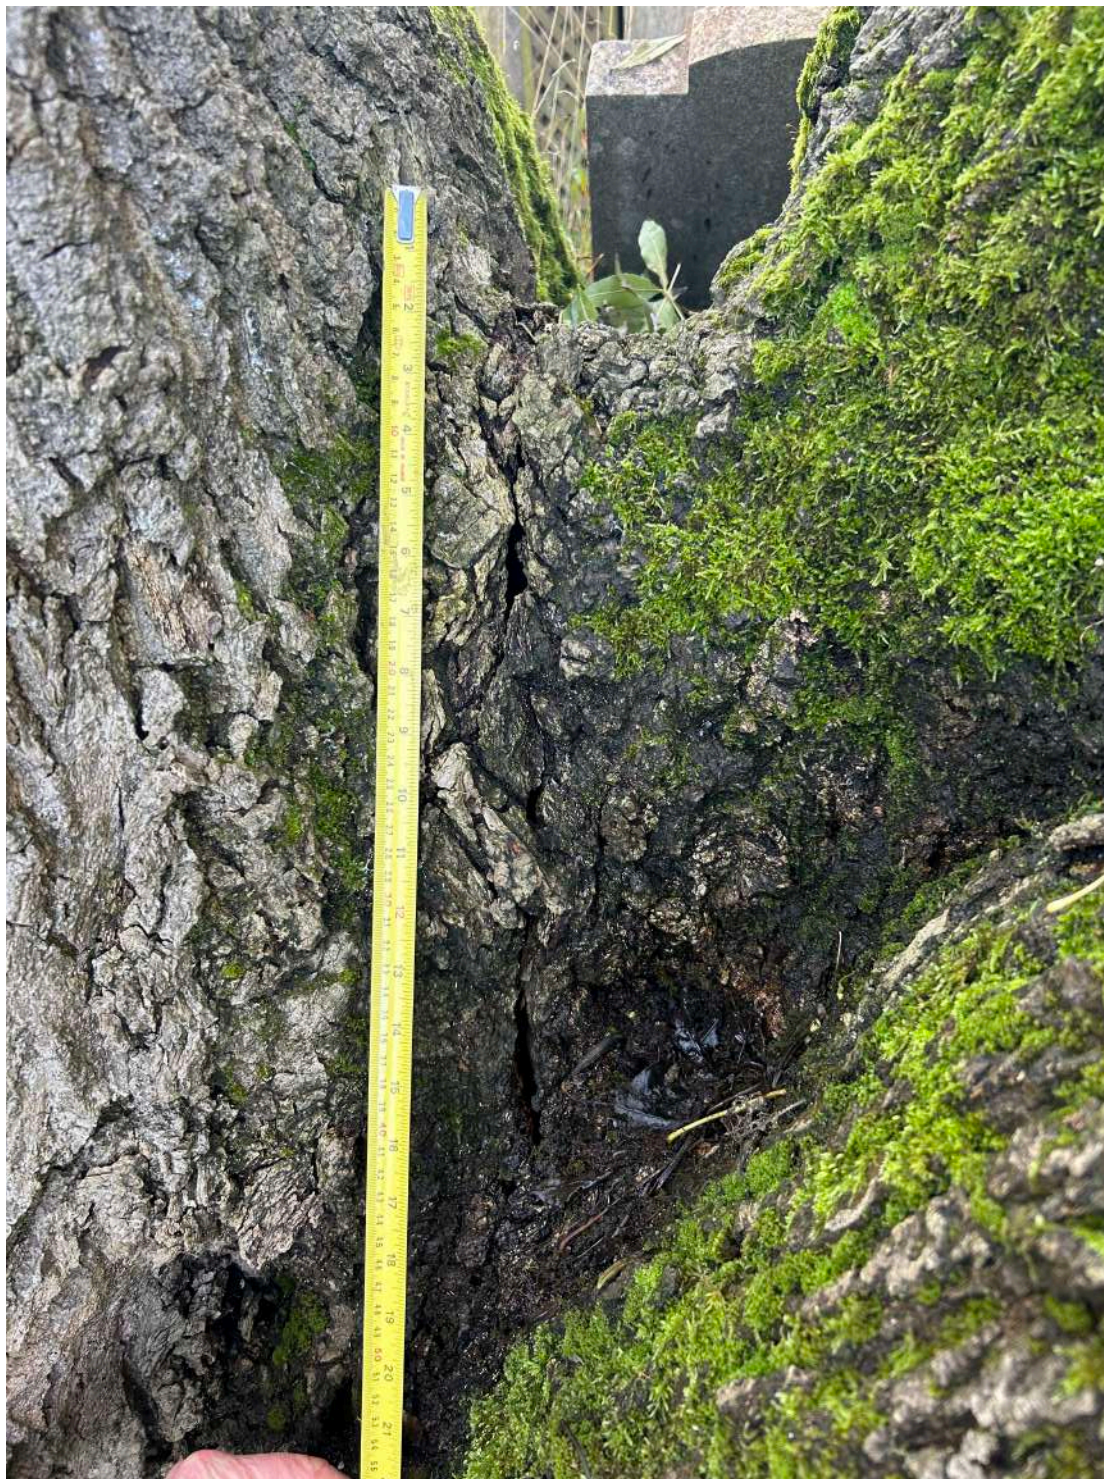
A large, deep crack is evident at the tree's base, on its eastern side (measuring approximately 46cm in length) – see photo in Appendices. It is located in between the two main stems and is a significant sign of basal weakness.

Once noticed in the September survey, Mr Mellish placed two small nails on either side of the crack, as a simple monitoring device. Measurements taken on 23<sup>rd</sup> October 2024, displayed a 3mm increase in the size of the crack compared to those taken on 3<sup>rd</sup> September, 2024.

**T1** – Basal Crack on east side of tree

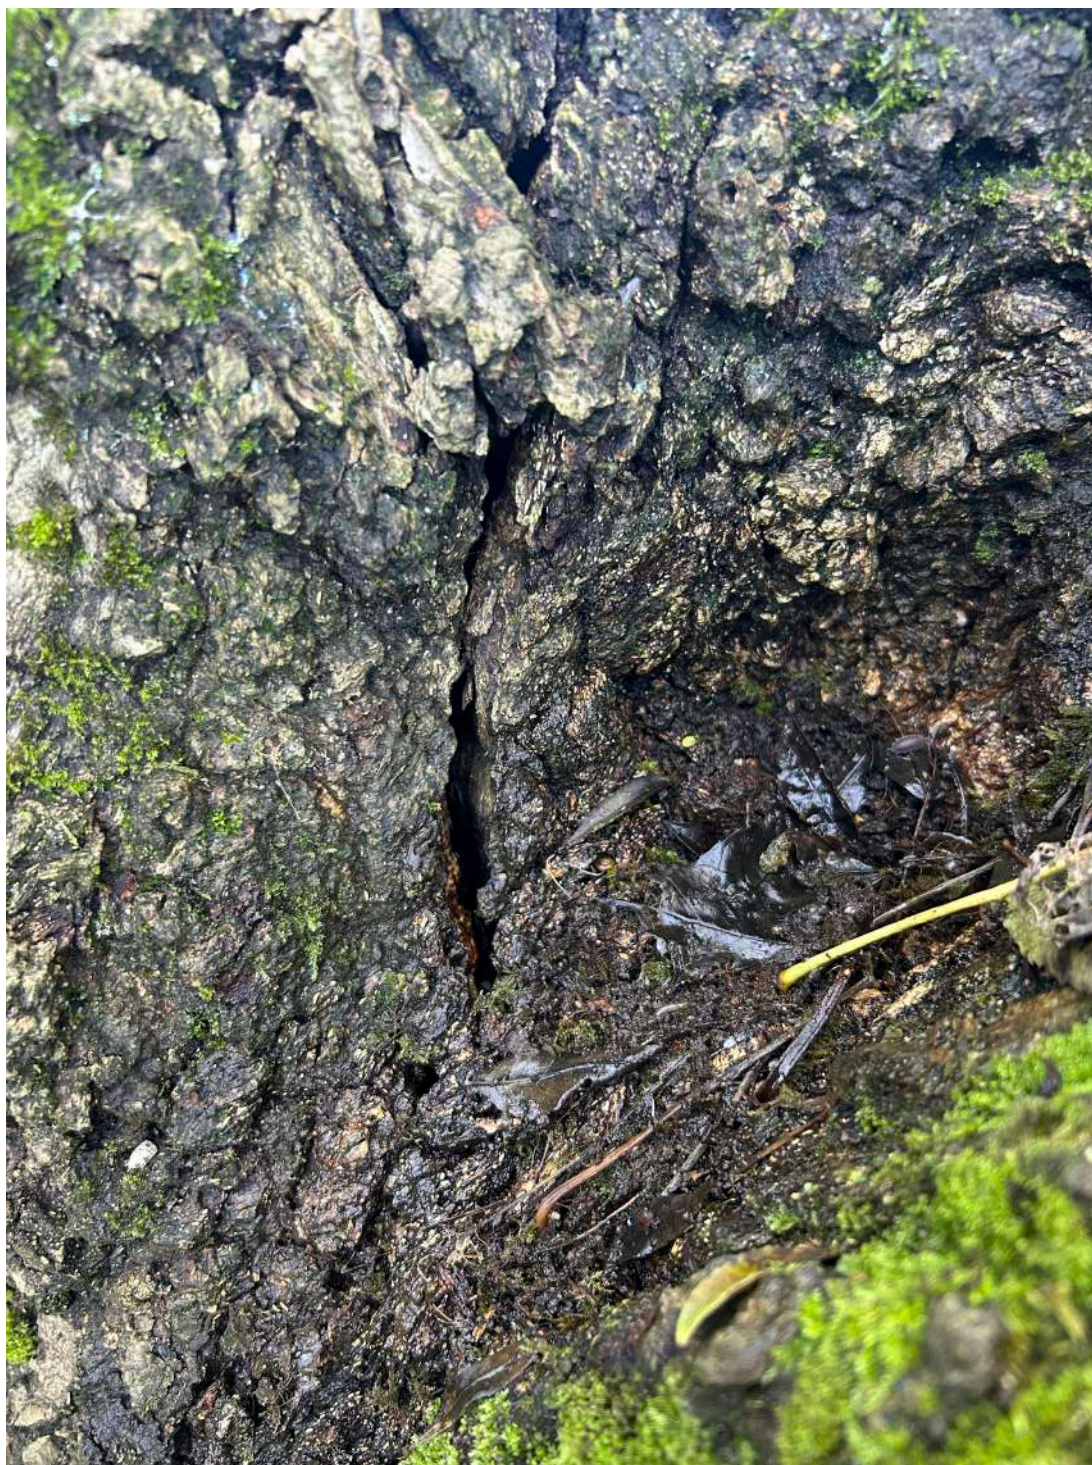
**T1** – Basal crack, close-up
