## DRAINAGE STATEMENT

Ote Hall Farm  
Jane's Lane  
Burgess Hill RH15 0SR

**Ref:** 2021-103  
**Issue:** 3  
**Date:** 09 April 2025

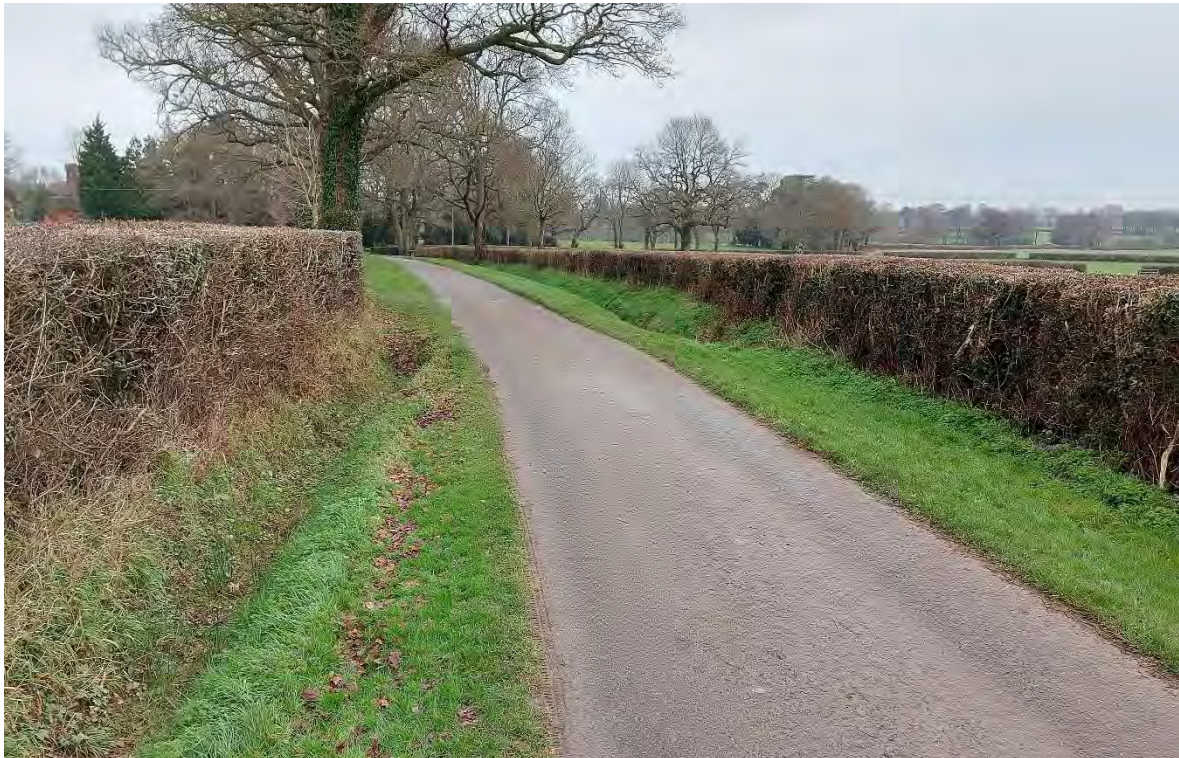
**Photo 1:** Looking north along access road with receiving ditch on left hand side

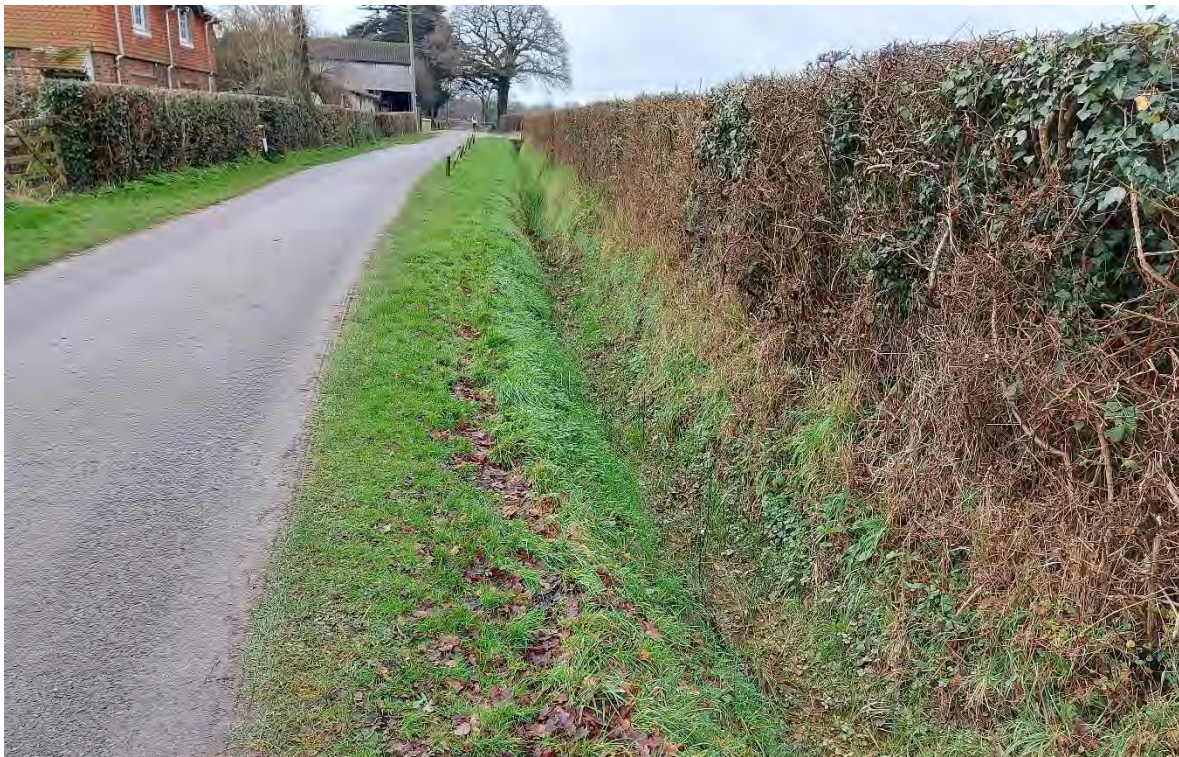
**Photo 2:** Looking south along access road with receiving ditch on right hand side

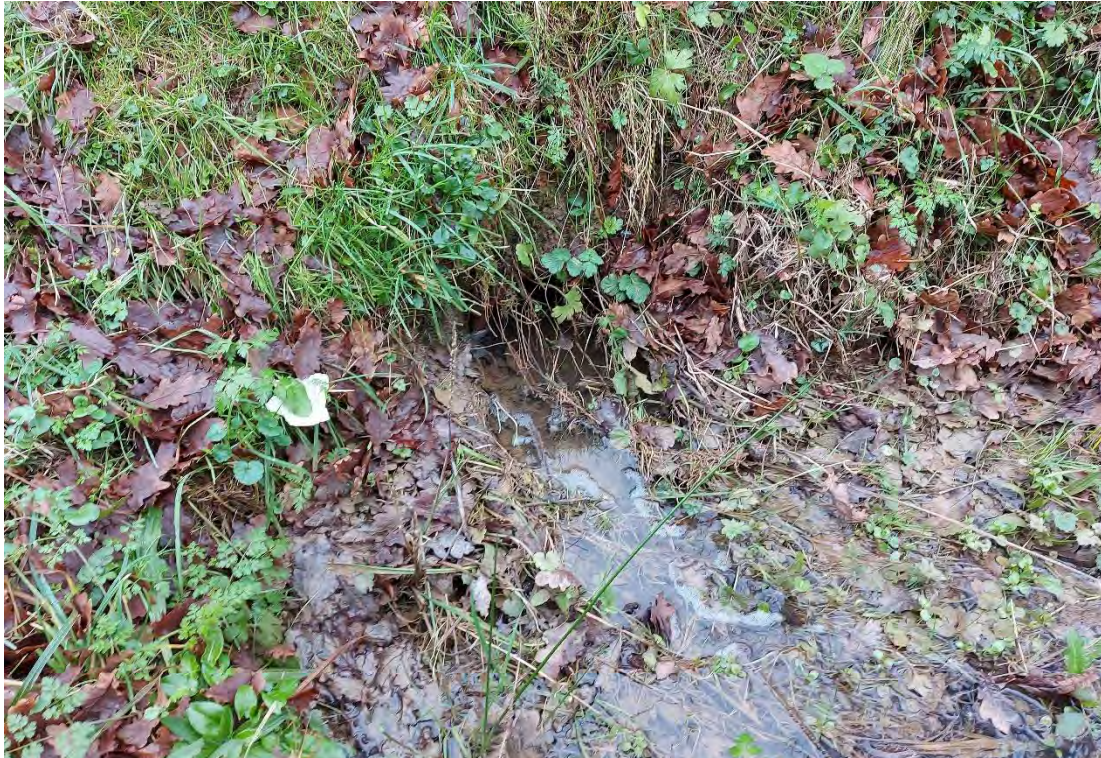
**Photo 3:** Culvert outlet from receiving ditch entering ditch on opposite side of access road, viewed from the east

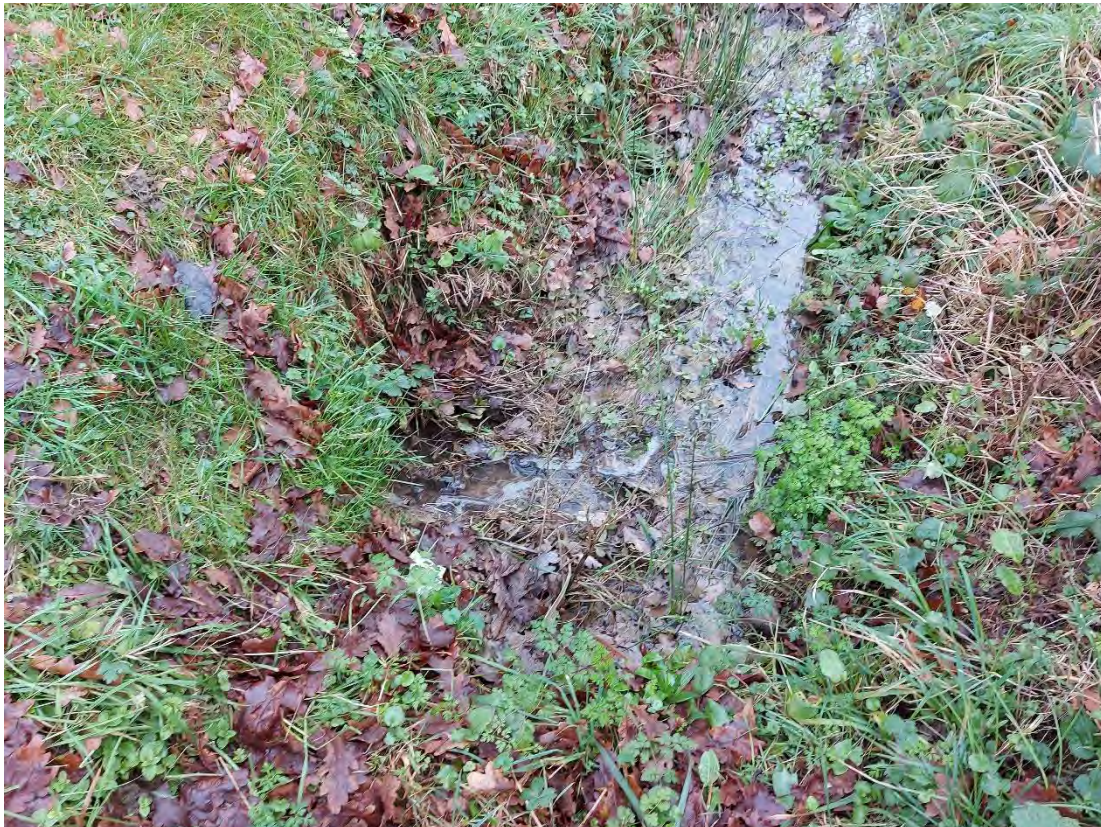
**Photo 4:** Culvert outlet from receiving ditch entering ditch on opposite side of access road, viewed from the south

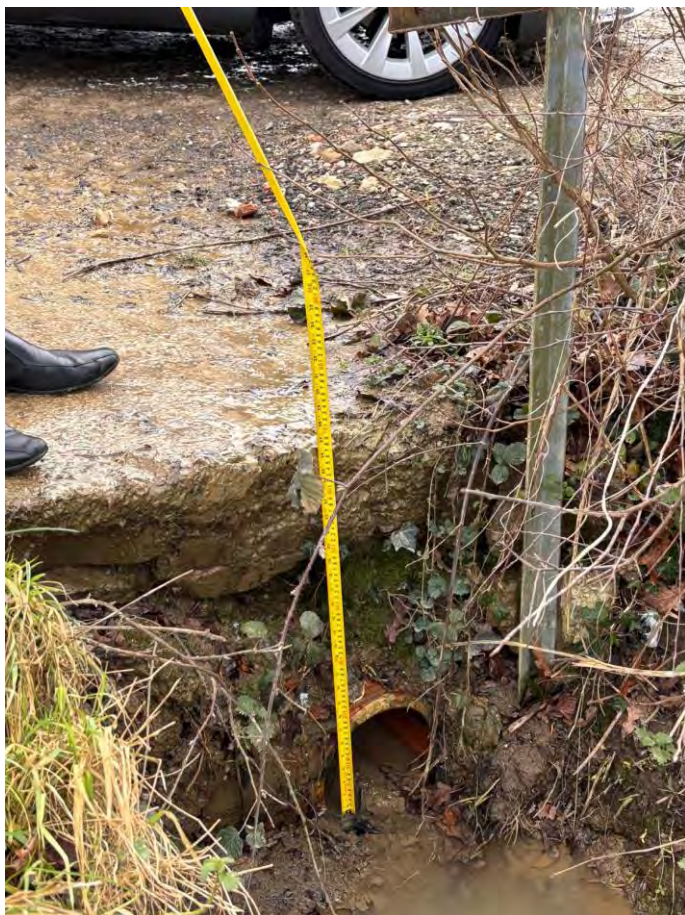
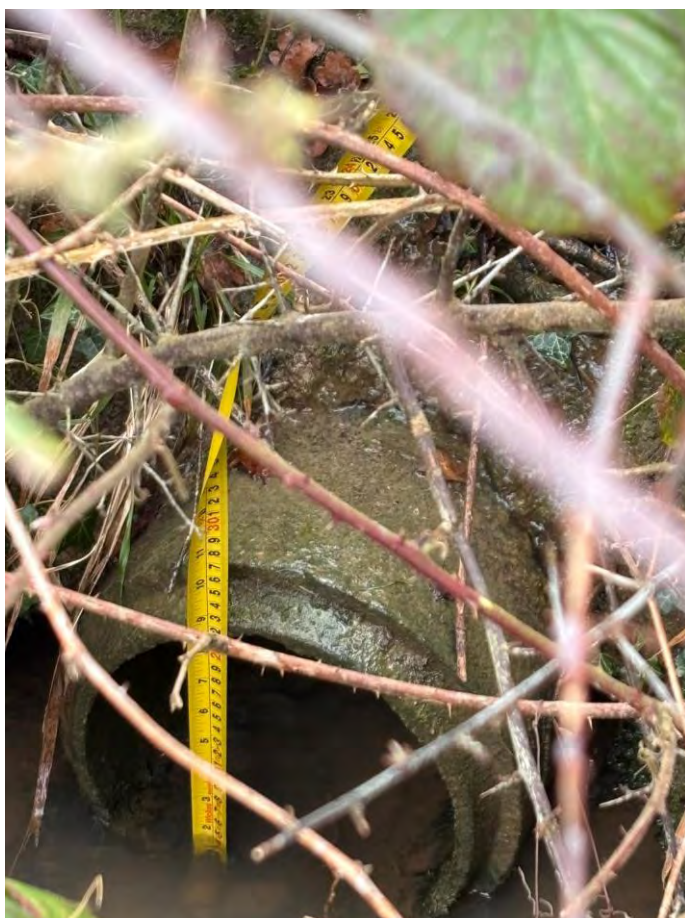
**Photos 5 and 6:** Measurements of existing culverts showing 225mm diameter

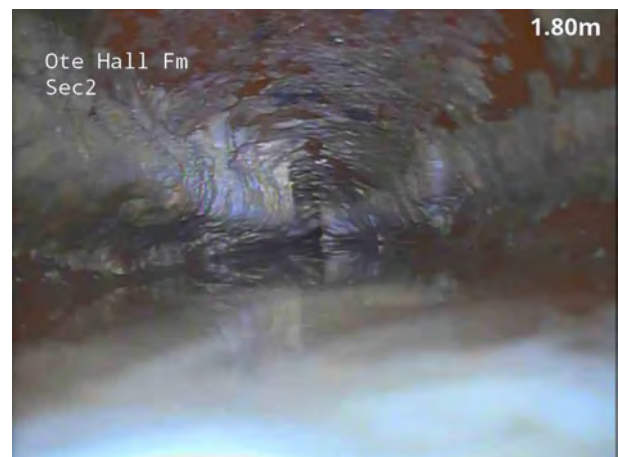
5, 00:00:24, 1.90 m  
Attached deposits, grease from 9 o'clock to 3 o'clock, 20% cross-sectional area loss, start

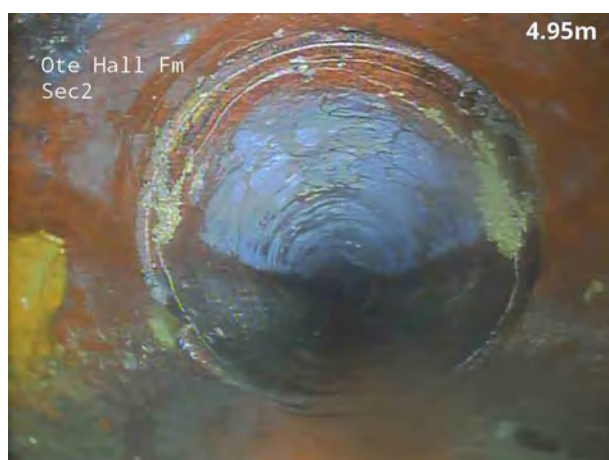
9, 00:06:06, 5.10 m  
Fracture, circumferential at joint from 12 o'clock to 12 o'clock

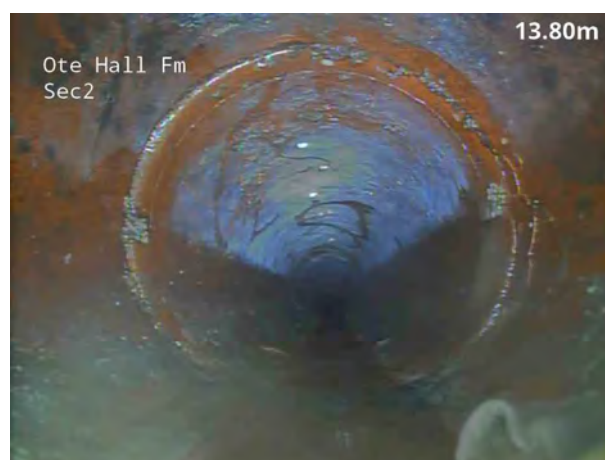
10, 00:05:23, 14.00 m  
Fracture, circumferential at joint from 12 o'clock to 12 o'clock

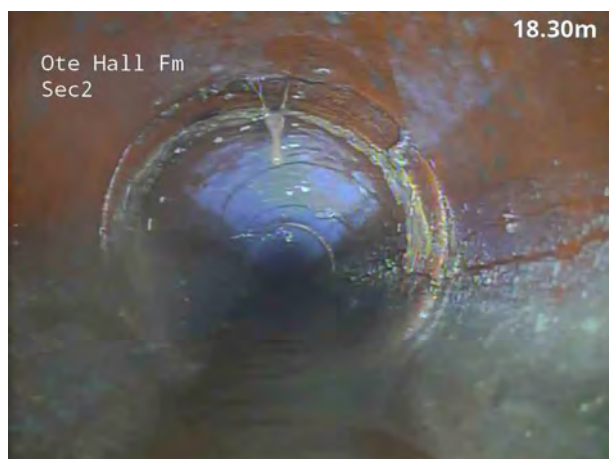
11, 00:05:04, 18.50 m  
Fracture, circumferential at joint from 12 o'clock to 12 o'clock

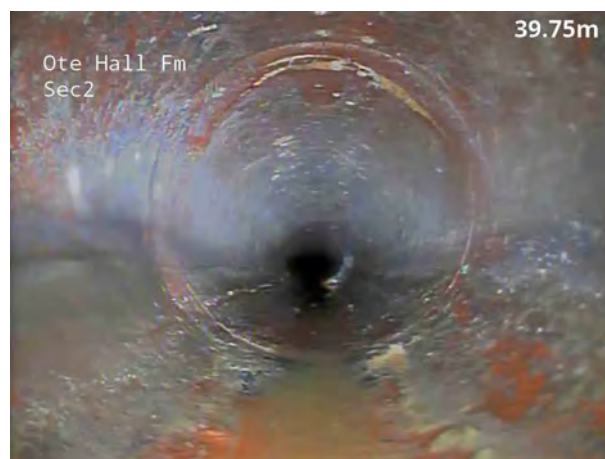
12, 00:03:18, 39.90 m  
Fracture, circumferential at joint from 12 o'clock to 12 o'clock

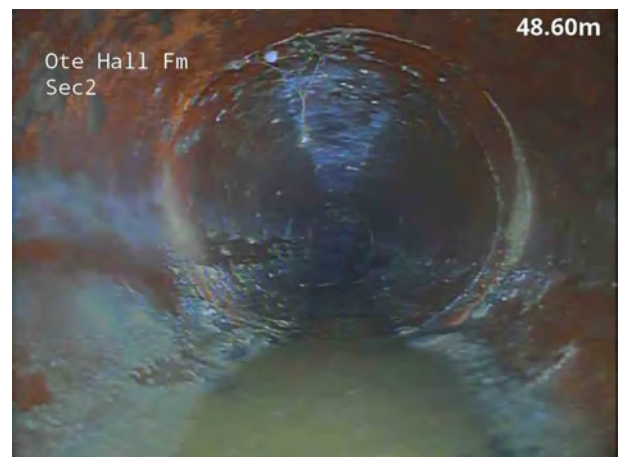
17, 00:02:12, 48.20 m  
Fracture, circumferential at joint from 12 o'clock to 12 o'clock

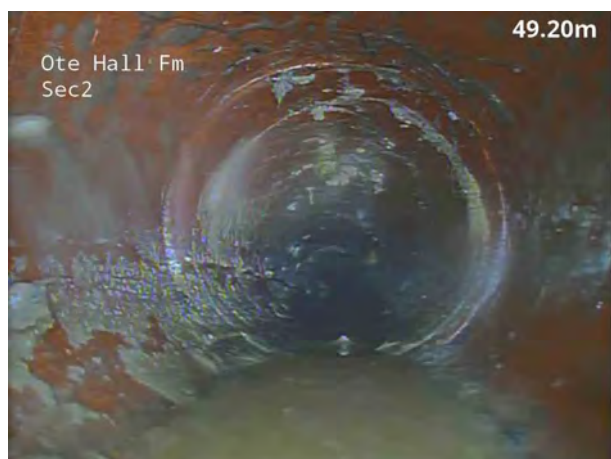
18, 00:02:05, 48.80 m  
Fracture, circumferential at joint from 11 o'clock to 6 o'clock

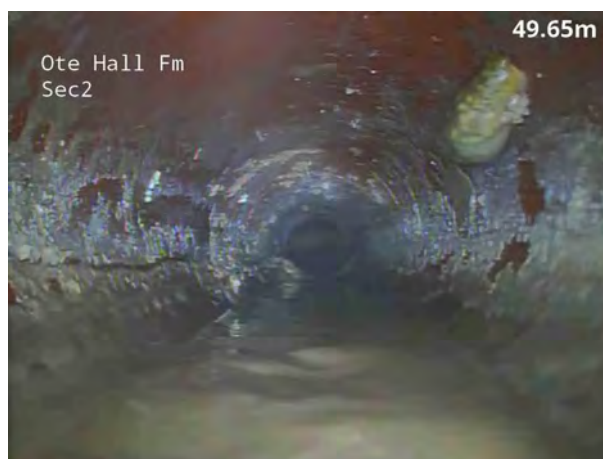
19, 00:01:57, 49.40 m

Fracture, circumferential at joint from 12 o'clock to 12 o'clock

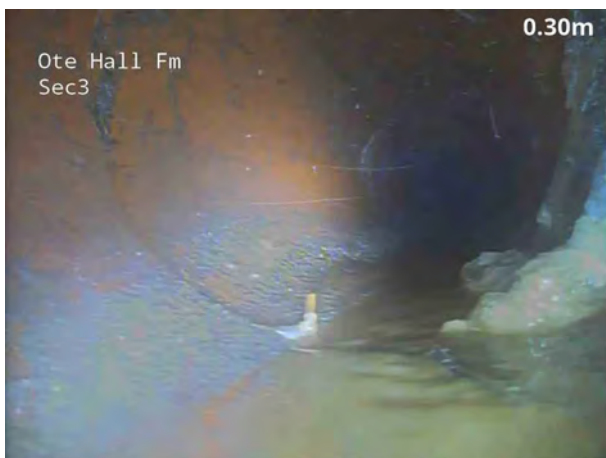
2, 00:00:11, 0.30 m  
Roots, fine at joint
