Stonehurst  
Selsfield Road, Ardingly,  
Haywards Heath RH17 6TN

Structural Inspection Report

| Date | Version | Notes/Amendments/Issue Purpose |
|---|---|---|
| 27 <sup>th</sup> May 2025 | 1 | For Information |

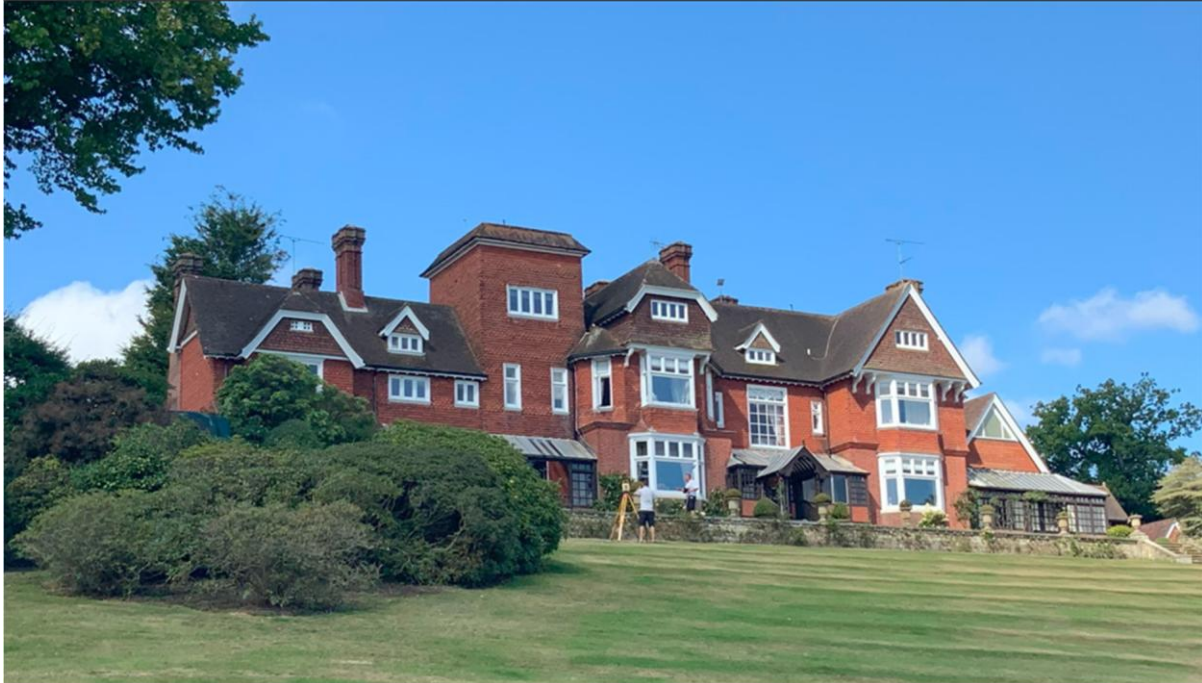
Figure 4 – Current Building

There are no signs of structural issues observed in the tower. The brickwork observed internally at high level second floor below roof level is in good condition as are the timber joists supporting the roof. There is no visible structural cracking internally and the exposed brickwork at ground floor level is in very good condition and of high quality workmanship from the original construction.

The structure of the building is in good condition from the visual inspection and would be capable of re-supporting a modern replacement of the upper tower.
