**SPECIFICATION AND SCHEDULE  
OF  
STRUCTURAL REPAIRS  
TO  
THE TIGER,  
122 HIGH STREET  
LINDFIELD  
WEST SUSSEX**

**Date:** August 2025

**Reference:** EJM/CH/SPEC/20560~spec rev 0

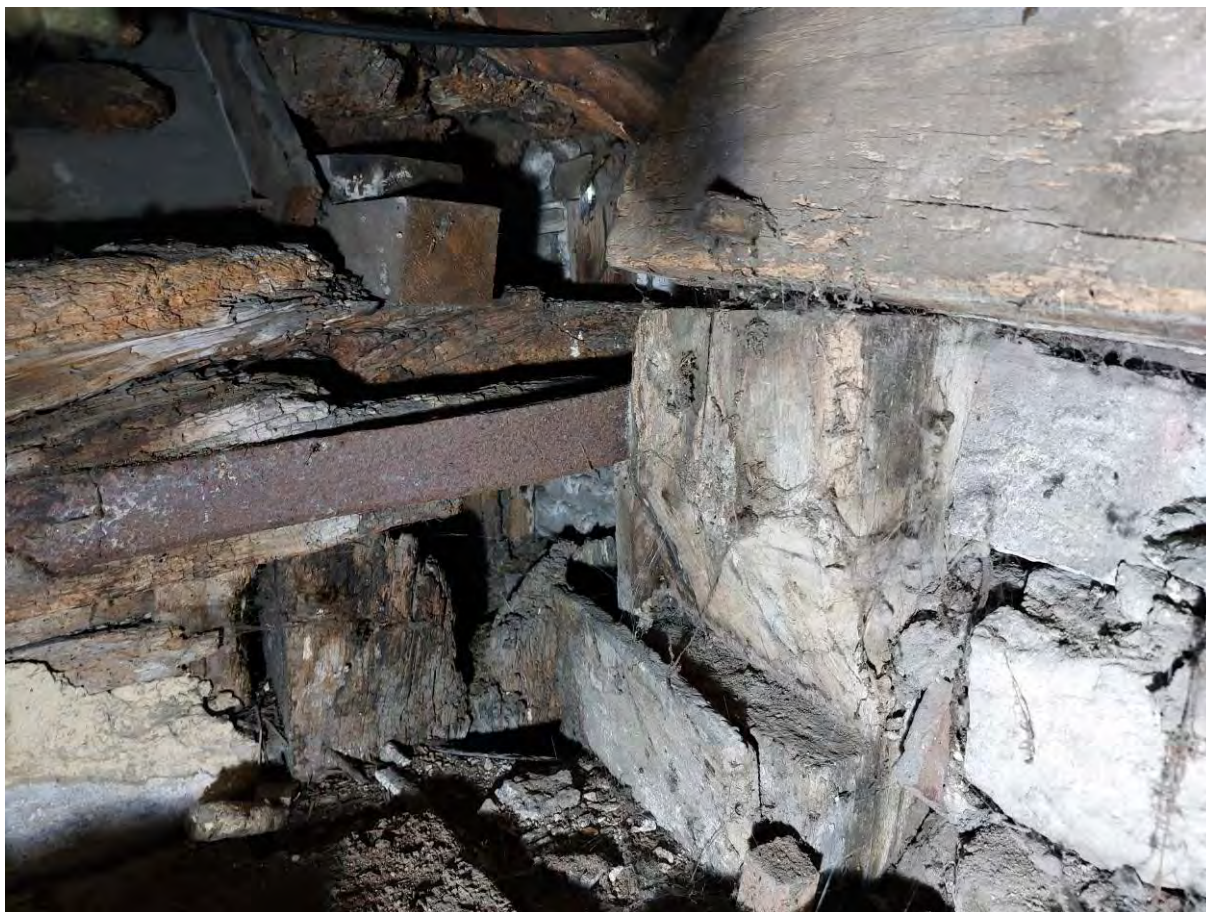
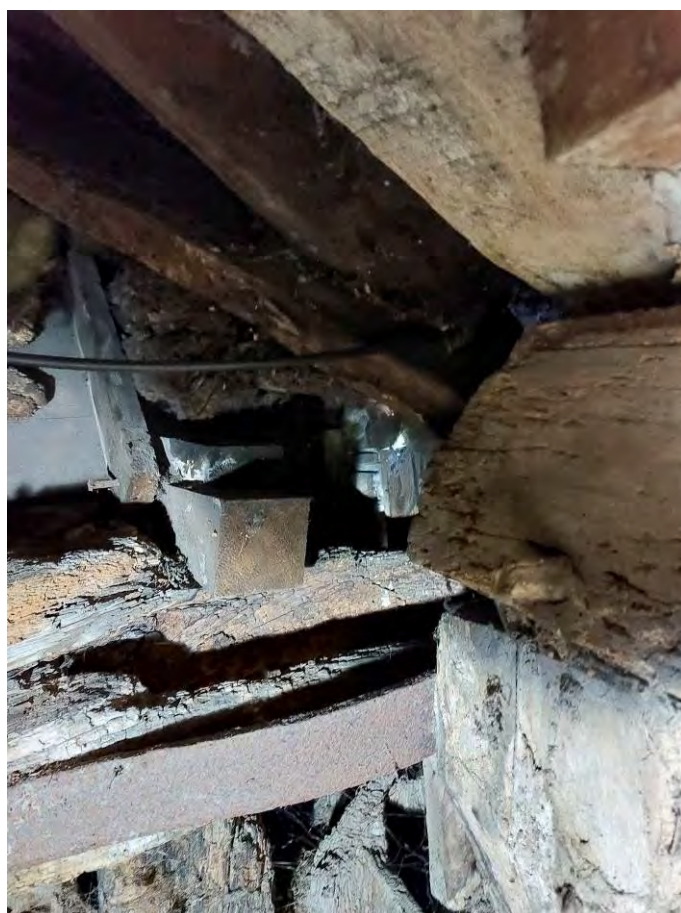
| | | £ | p |
|---|---|---|---|
| 2.3.1 | To the north east corner, there is decay to both the eaves plate to the east wall and also the gable tie beam to the north wall (see photographs 1 and 2). This relates to the valley above and is long standing and no longer active. The eaves plate has got an iron strap added alongside, which extends out and hooks around the storey post to the north west corner of the east range and is adequate, particularly as the eaves plate is supported by timbers below. | | |

Photograph 1: NE corner of Bay 5

Photograph 2: NE corner of Bay 5

| | | £ | p |
|---|---|---|---|
| 2.3.2 | However, to the tie beam, an additional purpose made fabricated strap is recommended to bridge across the junction between this and the eastern eaves plate. This should be 1200mm long and fixed to the tie beam and the eaves plate with 3No. 10mm coach screws at 180mm long and with the strap being 75mm wide x 10mm thick and this fabricated to allow for the 'out of alignment' of the two plates in the north south direction, as well as the eaves plate to the east range being at a lower level. Provide sketch of strap prior to manufacture for approval and after completion of stripping of roof. | | |

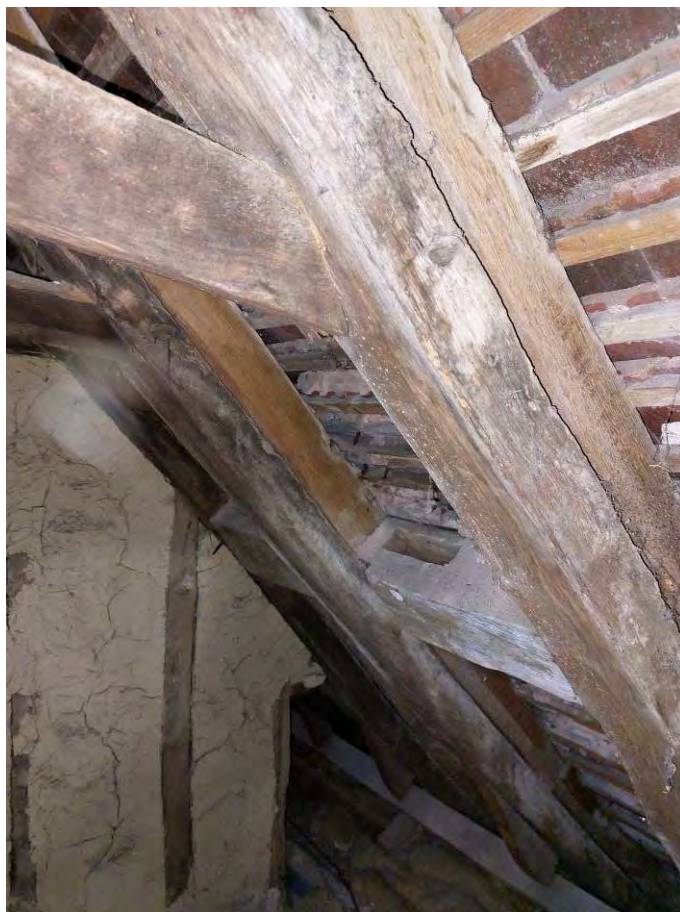
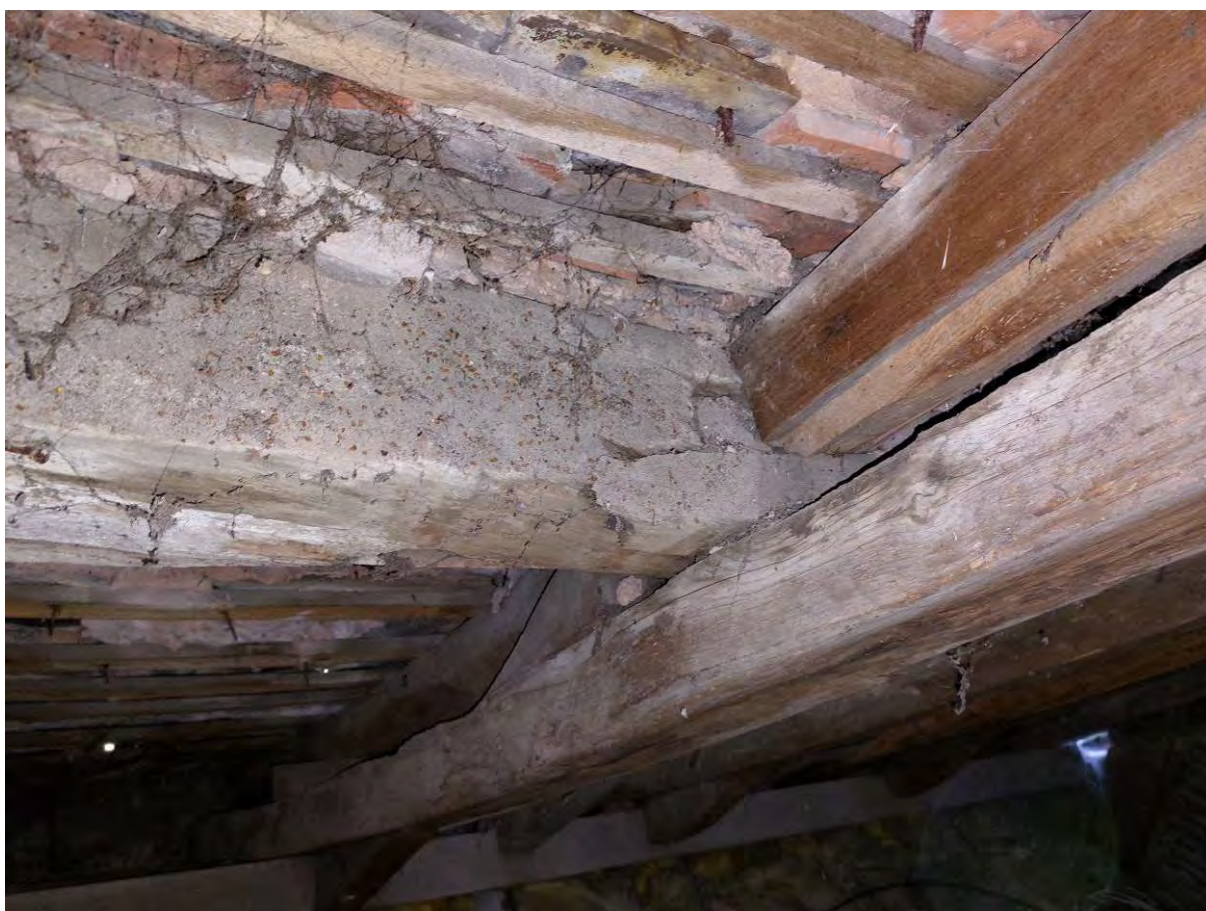
**Photograph 3: Purlin to west elevation of Bay 5**

**Photograph 4: Fracture to purlin to west elevation of Bay 5**

| | | £ | p |
|---|---|---|---|
| 2.3.4 | The purlin to the west front elevation is fractured at the centre (see photographs 3 and 4). Allow for a new 170mm wide x 10mm thick steel plate, 1m long, should be fitted to the top face centre over the fracture and fixed down with 8No. 12mm staggered coach screws and extending a minimum of 80mm into the purlin (see drawing 20560/26). | | |

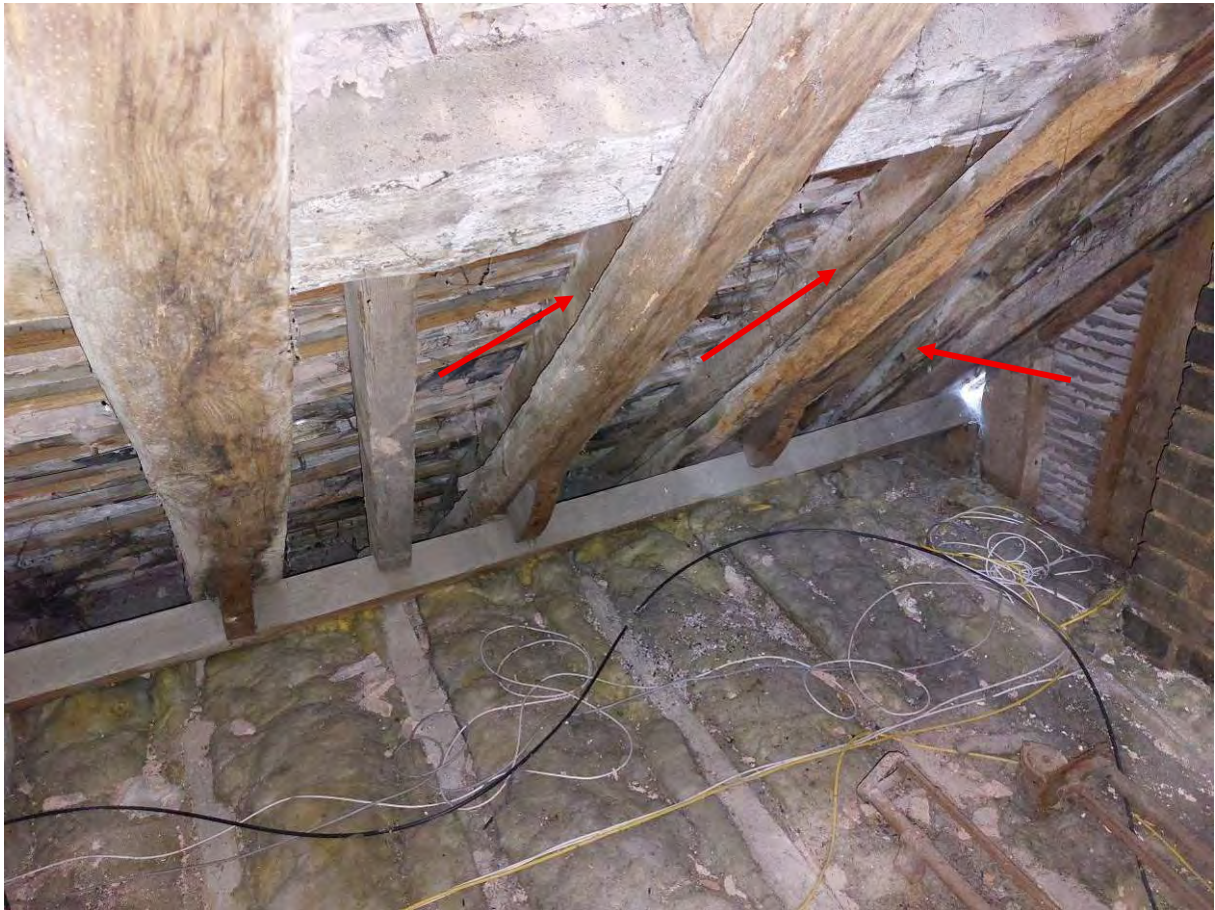
**Photograph 5: West elevation of Bay 5 with added rafters over originals**

| | | £ | p |
|---|---|---|---|
| 2.3.5 | The added rafters (see photograph 5), we assume introduced when the west brick elevation was added and particularly below the purlin, have a number of blocking pieces (see photograph 6), whereas others have none, but have deflected. Allow to remove all existing blocking pieces and replace with 2 No. new 200mm long x 110mm wide oak blocking pieces per rafter, depth to suit and fixed through upper rafters with Timberlok fixings with minimum 60mm penetration into blocking pieces, to provide additional support to upper rafters off the original. Repeat for rafters with no blocking pieces as above. Allow for this to all rafters in Bay 5 west elevation (see drawing 20560/26). | | |

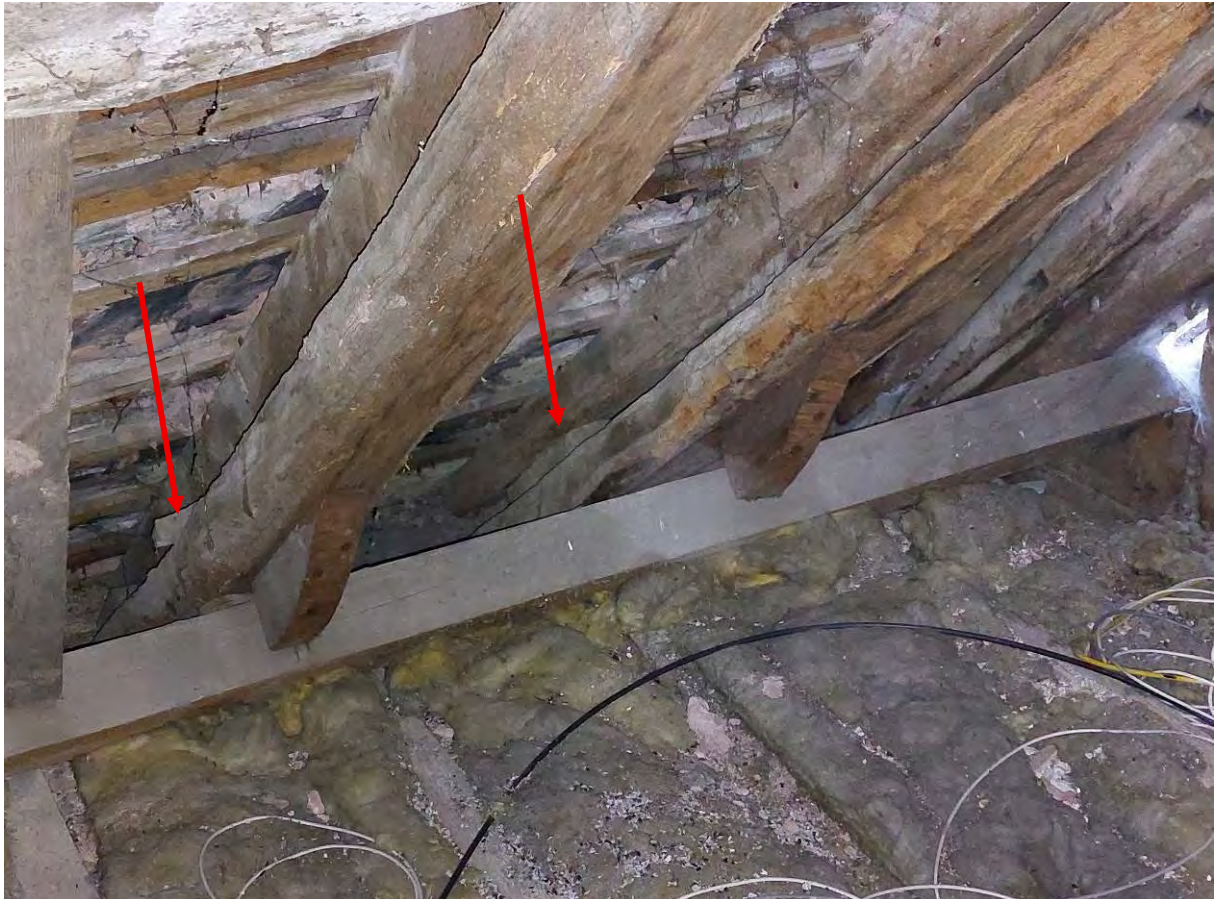
**Photograph 6: Wedges between earlier rafters and added rafters**

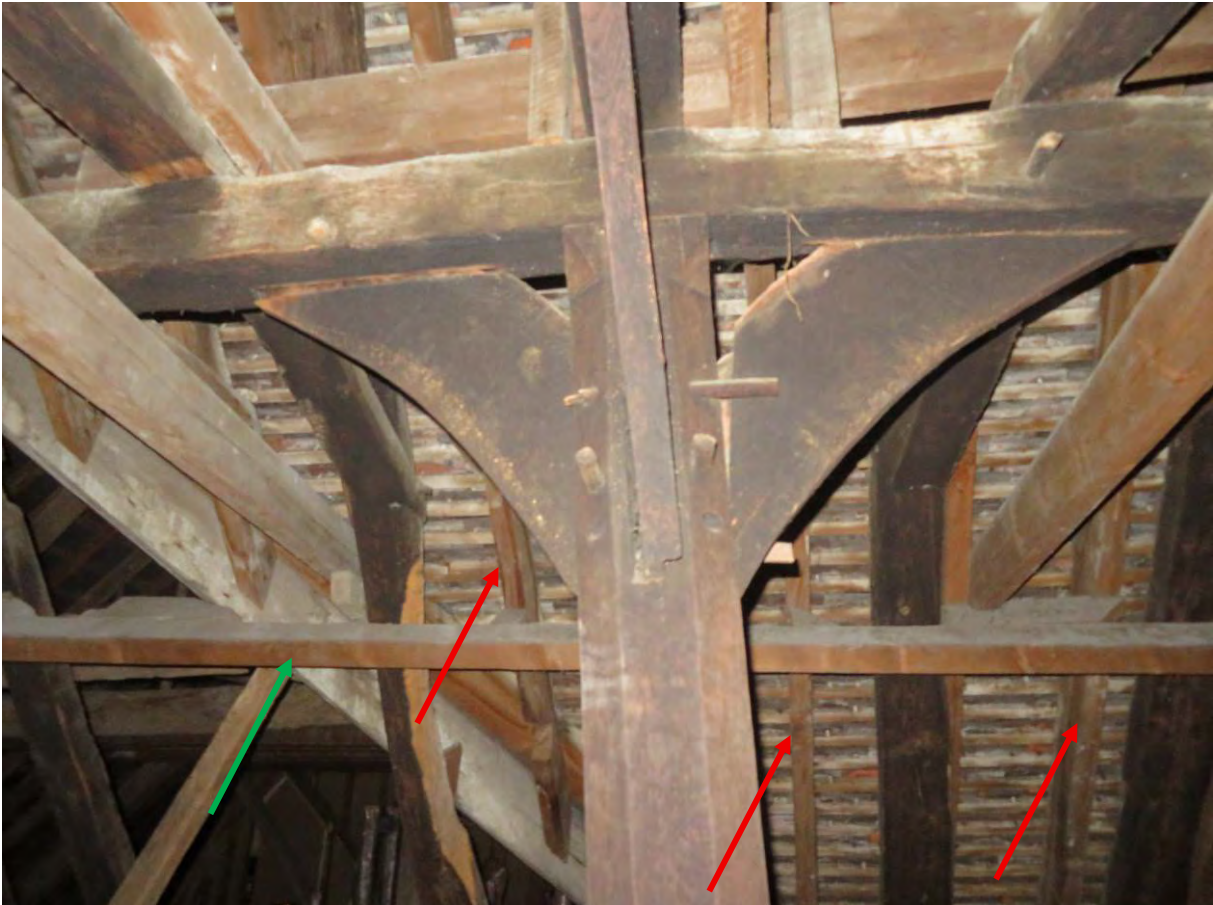
Photograph 8: Modern rafters to east of Bay 2/3 (red) and purlin (green)

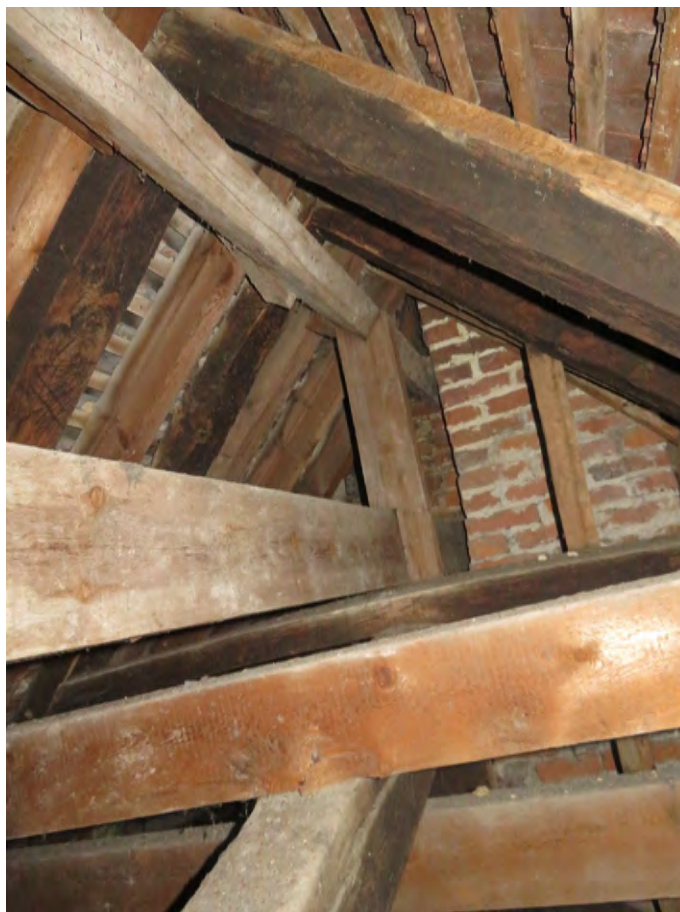
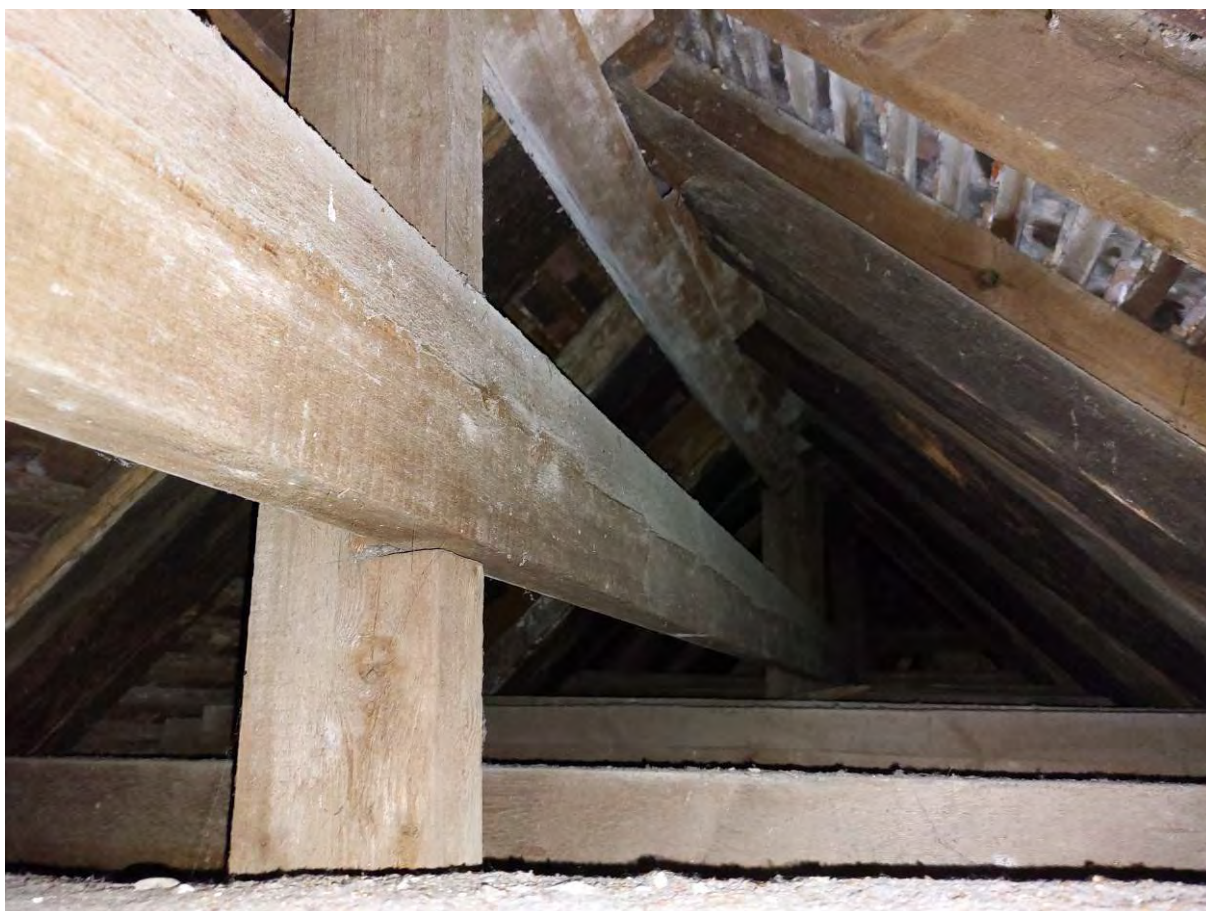
**Photograph 9: Added frame above collars purlins to Bay 3 and 4**

**Photograph 10: Added frame above collars purlins to Bay 3 and 4**

| | | £ | p |
|---|---|---|---|
| 2.4.6 | <p>In these bays there is upper timber over the collar purlin with struts under a purlin below the ridge (see photographs 9 and 10). Wedges of blocking pieces are positioned to one side but some loose, and no blocking pieces to opposite side. Allow provisionally to re-fix all existing blocking pieces with Timberloks. To opposite side allow to add new kiln dried oak blocking pieces to underside of rafter to lock in place. New section to be up to 150mm long x 75mm wide x depth to suit gap and fix with Timberloks.</p> <p>[Indicate extra over/under cost per new blocking piece £.....]</p> | | |

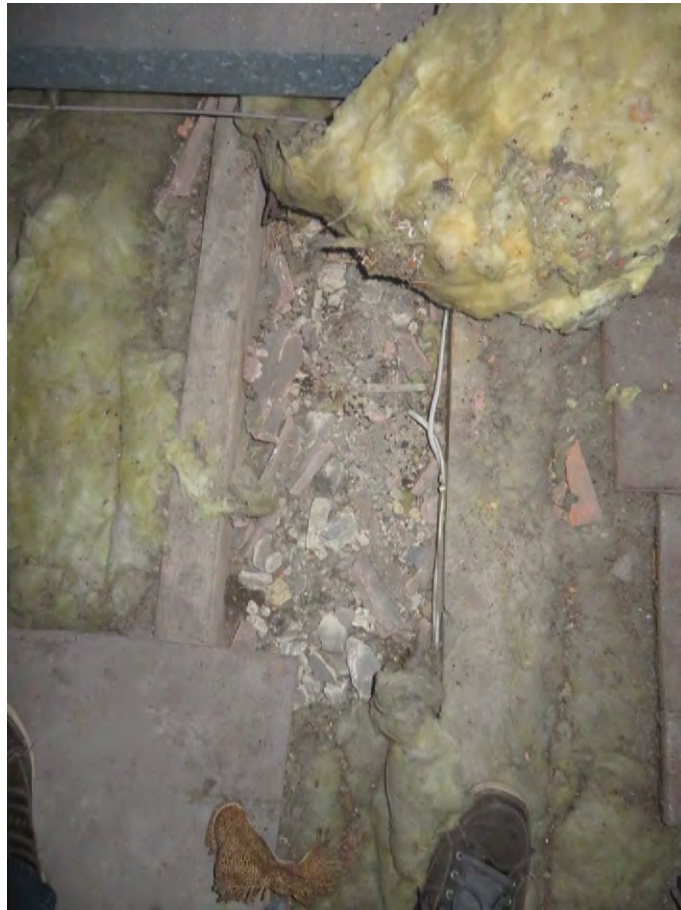
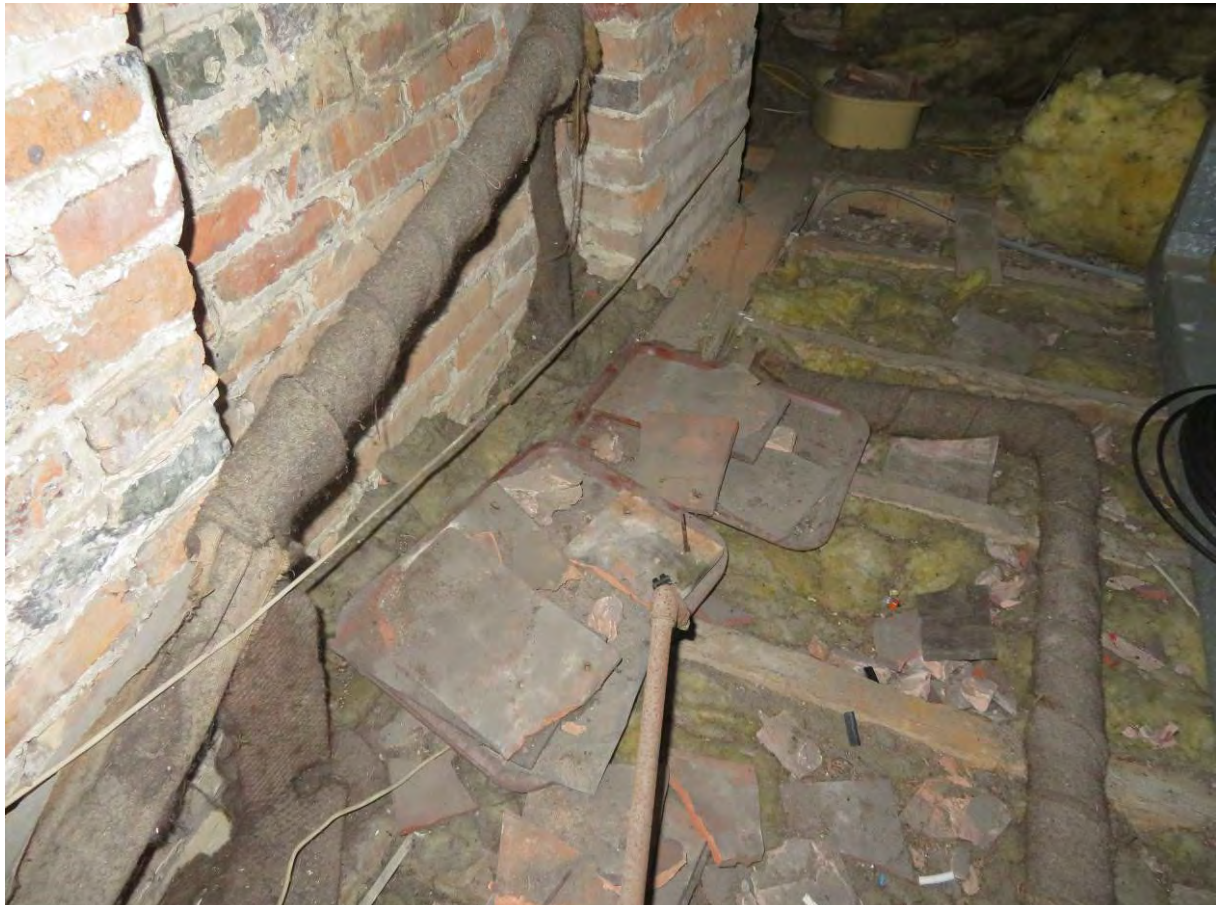
Photograph 11: Debris on ceiling backings

Photograph 12: Debris on ceiling backings

| | | £ | p |
|---|---|---|---|
| 2.2.1 | Allow for clearing out all roof voids of all debris, insulation, old materials etc including vacuuming to leave clear, including eaves areas voids etc. Any historic artefacts to be set aside for inspection by the Surveyor and should be cross-referenced to a plan for location. Not all vacuum's to use soft brush nozzles to avoid damage to any plaster nibs. Note the build-up is quite significant on ceiling backings in areas from past roofing works (see photographs 11 and 12). | | |

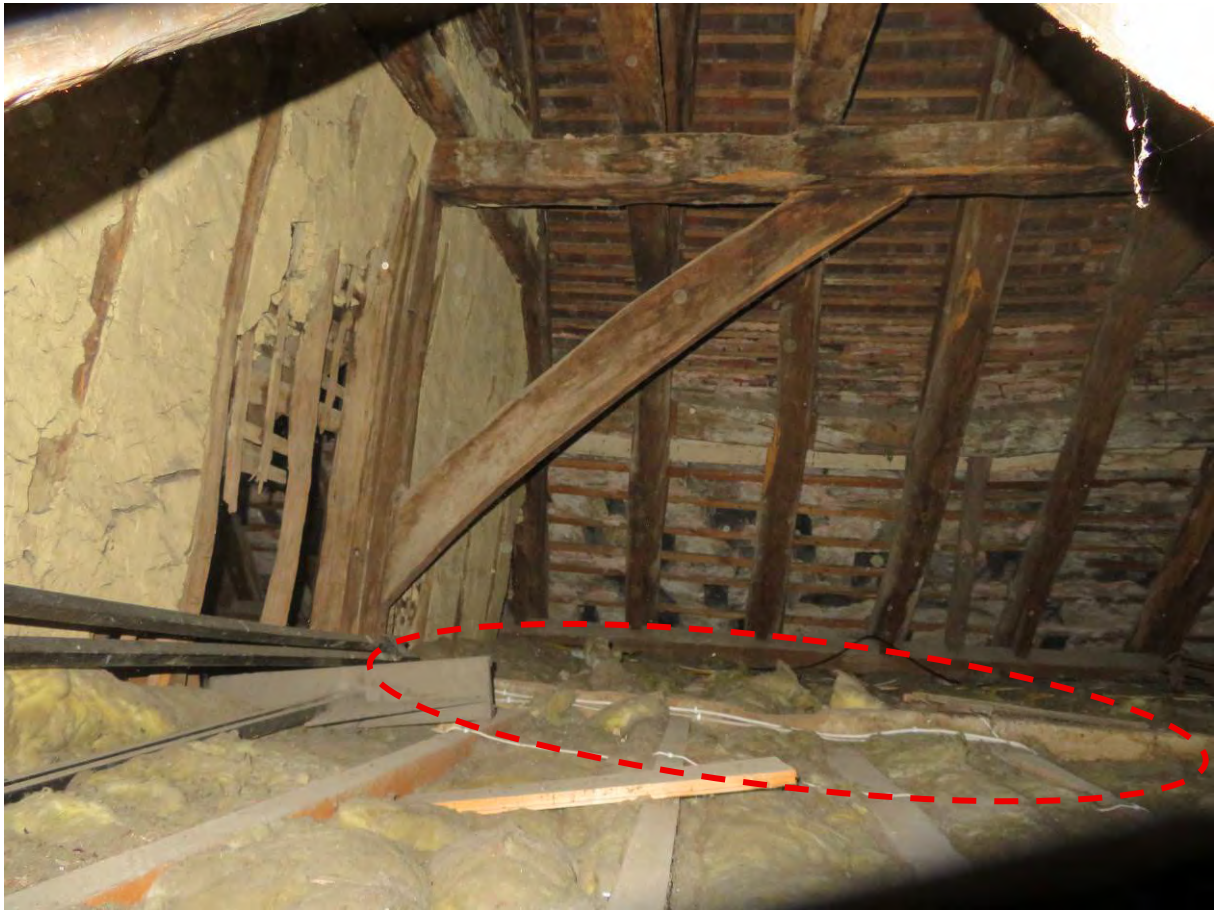
Photograph 13: Ceiling joist and spine beam jointing to Bay 5

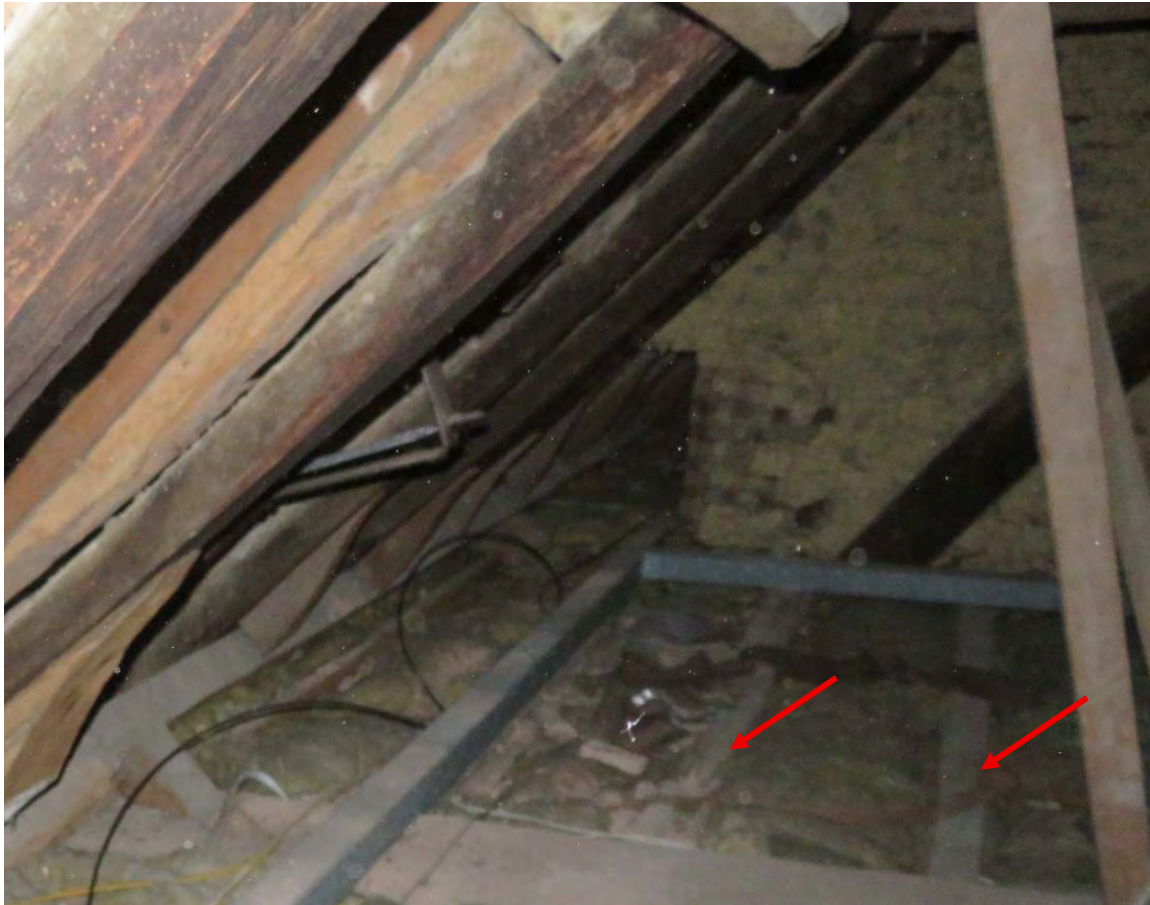
Photograph 14: Ceiling joists in Bay 4

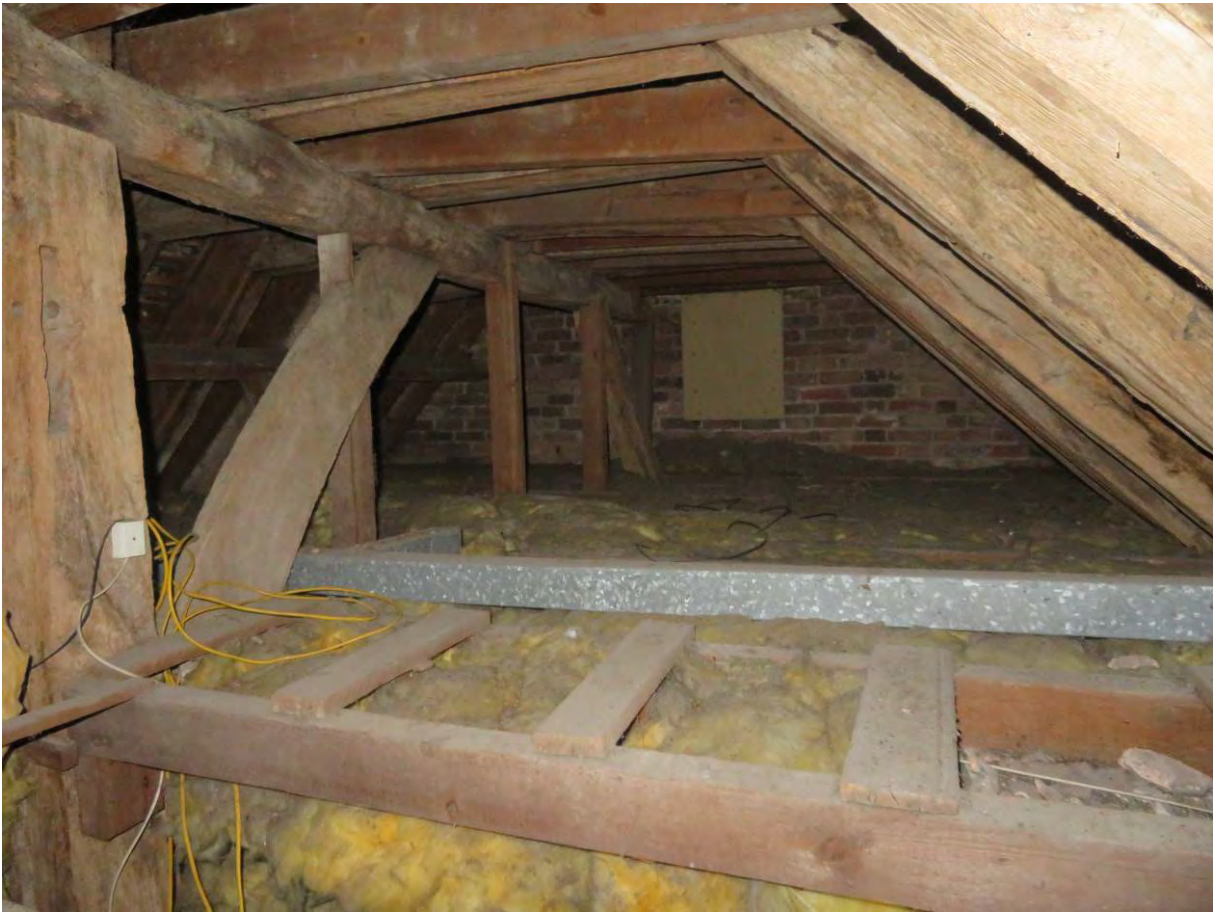
**Photograph 15: Bay 1 roof structure**

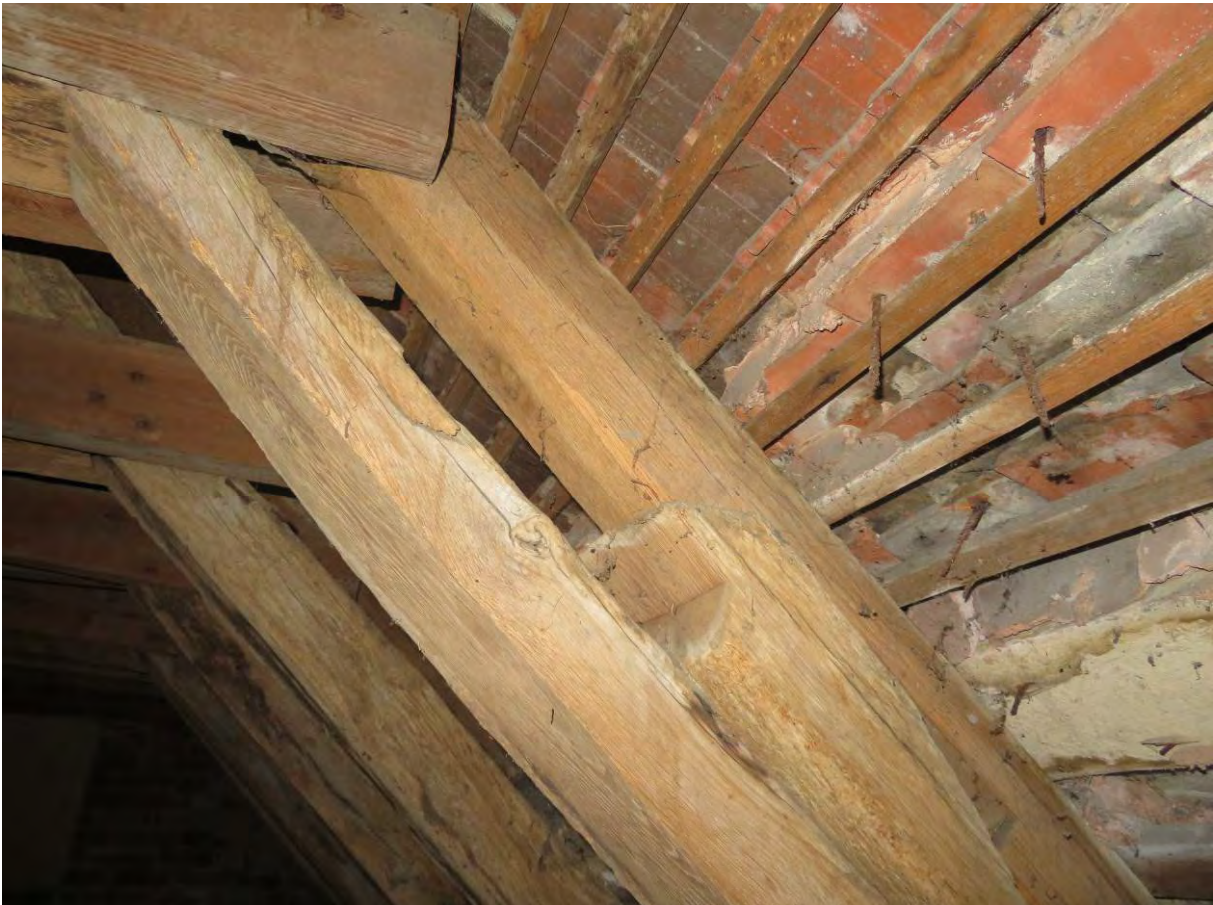
**Photograph 16: Outer rafters to west elevation to Bay 1 and 2**

| | | £ | p |
|---|---|---|---|
| 2.6.4 | <p>The added rafters (see photograph 16), we assume introduced when the west brick elevation was added and particularly below the purlin, have a number of blocking pieces (see photograph 16). Allow to remove all existing blocking pieces and replace with 2 No. new 200mm long x 110mm wide oak blocking pieces per rafter, depth to suit and fixed through upper rafters with Timberlok fixings with minimum 60mm penetration into blocking pieces, to provide additional support to upper rafters off the original. Repeat for rafters with no blocking pieces as above. Allow for this to all rafters in Bay 1 and 2 west elevation (see drawing 20560/26 for diagrammatic detail).</p> <p>[Indicate extra over/under cost per rafter £.....]</p> <p>I also to note that the spacings between rafters are very wide and the new batten sizes will need to be sized to accommodate these and prevent deflection between.</p> | | |
