# Visual Tree Assessment - VTA (Tree Survey)

Beacon Woods (Burgess Hill)  
Burgess Hill  
West Sussex  
RH15 0ZL

Report ref: 00831-2-2025

**Survey Inspection date:** 7<sup>th</sup> February 2025

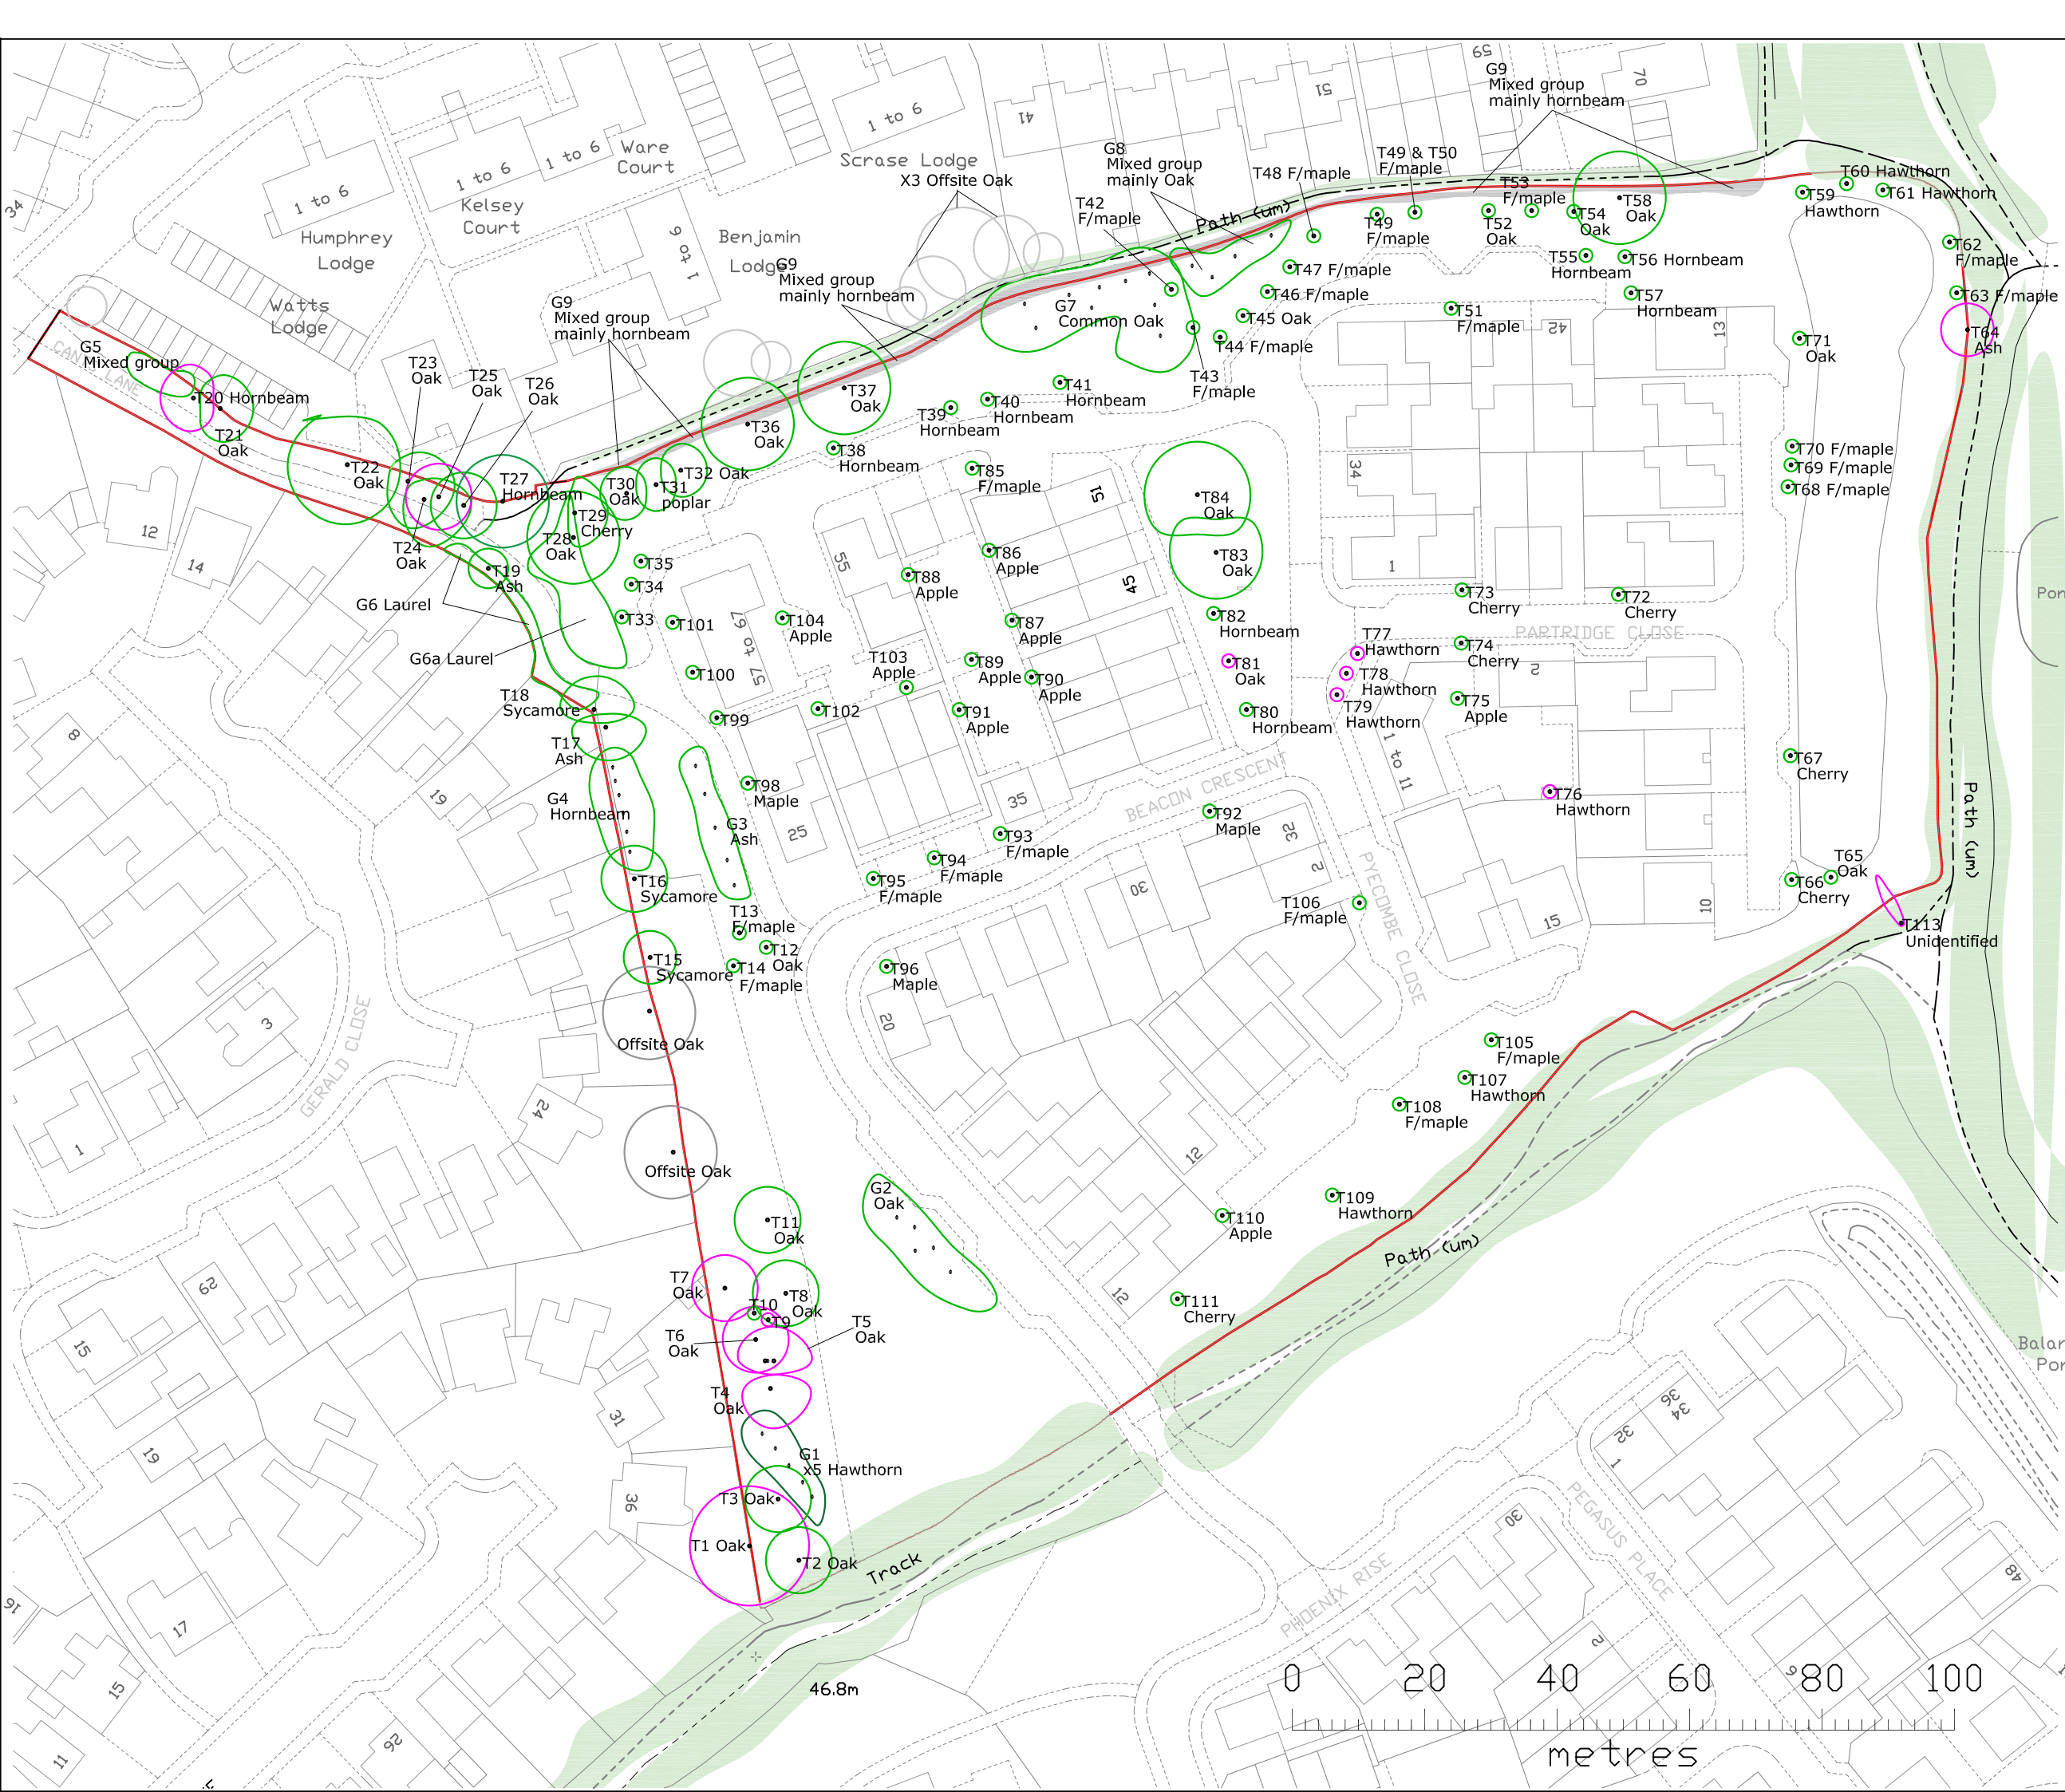
- PINK CANOPY EDGE ILLUSTRATES TREES THAT ARE RECOMMENDED FOR WORKS
- TRUNK
- T1 TREE NO.
- ASH SPECIES
- CANOPY EDGE
- ESTATE BOUNDARY

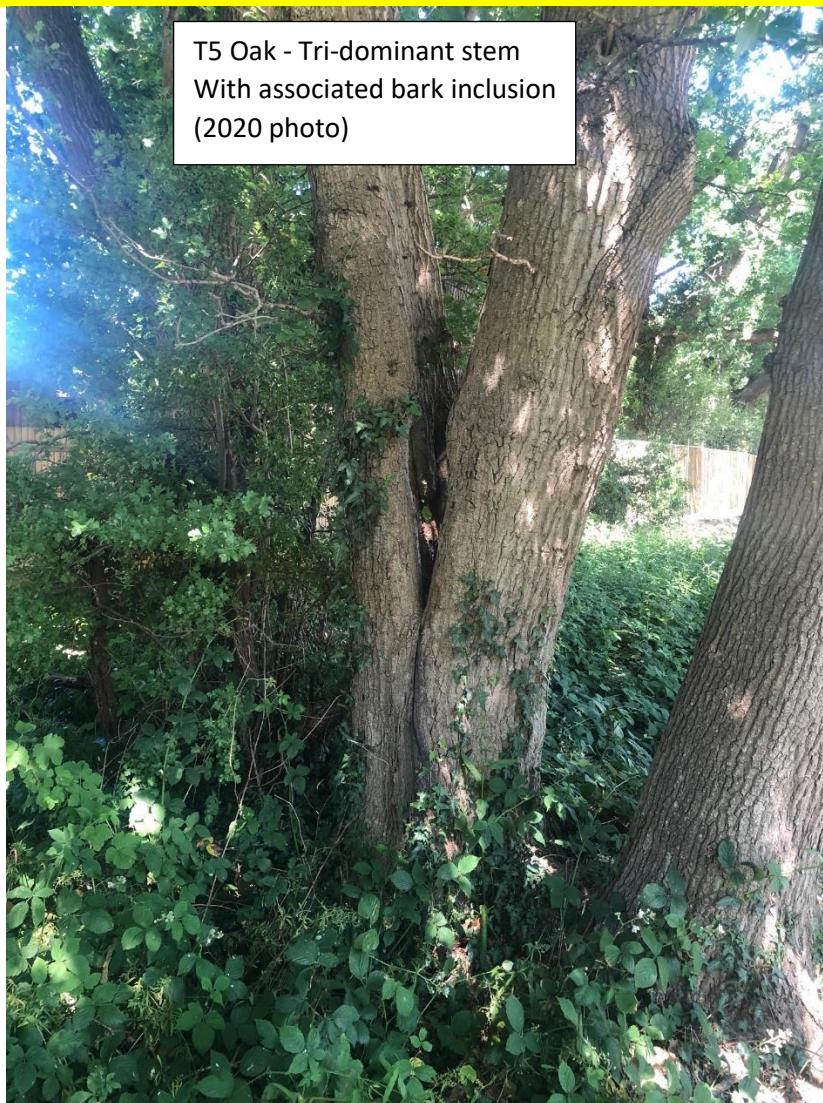
| Tree ID | Species | Height Est-M | Crown Spread Av-M | Crown Clearance | Age class | Physiology | Structure | Observations | Works | Reinspection | Work priority |
|---|---|---|---|---|---|---|---|---|---|---|---|
| T5 | Common Oak ( <i>Quercus robur</i> ) | 18m | N5m<br>E7m<br>S2m<br>W4m | | M | Good | Hazardous | Tri dominant stem from base; poor structural condition, bark inclusion at 0.5m (on twin stem) with historical movement at union with associated historical inset decay, potential risk of stem failure stem in adverse weather conditions. | Fell double stem with bark inclusion, reduce overall canopy of remaining stem by at least 8m | 01/07/2026 | 3 months |

T5 Oak - Tri-dominant stem  
With associated bark inclusion  
(2020 photo)

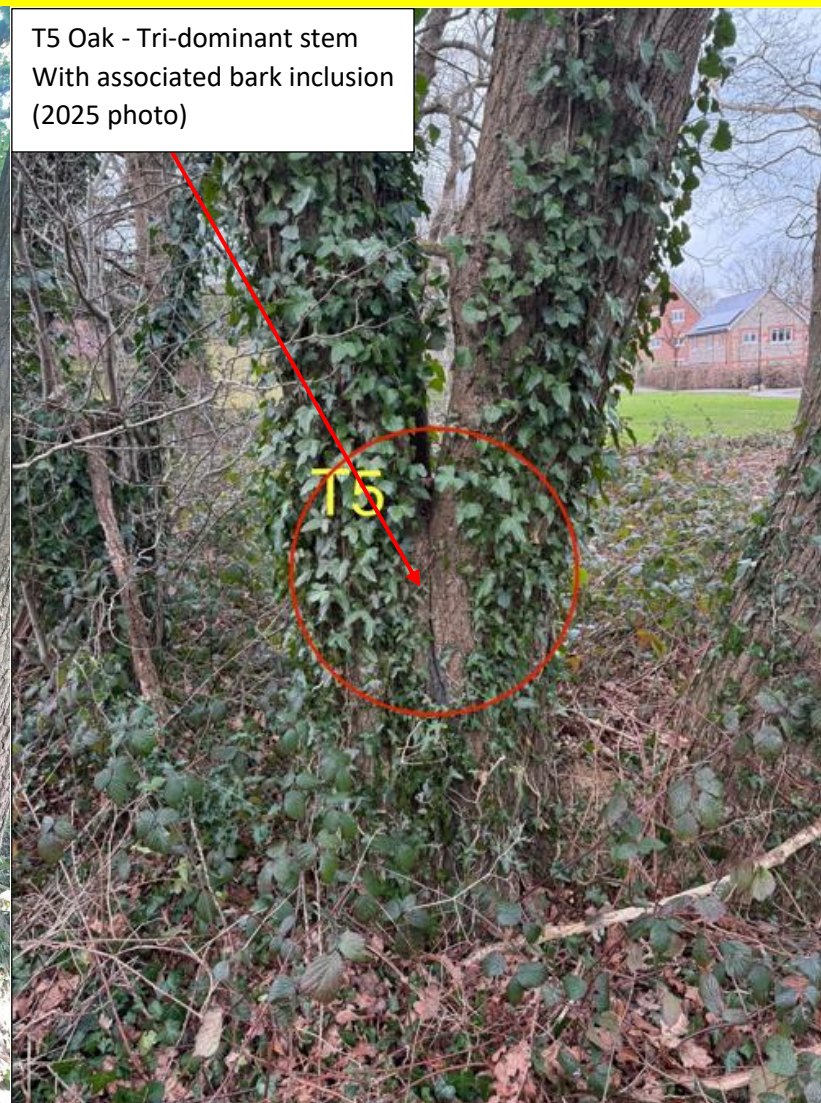
T5 Oak - Tri-dominant stem  
With associated bark inclusion  
(2025 photo)
