# TREE RISK ASSESSMENT REPORT

**For one horse chestnut to the rear of  
Mimosa House, 54A Folders Lane, Burgess Hill, RH15 0DX**

| <b>Document reference:</b> | MDJAC-AM25107-TRAR-01 |
| <b>Date:</b> | 9 September 2025 |

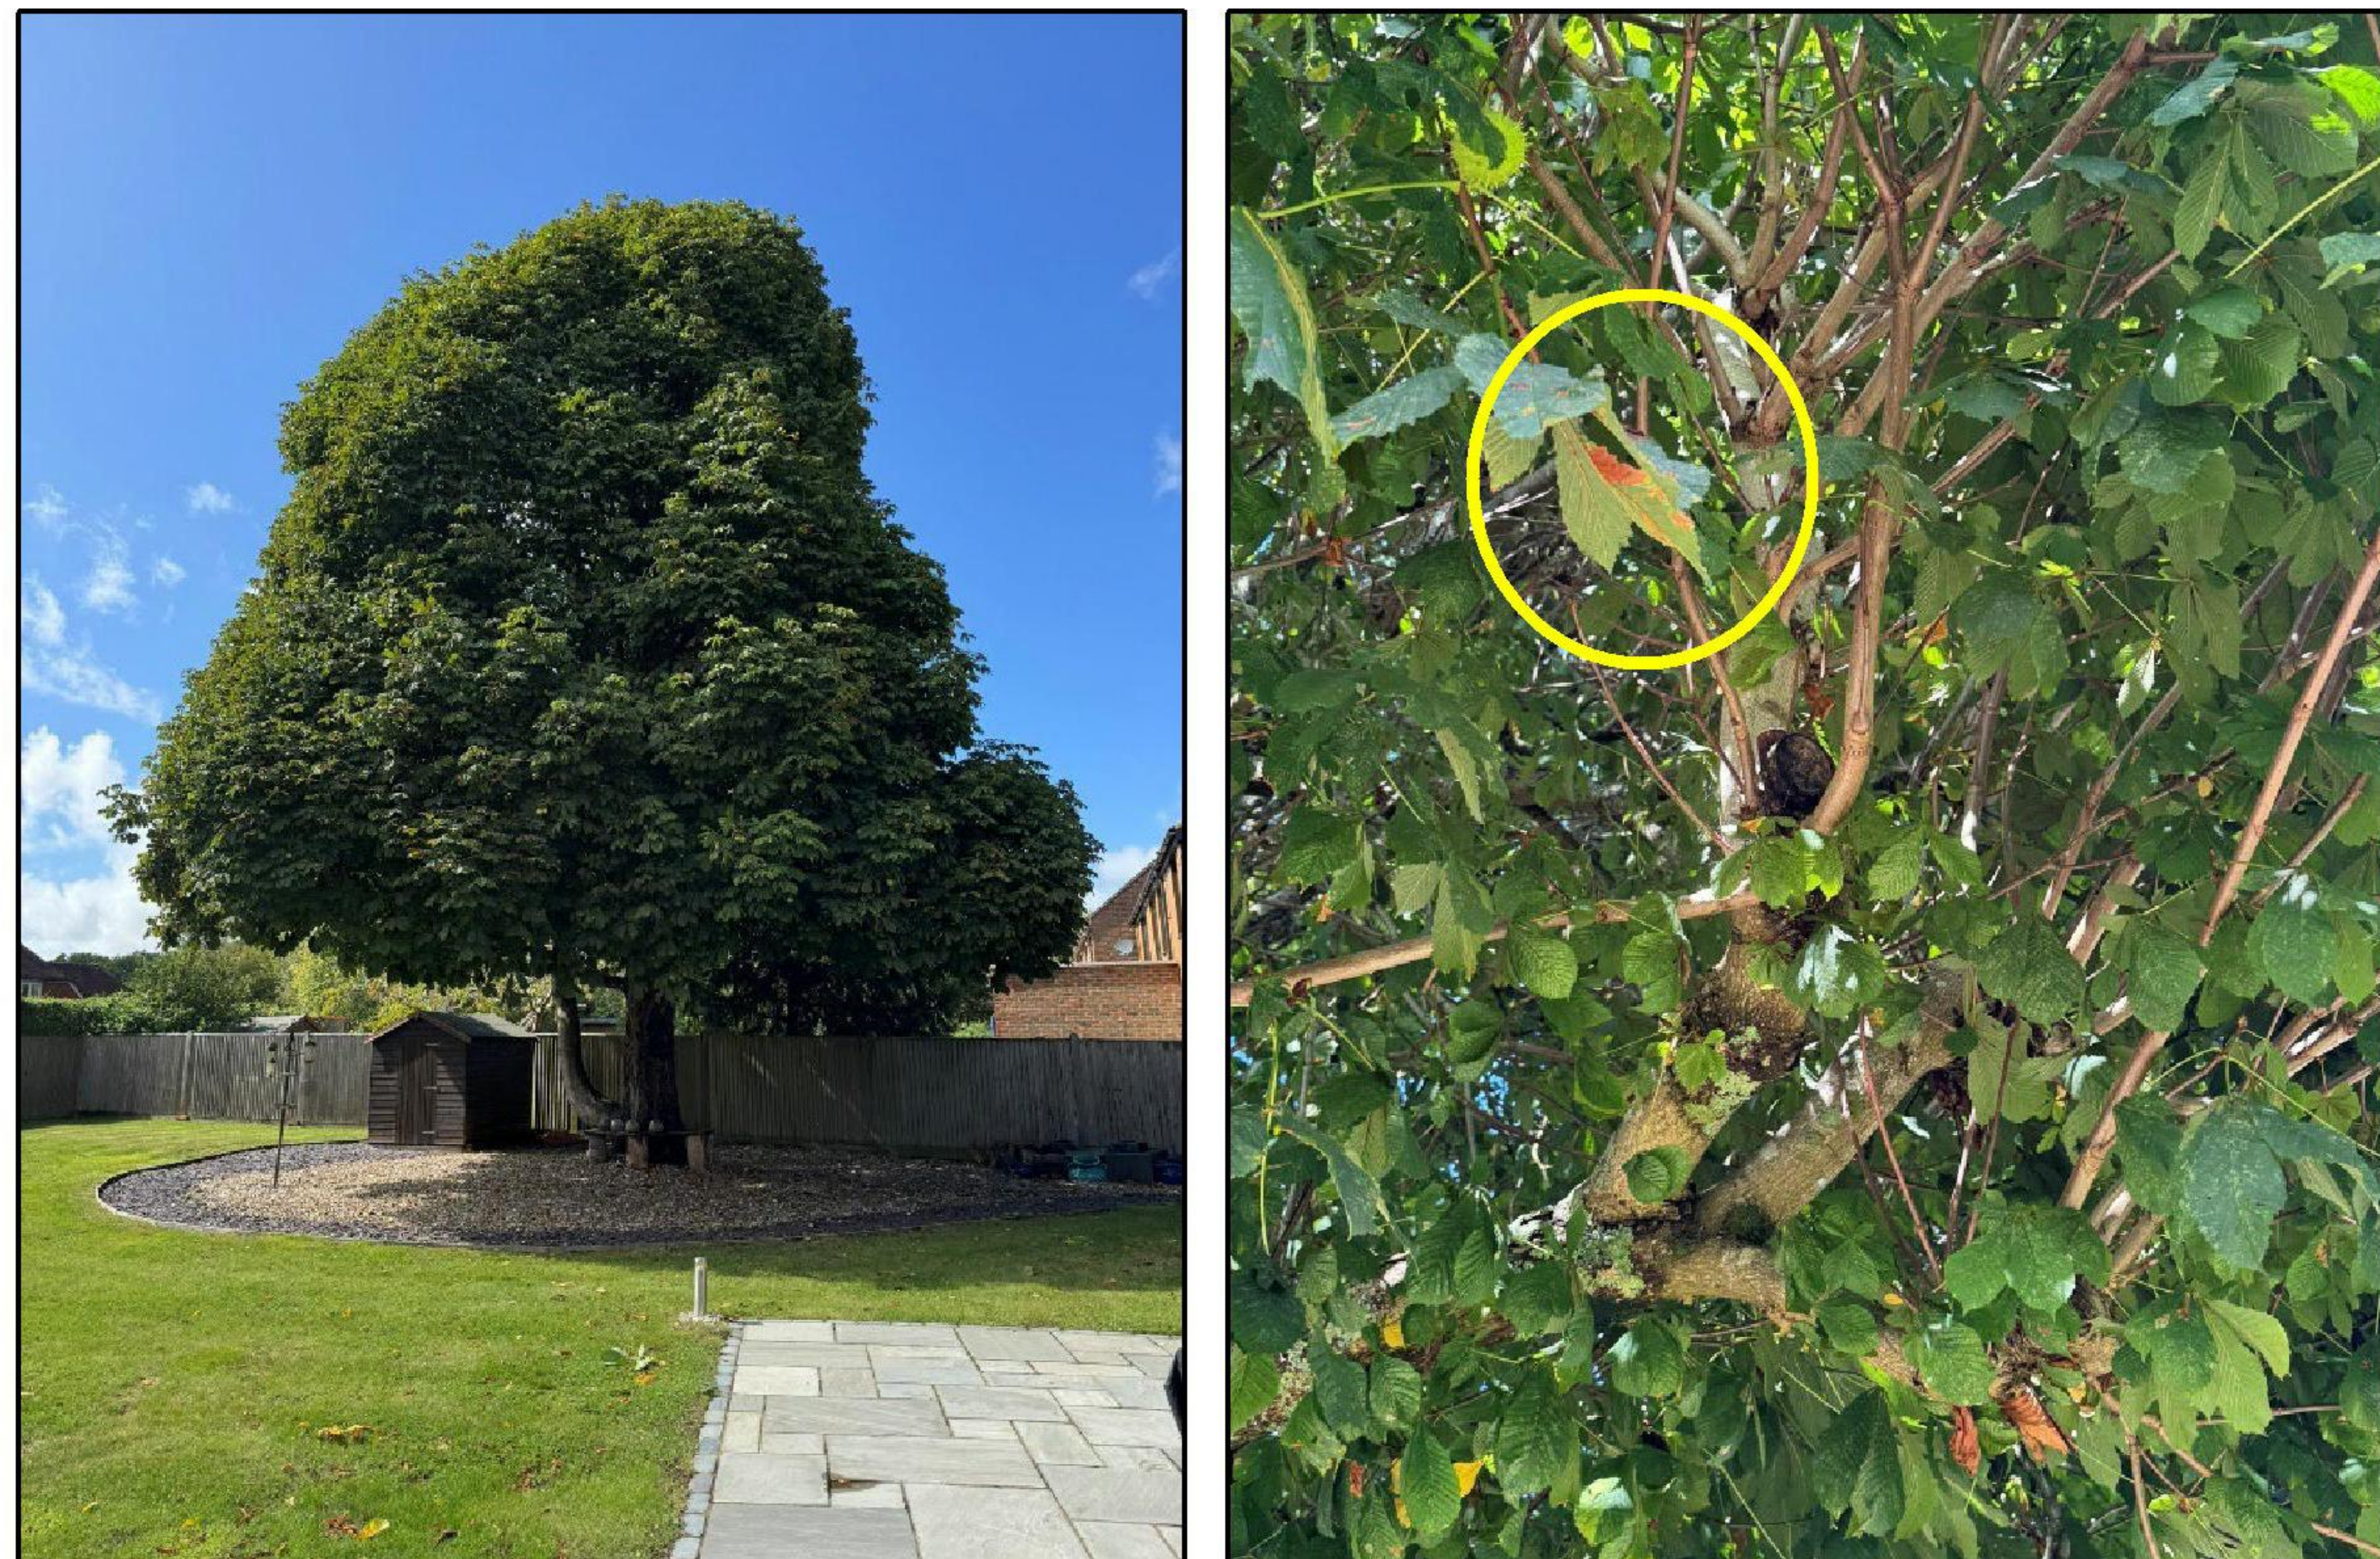
*Photograph 1: below left, looking westwards towards the subject tree, showing its dense foliage; and*

*Photograph 2: below right, showing the sporadic evidence of the pest *Cameraria ohridella*, discussed below.*

4.1.2. I noted early symptoms of Horse Chestnut Leaf Miner, referred to as HCLM henceforth, which is a pest that causes damage to the leaf tissue as borrowing larvae feed ahead of the moth's (*Cameraria ohridella*) emergence. This was evident on a small proportion of the total number of leaves throughout the canopy and is significantly less than other chestnut trees commonly seen throughout the UK.

4.1.3. Owing to the timing of the damage late in the growing season, the presence of HCLM and its associated leaf damage does not normally significantly impair tree health<sup>10</sup>. Its impacts are therefore largely aesthetic in nature and I do not see this as a material concern in relation to the subject tree.

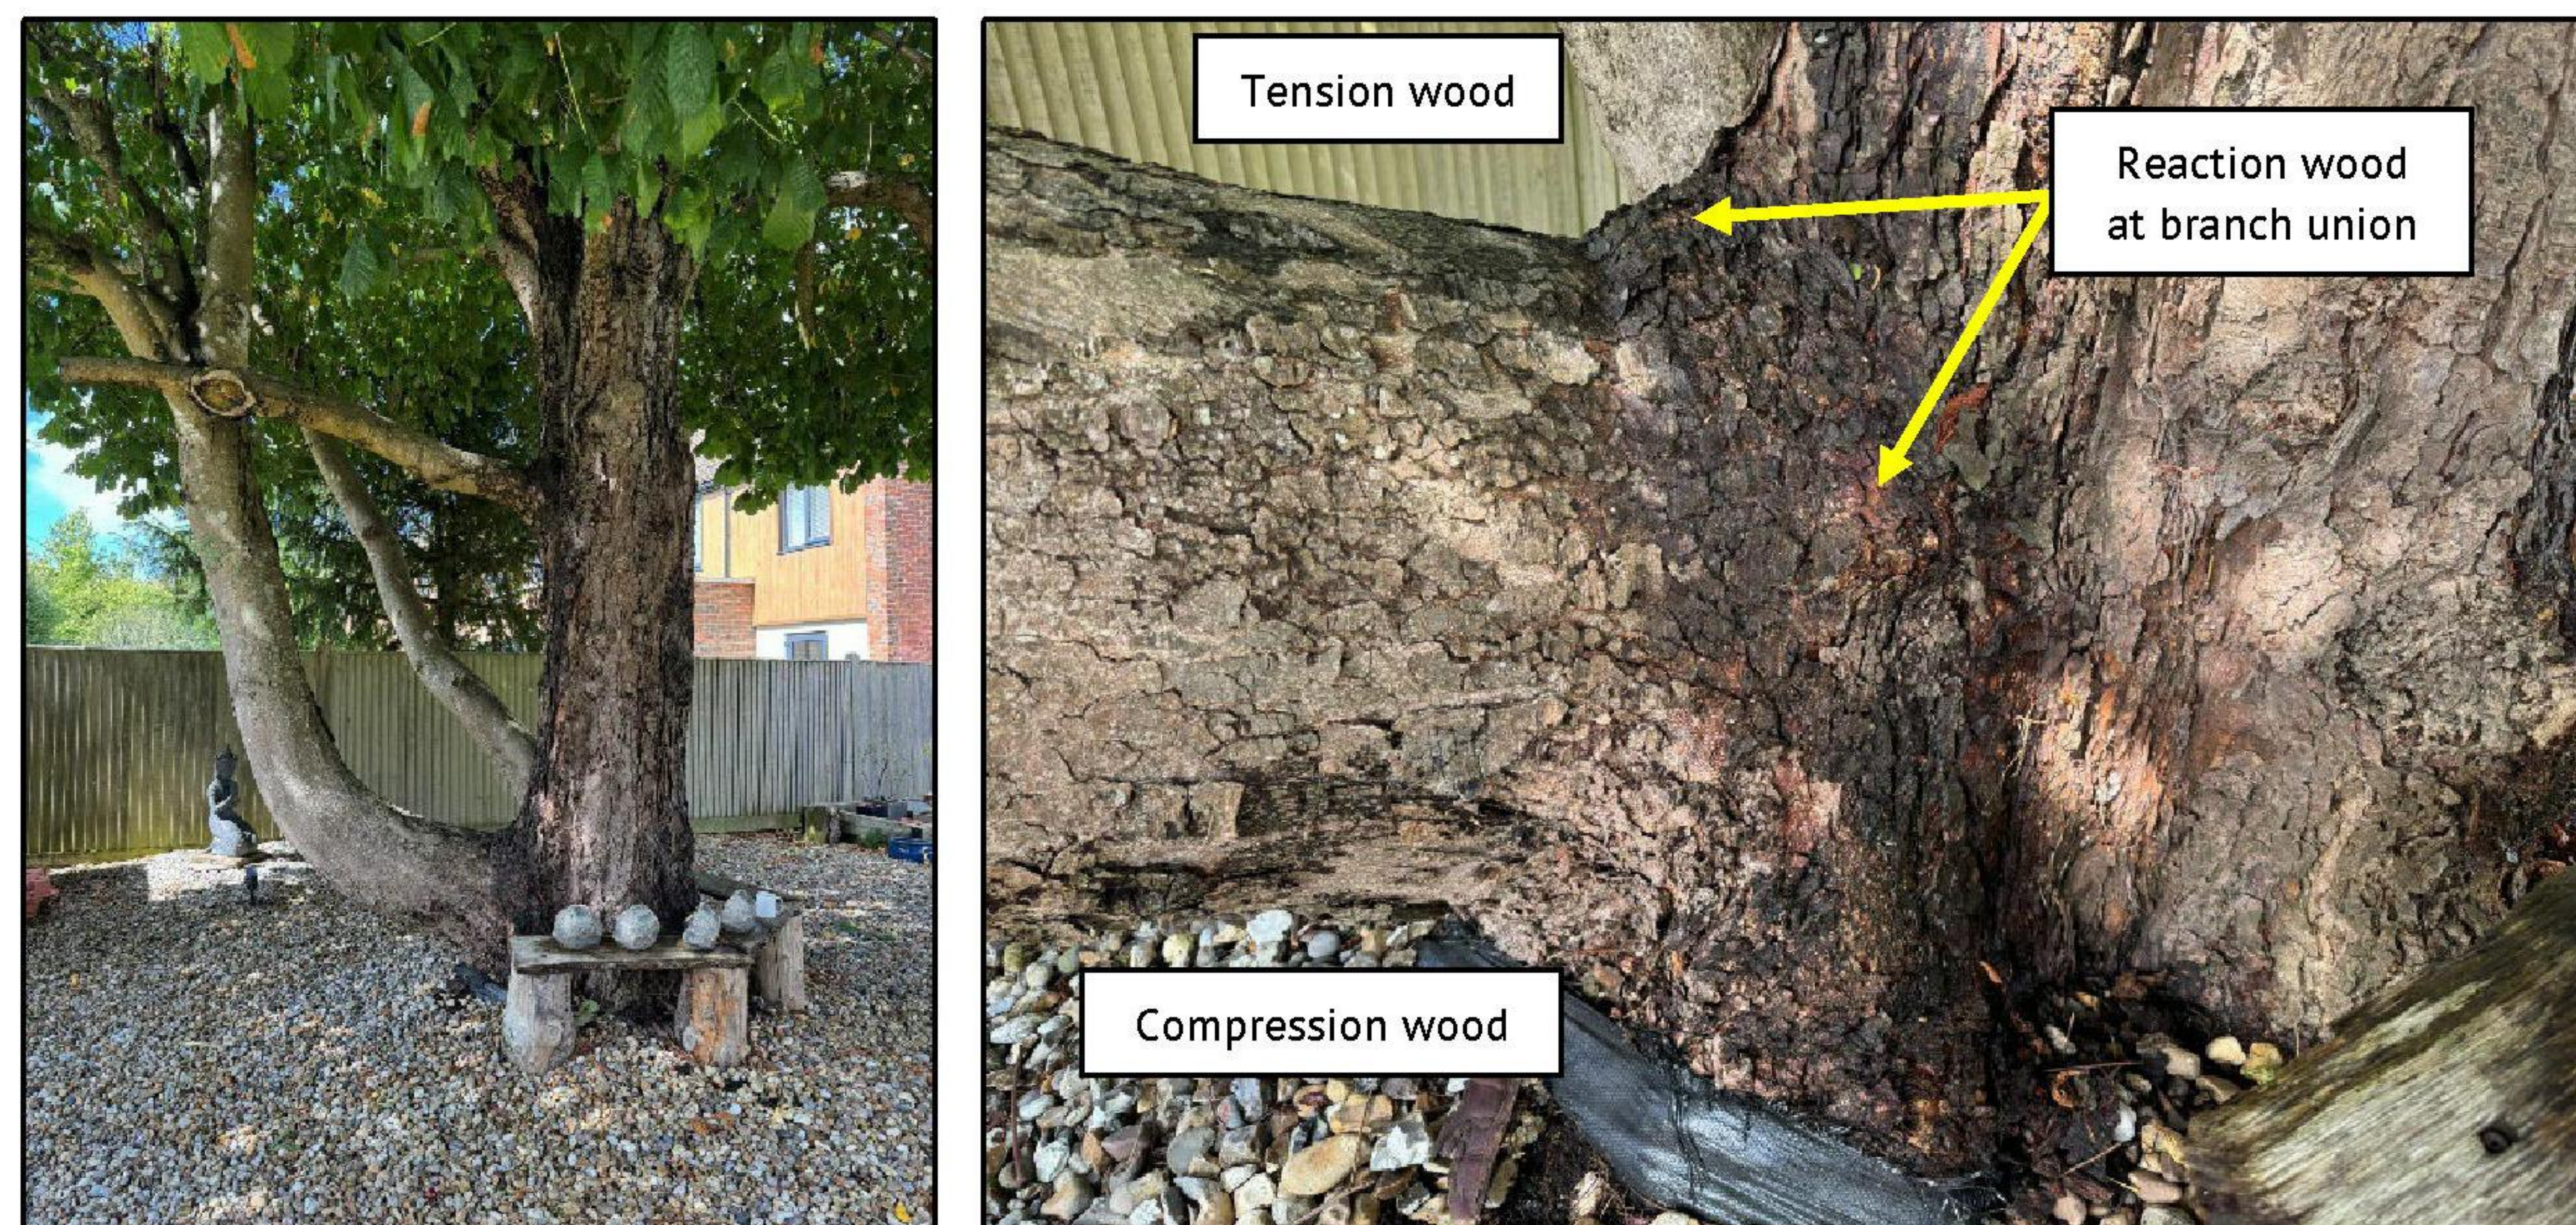
4.1.4. The structural condition of the tree appears to be sound. The most evident example of this is where two large branches originate from around 500mm on the south and south-west aspects of the tree. Here, the tree has responded by laying down response wood that is denser on the upper side of the branch. This process of forming tension and compression provides additional strength at the branches attachment point, thereby enabling it to withstand the forces acting on it (e.g. gravity and wind forces).

*Photograph 3: below left, showing the general arrangement of the low branches and stems; and*

*Photograph 4: below right, annotated photograph of the principal branch union.*

4.1.5. The tree appears to have been pruned several times in the past which is evidenced by a numerous instances of historical pruning wounds. Where trees are pruned regularly, and by the contractor observing best practice of not cutting back beyond the original pruning points, there is a tendency for the pruning points to start to creep outwards, meaning that the extent of reduction is reduced progressively over time. In any event, the previous pruning operations have maintained the tree as a relatively compact form which has prevented the formation of long, pendulous branches which are a natural feature of the species; and

4.1.6. With the above in mind, I consider the risk of failure posed by the tree to be **low**, and therefore, no works for the purpose of proactively reducing this risk are required at this time.

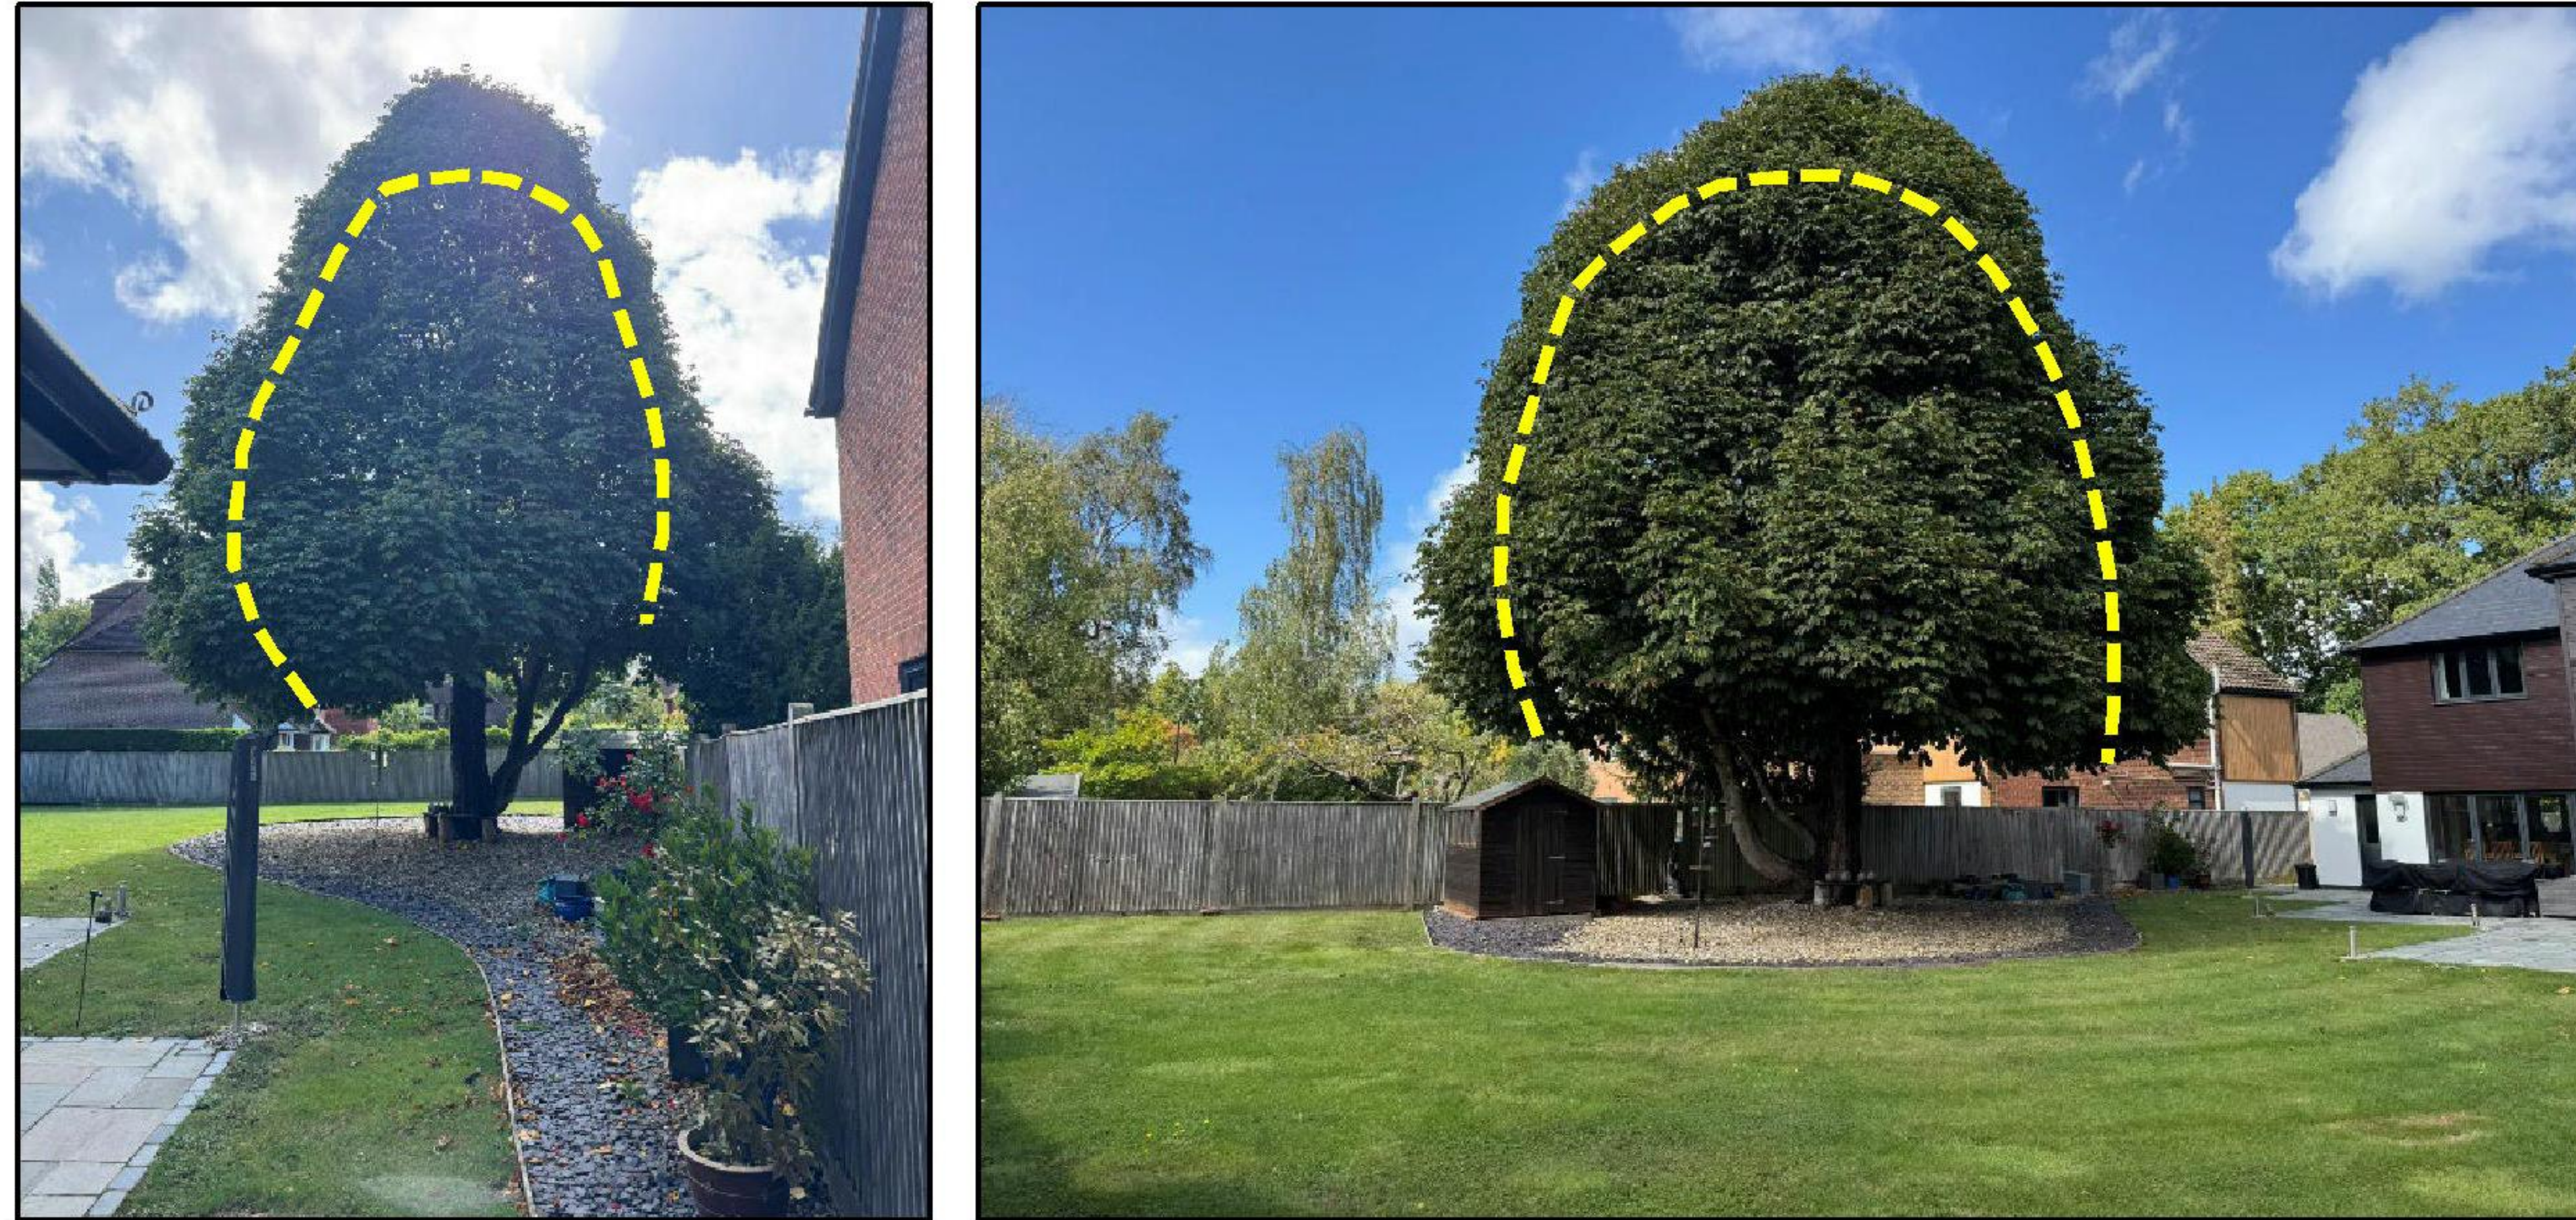
*Photograph 5: below left, looking southwards towards the tree. Illustrative pruning line shown in yellow.*

*Photograph 6: below right, looking westwards towards the tree. Illustrative pruning line shown in yellow.*

4.1.10. I therefore recommend that future pruning seeks to cut back the new growth by between 2 and 2.5m, to the original pruning points. In some instances, this will involve cutting beyond the most recent pruning points that have arisen from numerous past pruning operations, as eluded to at paragraph 4.1.5 above. An illustrative pruning line is shown below for ease of reference.

1. T1 – Horse chestnut – reduce canopy by up to 2.5m height to but not beyond the original pruning points at c. 11m x 3m, whilst ensuring that all internal shoots are maintained; and
