Tree Condition Report

12 North Court, Hassocks, BN6 8JS

October 2025

Ref: TCR/702/25

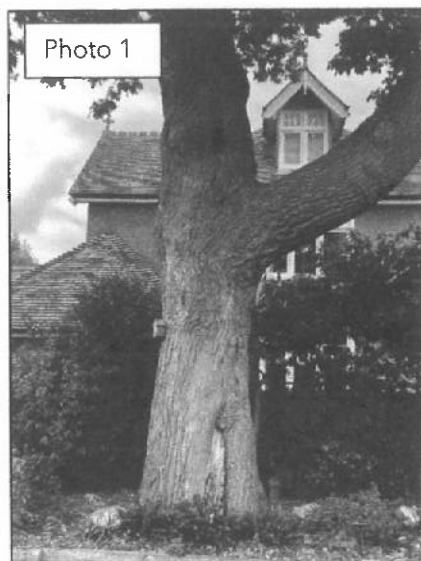
- The wider landscape encompasses Hassocks to the north, east and south with open farmland to the west
- On the west side of the main stem at c.3.8m is an open cavity measuring 24x10x40cm (HxWxD), where the stem has a diameter of c.109cm. The steel probe extended down the stem to a depth of 20cm and up the stem to a height of c.80cm – see Photo 1 below

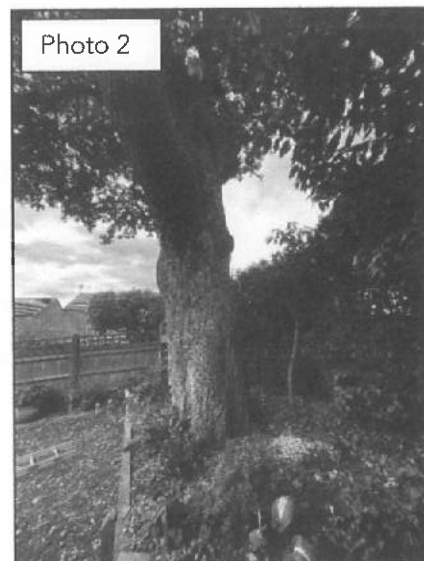
- At c.4.8m on the south side of the stem is a further smaller cavity measuring 10x10x40cm (HxWxD); it was not possible to assess the extent of the cavity in an upward and downward direction due to squirrels being present within the cavity – see the red circle in Photo 2 below

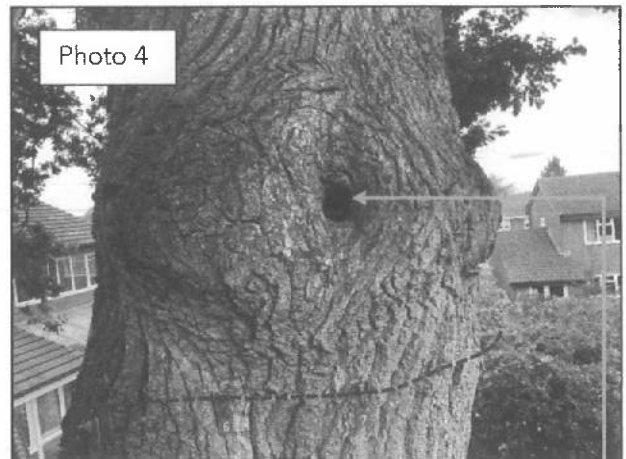
Cavity at c.4.8m on the south side of the tree

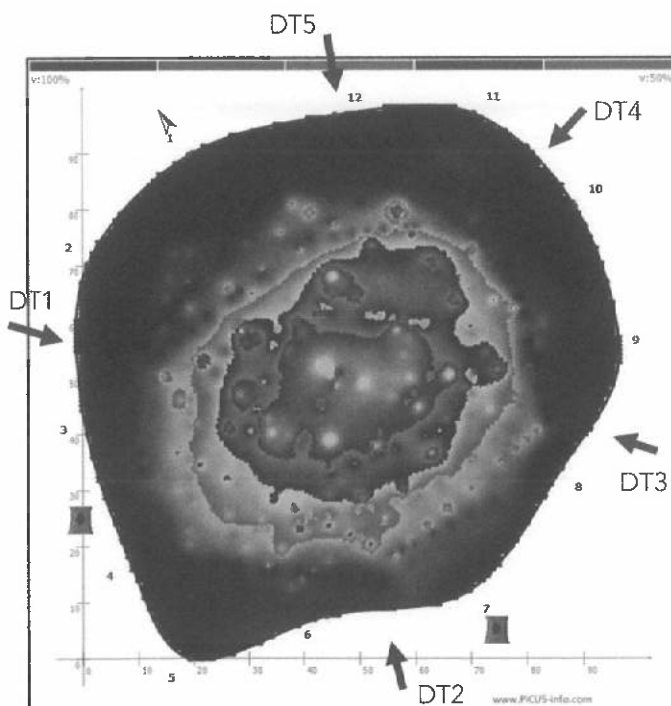
- The tomogram indicates an area of high sonic velocity, and as such sound wood, around the outer edge of the stem at the level of assessment as shown by the brown colour

- The blue colouration in the centre of the tomogram shows an area of low sonic velocity and as such decay/hollowing whilst the purple and green colours show wood that is becoming decayed
- The symbols between MP3 and MP4, and at MP7 show the location of the cavities at c.3.8m and c.4.8m respectively
- To confirm the tomogram the Resi PD400 was used in five locations at the level of assessment
- Please see the red arrows on the tomogram and the drill traces overleaf:

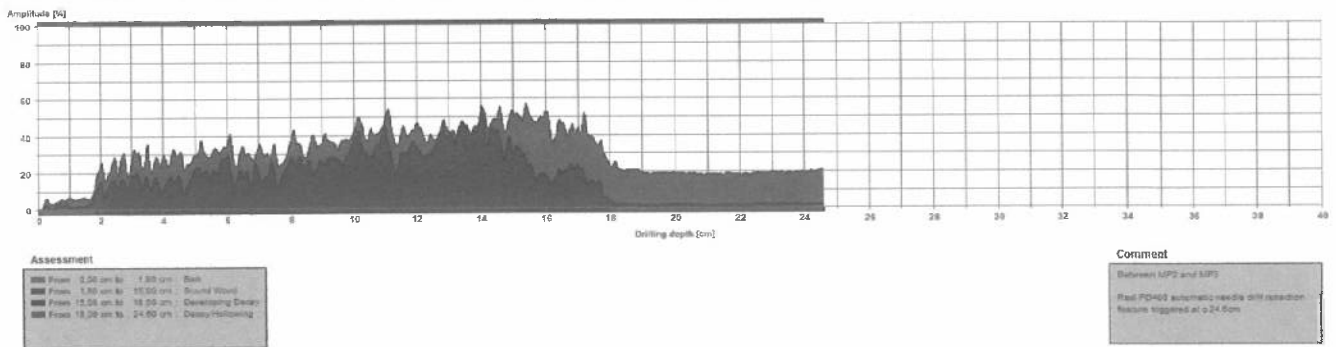
### Drill Trace 1 – between MP2 and MP3 150/3500 feed/drill speed

- The depths at which the Drill Traces 1 – 5 reached their respective drops in resistance have been overlaid onto the tomogram and with the exception of DT4, all confirm the depths of the sound wood at their respective points on the stem
- The sharp drop on Drill Trace 4 suggest the needle drill entered the cavity, but this does not match the depth of sound wood shown by the tomogram

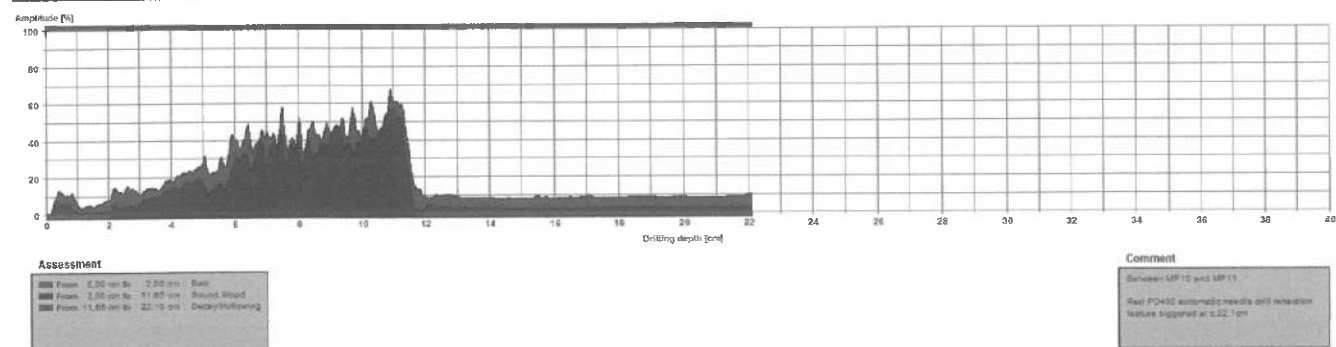
### Drill Trace 4 – between MP10 and MP11 200/3500 feed/drill speed

- It is not clear why the discrepancy occurred, but the drill trace depth should be taken as a more realistic depth of sound wood at that measuring point

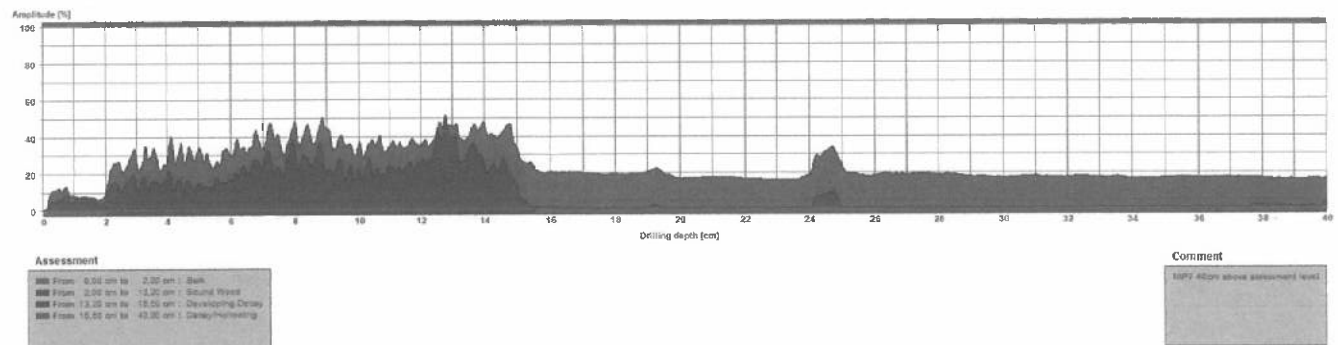
### Drill Trace 6 – MP7 70cm above assessment level 150/3500 feed/drill speed

- Drill Trace 6 which was undertaken 70cm above the assessment line (c.40cm above the top of the cavity) and shows the depth of sound wood is only c.13.2cm whilst Drill Trace 7, c.40cm above MP12, shows the depth of sound wood is c.30cm

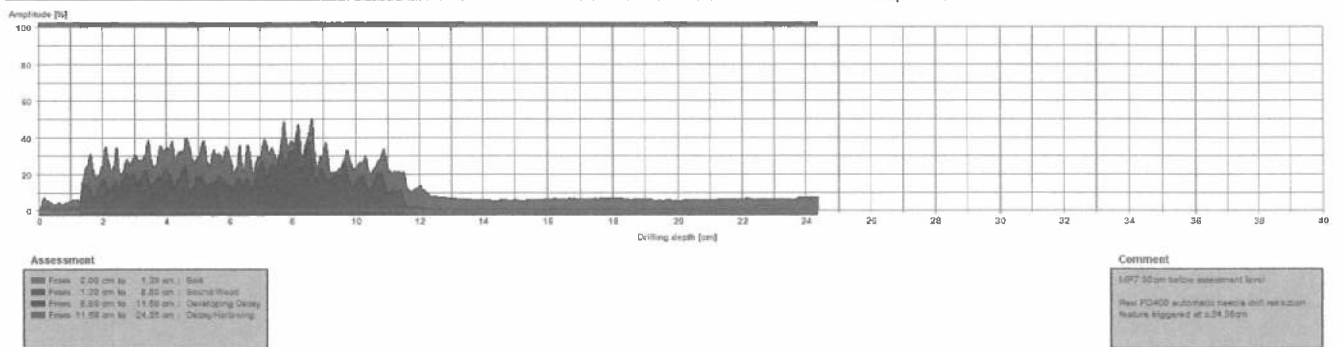
### Drill Trace 8 – MP7 30cm below assessment level 150/3500 feed/drill speed

- This suggests that the cavity is favouring the southern side of the stem which would match the location of the cavity and the tomogram
- Drill Traces 8 -10 show the depth of sound wood 30cm below the assessment level has an average thickness of c.13.8cm with the thinnest section being below MP7 at c.8.8cm – the location of the cavity

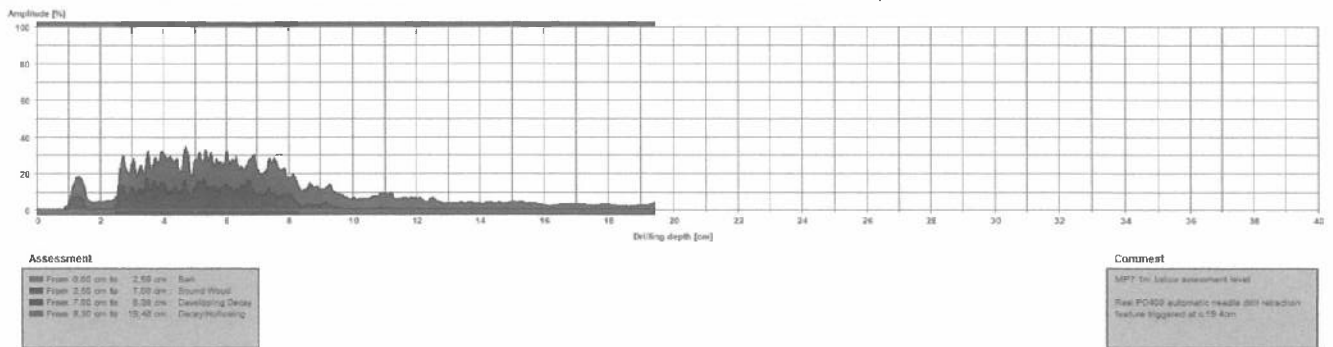
### Drill Trace 12 - MP7 1m below assessment level 200/3500 feed/drill speed

- The three assessments undertaken at 1m below the assessment level show the average depth of sound wood is c.44.5cm. However, Drill Trace 13 somewhat skews this figure with a depth of c.28cm as Drill Traces 11 and 12 have an average depth of sound wood of c.8.25cm with Drill Trace 12 beneath MP7 showing a depth of only c.7cm

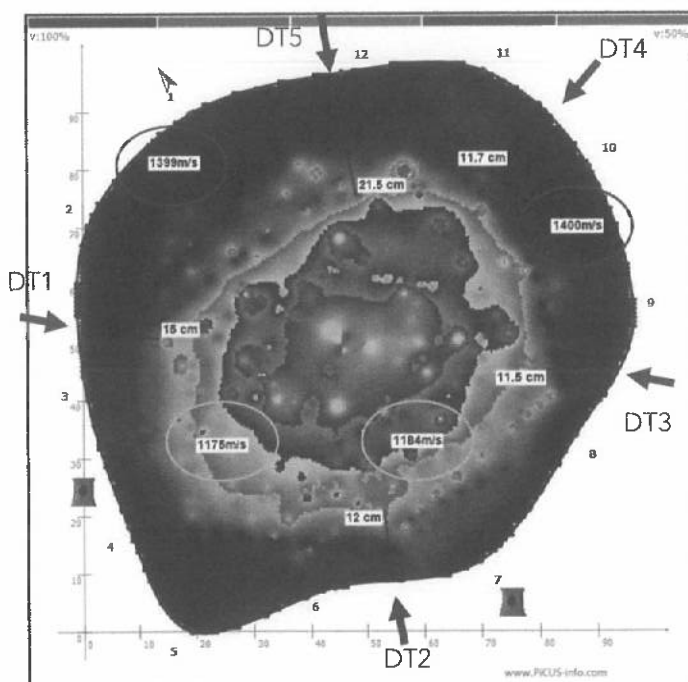
- On the tomogram below, it is clear that the wood around the north and east side of the stem has high sonic velocity as shown by the dark brown colouration – note the 1399m/s and 1400m/s readings circled red

- However, the brown colour lightens towards the south and west side of the stem indicating a reduction in sonic velocity and as such wood quality – note the 1175m/s and 1184m/s readings circled yellow

- This suggests that the decay, and as such the extent of the cavity, is increasing towards that side of the stem and towards the inner areas of the 'sound' wood to where it becomes green in colour

Four areas of measured sonic velocity shown as m/s on the north, east, south and west side of the stem – circled red and yellow

N.B. – the measurements 1184m/s and 1175m/s are for the areas of light brown next to the figures

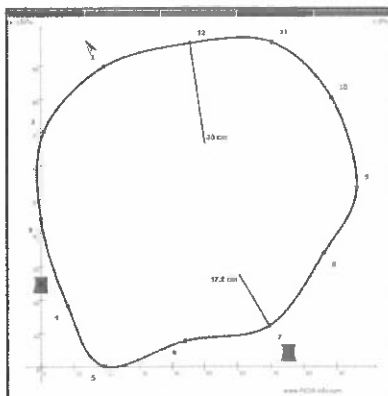
70cm and 40cm above assessment level drill points

- On the three tomograms below, the depths at which the needle drill reached their respective drops in resistance have been overlaid which once again shows the south side of the tree has the narrowest depth of sound wood
