## Tree Survey Report:

Burgess Hill Town Council - Poveys Allotments -  
PICUS Assessment

4.1 T01775 - Pedunculate Oak - *Quercus robur*

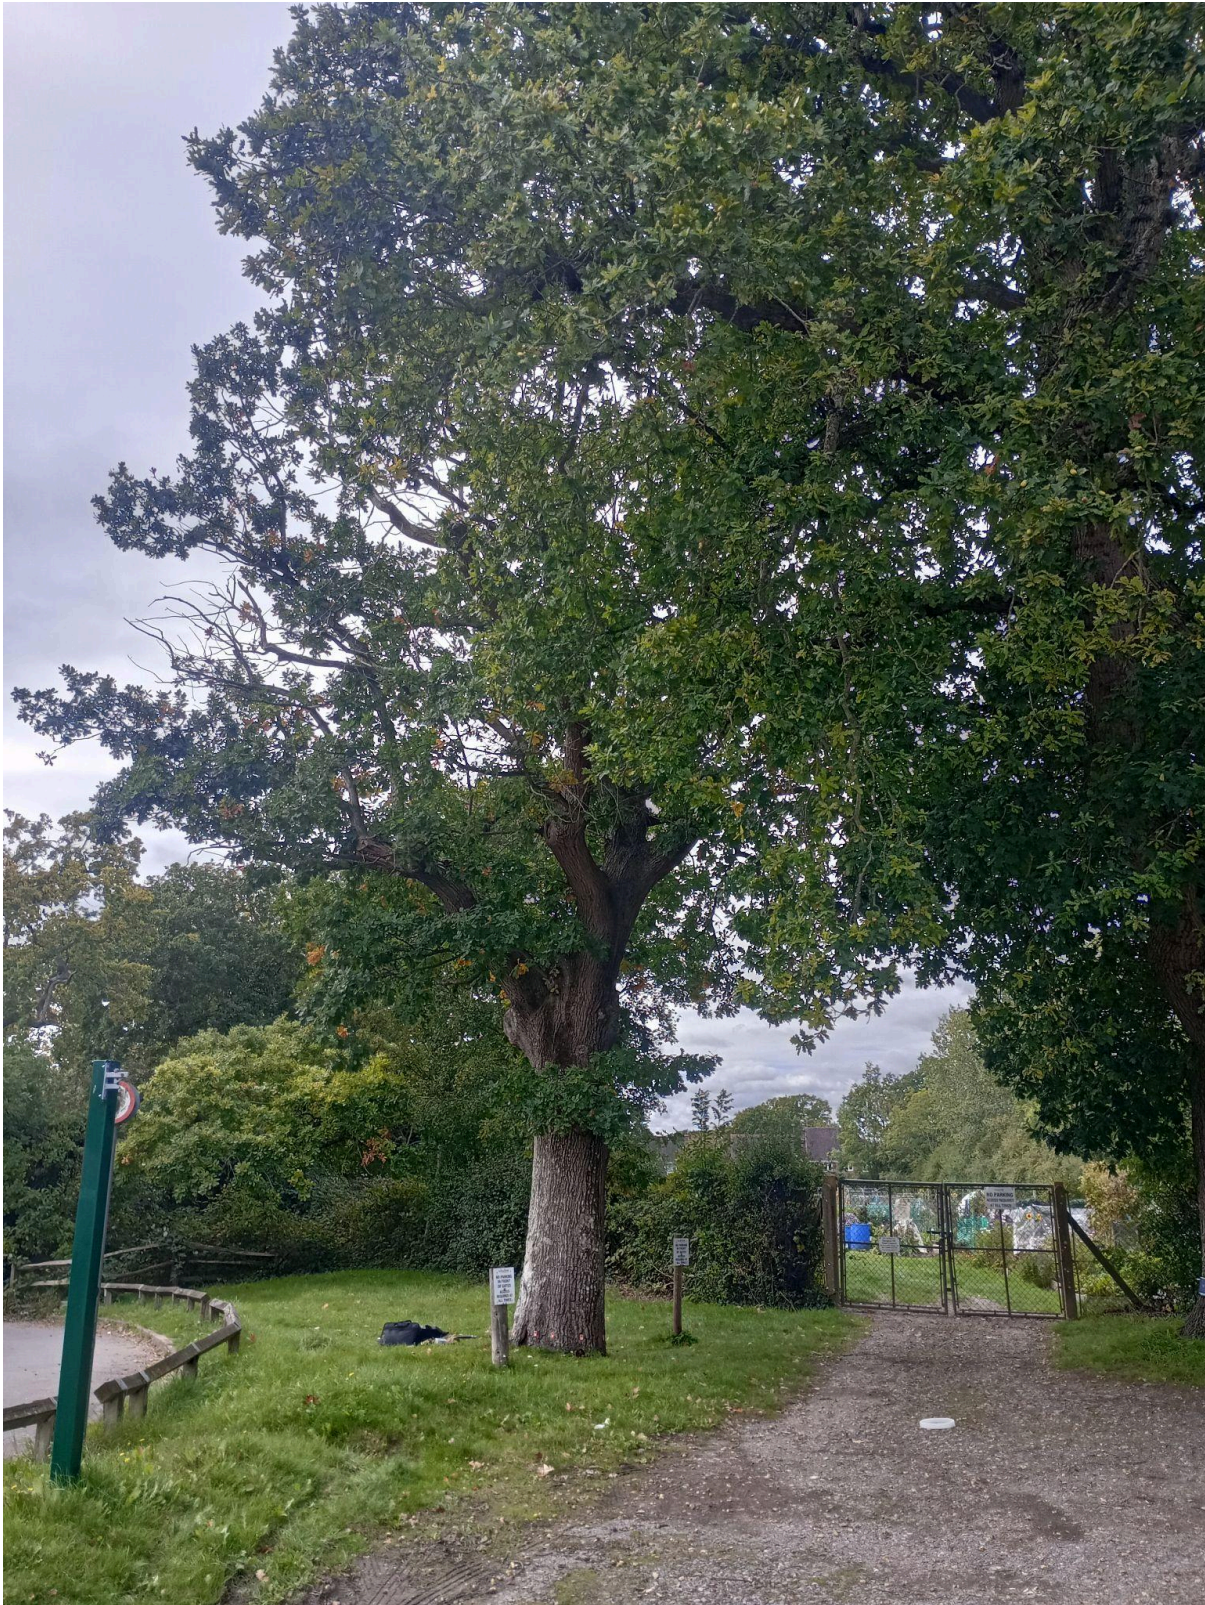
Figure - Photograph showing the whole tree facing west towards the allotments and parked cars.

- Previous crown reduction has left the tree with an asymmetrical crown.
- Significant dieback and sparse crown, major indicators of poor vitality, stress, or root/stem decay affecting nutrient and water transport.
- Deadwood over 150mm diameter scattered throughout the crown.

Compounding these stem defects are multiple other large wounds, a severely compromised crown exhibiting significant dieback and a sparse appearance, and the presence of significant deadwood. Given the documented basal decay, the unconfirmed extent of decay at 4m, the presence of two active decay fungi, and the overall poor vitality, the tree is considered a high-risk specimen. Management intervention is necessary to mitigate the likelihood of failure.

Given the tree's poor vitality, a crown reduction to reduce wind load and structural stresses is not recommended. The tree is currently unlikely to have sufficient energy reserves to successfully adapt to a significant pruning operation of this nature. Removing a substantial portion of its leaf-bearing canopy would place immense stress on an already struggling specimen and likely lead to a further decline in health, potentially accelerating its ultimate failure. Therefore, we would recommend the removal of this tree to mitigate future risk. We further advise that this removal is followed by the installation of appropriate replacement plantings nearby to ensure the continued ecological and aesthetic value of the area.

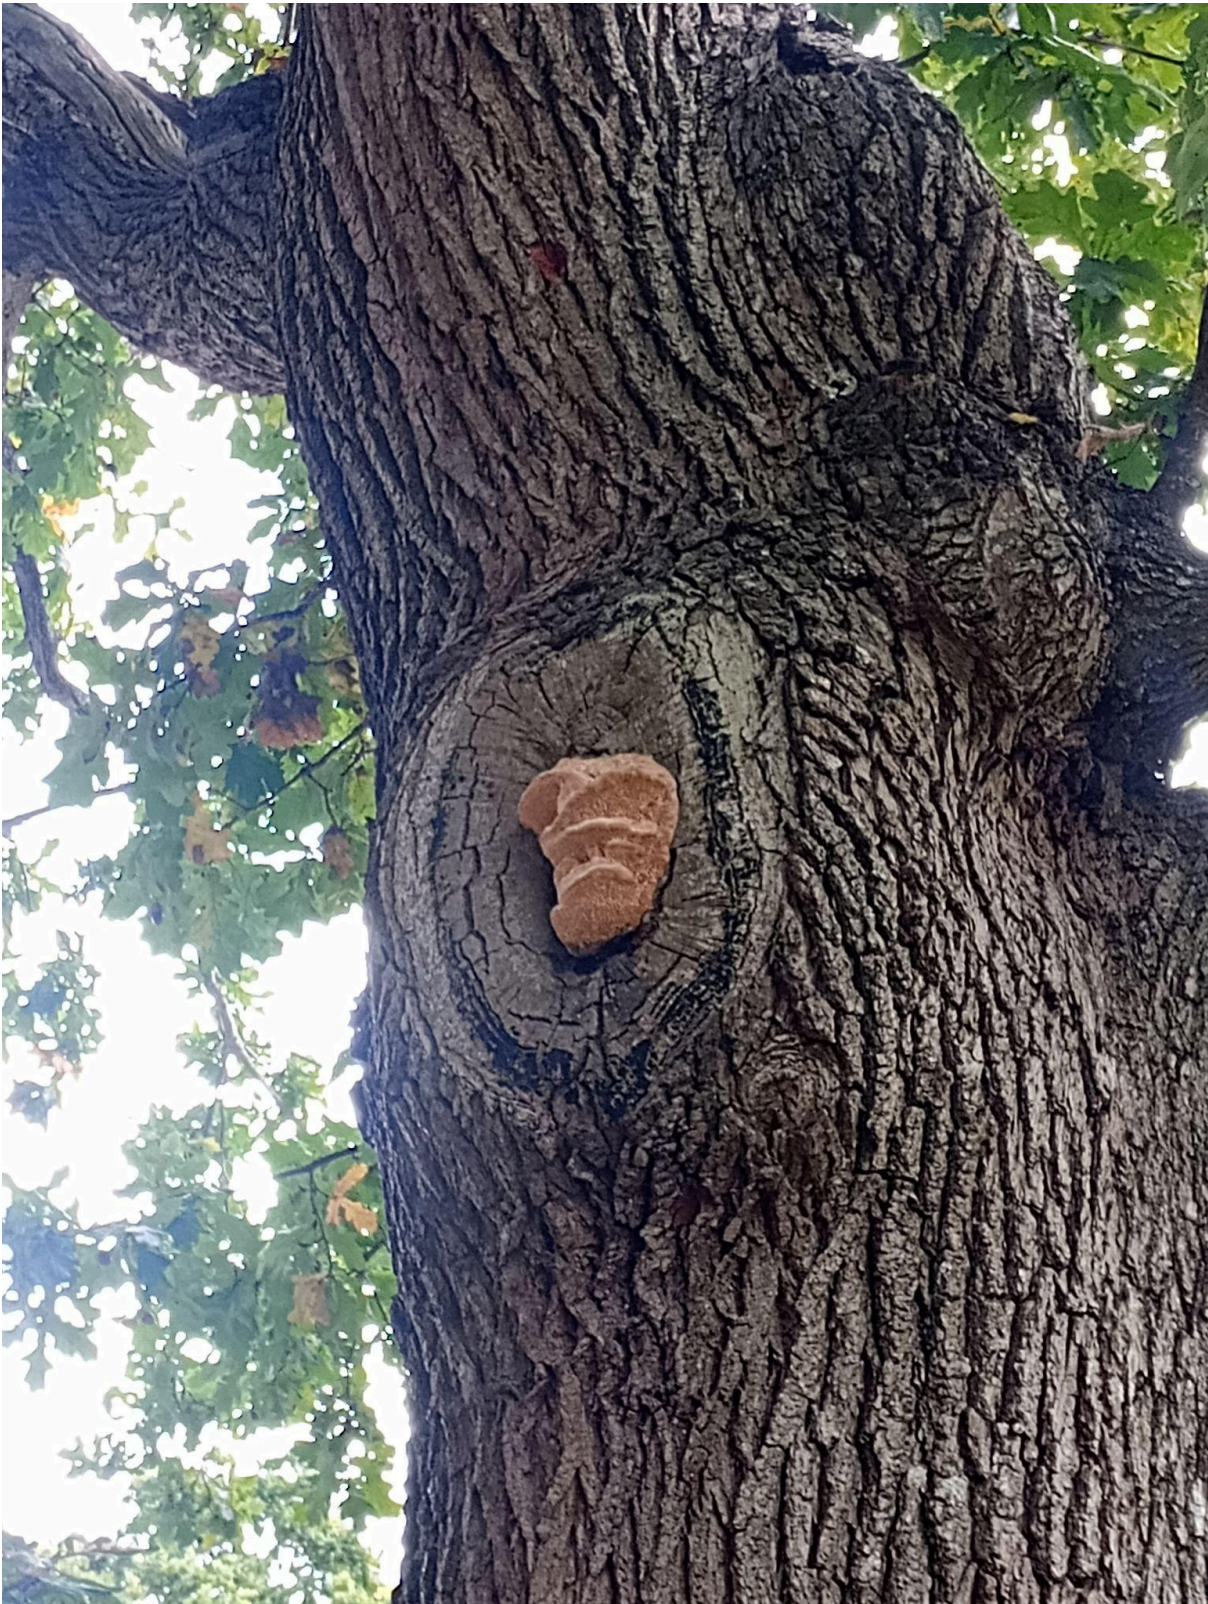
- Multiple partially and fully occluded wounds up to 250mm diameter from 1.5m up.
- Large partly occluded wound at 4m north with young FFB (*Aurantiporus fissilis*).

Figure - Photograph showing FFB (*Aurantiporus fissilis*) at XXm north.

A large, partially occluded wound is actively supporting a young FFB of *Aurantiporus fissilis*, this defect at 4m introduces an unquantifiable (without further testing) instability in the structure.

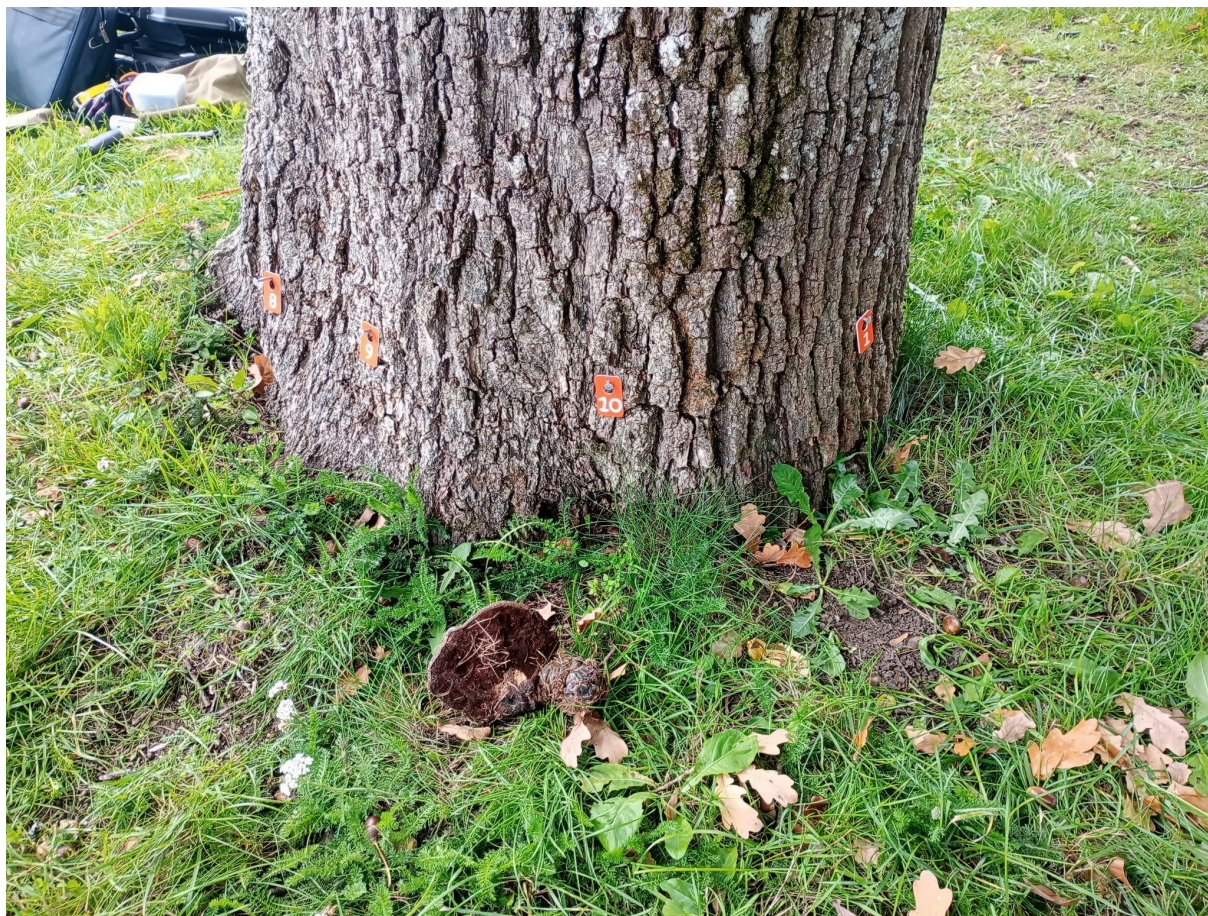
- Cavity opening at ground level south-east between sensors 7-8, mallet indicates some internal dysfunction around the opening up to 0.3m.
- Old darkened Fungal Fruiting Body (FFB) (likely *Pseudoinontus dryadeus*) between sensors 4-5.
- Old darkened detached FFB (likely *Pseudoinontus dryadeus*) located on adjacent grass. Attachment point looks to be under sensor 10.

*Figure - Photograph showing base of tree north-east with old detached FFB (Pseudoinontus dryadeus)*

The assessment confirms that this tree presents a structural risk that is difficult to fully quantify from ground level. Testing highlights some basal decay, with a cavity opening between sensors 7-8 and the presence of the decay fungus *Pseudoinontus dryadeus*, confirmed by an FFB at sensors 4-5 and a detached FFB near sensor 10. While the tomogram results are largely normal, the slower transition speeds between sensors 10-7 suggest the decay is initiating a structural change in this basal region.

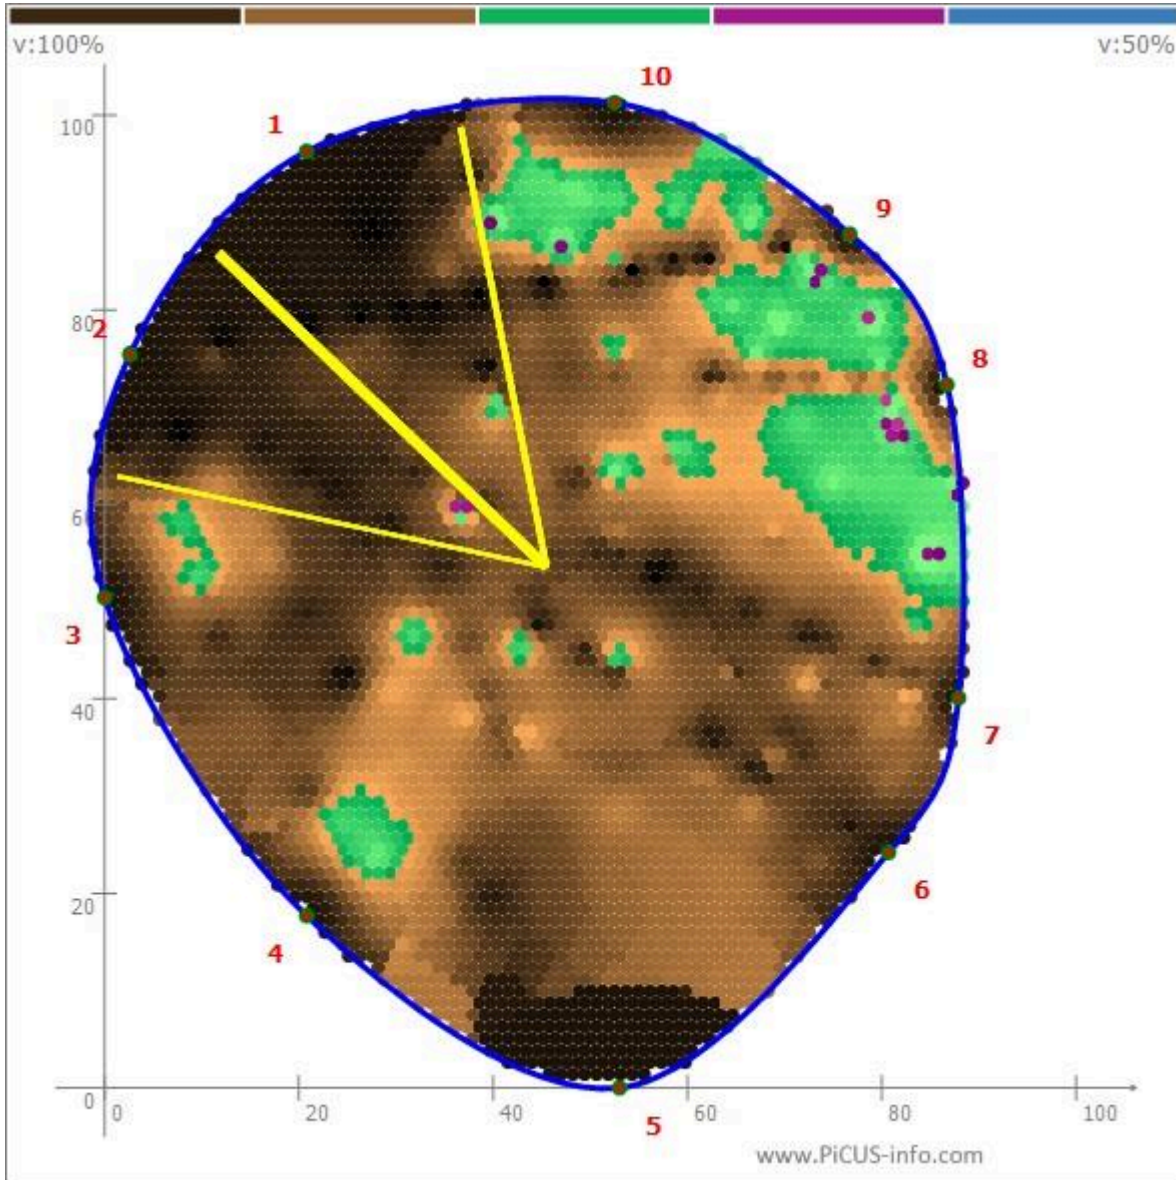
*Figure - Tomogram from 0.3m*

The tomograph results were mostly normal, showing transmission speeds consistent with structurally sound wood and no significant internal decay. A small area of slower transition speed, indicating probable early decay, was recorded between sensors 7 and 10. This is not considered significant and aligns with both the Fibre-optic Bundle (FFB) attachment point and observations made during the inspection.

Furthermore, three lineal cracks were detected between sensors 3 and 10. These cracks are also not considered significant and are likely attributable to historic fibre buckling as the tree matures.

On this basis, no further investigation with the IML Resistograph drill was deemed necessary.
