Heritage Schedule

| Project Address: | The Castle Inn, Hickstead, RH17 5LZ |
| Proposal: | Erection of outbuildings, internal and external alterations to Grade II Listed building |

## Heritage Schedule of Condition - April 2025

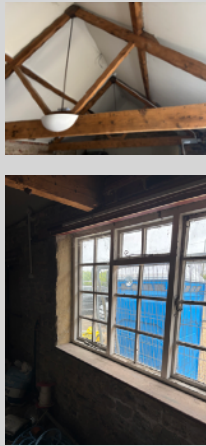
| Room | Photos | Proposed Works | Works Carried Out |
|---|---|---|---|
| G.10<br>BARN STORE | | <ul style="list-style-type: none"> <li>- new B reg compliant ramp</li> <li>- non original timber frame windows replaced with timber frame windows</li> </ul> | |

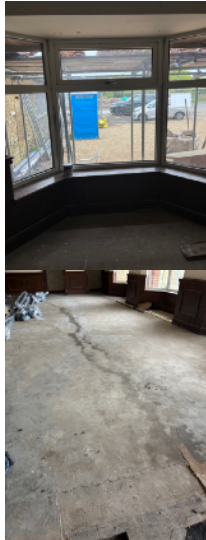
| Room | Photos | Proposed Works | Works Carried Out |
|---|---|---|---|
| G.11<br>RESTAURANT | | <ul style="list-style-type: none"> <li>- 20mm underfloor heating tiles installed over screed</li> <li>- non original UPVC windows replaced with timber frame french doors and fixed lights</li> </ul> | <ul style="list-style-type: none"> <li>- non original vinyl flooring removed</li> </ul> |

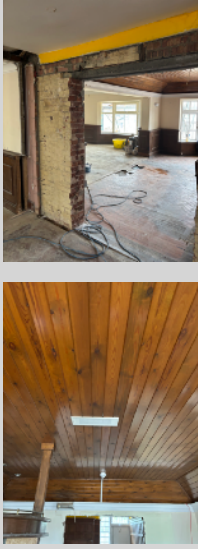
| Room | Photos | Proposed Works | Works Carried Out |
|---|---|---|---|
| G.12<br>RECEPTION | | <ul style="list-style-type: none"> <li>- underfloor heating installed over screed</li> <li>- non original timber frame window replaced with glazed timber frame door and fixed light</li> <li>- non original ceiling to be removed and replaced with plasterboard</li> <li>- panelling to be painted</li> </ul> | <ul style="list-style-type: none"> <li>- existing opening reestablished</li> </ul> |

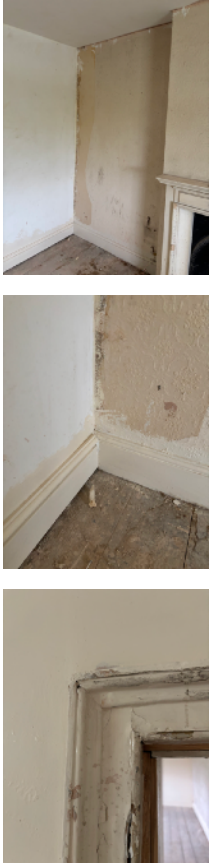
| Room | Photos | Proposed Works | Works Carried Out |
|---|---|---|---|
| 1.03<br>BED 2 | | <ul style="list-style-type: none"> <li>- in-joist underfloor heating installed</li> <li>- non original skirtings and architraves replaced to match original</li> <li>- woodchip removed and re-skimmed with new plaster to walls</li> <li>- new doorway to room 1.04 with traditional panelled door</li> <li>- floorboards retained - sanded and oiled</li> </ul> | <ul style="list-style-type: none"> <li>- new timber studwork partition to reinstate original partition between rooms</li> <li>- non original floor covering removed</li> </ul> |

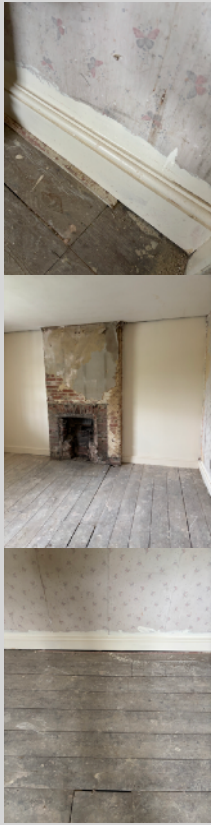
| Room | Photos | Proposed Works | Works Carried Out |
|---|---|---|---|
| 1.05<br>BED 3 | | <ul style="list-style-type: none"> <li>- in-joist underfloor heating installed</li> <li>- non original skirtings and architraves replaced to match original</li> <li>- woodchip removed and re-skimmed with new plaster to walls</li> <li>- new doorway to room 1.04 wit traditional panelled door</li> <li>- floorboards retained</li> </ul> | <ul style="list-style-type: none"> <li>- non original floor covering removed</li> <li>- plaster hacked off chimney breast</li> </ul> |

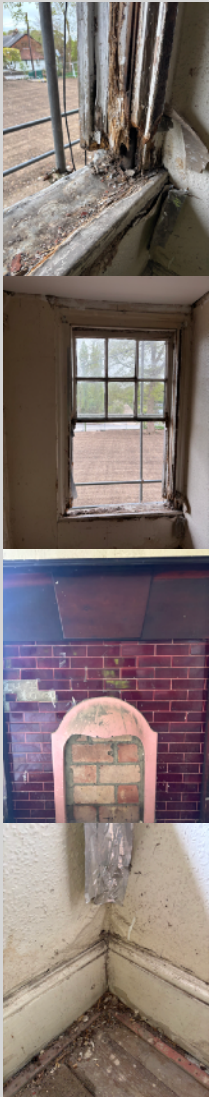
| Room | Photos | Proposed Works | Works Carried Out |
|---|---|---|---|
| 1.07<br>BED 5 | | <ul style="list-style-type: none"> <li>- in-joist underfloor heating installed</li> <li>- woodchip removed and re-skimmed with new plaster to walls</li> <li>- non original 1920s fireplace removed</li> <li>- new timber studwork to form ensuite bathroom with traditional panelled door</li> <li>- non original skirtings and architraves replaced to match original</li> <li>- floorboards retained - sanded and oiled</li> <li>- damaged window replaced with timber sash to match existing</li> </ul> | <ul style="list-style-type: none"> <li>- non original floor covering removed</li> <li>- rotten window removed</li> </ul> |

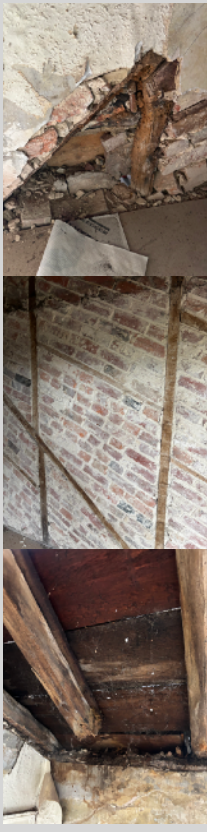
| Room | Photos | Proposed Works | Works Carried Out |
|---|---|---|---|
| 1.08<br>HALLWAY | | <ul style="list-style-type: none"> <li>- in-joist underfloor heating installed</li> <li>- brick repaired with reclaimed brick and lime mortar</li> <li>- leave brickwork exposed and seal with matt sealant</li> <li>- replace rafters to cat slide roof due to rotting timber</li> <li>- non original skirtings and architraves replaced to match original</li> <li>- floorboards retained - sanded and oiled</li> </ul> | <ul style="list-style-type: none"> <li>- plasterwork hacked off and ceilings taken down to expose rafters</li> <li>- non original floor covering removed</li> </ul> |

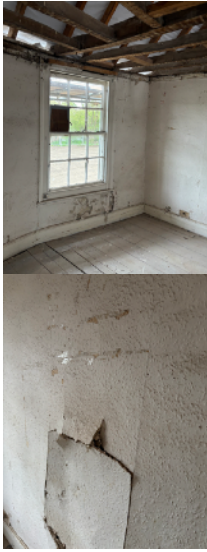
| Room | Photos | Proposed Works | Works Carried Out |
|---|---|---|---|
| 1.09<br>BED 6 | | <ul style="list-style-type: none"> <li>- in-joist underfloor heating installed</li> <li>- chamfer joists to level floor</li> <li>- woodchip removed and re-skimmed with new plaster to walls</li> <li>- new ceiling above existing ceiling as per SE details</li> <li>- new timber studwork to form ensuite bathroom with traditional panelled door</li> <li>- new timber studwork to form cupboard / wardrobe</li> <li>- non original skirtings and architraves replaced to match original</li> <li>- floorboards retained - sanded and oiled</li> </ul> | <ul style="list-style-type: none"> <li>- roof strengthening to existing roof as per SE details</li> </ul> |

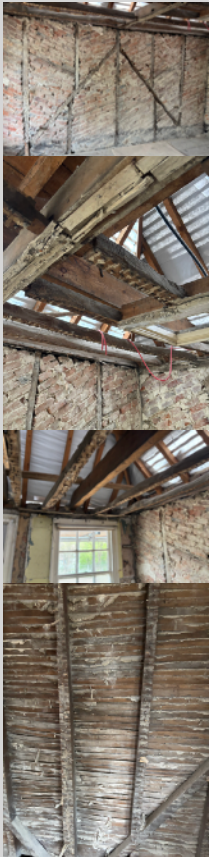
| Room | Photos | Proposed Works | Works Carried Out |
|---|---|---|---|
| 1.10<br>BED 7 | | <ul style="list-style-type: none"> <li>- brick chimney removed</li> <li>- in-joist underfloor heating installed</li> <li>- new timber studwork to form ensuite bathroom with traditional panelled door</li> <li>- non original skirtings and architraves replaced to match original</li> <li>- floorboards retained - sanded and oiled</li> <li>- new ceiling above existing</li> </ul> | <ul style="list-style-type: none"> <li>- plasterwork and ceilings removed to expose original fabric</li> </ul> |

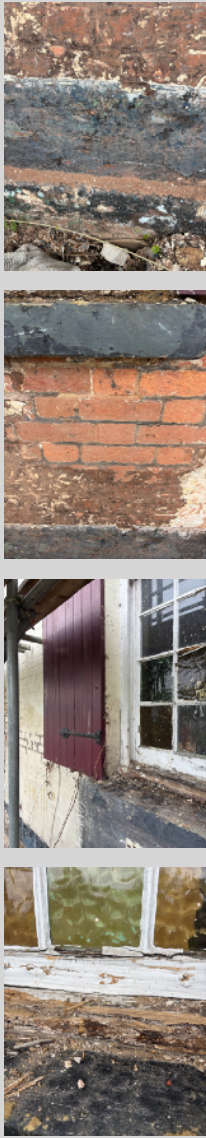
| Room | Photos | Proposed Works | Works Carried Out |
|---|---|---|---|
| East Elevation | | <ul style="list-style-type: none"><li>- facade sandblasted and re pointed with lime mortar brush finish</li><li>- plinth rendered</li><li>- 'heritage' black aluminium rainwater goods to replace non original pvc</li></ul> | <ul style="list-style-type: none"><li>- non original shutters removed</li></ul> |

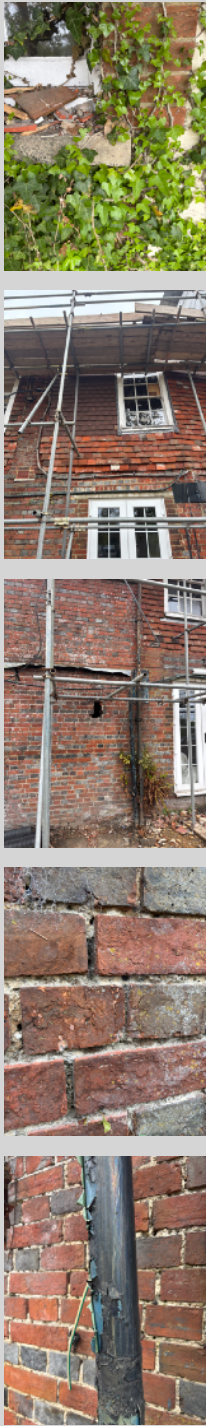
| Room | Photos | Proposed Works | Works Carried Out |
|---|---|---|---|
| South Elevation | | <ul style="list-style-type: none"><li>- non original marley tiles replaced with reclaimed tiles to tie into original</li><li>- brickwork re pointed with lime mortar</li><li>- 'heritage' black aluminium rainwater goods to replace non original pvc</li><li>- new painted timber frame signage</li><li>- all UPVC doors / windows replaced with timber framed doors / windows</li></ul> | |
