# **NETHER WALSTEAD,**

East Mascalls Lane, Haywards Heath, West Sussex

## **Historic Fabric Assessment**

**Document No:** TJC2025.173

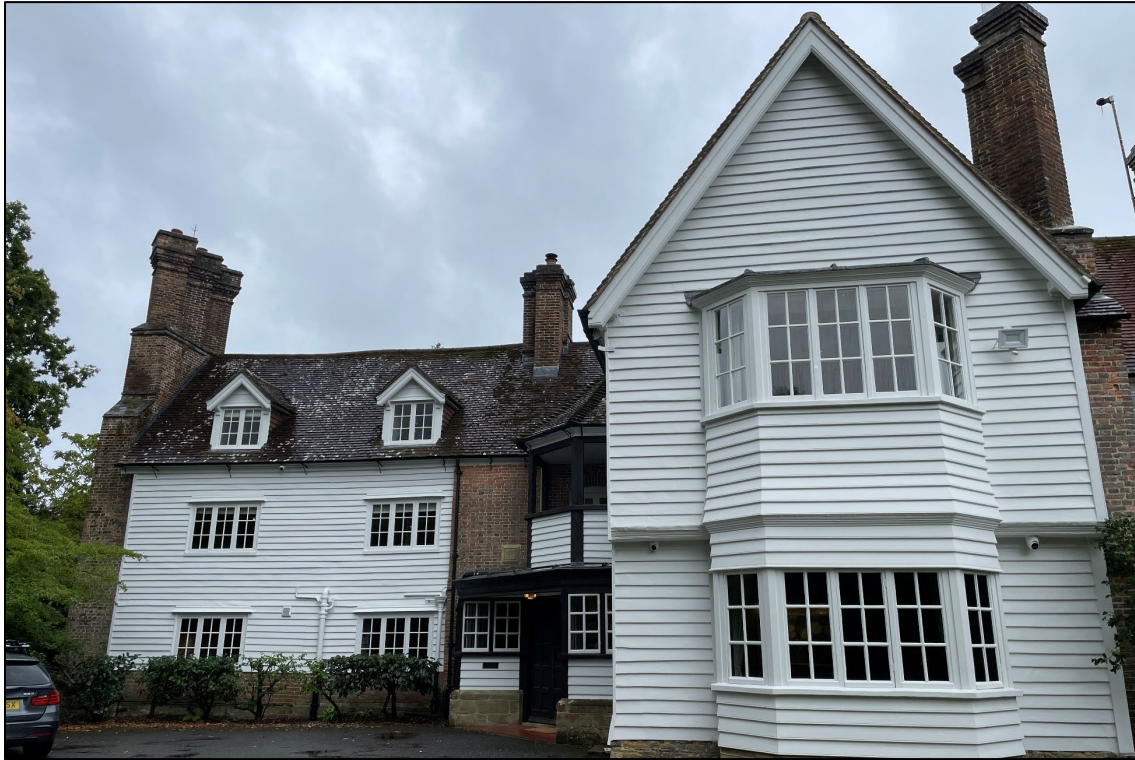
Nether Walstead comprises a house of probable early-17<sup>th</sup> century origin with later phases including 18<sup>th</sup> & 19<sup>th</sup> century alterations and subsequent phases of extension in the early and mid-20<sup>th</sup> century (**Appendix 2.1**).

**Appendix 2.1:** General view of the house, looking south

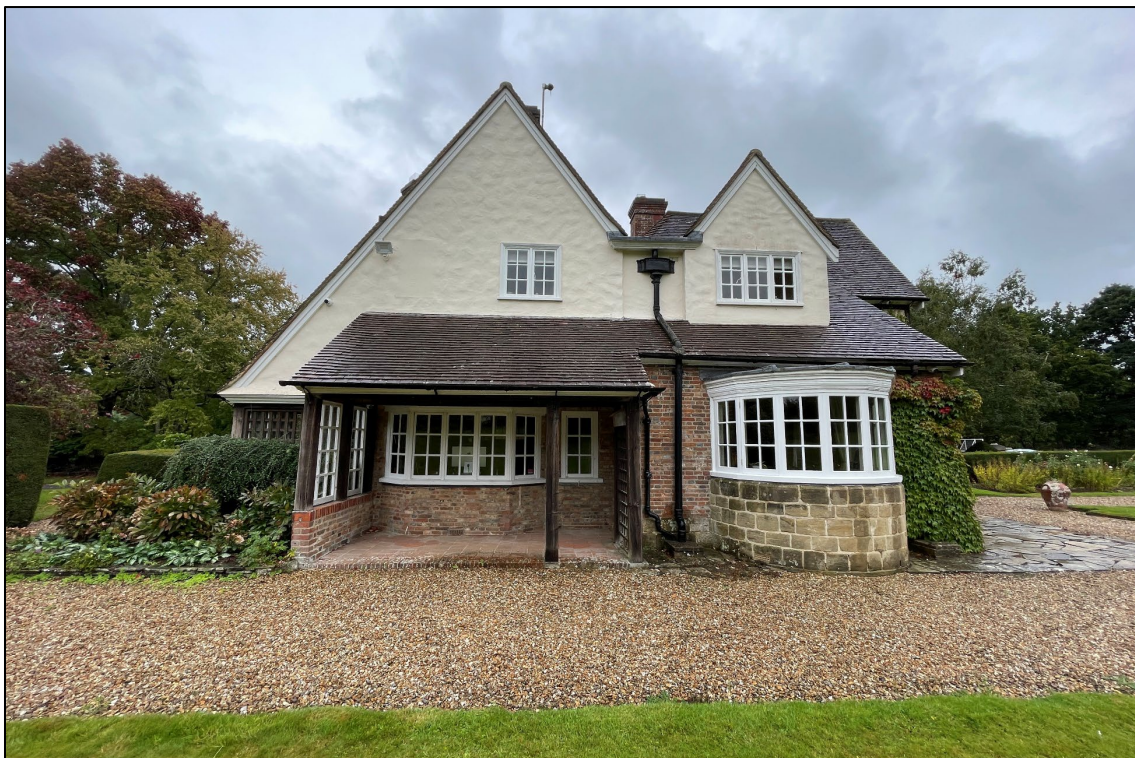
The western part of the house comprises an early-20<sup>th</sup> century extension undertaken in the Arts & Crafts style. Externally, this is expressed with brick, large rendered and timber-framed gables, and sweeping catslide roofs (**Appendix 2.2**).

**Appendix 2.2:** General view of early-20<sup>th</sup> century extension, looking east

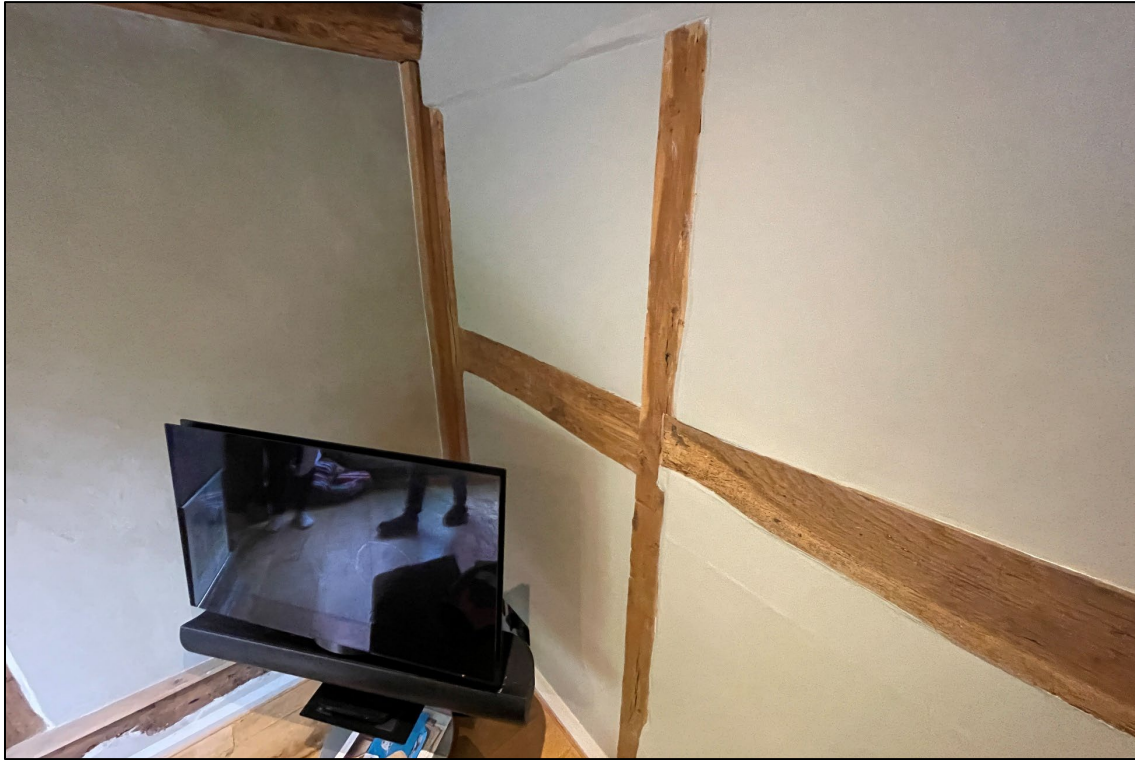
**Appendix 2.3:** General view of blocked door in **Room 0-11**, looking south-east

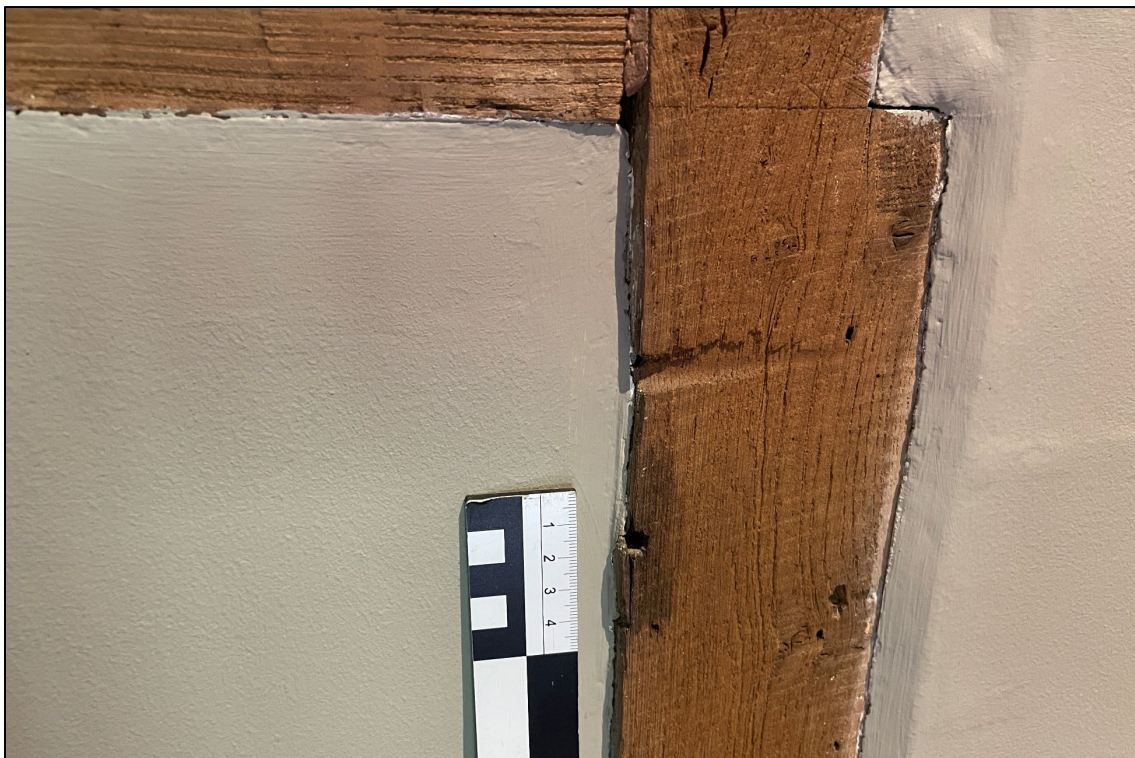
**Appendix 2.4:** Detail of reused timber in blocking, **Room 0-11**, looking south (5cm Scale)

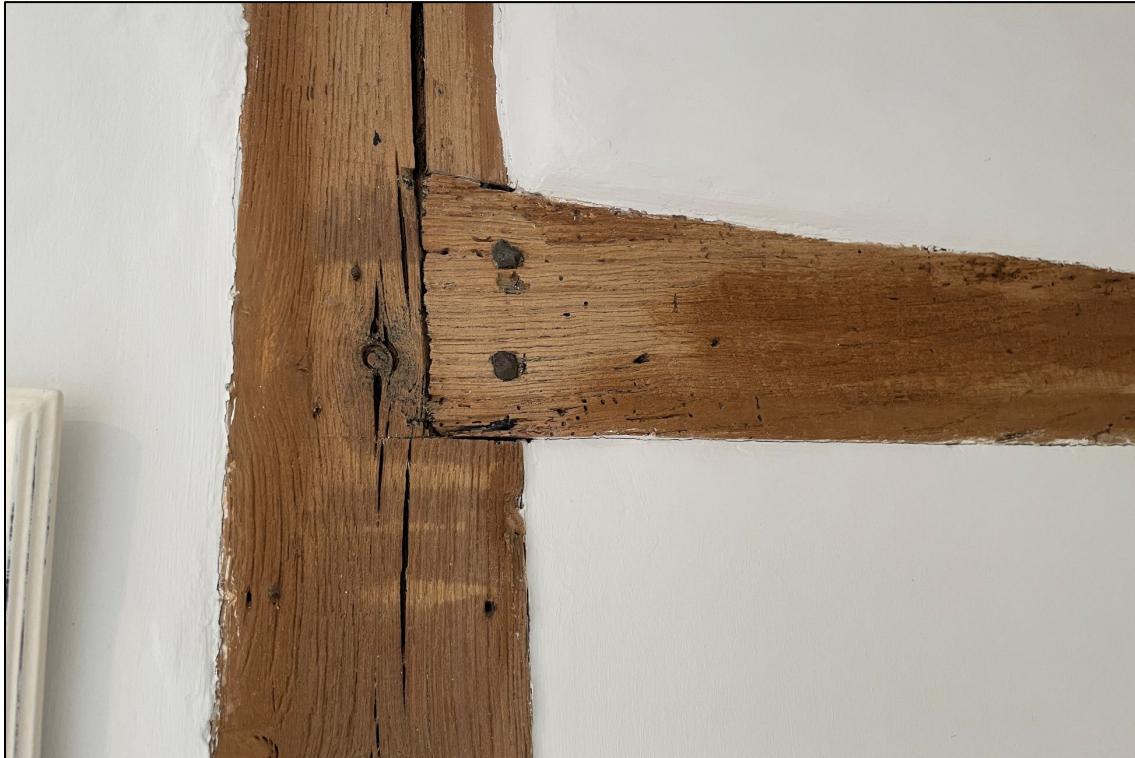
Within the eastern part of the house, the timber frame structure is exposed internally, being obscured externally by weatherboarding, hung tiles, and later extensions. **Room 0-13** comprises a corridor providing access from the external door in the south elevation to the panelled living room (**0-16**), stair tower (**0-15**), and kitchen (**0-12**). The north wall of this forms a timber framed partition to **Room 0-11** and features a scar from a blocked door at its eastern end, noted by a recess to the wall finish and a change in skirting style within **0-11** (**Appendix 2.3**). The infill comprises two posts and a central rail, with evidence of reuse, the western post having a truncated peg hole on the north face (**Appendix 2.4**). Within **0-13**, the post and rail are fitted with nails, suggesting the door was either not part of the original timber framing or these elements were added to achieve the infilling (**Appendix 2.5**).

**Appendix 2.5:** Detail of infill to blocked door in **Room 0-13**, looking north

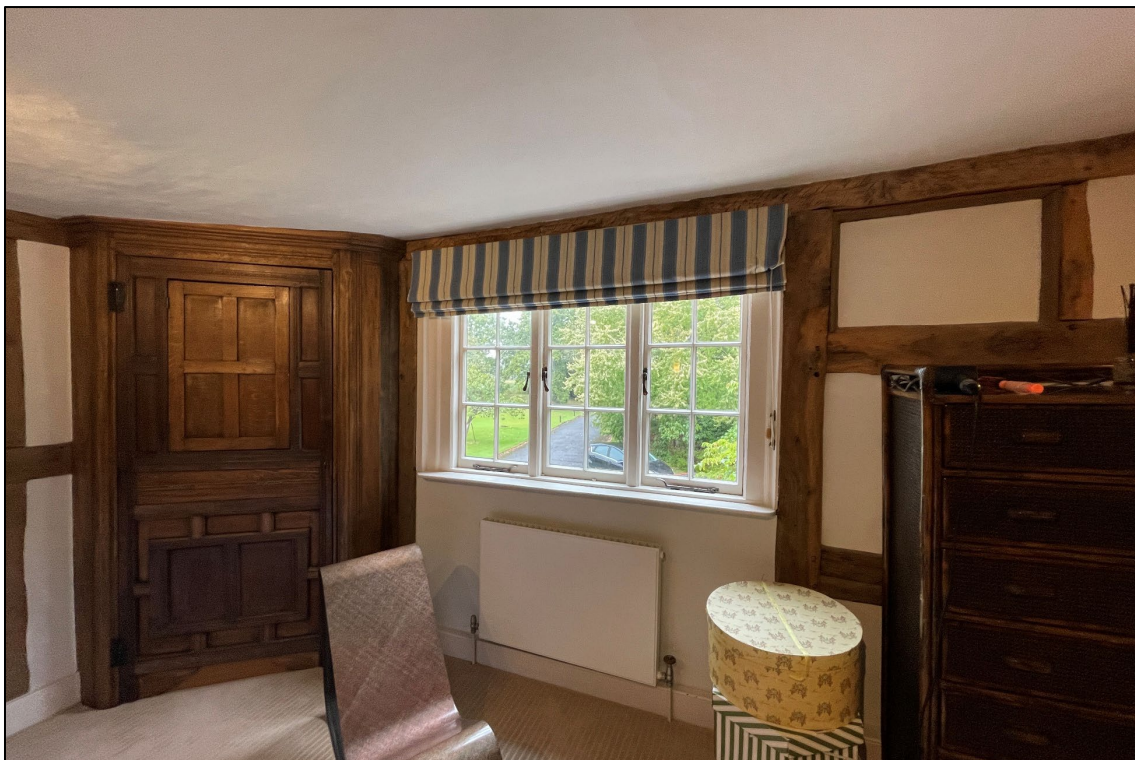
In the north-west corner of the room is a corner cupboard constructed of multiple types of historic timber panelling, the provenance of which is unknown. The cupboard itself was possibly installed in the late-20<sup>th</sup> century (**Appendix 2.6**).

**Appendix 2.6:** General view of north wall and corner cupboard, **Room 1-22**, looking north-west

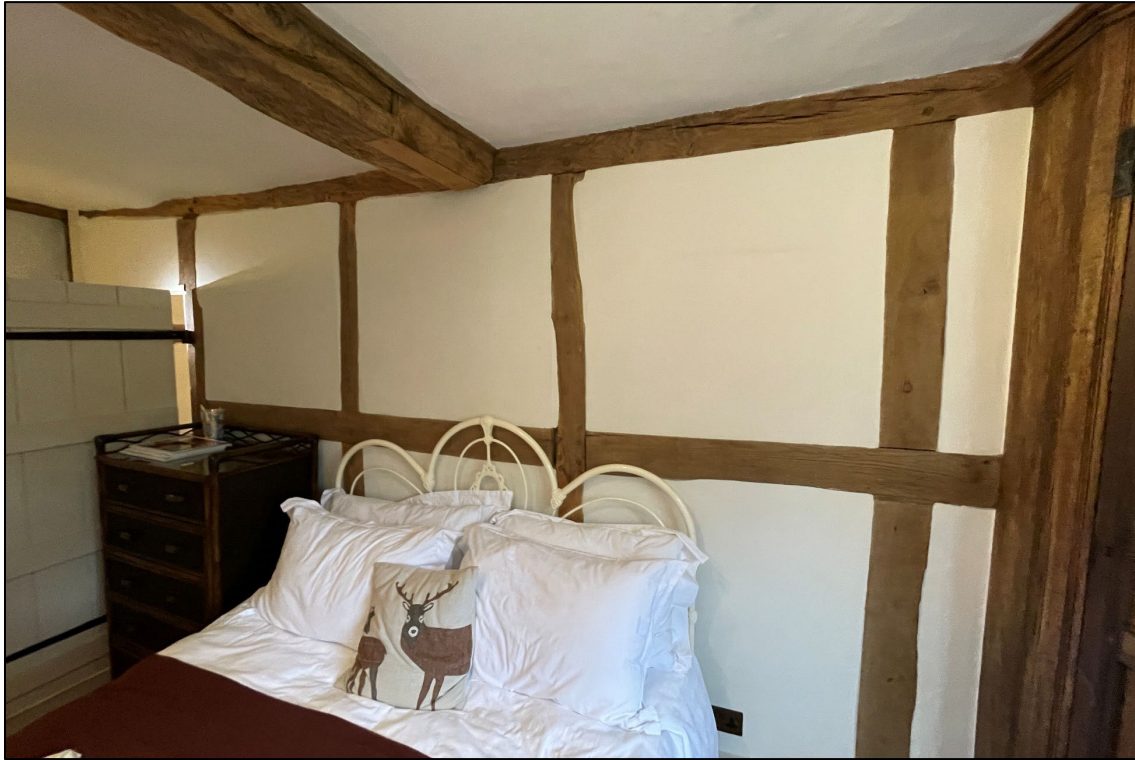
The west wall of the room comprises a cross frame formed of a mid rail and a series of studs. The principal stud to the centre of the wall retains pegs for the terminal ends of the mid rails on either side, however, there are no visible peg holes on either mid rail corresponding to the secondary studs, which are present on the wall plate above. It appears that a repair has been carried out to the mid rail, planting on newer timber and obscuring the peg holes behind (**Appendix 2.7**).

**Appendix 2.7:** General view of cross frame, **Room 1-22**, looking west

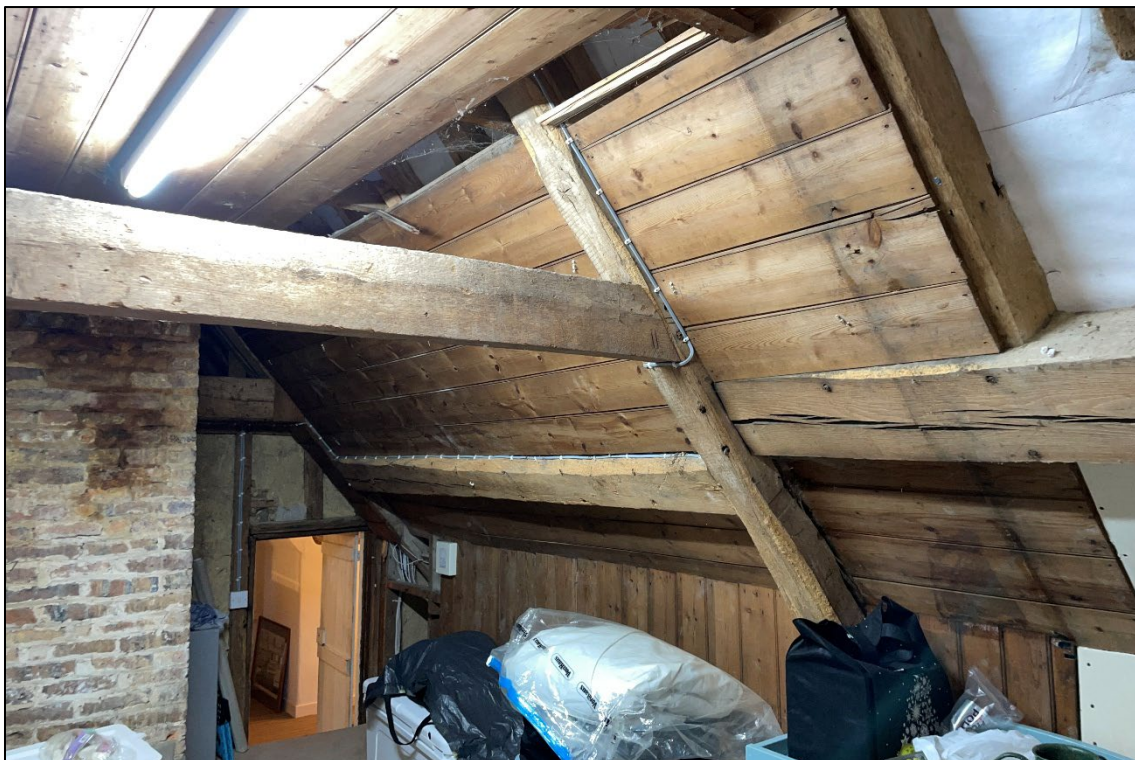
The roof structure above rooms **1-14**, **1-15** & **0-16** comprises two pit-sawn hardwood collar and tie-beam trusses, with tenoned purlins and common rafters tenoned to the purlins (**Appendix 2.8**). The trusses have incised assembly marks numbered I & II at the joint between the collars and principal rafters on the south side, and additionally at the apex of the principal rafters. The roof structure is potentially of an 18<sup>th</sup> century date, although the simple collar and tie-beam construction may suggest a slightly earlier date. There is also evidence of reuse of timbers, including rafters with redundant lap joints (**Appendix 2.9**). Later alteration (19<sup>th</sup> century) included the partial boarding of the attic space with softwood tongue & groove boards fitted with square-section nails and late-19<sup>th</sup> century pencil graffiti (1894).

**Appendix 2.8:** General view of roof space, **Room 2-05**, looking south-east

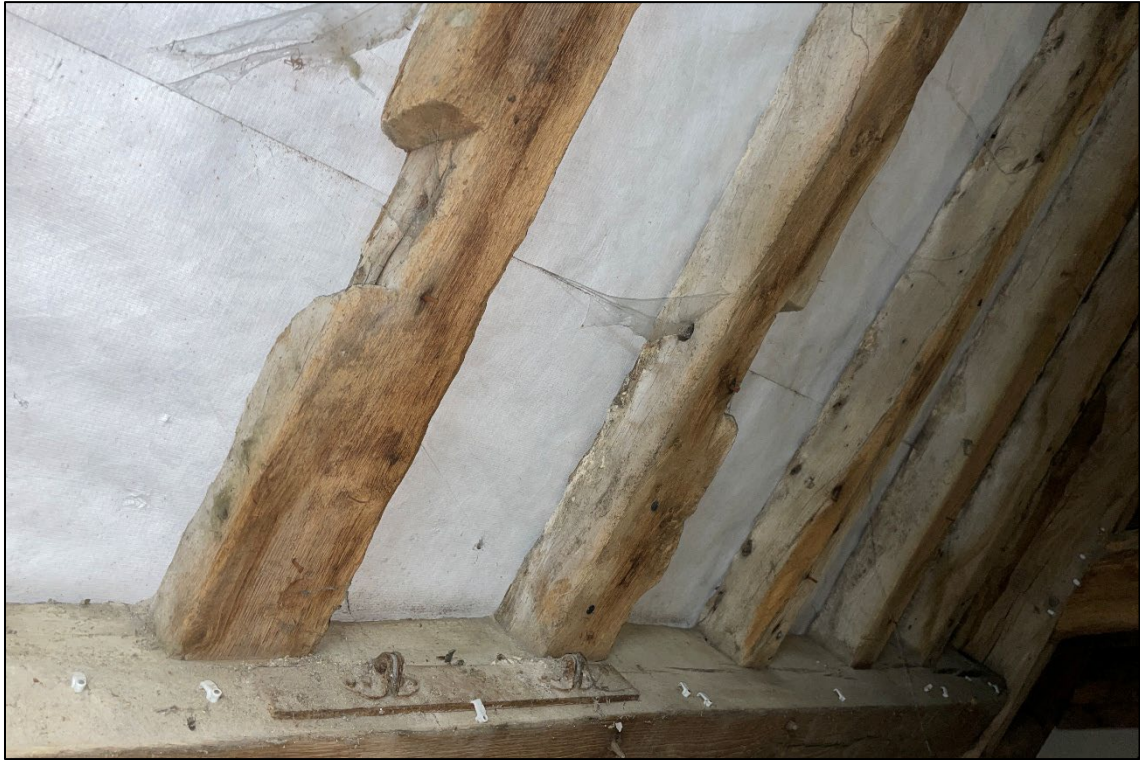
**Appendix 2.9:** Detail of reused common rafters, **Room 2-05**, looking south-west

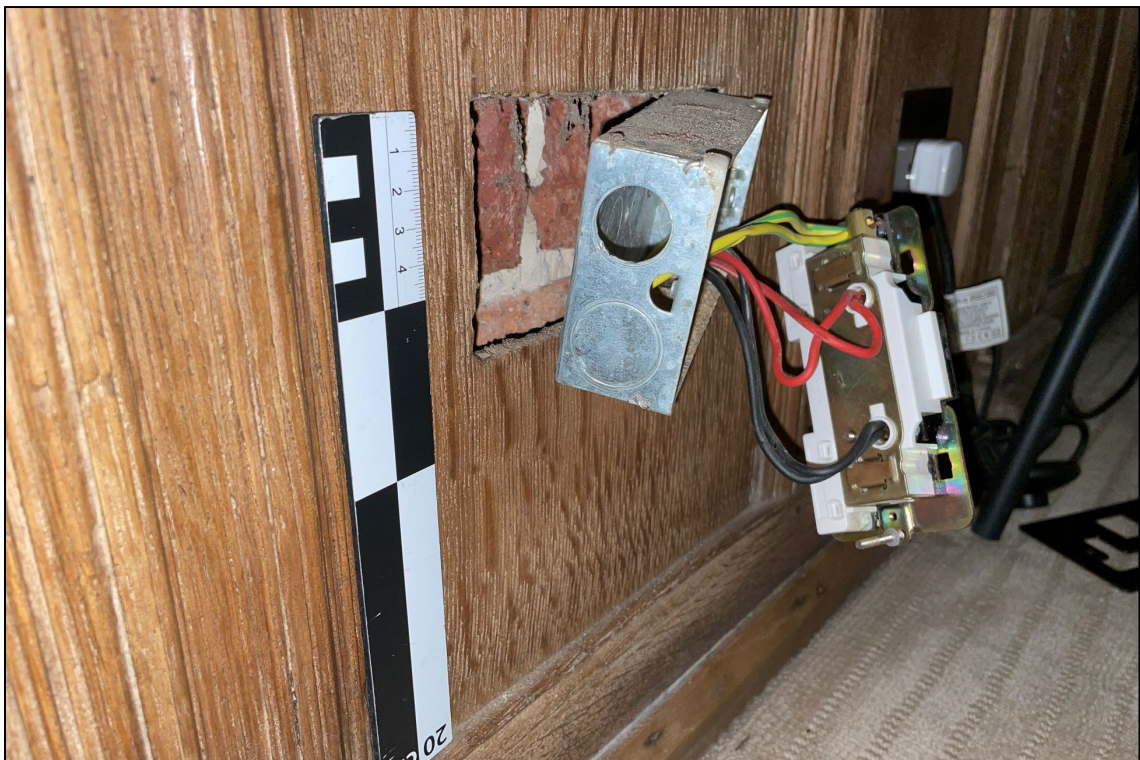
*Observation 3:* A modern plug socket was removed from the face of the panelling exposing the walling material behind. The face of the north wall of the room was found to comprise handmade red brick laid in thick lime mortar (**Appendix 2.10**). Parts of the wall were observed to be lime plastered (**Appendix 2.11**). The appearance of the hand made brick and use of thick bedding mortar is typically indicative of a pre-20<sup>th</sup> century date. The wall thickness here is notably thinner than the south wall and north-east corner of the room, which is likely attributed to an 18<sup>th</sup> century rebuilding, or cladding in brick. It is therefore possible that this narrower part of the north wall post-dates that phase, most likely being from 19<sup>th</sup> century.

**Appendix 2.10:** Detail of north wall, **Room 0-16** (Observation 3), looking north-east (20cm scale)

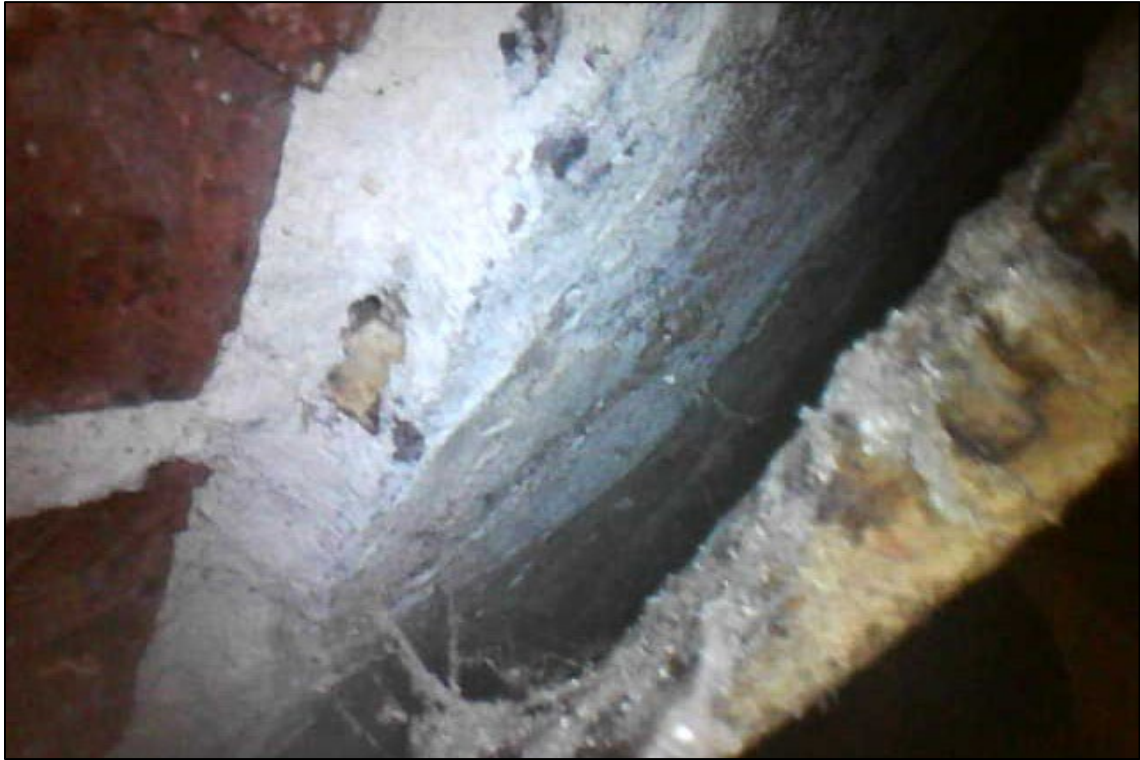
**Appendix 2.11:** Detail of lime plaster, **Room 0-16** (Observation 3), looking north-east

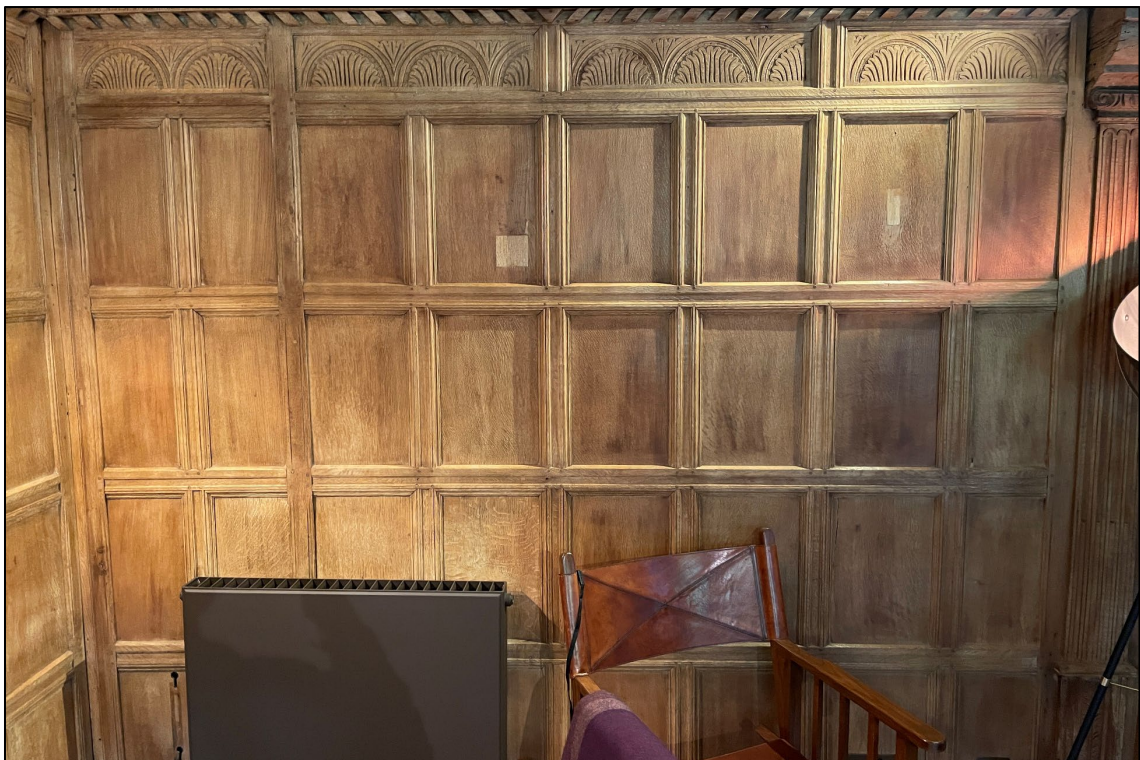
The timber panelling within the room is stylistic of 17<sup>th</sup> century small square panelling and includes a frieze of stylised foliate lunettes (**Appendix 2.12**). As with many cases, it is suggested that the panelling has been moved or rearranged within the house or inserted from elsewhere (Hall 2005, 136-9). This is evidenced by the mouldings on the full-length vertical stiles, which differ to that of the shorter stiles, and the frieze above appears to be truncated in places.

**Appendix 2.12:** Detail of panelling in **Room 0-16**, looking north

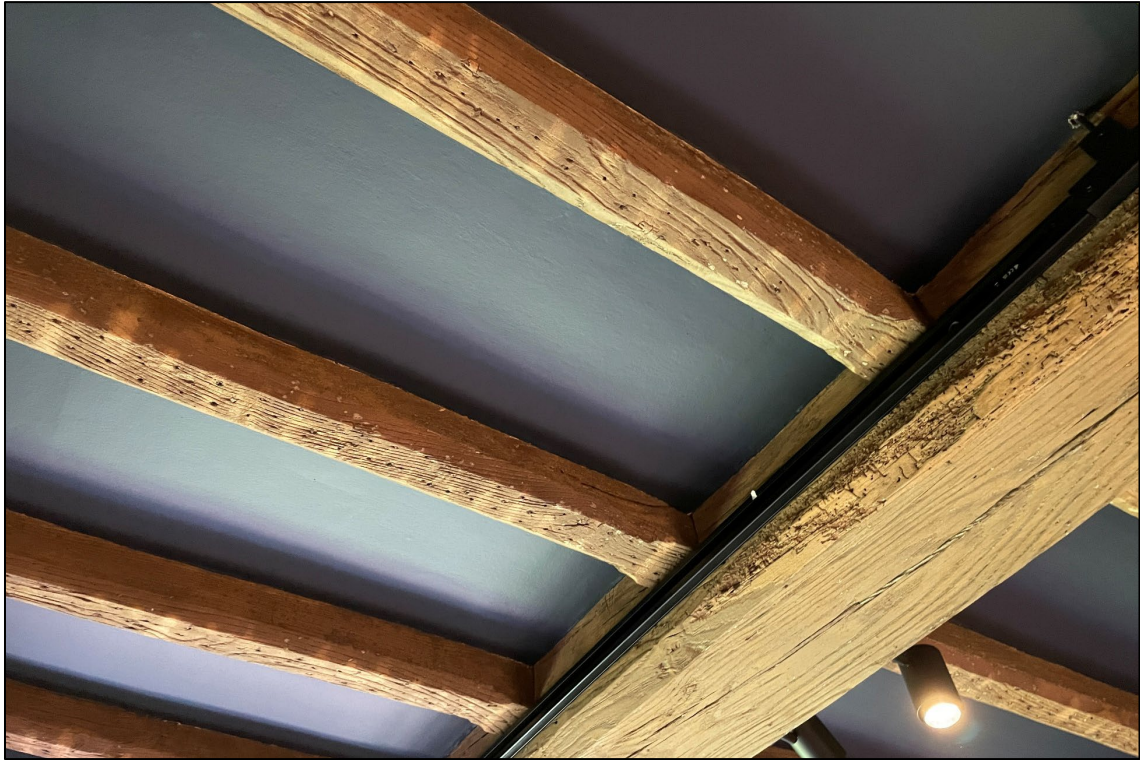
*Observation 5:* The southern part of this room appears to have been altered as part of the early-20<sup>th</sup> century works. The ceiling to the south sits lower than that to the north, which features a chamfered and stopped bridging beam and joists (**Appendix 2.13**). This lower ceiling is formed by two parallel cross beams above four timber columns. The columns do not appear to be load bearing, with evidence in the cellar below indicating the north-west one was nailed through the flooring.

**Appendix 2.13:** Detail of chamfered ceiling beams, **Room 0-09**, looking north-east

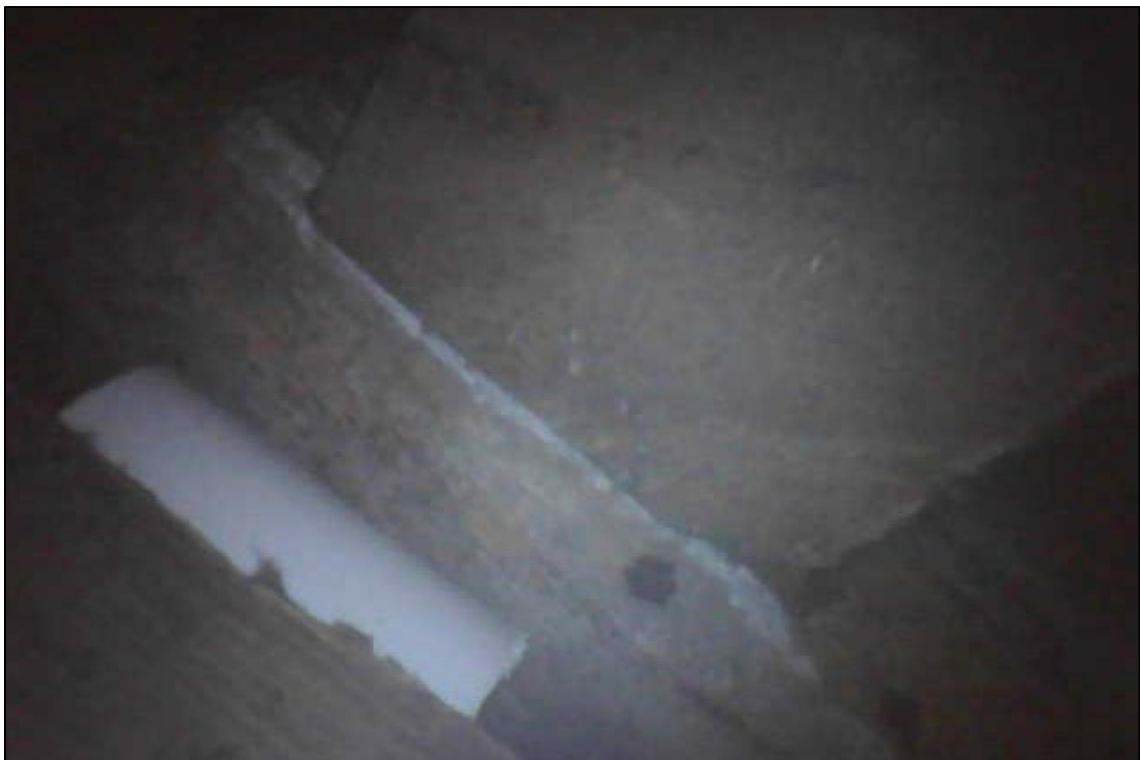
*Observation 6:* A modern spotlight was removed from the underside of the southern cross beam revealing a void containing modern services. Beyond this, the cross beam was found to be constructed of timber with one joist jointed to it within the area of observation (**Appendix 2.14**).

The form of the two cross beams above the hollow columns in **Room 0-09** visually takes the form of a boxed-in RSJ. On inspection, it appears these are in fact timber beams.

**Appendix 2.14:** Detail from inspection camera of timber beam above columns in **Room 0-09**, (Observation 6) looking north

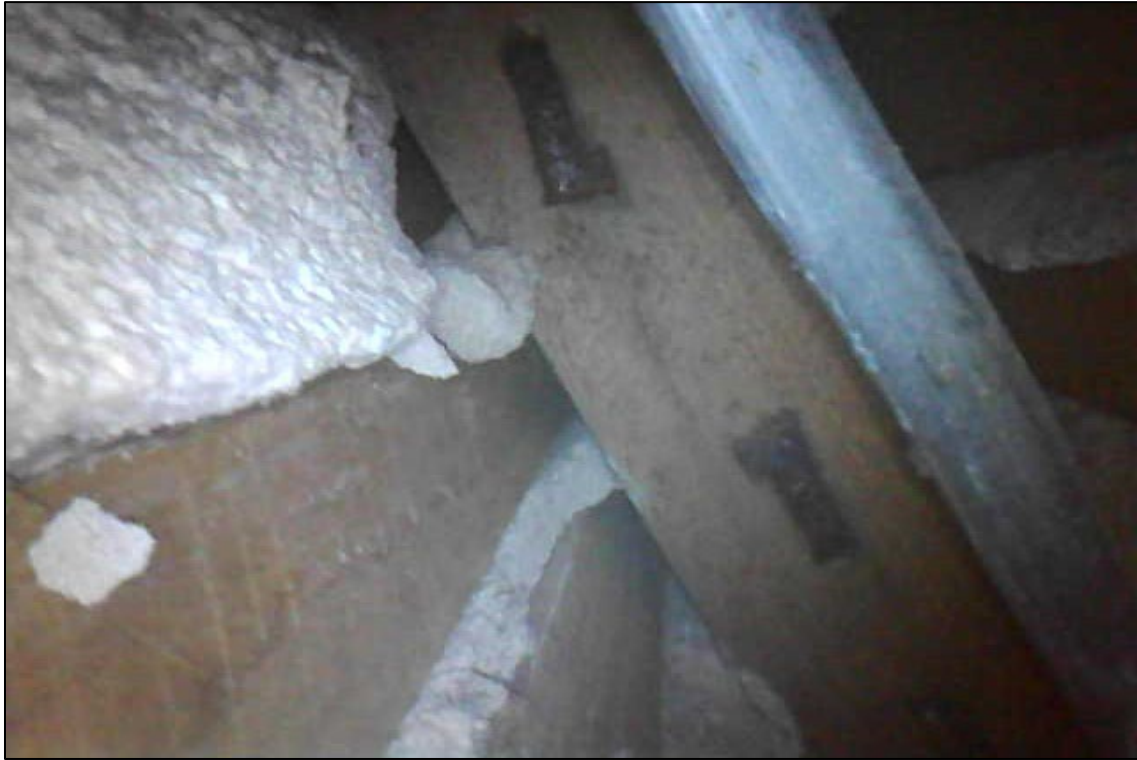
A modern plug socket was removed from the south wall of the room which forms a partition to **Room 1-21**. The wall was found to be constructed of lath and plaster with one timber stud visible having large redundant nails hammered flush to its surface, suggesting reuse. The laths appear to be machine-sawn, indicating a potential date for the partition being in the last half of the 19<sup>th</sup> century (**Appendix 2.15**).

**Appendix 2.15:** Detail from inspection camera of lath and plaster south wall in **Room I-15**, (Observation 7) looking east

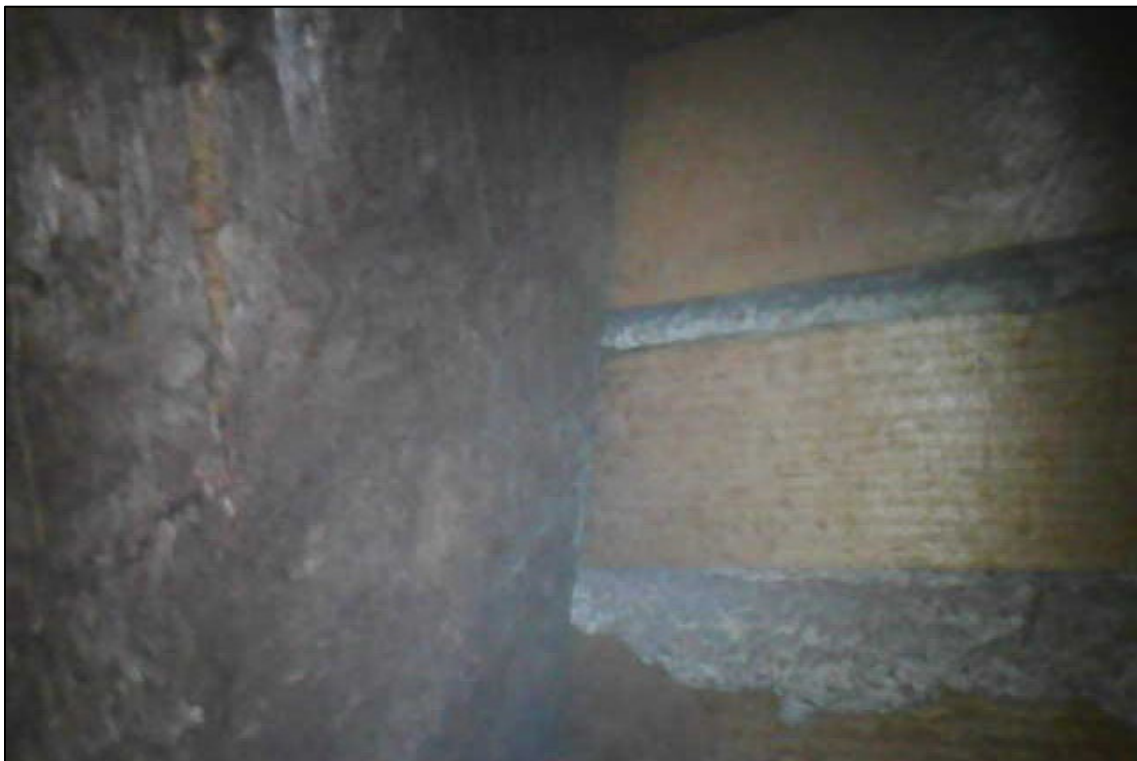
*Observation 8.* A plug socket was removed from the north wall of the room, revealing its construction to be a lath and plaster stud wall (**Appendix 2.16**). The laths appear to be machine-sawn, indicating a potential date for the wall being in the last half of the 19<sup>th</sup> century. A timber beam was noted at the base of the north side of the wall void, while the south side was finished with lath and plaster all the way to the base. This beam was potentially inserted to achieve the raised floor level in the first-floor corridor to the north (**Room 1-09**).

**Appendix 2.16:** Detail from inspection camera of timber stud and lath and plaster north wall in **Room I-14**, (Observation 8) looking north

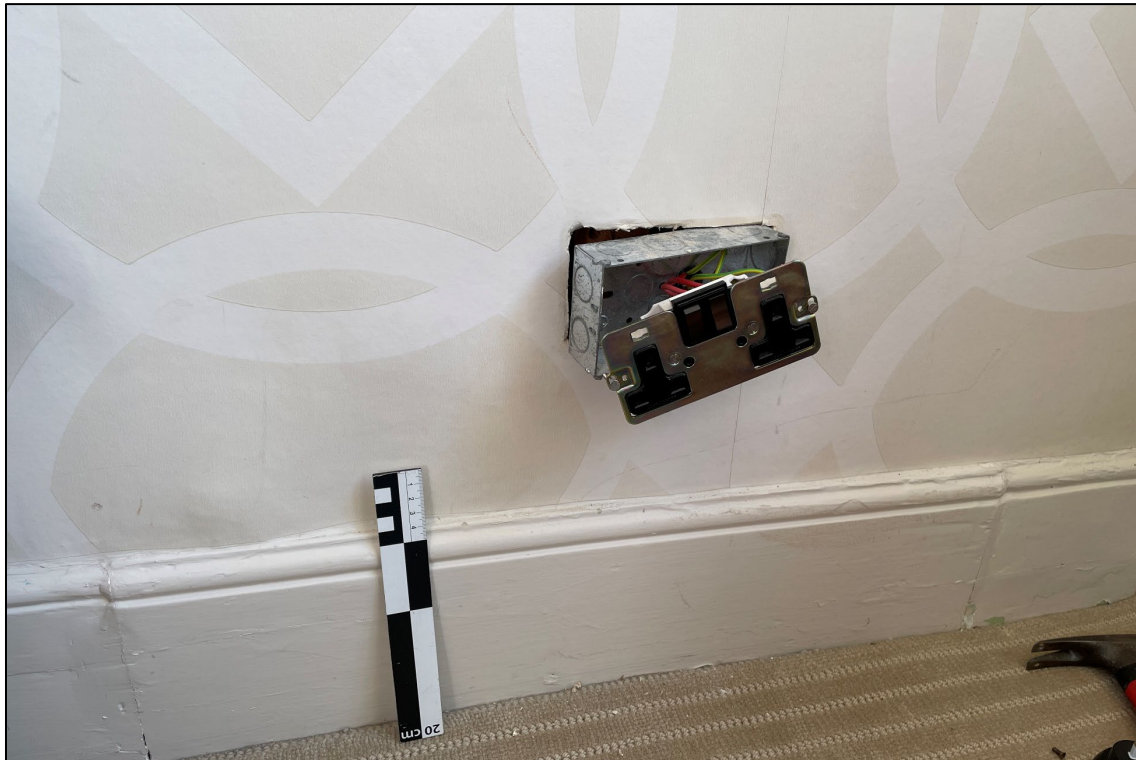
*Observation 9.* The west wall of the room forms a partition to another bedroom (**Room 1-15**). Within **1-15**, raking light highlights a vertical scar in this wall, and it corresponds to a cut mark on the skirting board and a slight change in moulding. On the west side of the partition, within **Room 1-14**, a similar alteration to the skirting is visible, although this is narrower (**Appendix 2.17**). A plug socket was removed, and the wall construction was found to be of timber studs with lath and plaster. The laths appear to be machine-sawn, indicating a potential date for the wall in the last half of the 19<sup>th</sup> century. Within the wall void, a redundant lead pipe was noted (**Appendix 2.18**).

**Appendix 2.17:** Detail of disturbed skirting board on east wall in **Room I-14**, (Observation 9) looking south-east (20cm Scale)

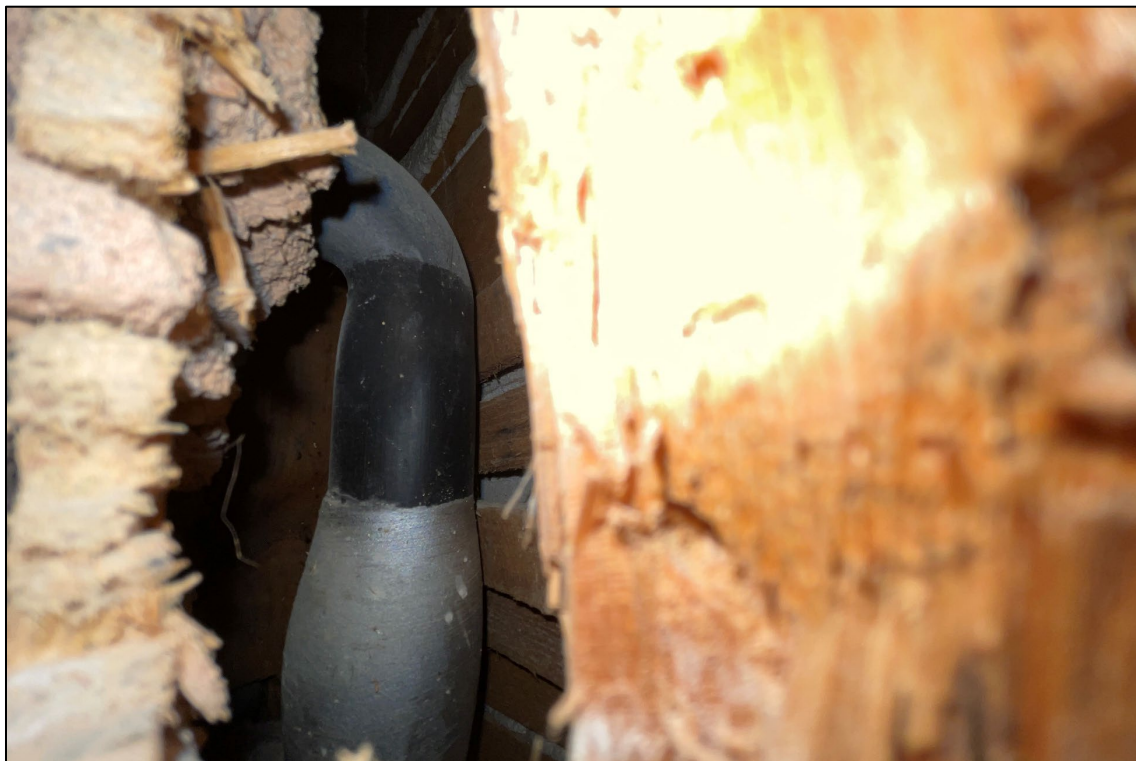
**Appendix 2.18:** Detail of lath and plaster east wall in **Room I-14**, (Observation 9) looking north-east
