STRUCTURAL SURVEY ON  
ORCHARD BARN, HAYWARDS HEATH  
JOB REF: WG1657  
DATE: OCTOBER 2024

Project: Orchard Barn, Nash Lane, Haywards Heath  
Client: SDP  
Ref: WG1657

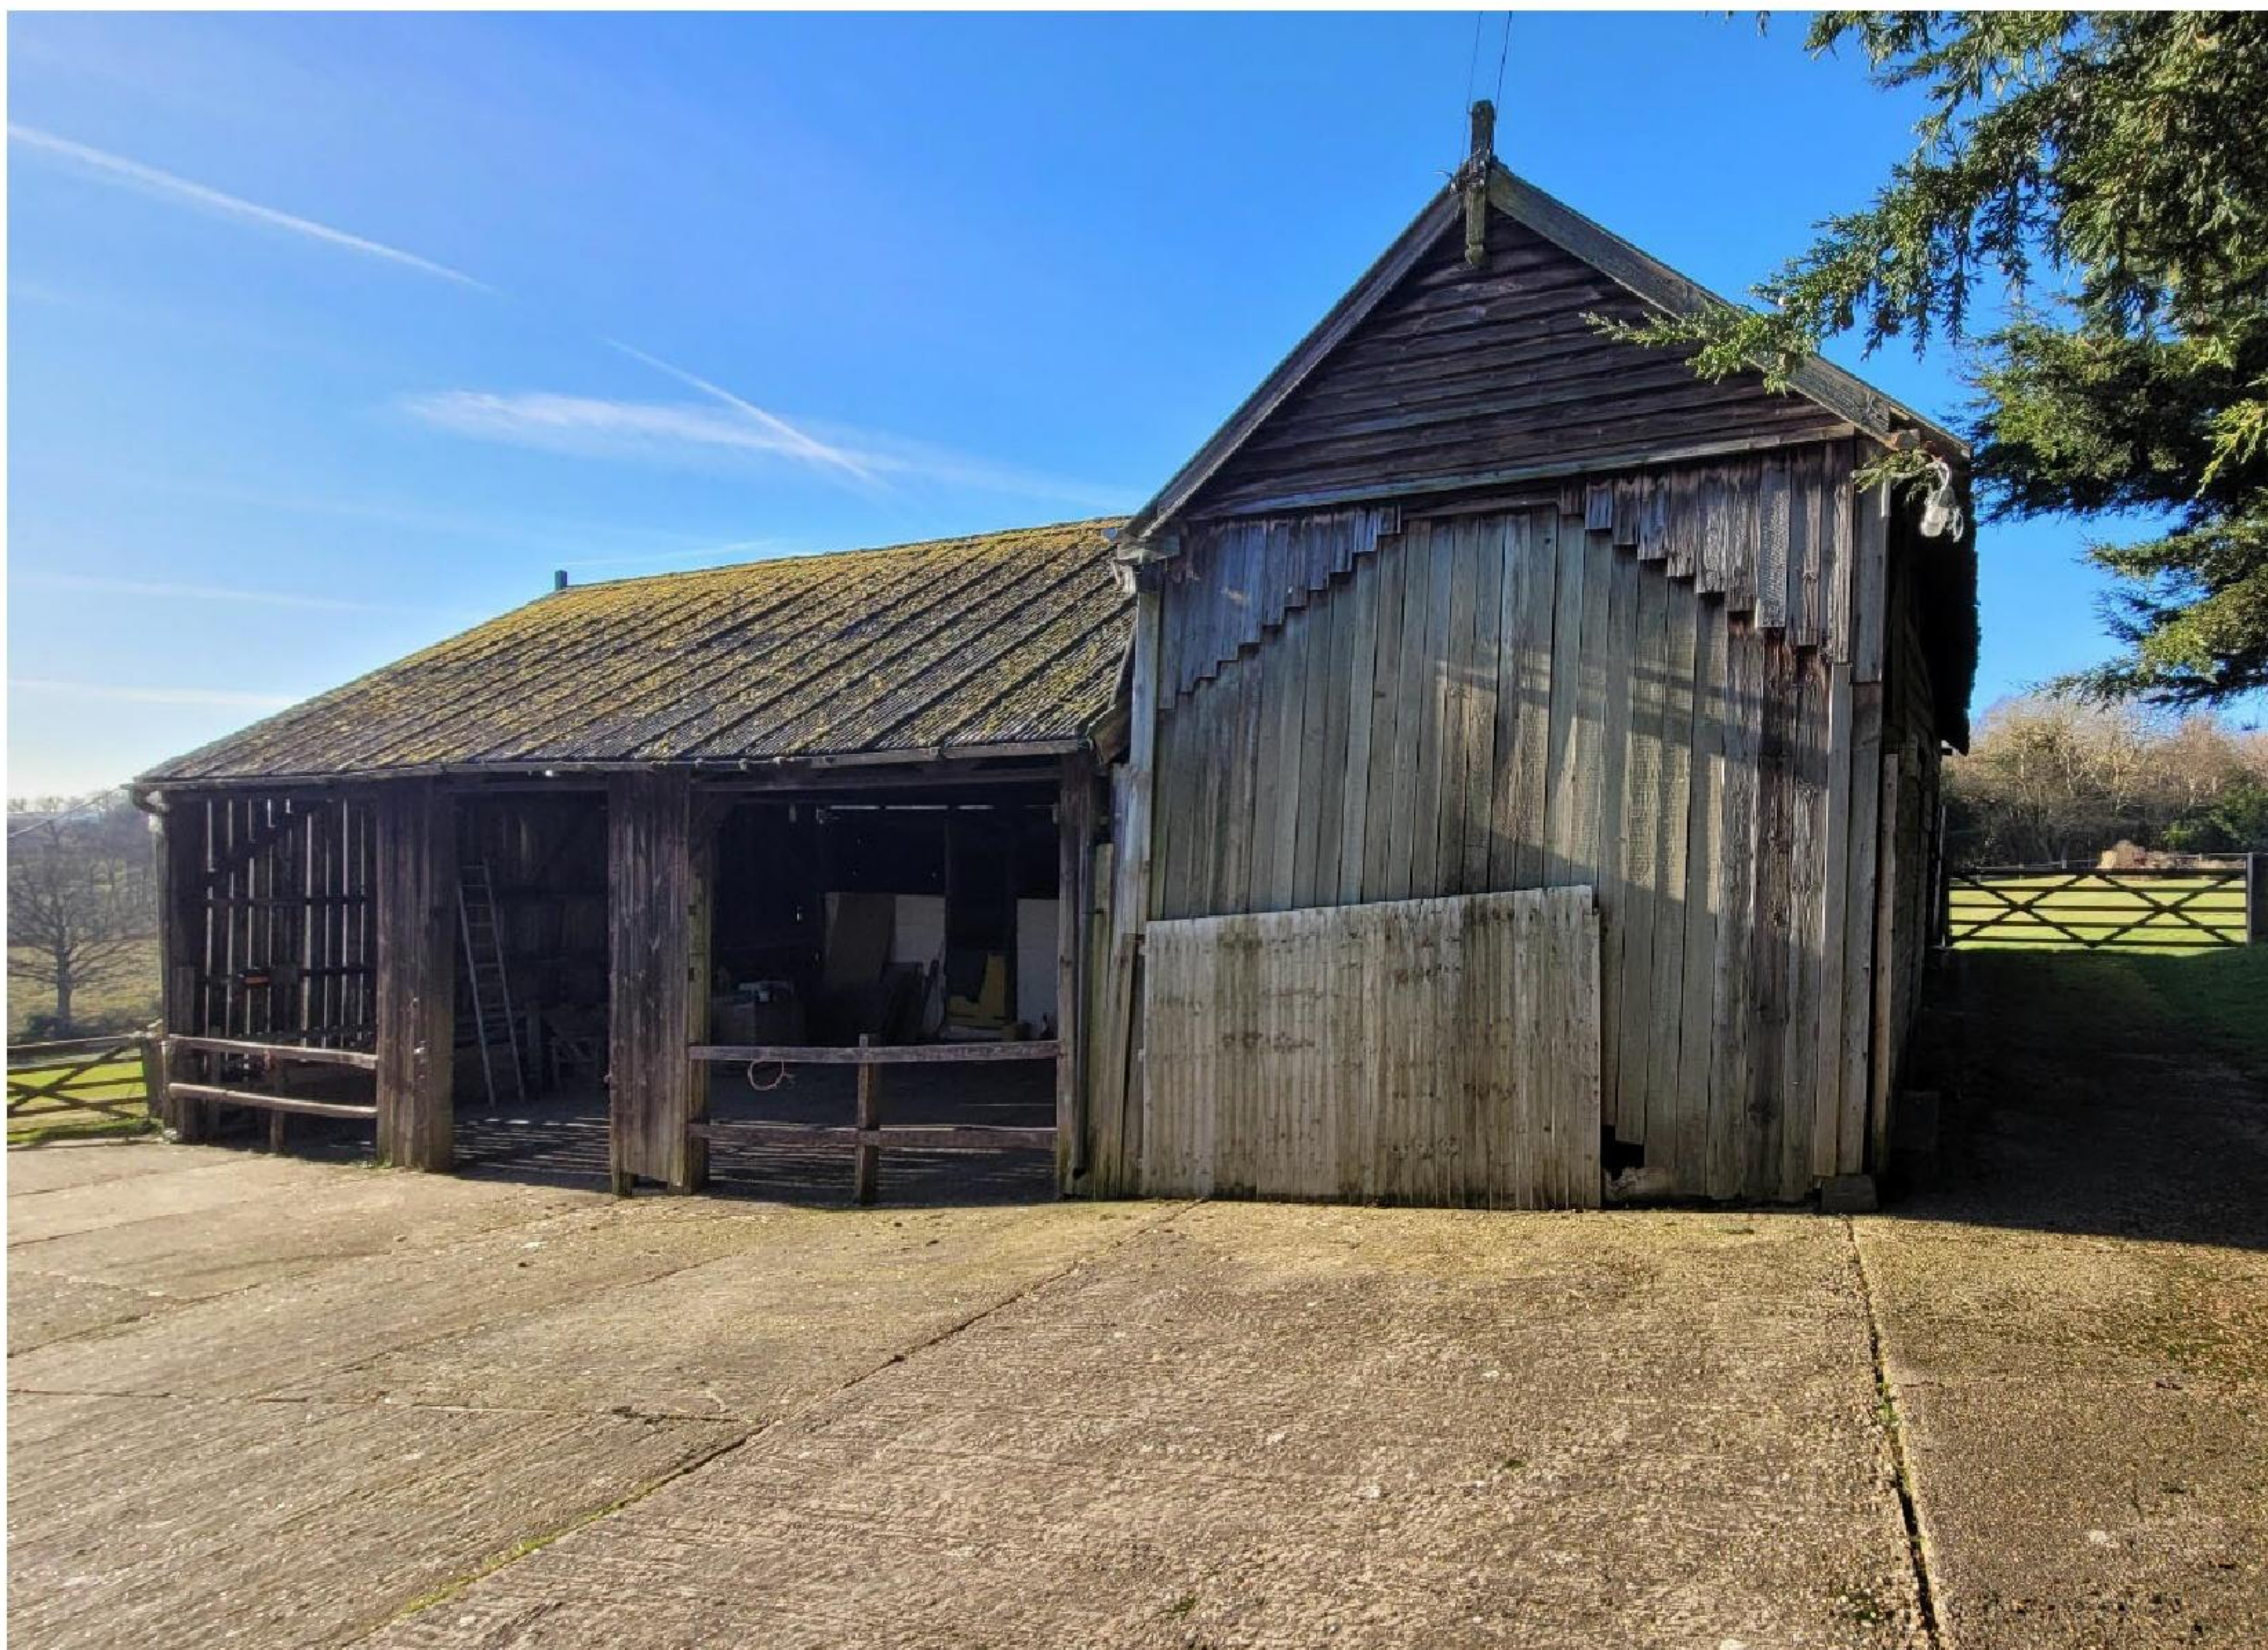
**PHOTO #1** – External view to the front elevation of Orchard Barn.

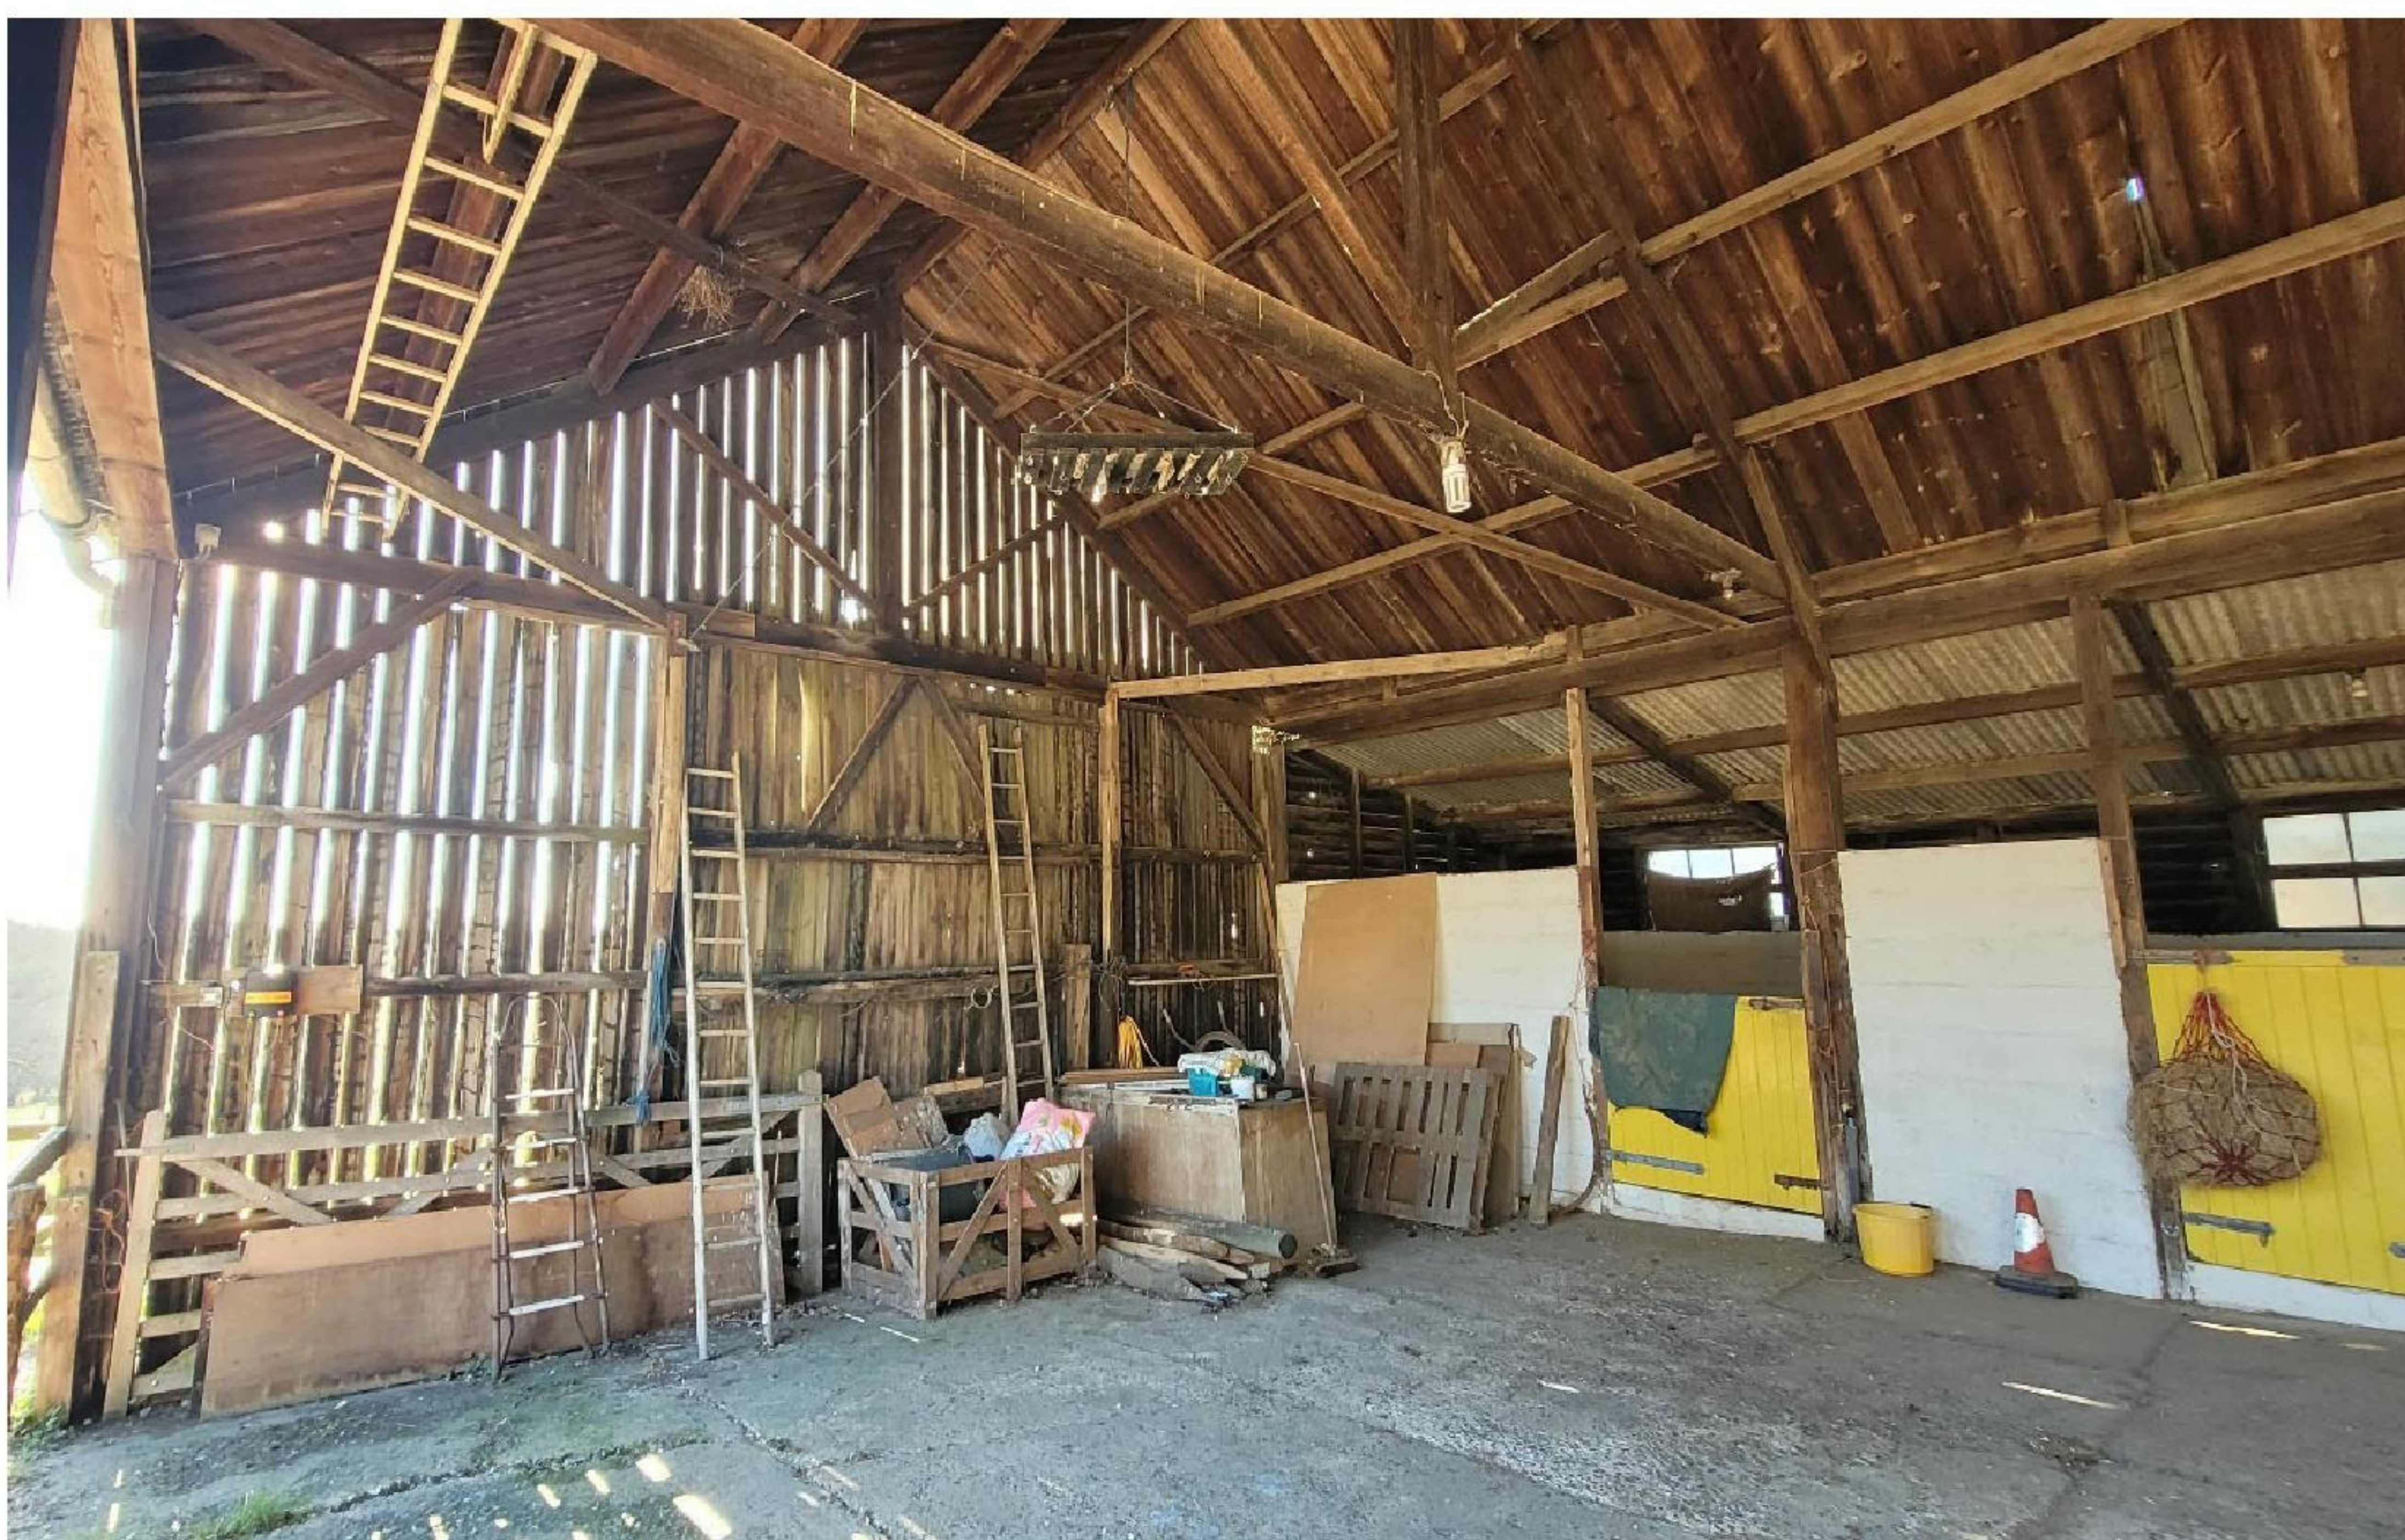
- 2.2 The main Open Barn had a timber trussed roof formed with four equally spaced hand-made trusses supported on timber posts. These supported a series of timber beams which in turn supported timber boarding running down the roof pitch. There were no rafters. This section of the barn was covered with corrugated sheet metal. The floor slab comprised a sloping concrete ground bearing slab following the natural profile of the external areas. Externally, the walls were timber clad. No internal finishes or insulation was present in either the roof or walls.

**PHOTO #2** – Internal view of main section of Open Barn

2.10 The roof to the Stables will need to be removed and replaced, and we would assume the same will be required to the Barn. The Open Barn should be able to retain its trusses as these are the main feature elements in this space. New rafters & purlins will be required. Any new roof finishes should be kept to an absolute minimum in terms of weight to minimise the effect on the existing structure. Insulated panels would be a good alternative to rafters & finishes and would retain the agricultural look externally while keeping loadings low.

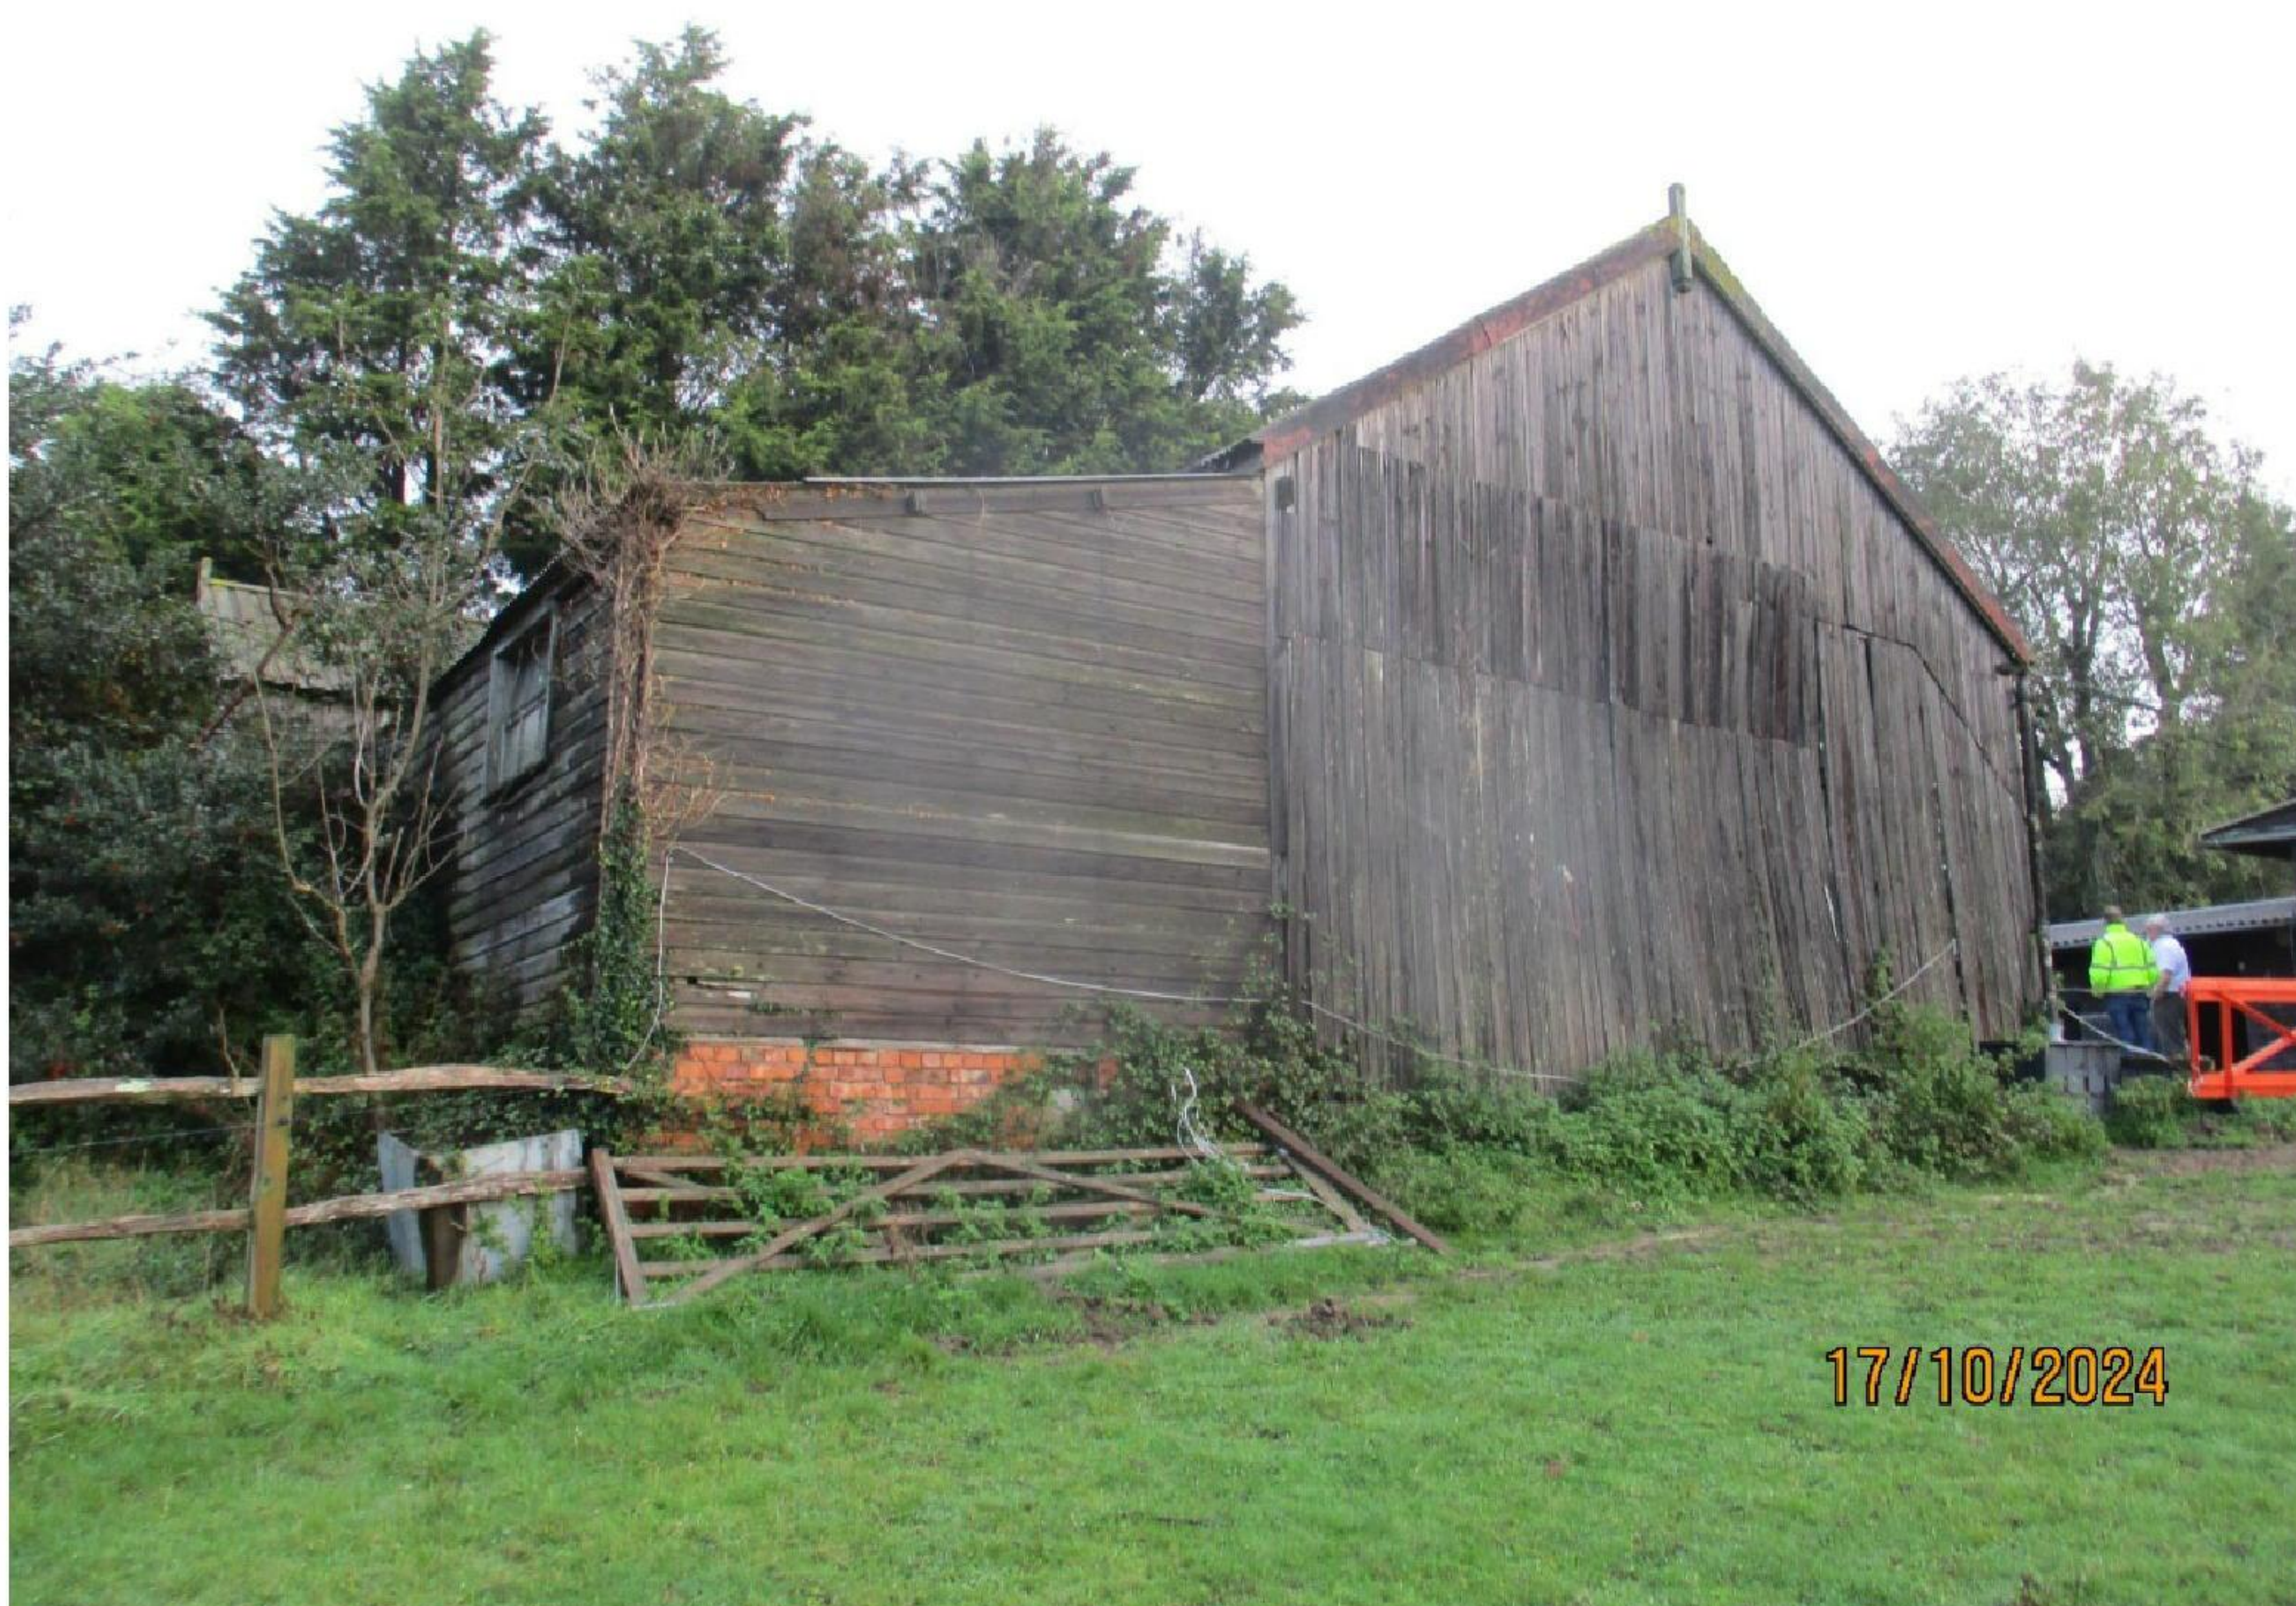
**PHOTO #3** – External side view of Orchard barn.

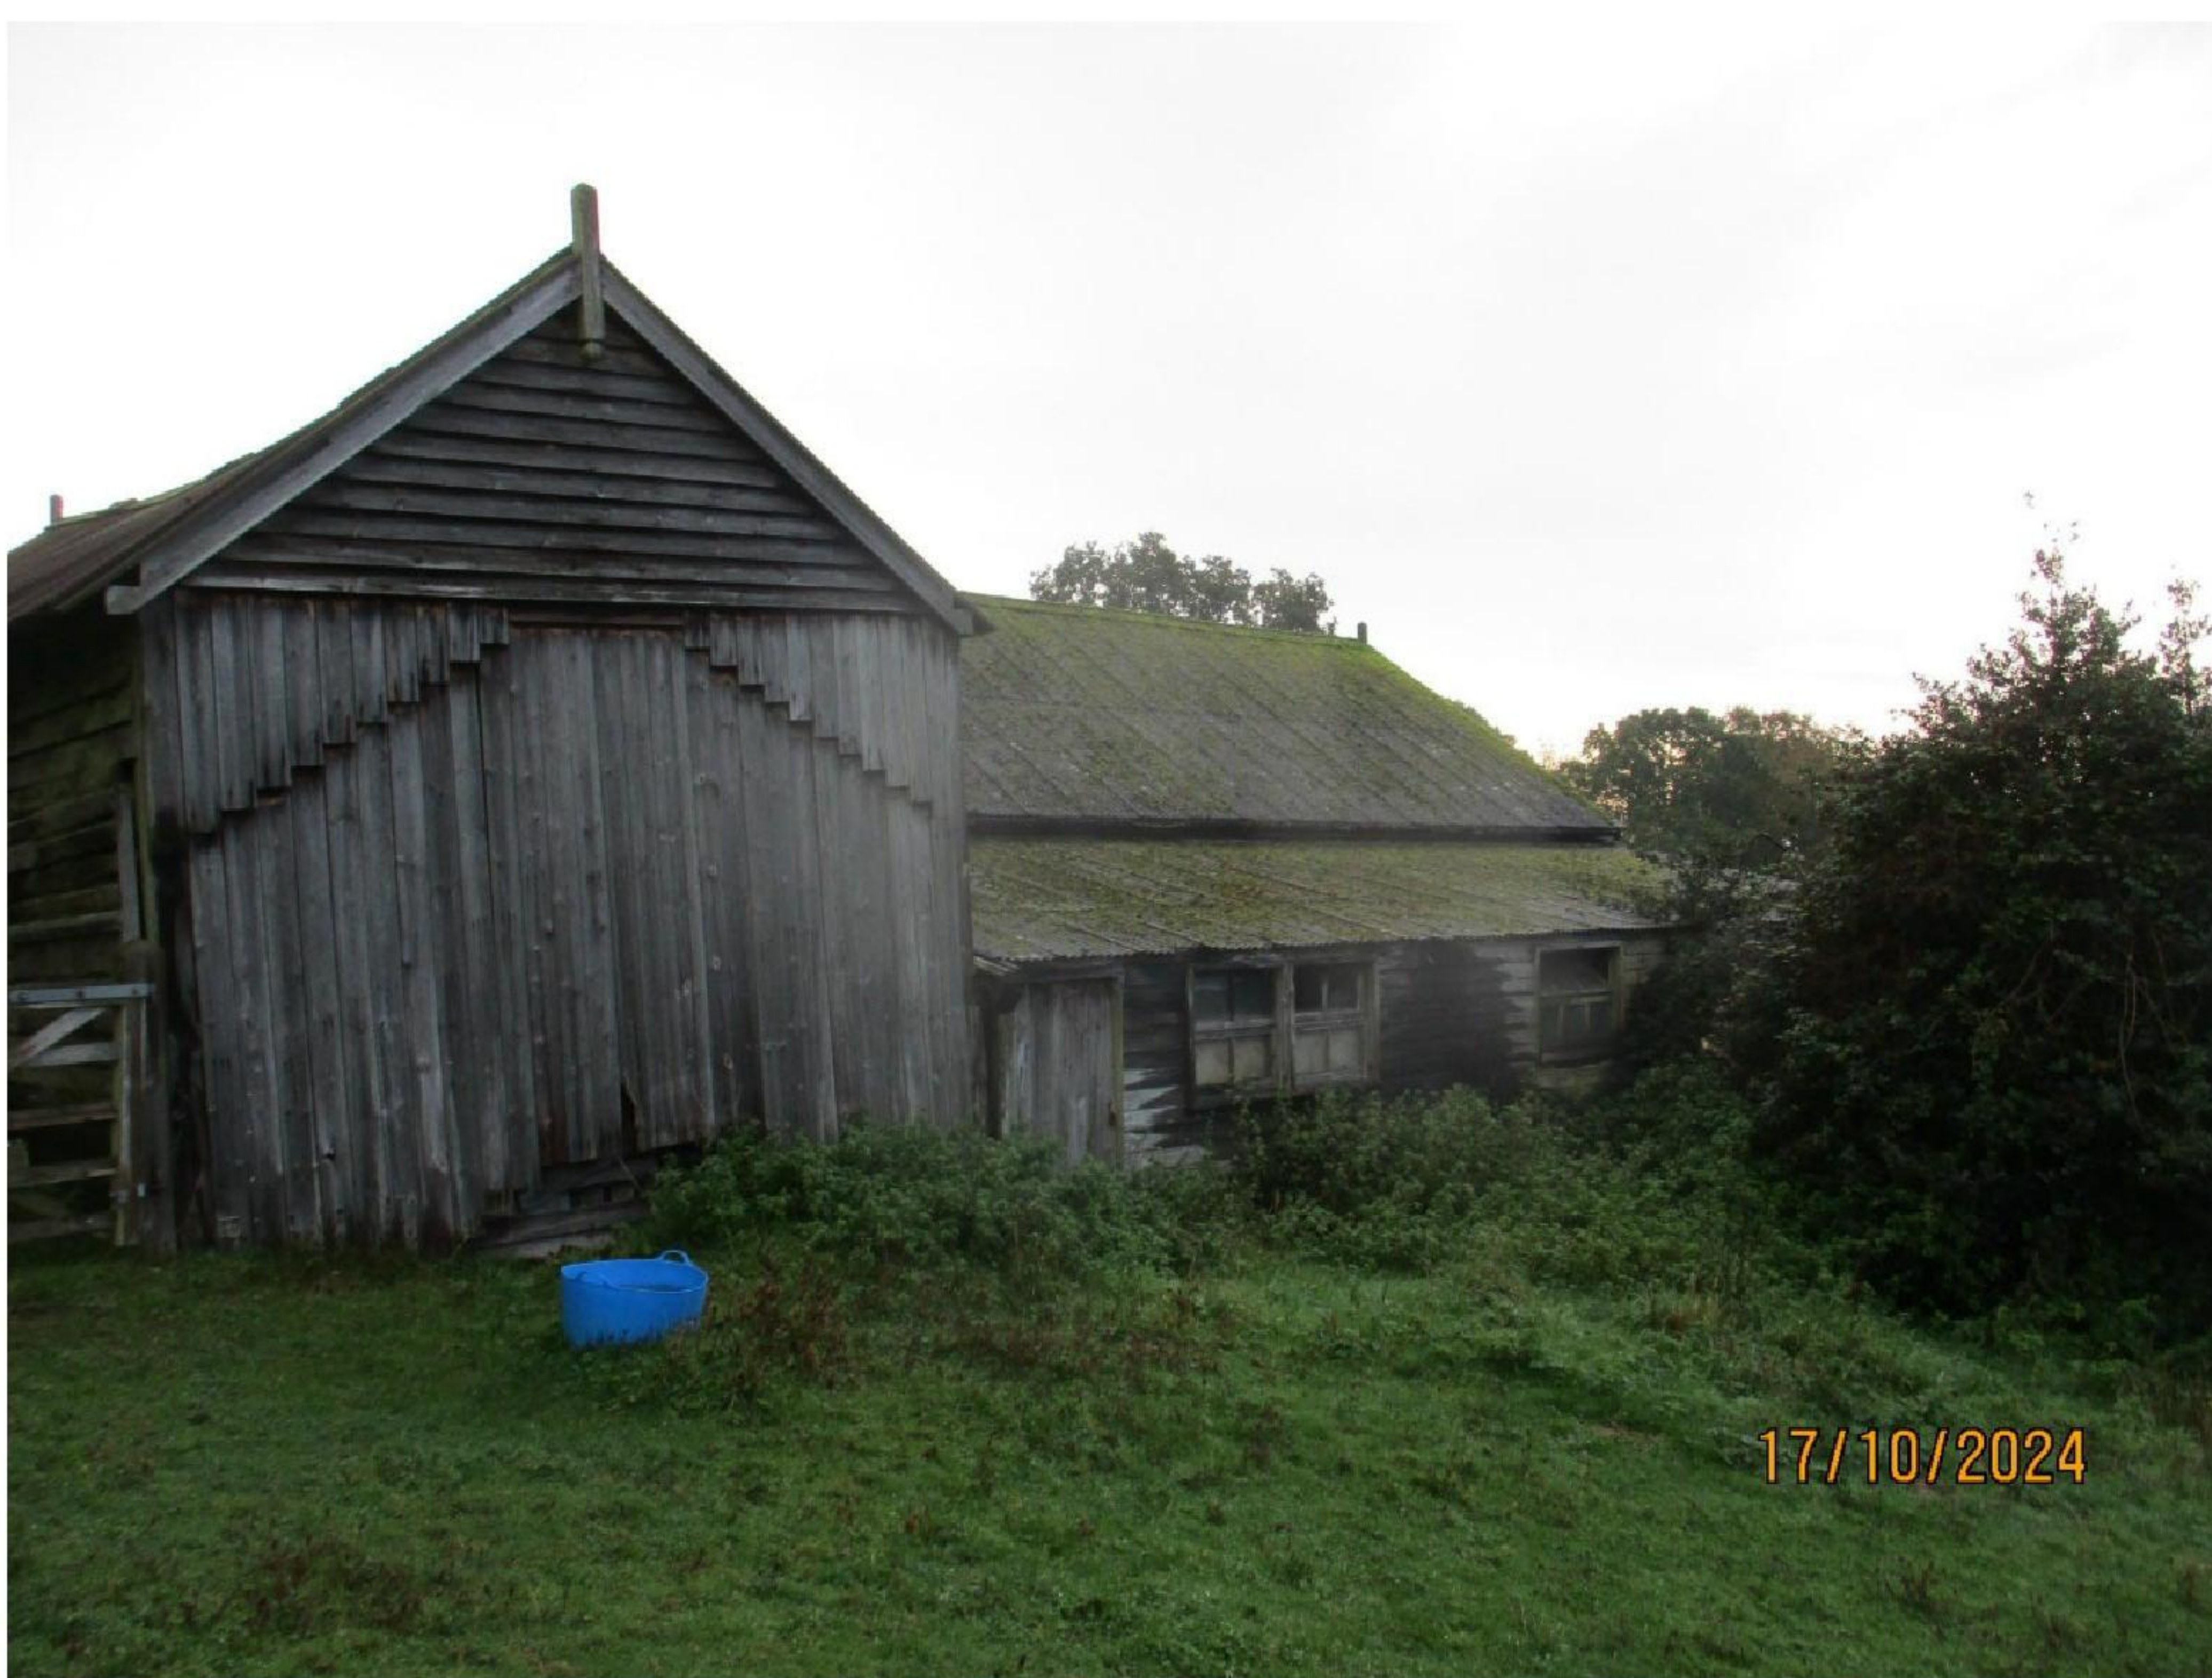
**PHOTO #4** – External rear view of Orchard Barn.

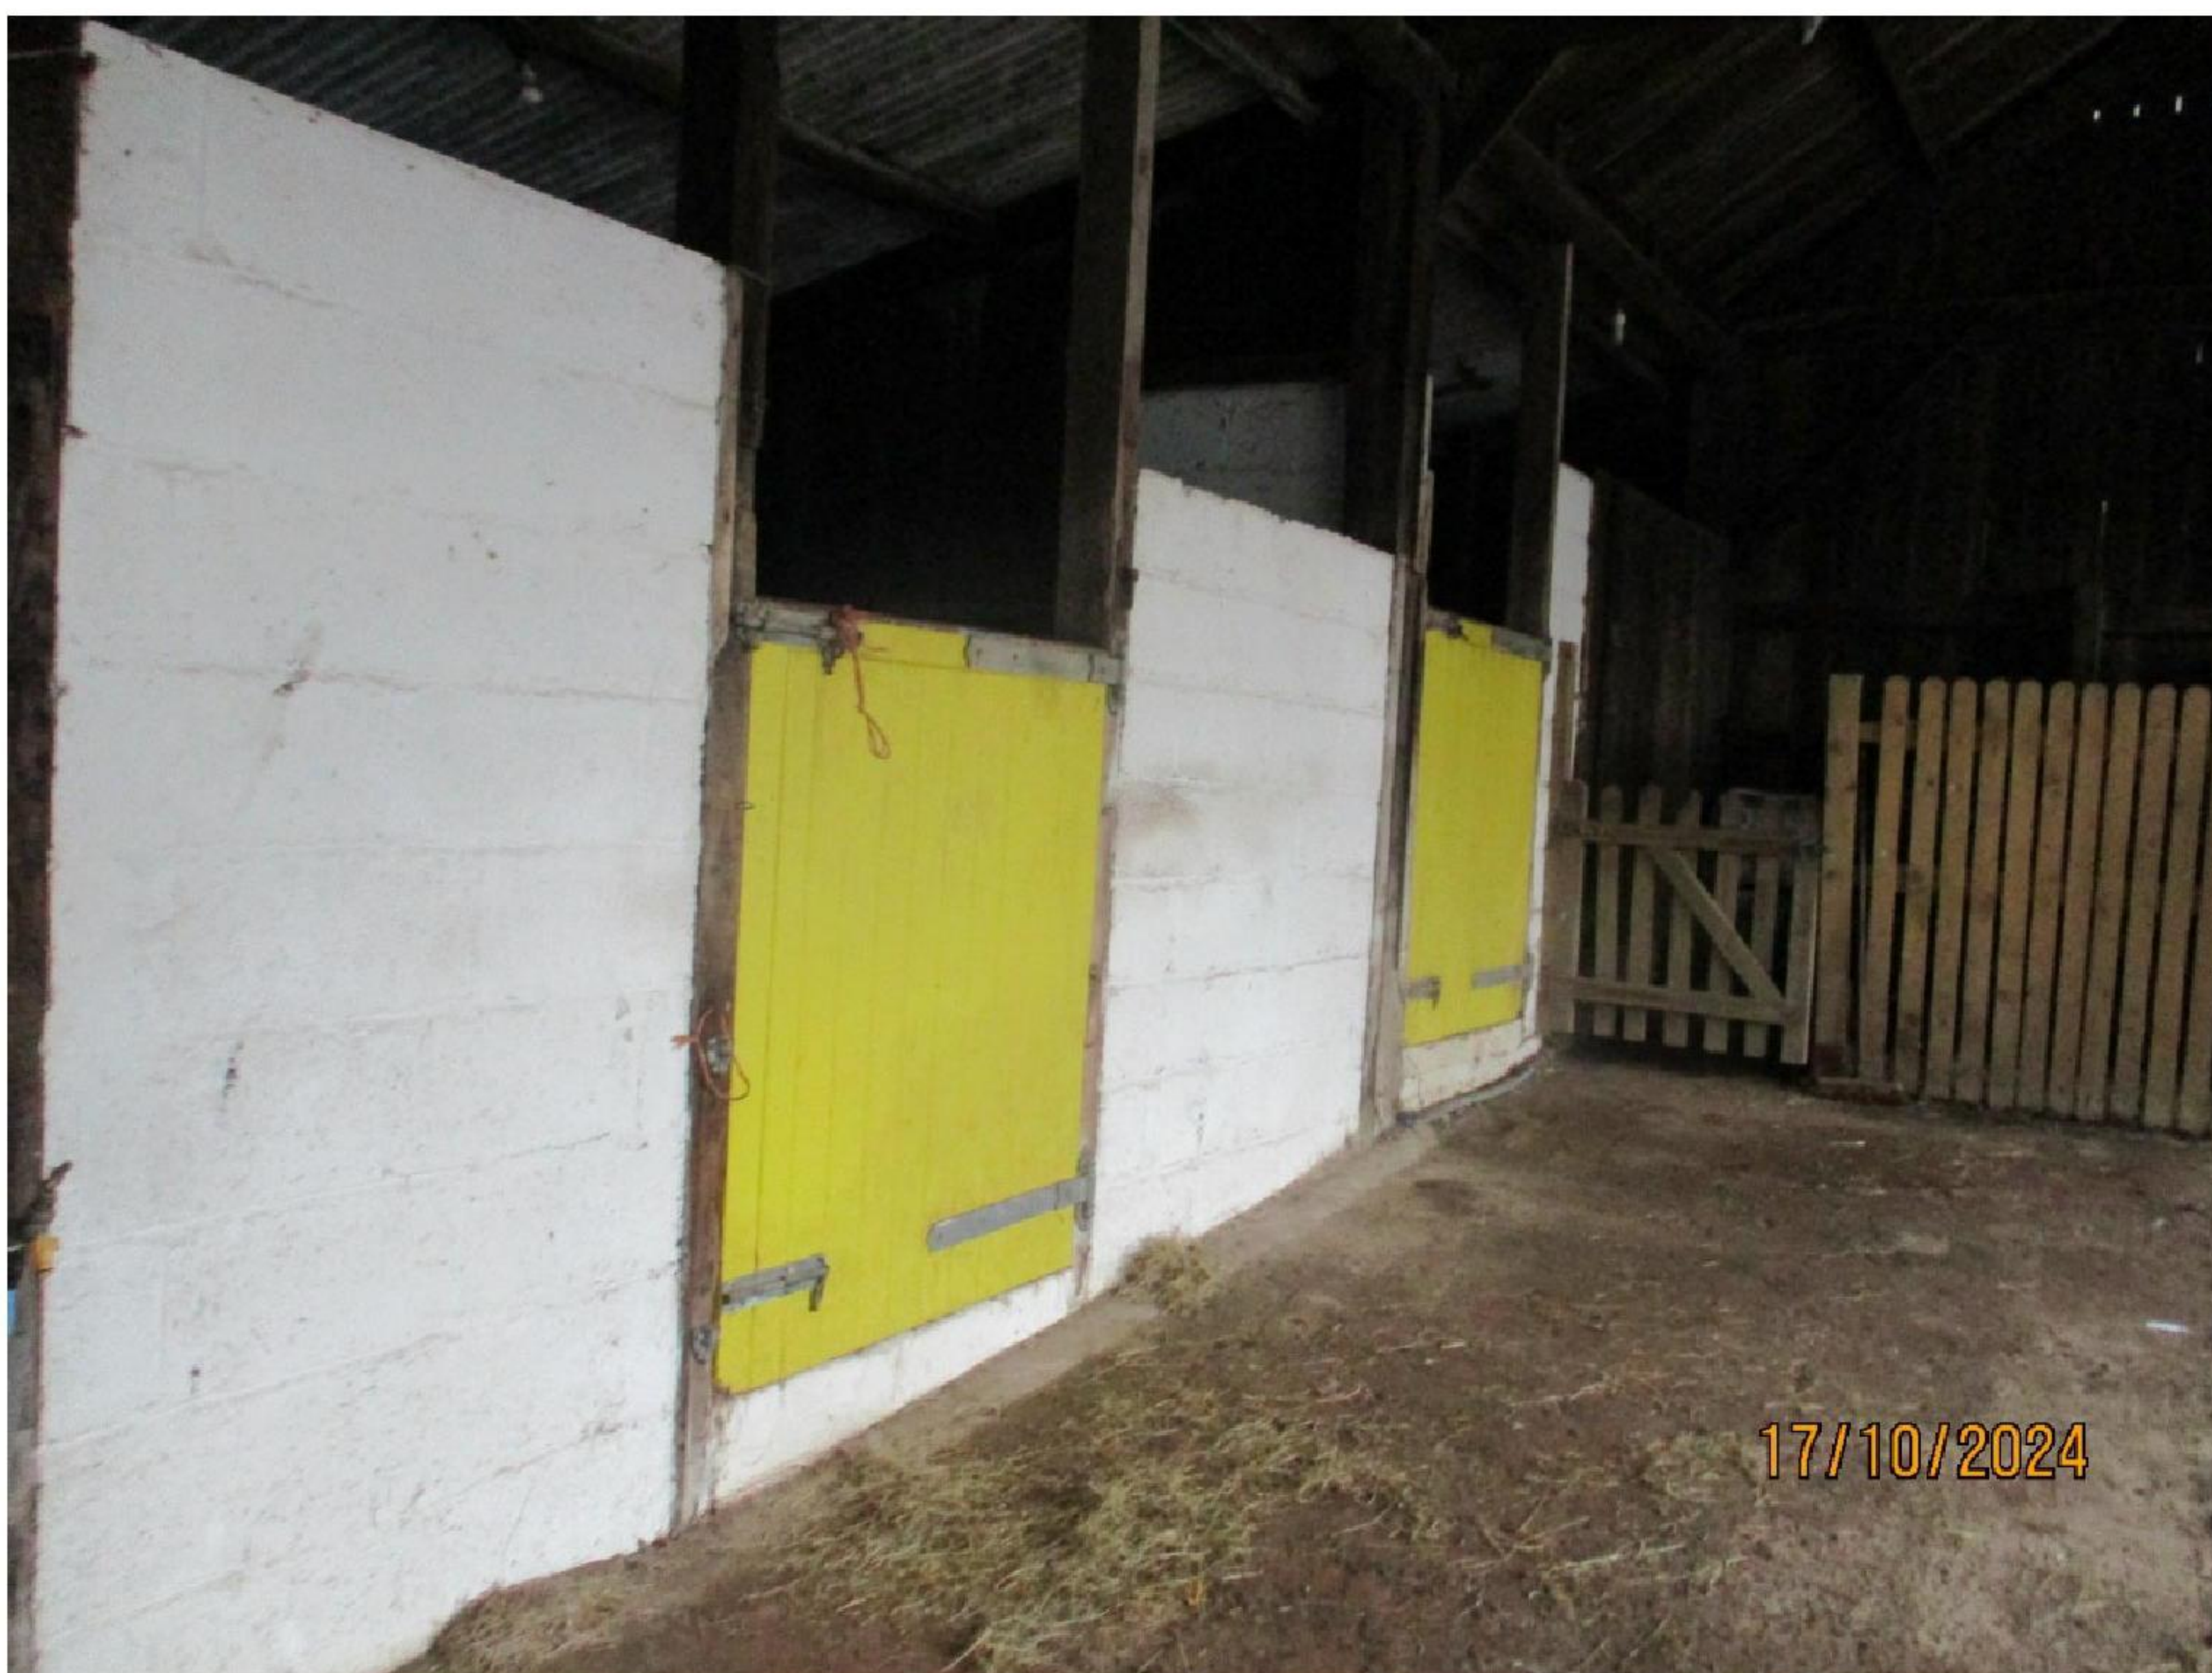
**PHOTO #5**– Internal view of main section of Open Barn

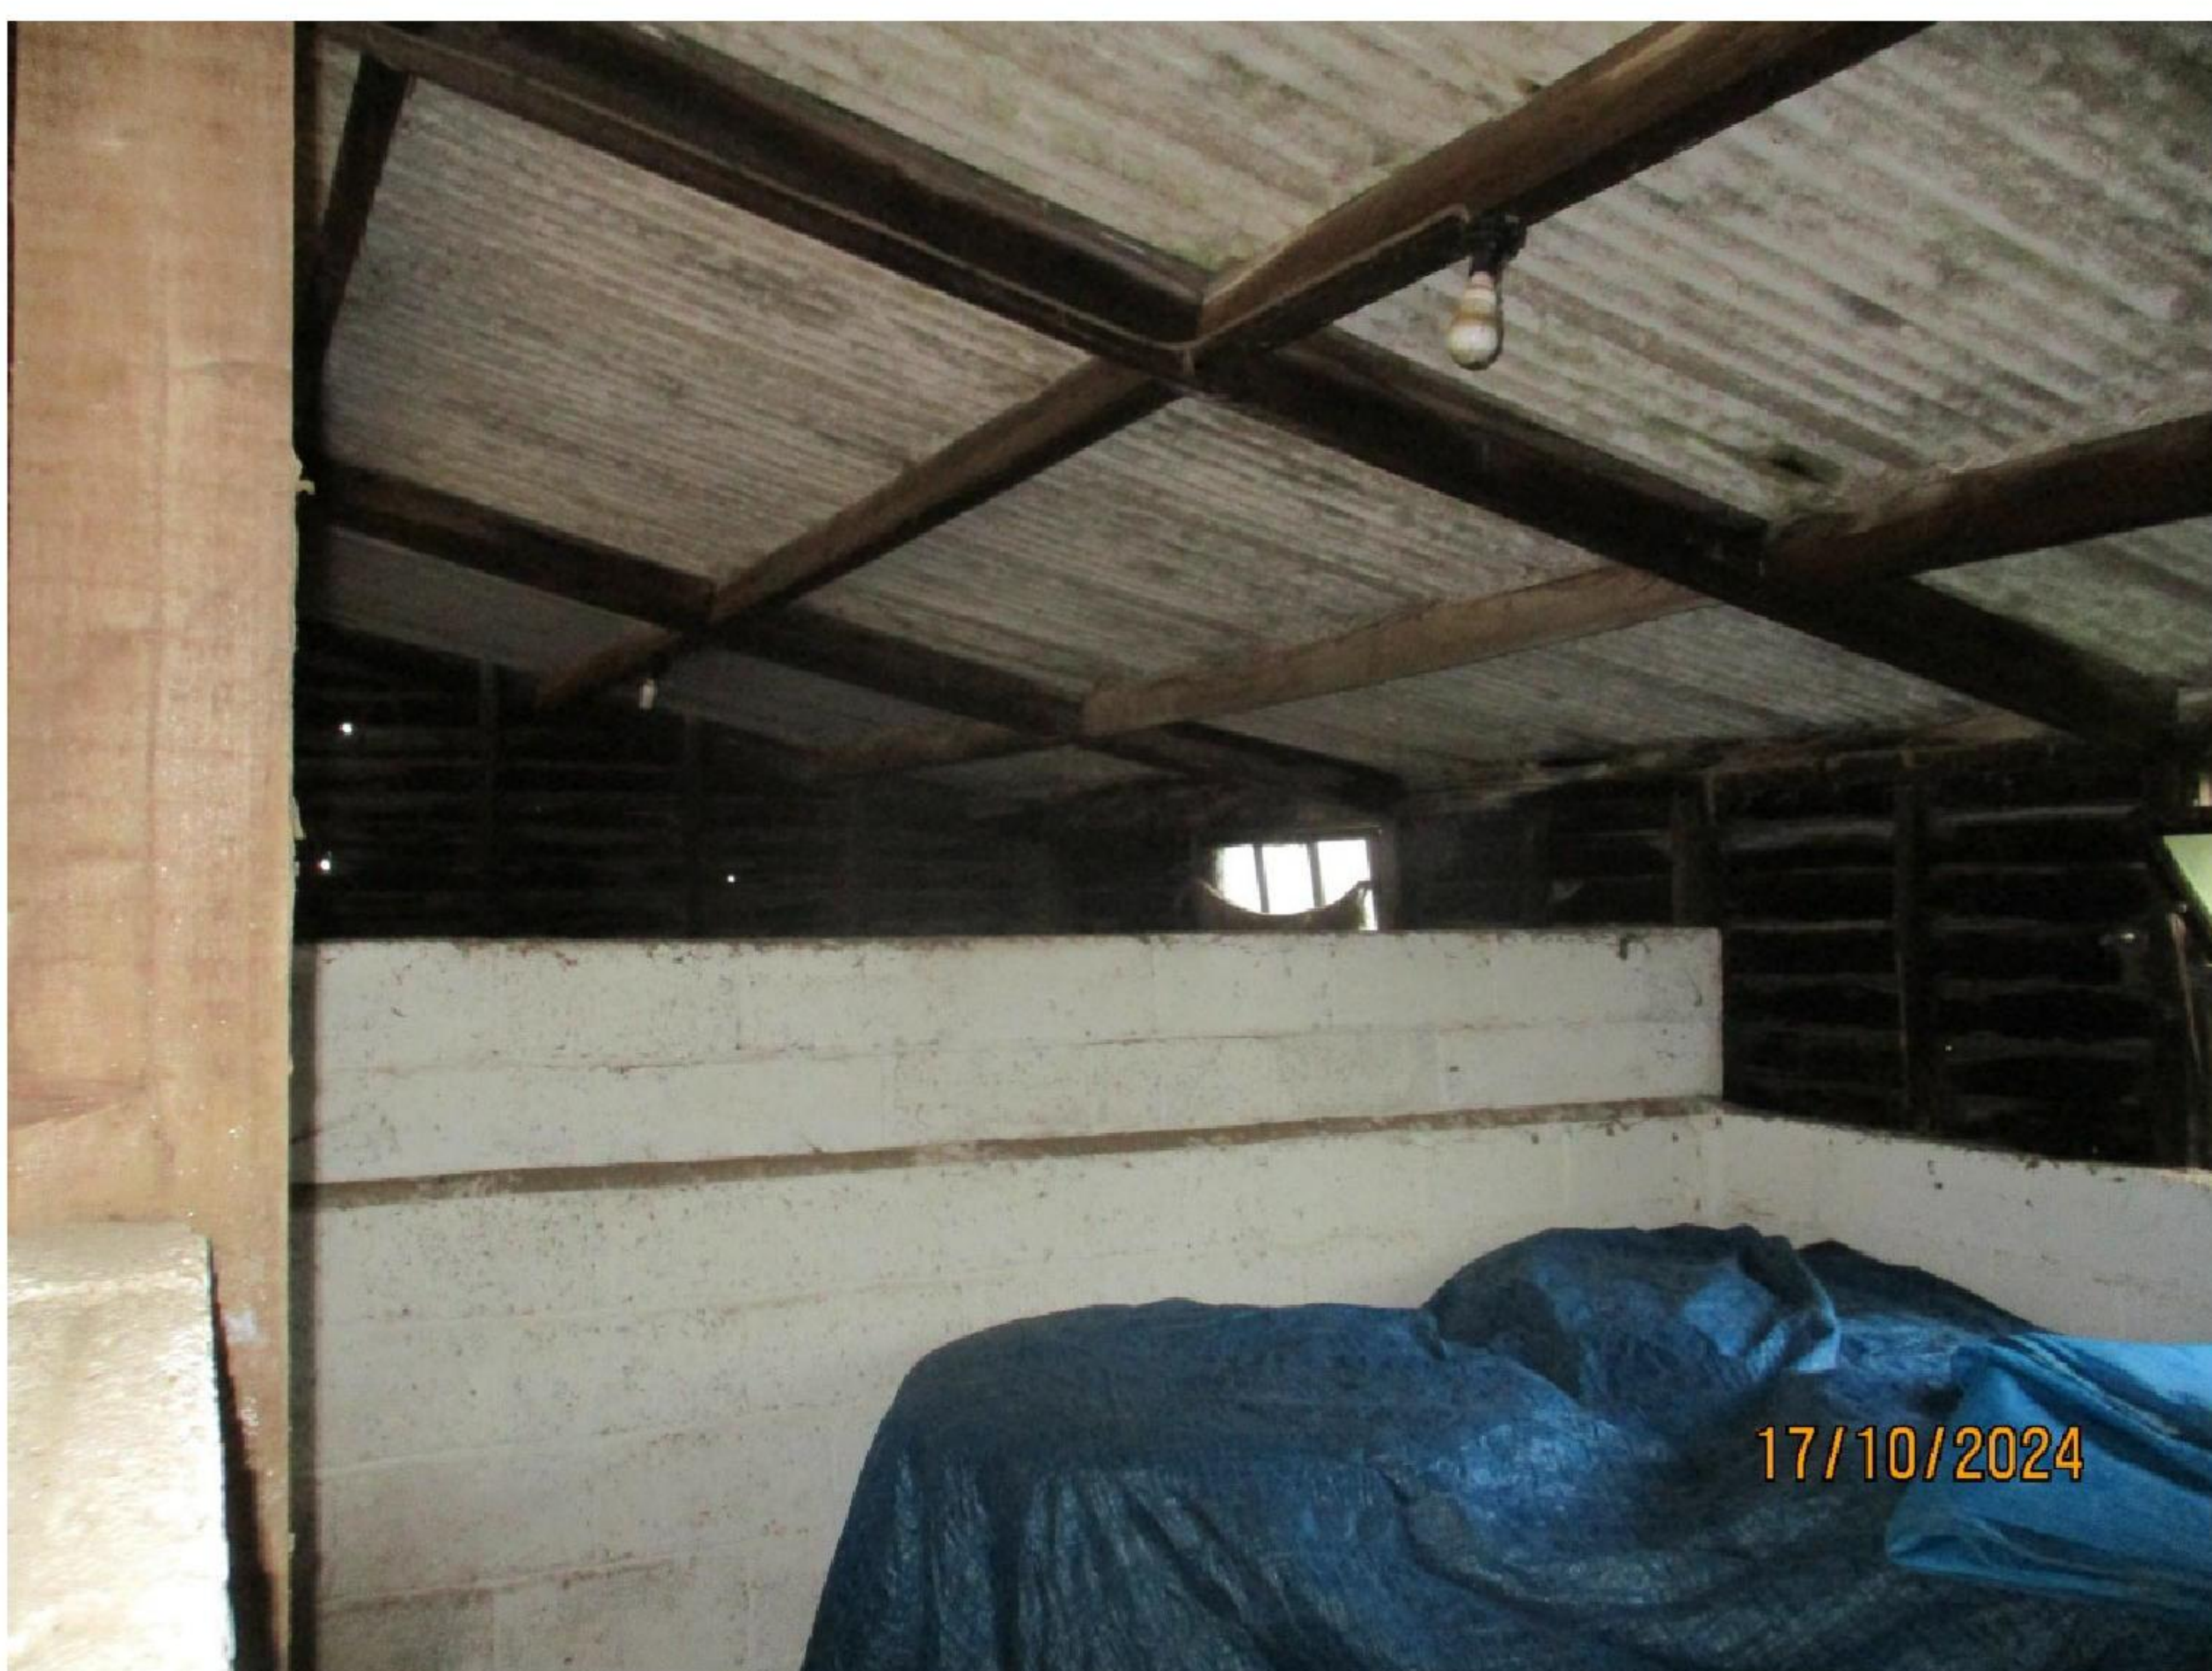
- 2.3 The Stables section of the building, with a single roof pitch much lower than the rest of the building, had timber beams spanning between external & internal walls formed from part masonry & part timber frames. These in turn supported timber boarding running down the roof pitch. There were no rafters. This section of the barn was covered with corrugated sheet metal. The floor slab to this section of the building was similar to the Open Barn. Externally, the walls were timber clad with low level masonry walls. No internal finishes & no insulation was present in either the roof or walls. We assumed these walls may have foundations, however this would need to be checked and confirmed with trial pits.

**PHOTO #6**– Internal view of Stables.
