STRUCTURAL SURVEY ON  
ORCHARD BARN, HAYWARDS HEATH  
JOB REF: WG1657  
DATE: OCTOBER 2024

Project: Orchard Barn, Nash Lane, Haywards Heath  
Client: SDP  
Ref: WG1657

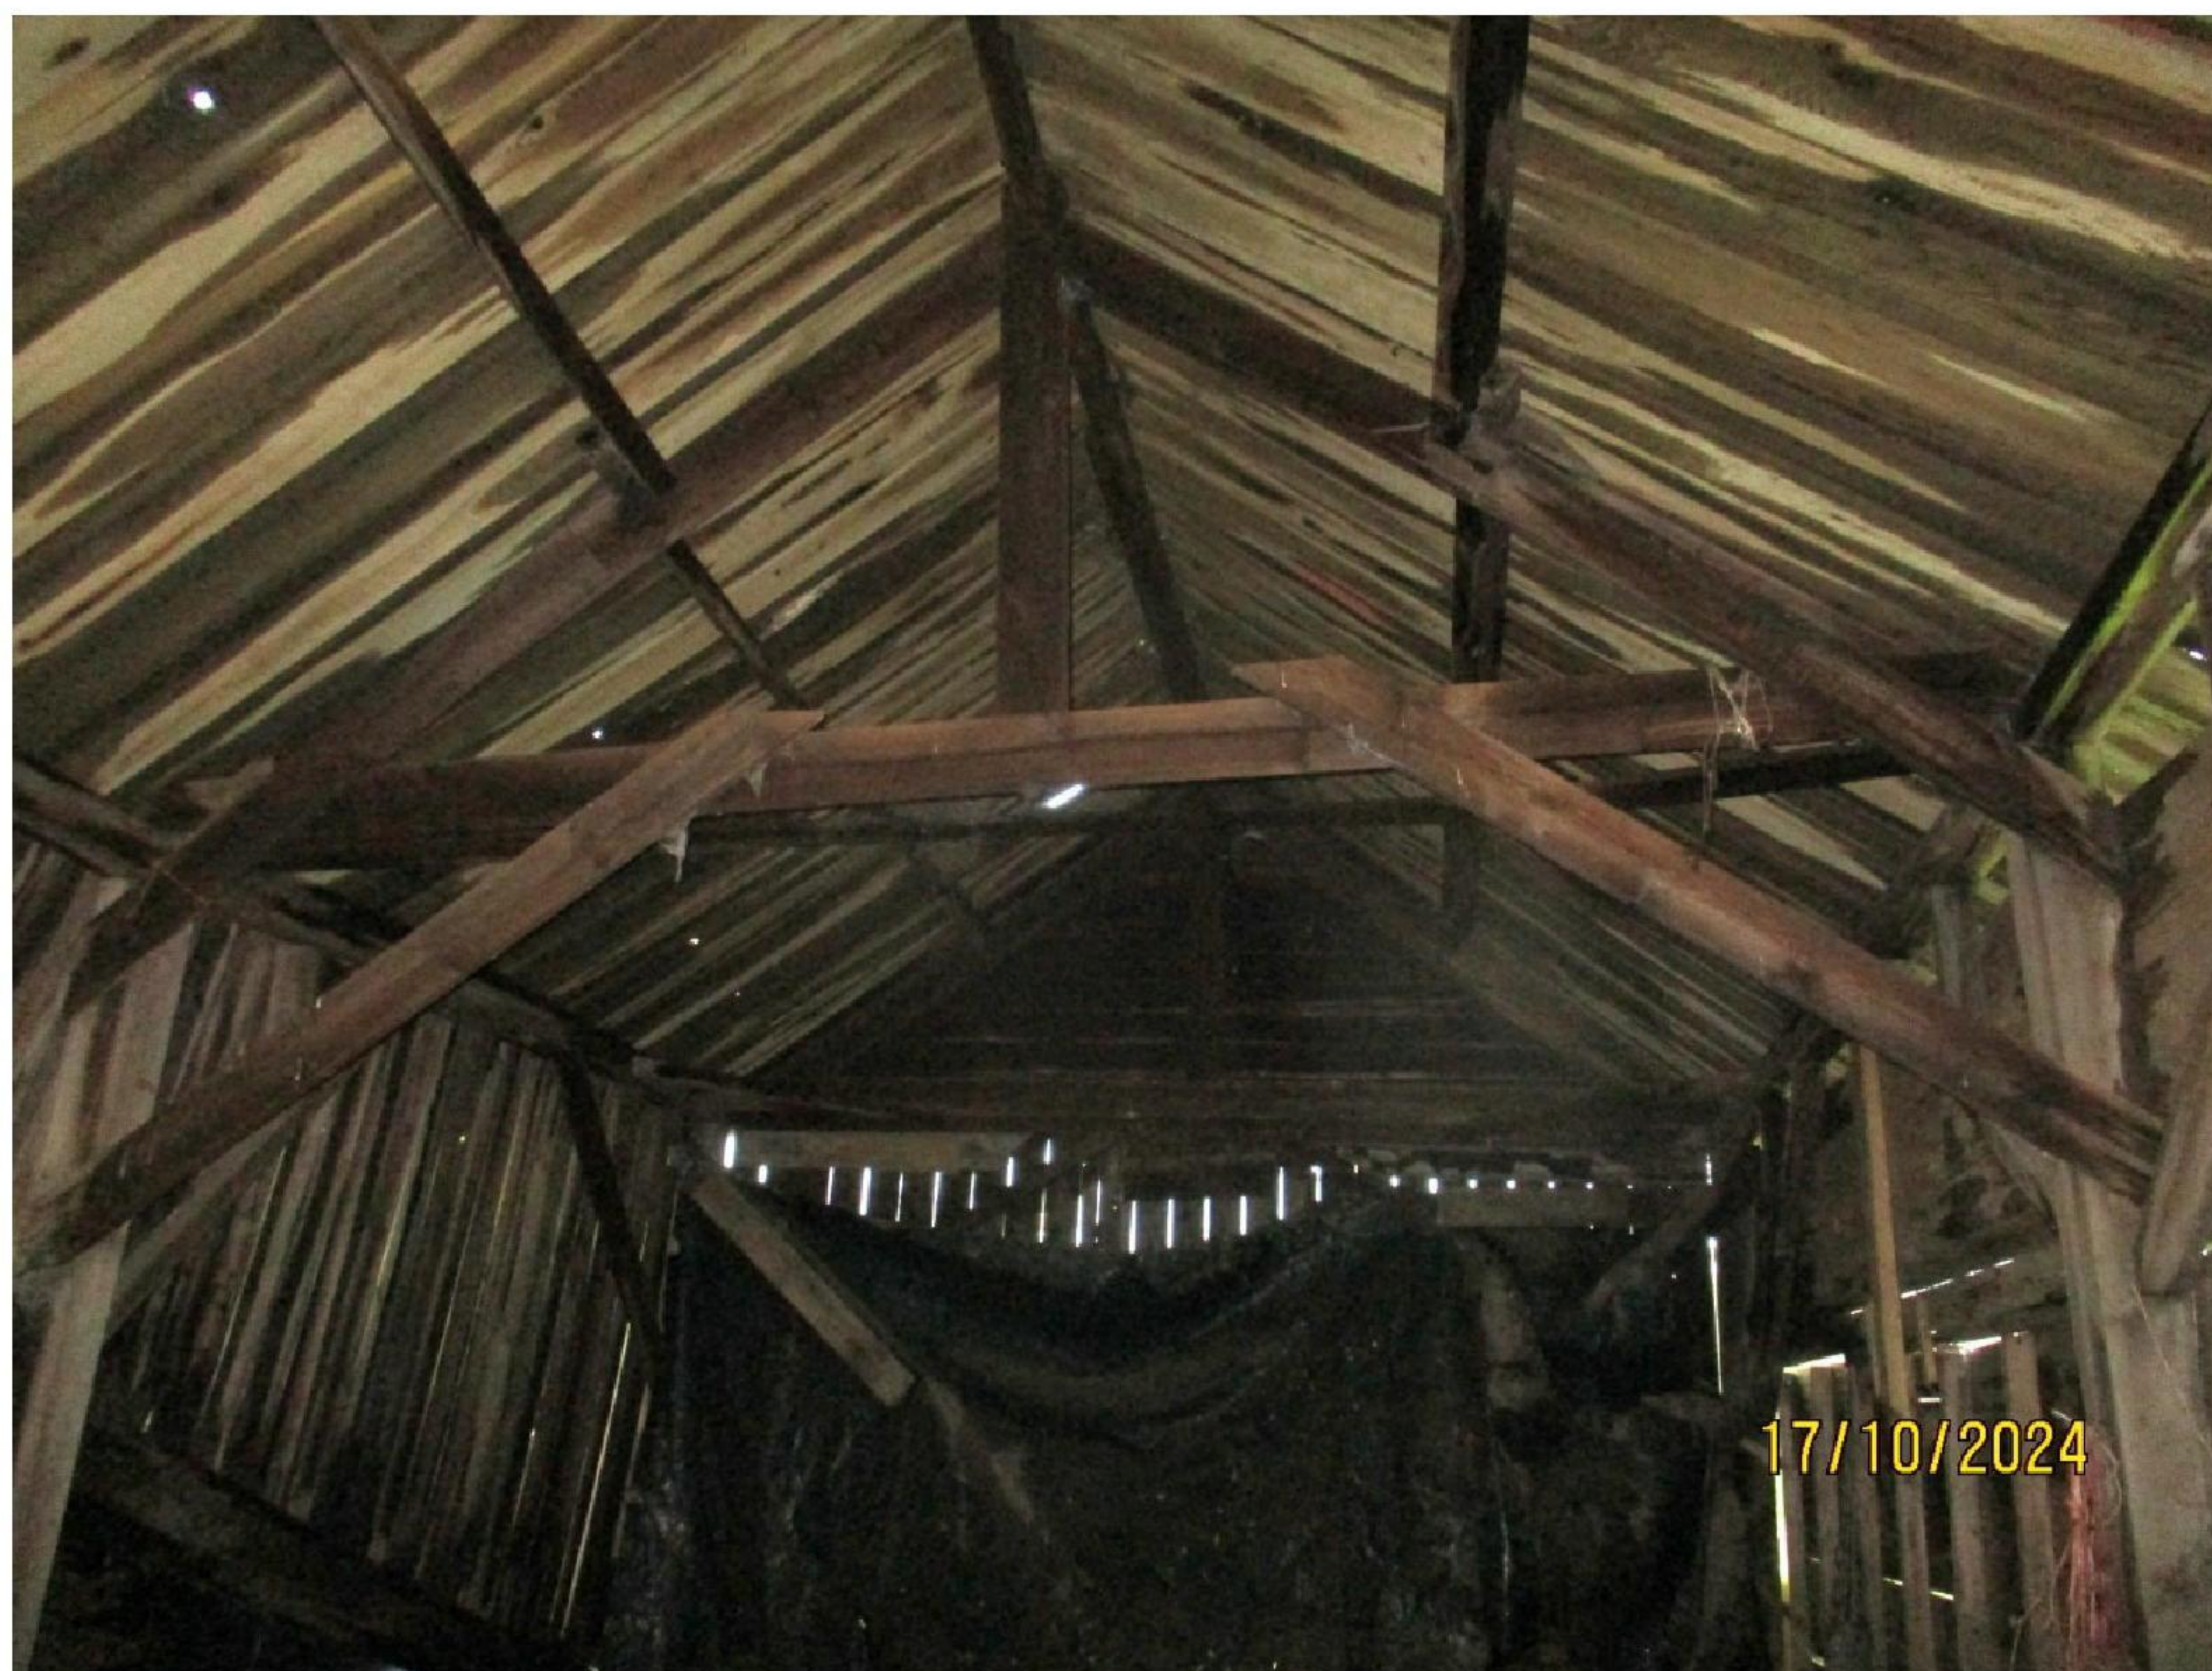
- 2.4 The Barn was completely timber framed in construction. Very poor truss like frames had been formed from loose timber & were supported on timber posts / timber framed walls. The roof was double boarded with no other finishes. The ground was compacted earth. Externally, the walls were timber clad. No internal finishes & no insulation was present in either the roof or walls.

- 2.5 All of the sections of building had various degrees of damage and were rotten in places due to rainwater ingress through poor roof & wall construction and through the large openings in the elevations. The Barn section of the building appears to have suffered most from this as was quite dilapidated with twisted internal posts that had moved away from the main section of the building. There was an open gap here between the two. Although we would surmise that these sections of building were built at different times. The Stables section roof was in poor condition and its supporting members appeared to be insufficiently sized. The Open Barn appeared to be the best section of the overall building but with obvious issues of watertightness etc.

PHOTO #7– Internal view of Barn.

2.10 The roof to the Stables will need to be removed and replaced, and we would assume the same will be required to the Barn. The Open Barn should be able to retain its trusses as these are the main feature elements in this space. New rafters & purlins will be required. Any new roof finishes should be kept to an absolute minimum in terms of weight to minimise the effect on the existing structure. Insulated panels would be a good alternative to rafters & finishes and would retain the agricultural look externally while keeping loadings low.
