Asbestos Reinspection Report

Job Ref No: **492967**, Account Ref No: **21707**, Contract Ref No: **70197**, Client Site Ref: **HU06**

Nationwide Hurstpierpoint, 58 High Street, Hurstpierpoint, West Sussex, BN6 9RG

Title: Re-inspection Survey to 0398-HU06

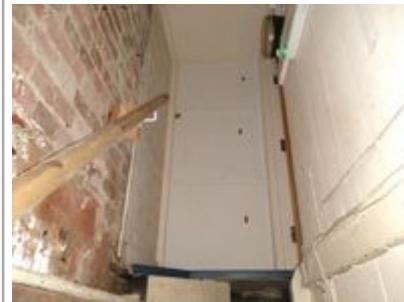
Building	Level	Location	Item / Product Examined	Sample No.	Material Description	Fibre Type	Material Score	Extent	Risk Level Assessment	Initial Control Recommendation	Photograph
Nationwide, Hurstpierpoint	-1	001/ stairwell	Panels to wall	65082-3	Asbestos-containing cement	Chrysotile	5	3 No.	R2	Reinspect Periodically

Building: Nationwide, Hurstpierpoint		Level: -1		Location: 001/ stairwell							
Item / Product Examined	Material Description	Sampling Strategy	Sample No.	Extent	Product Score	Material Condition	Surface Treatment	Fibre Id.	Material Score	Accessibility Score	Risk Level Assessment
Panels to wall	Asbestos-containing cement	Previously Sampled	65082-3	3 No.	2	1	1	Chrysotile	5	3

R2
From Lucion Report Ref:387041

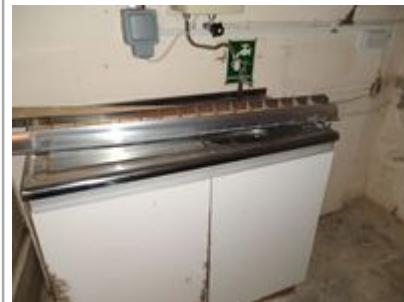
Nationwide, Hurstpierpoint	-1	002/ basement staff room	Sink pad	241497-8	Asbestos-containing bituminous product	Chrysotile	3	0.1 Sqm.	R3	Reinspect Periodically

Building: Nationwide, Hurstpierpoint		Level: -1		Location: 002/ basement staff room							
Item / Product Examined	Material Description	Sampling Strategy	Sample No.	Extent	Product Score	Material Condition	Surface Treatment	Fibre Id.	Material Score	Accessibility Score	Risk Level Assessment
Sink pad	Asbestos-containing bituminous product	Previously Sampled	241497-8	0.1 Sqm.	1	1	0	Chrysotile	3	3

R3
From Lucion Report Ref:387041

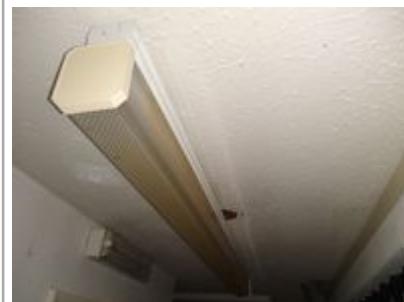
Nationwide, Hurstpierpoint	-1	003/ corridor	Ceiling	241497-9	Asbestos-containing textured coating	Chrysotile	3	5 Sqm.	R3	Reinspect Periodically

Building: Nationwide, Hurstpierpoint		Level: -1		Location: 003/ corridor							
Item / Product Examined	Material Description	Sampling Strategy	Sample No.	Extent	Product Score	Material Condition	Surface Treatment	Fibre Id.	Material Score	Accessibility Score	Risk Level Assessment
Ceiling	Asbestos-containing textured coating	Previously Sampled	241497-9	5 Sqm.	1	1	0	Chrysotile	3	3

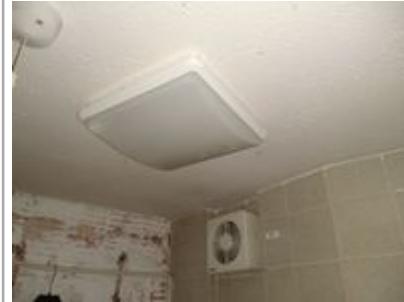
Building	Level	Location	Item / Product Examined	Sample No.	Material Description	Fibre Type	Material Score	Extent	Risk Level Assessment	Initial Control Recommendation	Photograph
Nationwide, Hurstpierpoint	-1	004/ wc	Ceiling	241497-9	Asbestos-containing textured coating	Chrysotile	3	3 Sqm.	R3	Reinspect Periodically

Item / Product Examined	Material Description	Sampling Strategy	Sample No.	Extent	Product Score	Material Condition	Surface Treatment	Fibre Id.	Material Score	Accessibility Score	Risk Level Assessment
Ceiling	Asbestos-containing textured coating	Previously Sampled	241497-9	3 Sqm.	1	1	0	Chrysotile	3	3

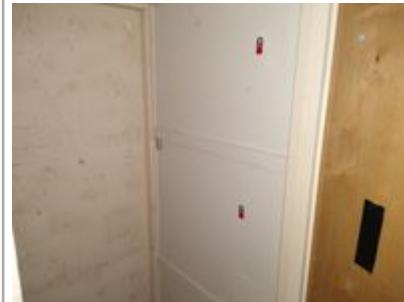
Nationwide, Hurstpierpoint	0	004/ Stairwell To Basement	Wall panels	241497-5	Asbestos-containing cement	Chrysotile	4	3 Sqm.	R3	Reinspect Periodically

Item / Product Examined	Material Description	Sampling Strategy	Sample No.	Extent	Product Score	Material Condition	Surface Treatment	Fibre Id.	Material Score	Accessibility Score	Risk Level Assessment
Wall panels	Asbestos-containing cement	Previously Sampled	241497-5	3 Sqm.	1	1	1	Chrysotile	4	3

R3
From Lucion Report Ref:387041
