**THE WHITE HARTE INN,  
SOUTH STREET,  
CUCKFIELD,  
WEST SUSSEX,  
RH17 5LB.**

**PROPOSED CONSERVATION ROOFLIGHTS TO ATTIC  
ROOMS.**

**HISTORIC BUILDING SURVEY  
(Updated February 2025).**

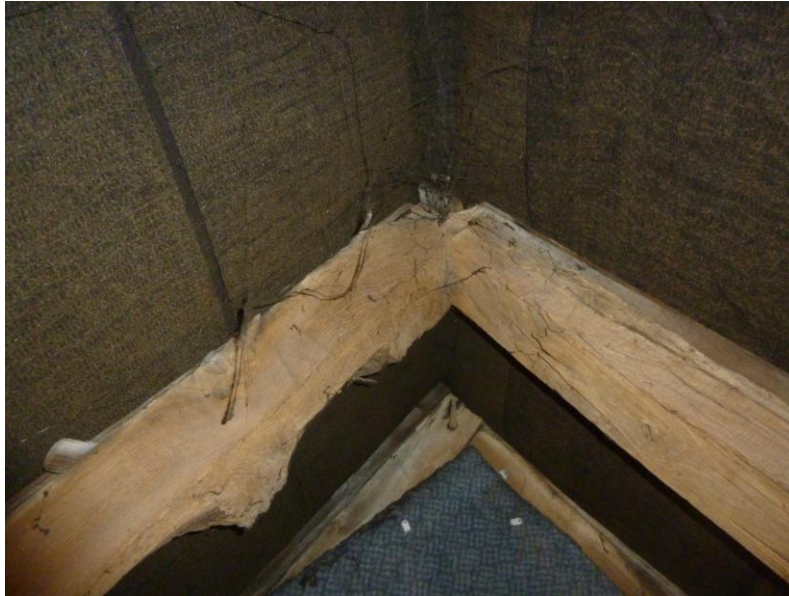
**3.2.** The original roof is constructed of hardwood timber rafters, purlins and beams in a traditional A frame. The rafters are hand cut hardwood timber of differing sizes of approximately 100 mm by 50 mm (4 inches x 2 inches). The timber rafters are fixed with pegs and nails at the ridge – see **photograph below**.

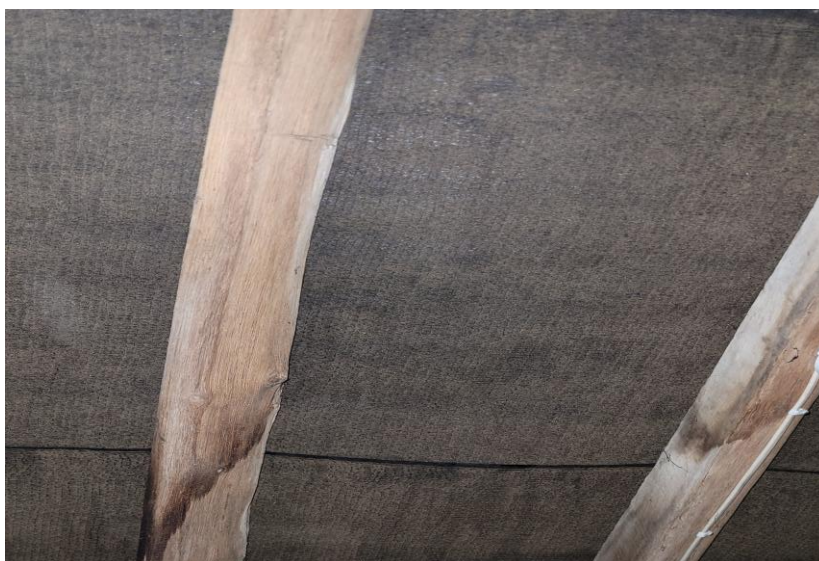
**3.3.** The timber rafters are spaced at approximately 500 mm (20 inches). It is assumed they are fixed to wall plates, albeit these are not visible. The timber rafters are shown in the **photograph below**. This is the proposed position of the conservation **Rooflight no. 2** as shown on drawing **8151-4-B**.

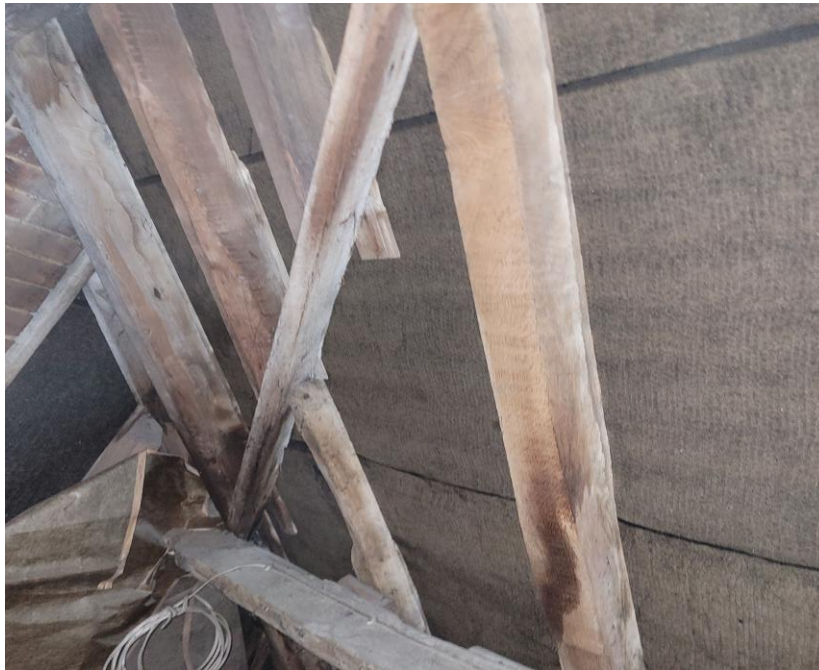
**3.4.** Timber purlins are connected to the rafters as structural support for the rafters. The purlin along the eastern roof elevation is shown in the **photograph below**. This photograph also shows the position of conservation **Rooflight no. 1** in the position of the existing shortened rafter.

**3.5.** The position of the proposed Rooflight no.1 is where original rafters have been damaged and cut. Bracing has been provided with a diagonal piece of timber that appears to have been installed later, probably when the roof was re-covered with roofing felt and reclaimed tiles.

**4.3.** Conservation rooflights 1, 2 and 3 are shown in the drawings below. The position of Rooflight no. 1 has been chosen because it is to be located where an existing original rafter is damaged and has been cut. The non original timber bracing would be removed. Rooflights no's. 2 and 3 are to be installed between existing original rafters which will not be altered.

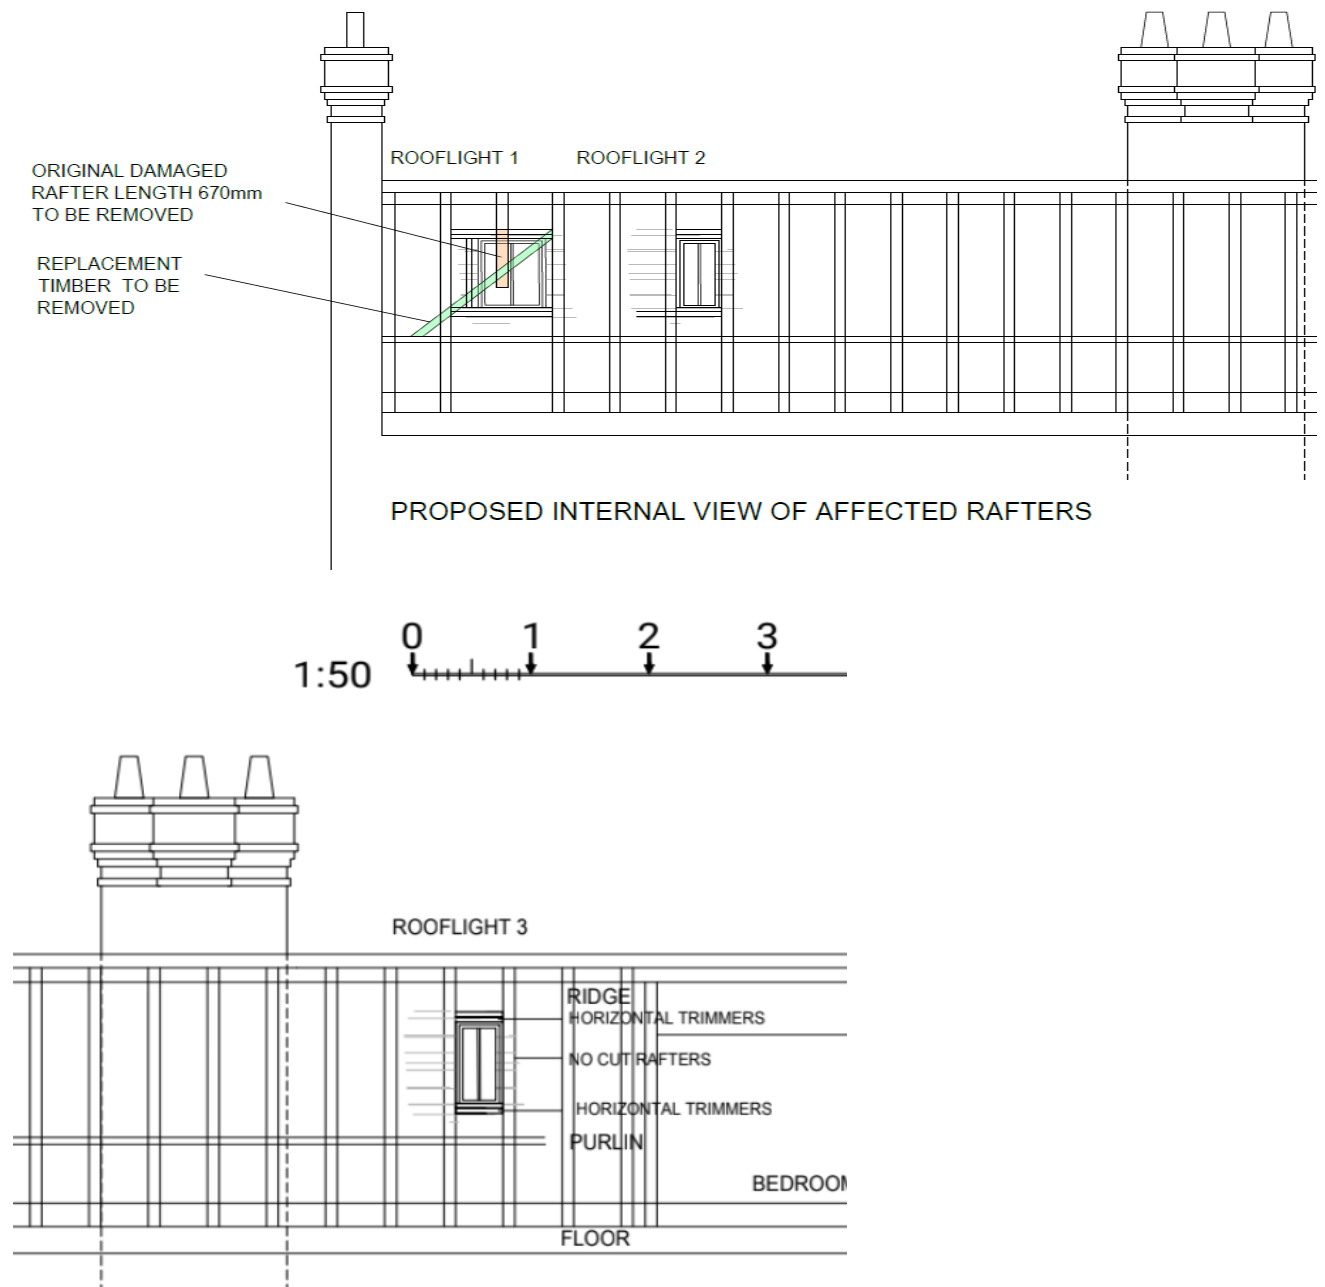
**4.2.** The proposal is for the inclusion of three conservation rooflights, as shown externally on **drawing no. 8151-1-B** and internally on **drawing no. 8151-4-B**.

**4.1.** The installation of the conservation rooflights involve the removal of the relevant clay tiles and secondary roofing felt. Between the retained rafter's new timber will be installed below and above each conservation rooflight, as shown the drawings below.
