**THE WHITE HARTE INN,  
SOUTH STREET,  
CUCKFIELD,  
WEST SUSSEX,  
RH17 5LB.**

**PROPOSED CONSERVATION ROOFLIGHTS TO ATTIC  
ROOMS.**

**HISTORIC BUILDING SURVEY  
AND  
ADDITIONAL HERITAGE STATEMENT DETAILS.**

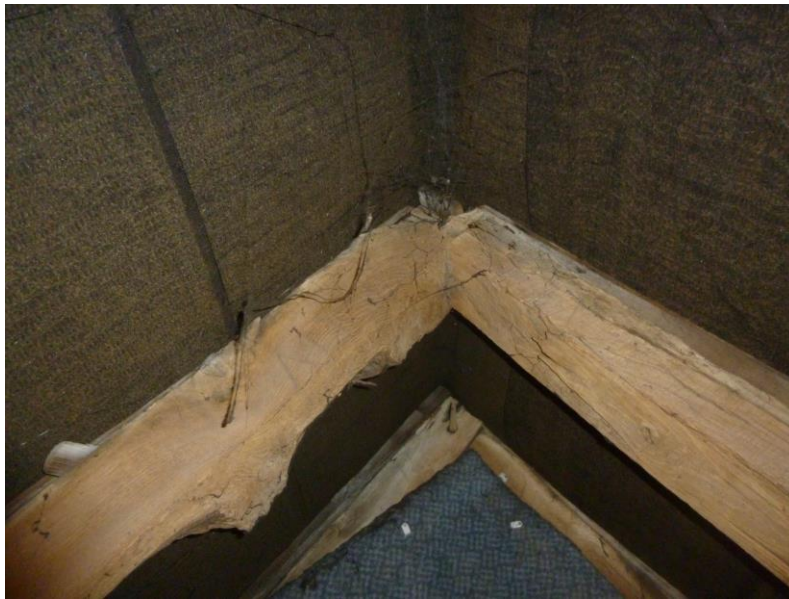
**3.2.** The original roof is constructed of hardwood timber rafters, purlins and beams in a traditional A frame. The rafters are hand cut hardwood timber of differing sizes of approximately 100 mm by 50 mm (4 inches x 2 inches). The timber rafters are fixed with pegs and nails at the ridge – see **photograph below**.

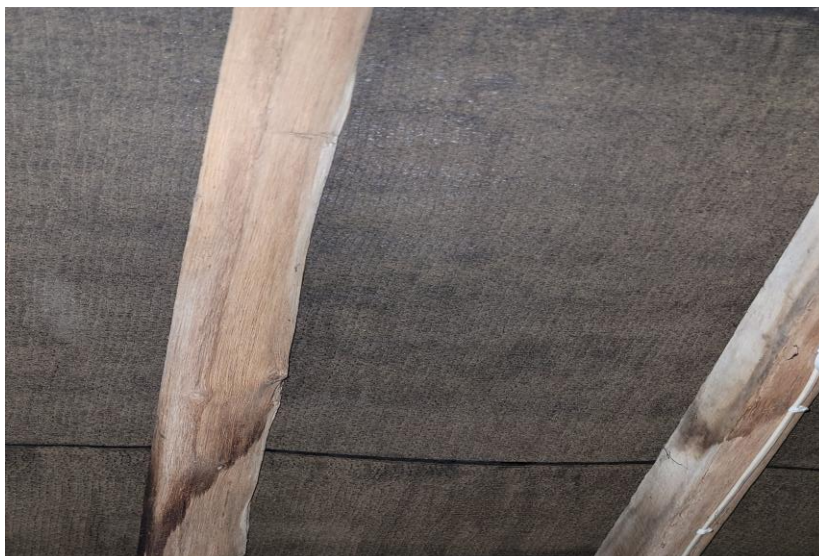
**3.3.** The timber rafters are spaced at approximately 500 mm (20 inches). It is assumed they are fixed to wall plates, albeit these are not visible. The timber rafters are shown in the **photograph below**. This is the proposed position of the conservation **rooflight no 2** as shown on drawing **8151-4-A**.

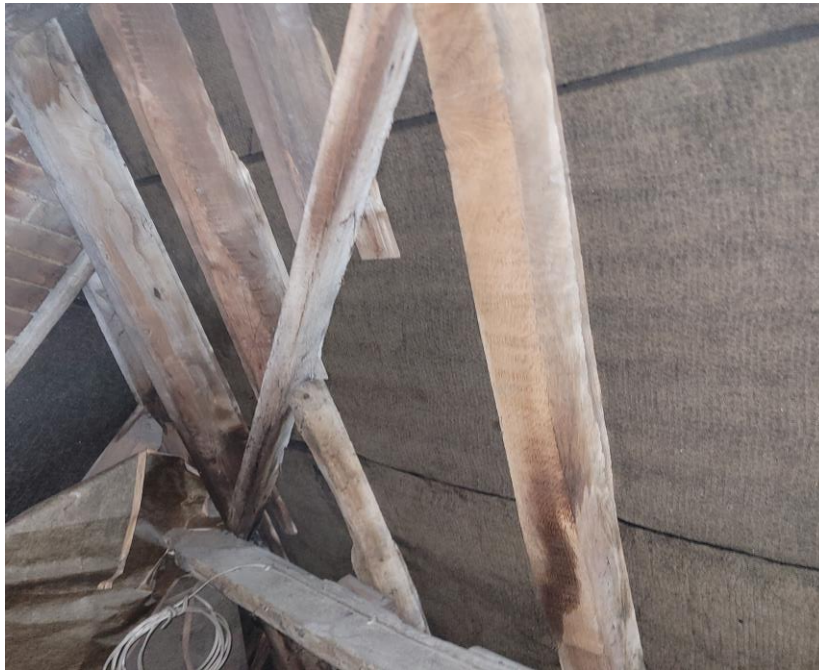
**3.4.** Timber purlins are connected to the rafters as structural support for the length of rafter. The purlin along the eastern roof elevation is shown in the **photograph below**. This photograph also shows the position of conservation **rooflight 1** in the position of the existing shortened rafter.

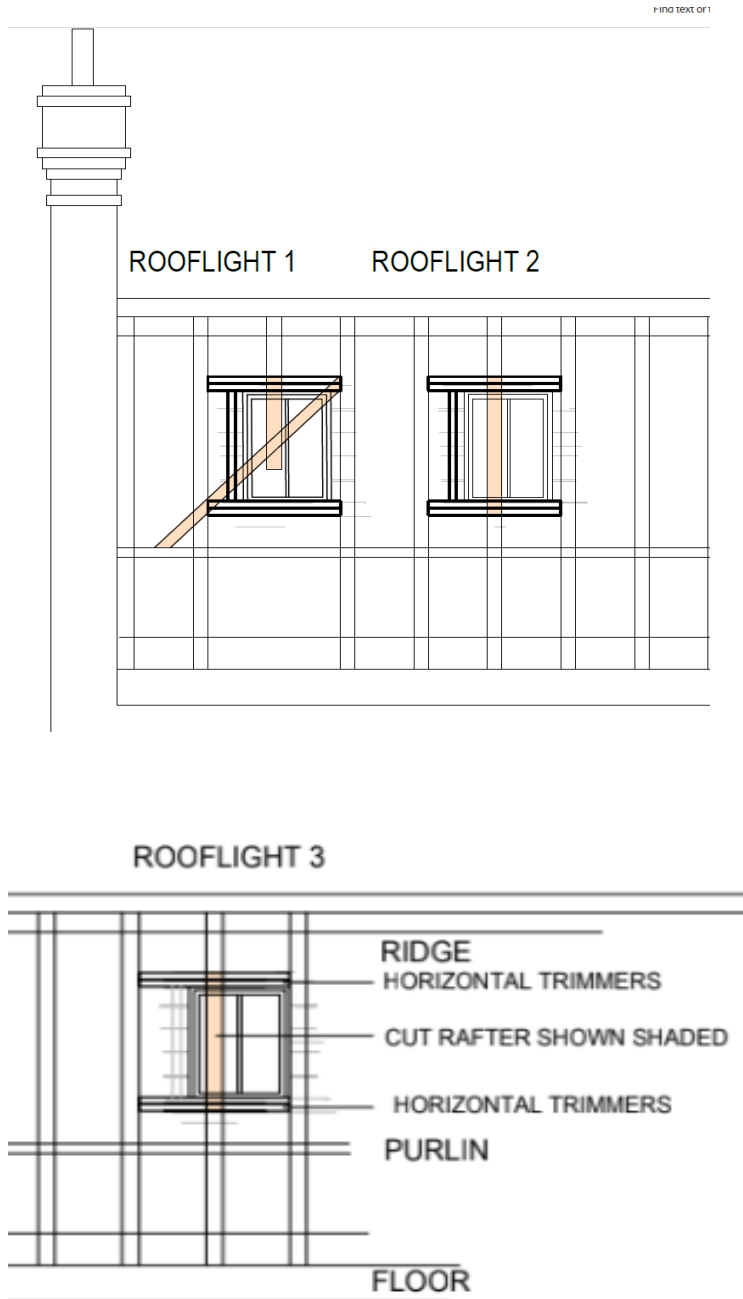
**4.3.** The installation of the conservation rooflights involve the removal of the relevant clay tiles and secondary roofing felt and small sections of timber rafters. Between the retained rafter's new timber will be installed below and above each conservation rooflight, as shown the drawings below.

**4.4.** The original part of rafters to be cut and removed are shown shaded brown in the drawings above. New timber will be installed to the top and bottom of the prefabricated conservation rooflight.
