## STATEMENT OF HERITAGE SIGNIFICANCE

**Property Address:** The Barn House, Cuckfield Road, Ansty, Haywards Heath  
RH17 5AG

**Prepared by** Richard Pocock MSc MRICS

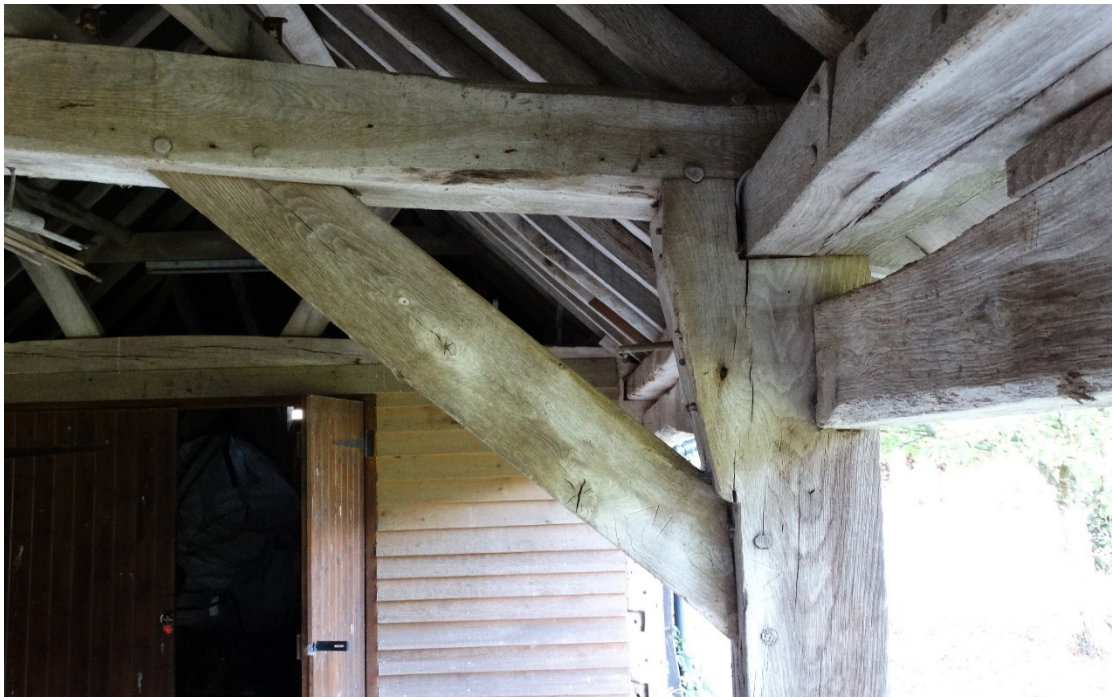
The building is in four framed bays, all of which were originally open to the western face – facing the barn and into the centre of the farm yard. Each framed bay has posts of scantling (around 170mm). The bay posts are jointed with fairly slim, lightly arched tie beams, connected via tease tenon joints, with chamfered and cut back jowls.

There are lower opening bars installed to the four bay openings (as can be seen in the image above, situated below the wall plate). These are original and denote the open bays on the western face. Upward bracing is straight and, unusually, cuts into the jowl (probably to ensure that they were sufficiently out of the way, as much as they could be).

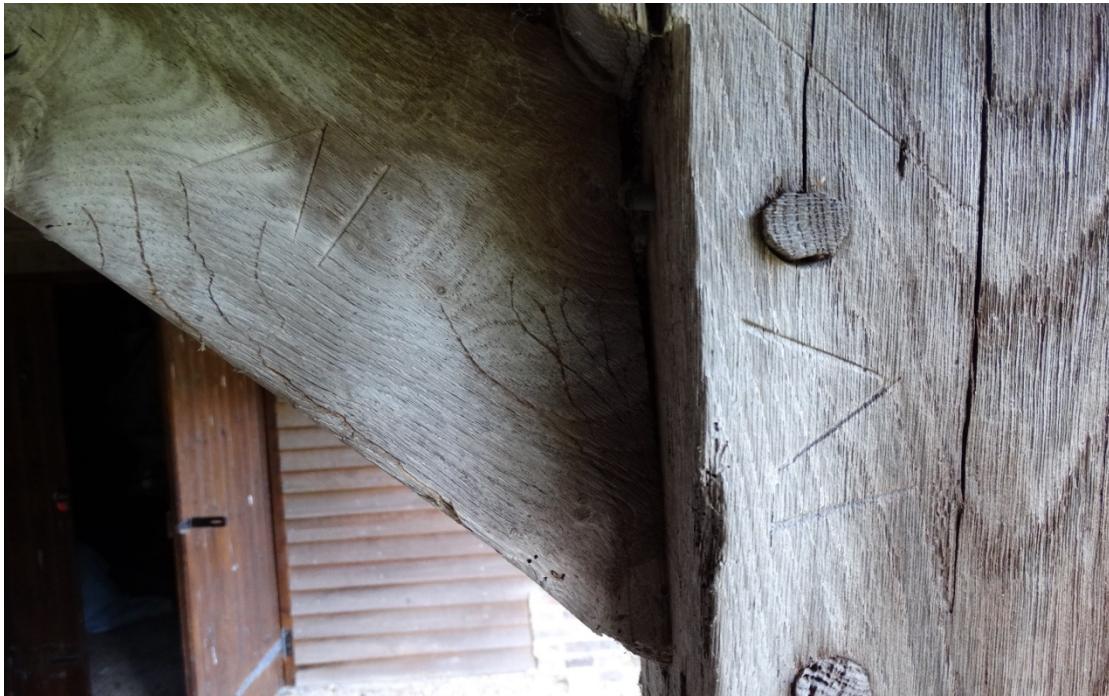
The bays are numbered, but the numbering is specific to the bay trusses and not numbered consecutively along the bays themselves. This tends to denote a date well after the 17<sup>th</sup> century, and the numbers are impressed with a chisel blade, or similar – again a slightly later date indication.

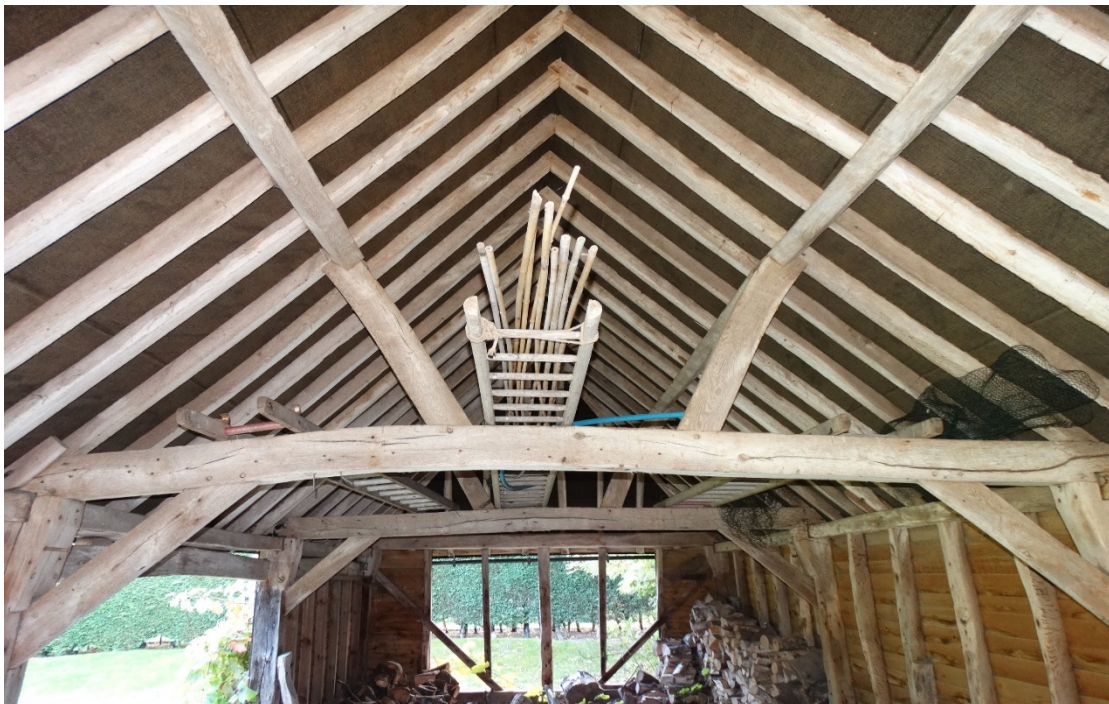
Trusses are simple and workmanlike, with raking struts clasp the purlins.

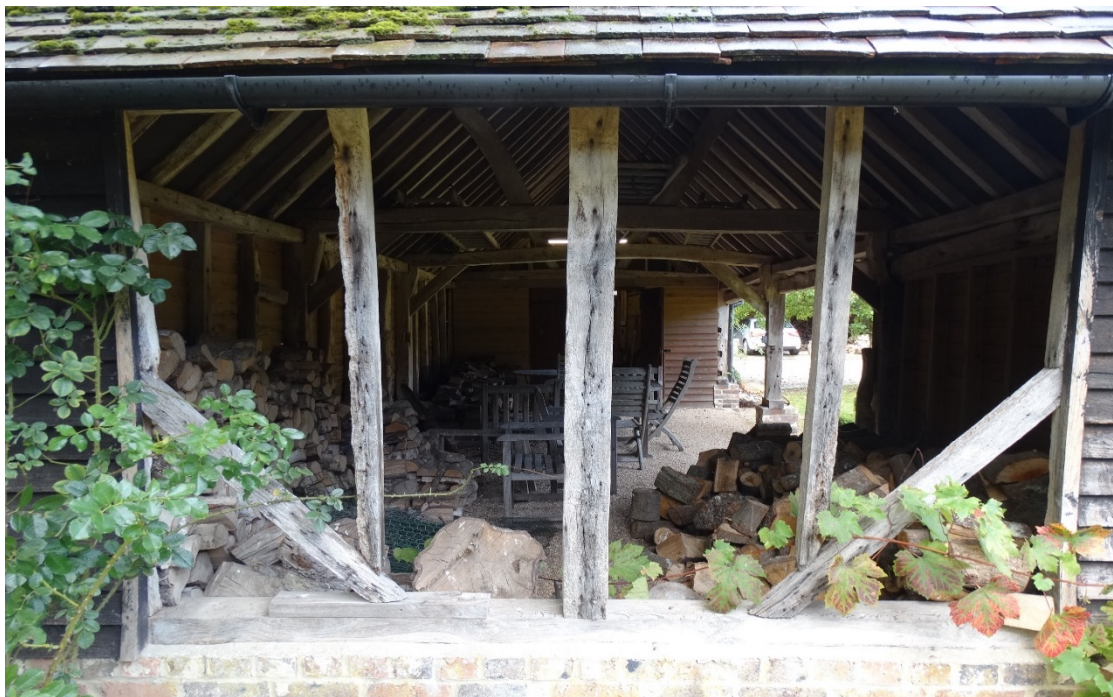
There are straight diagonal braces to both of the end panels and also on the face returns at the rear to prevent racking.

Apart from the main frontage bay posts and the dropped entry bars, none of the framed structure was meant to be visible from outside. Certainly, there were not meant to be any exposed frame elements, as is presently the case with the diagonal braces and studding on the southern end (above).

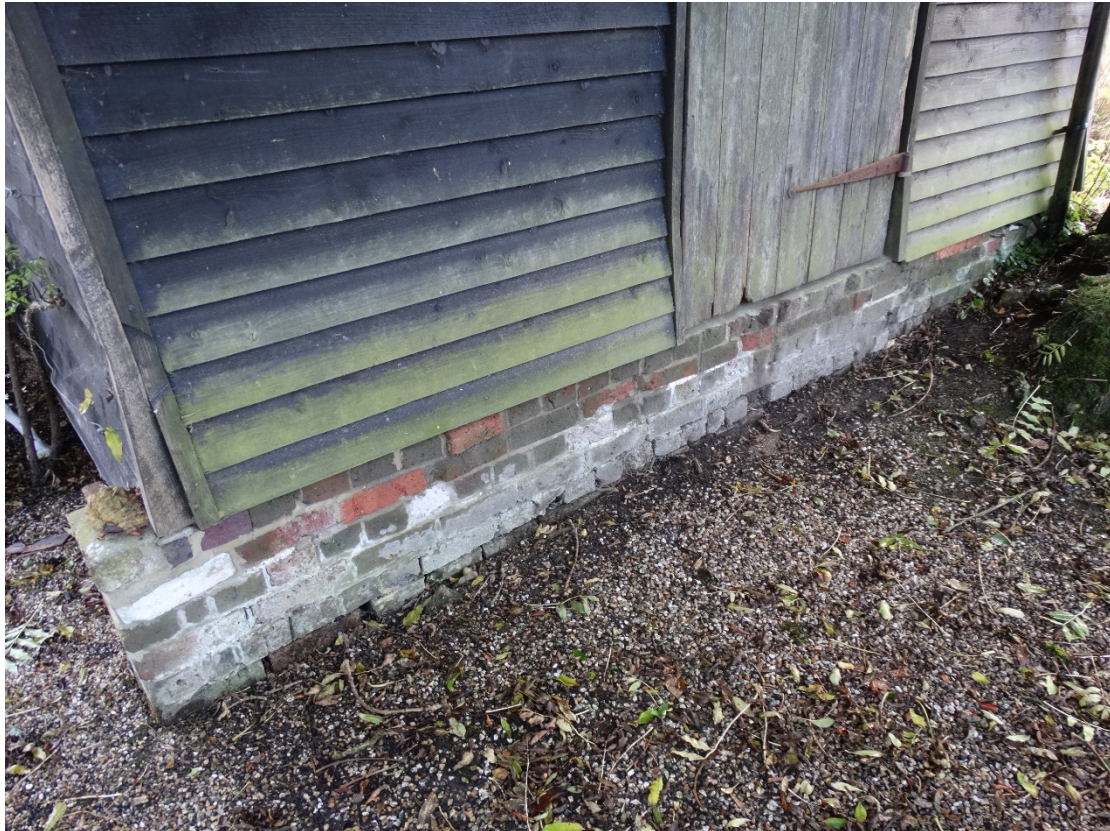
The structure was built with a sole plate, laid upon a brick plinth, of which only a small section remains and we are also not convinced that much of what can be seen is wholly original in any case. There are some bricks which can be identified in situ.

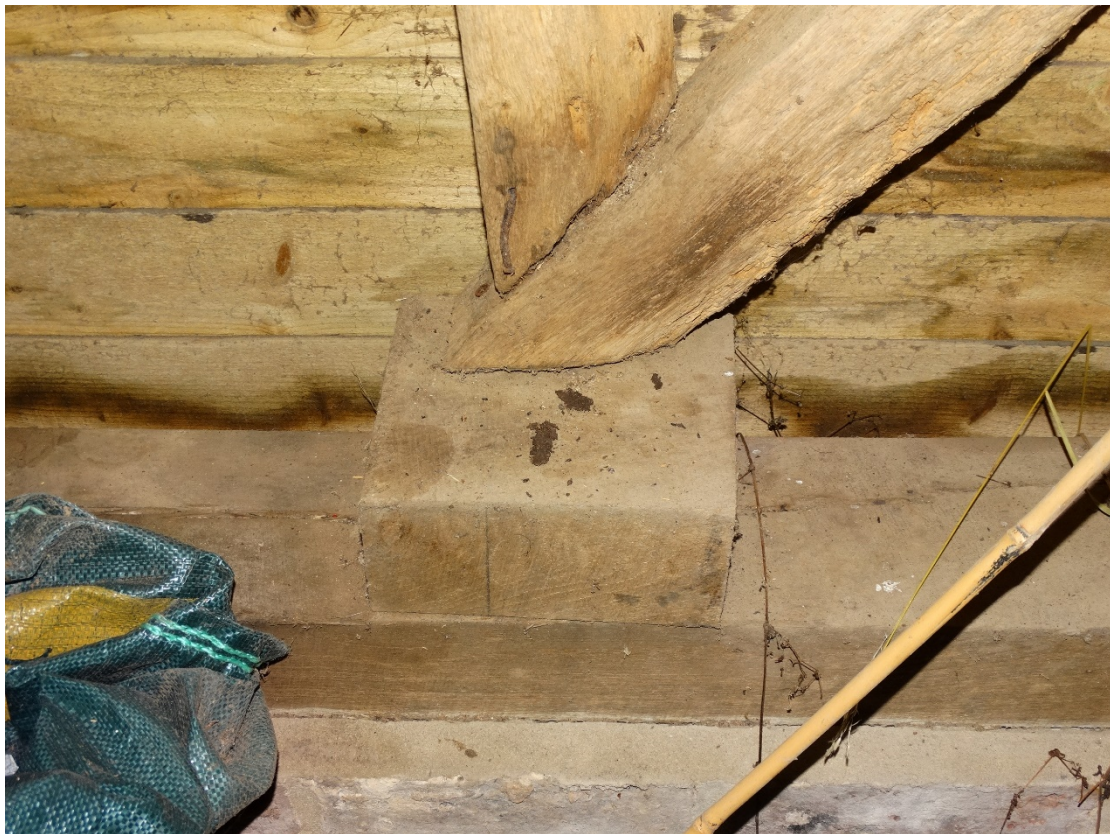
The restoration at this time did, however, require the replacement of the south plinth wall, along with the sole plate, together with the entire eastern plinth wall and sole plate. There was an attempt to ensure that as much of the studding and frame fabric was retained. There is minimal blocking to bracing, but otherwise, the original studs joint directly to the new wall plate (it also seems very likely that the building was levelled at the time).

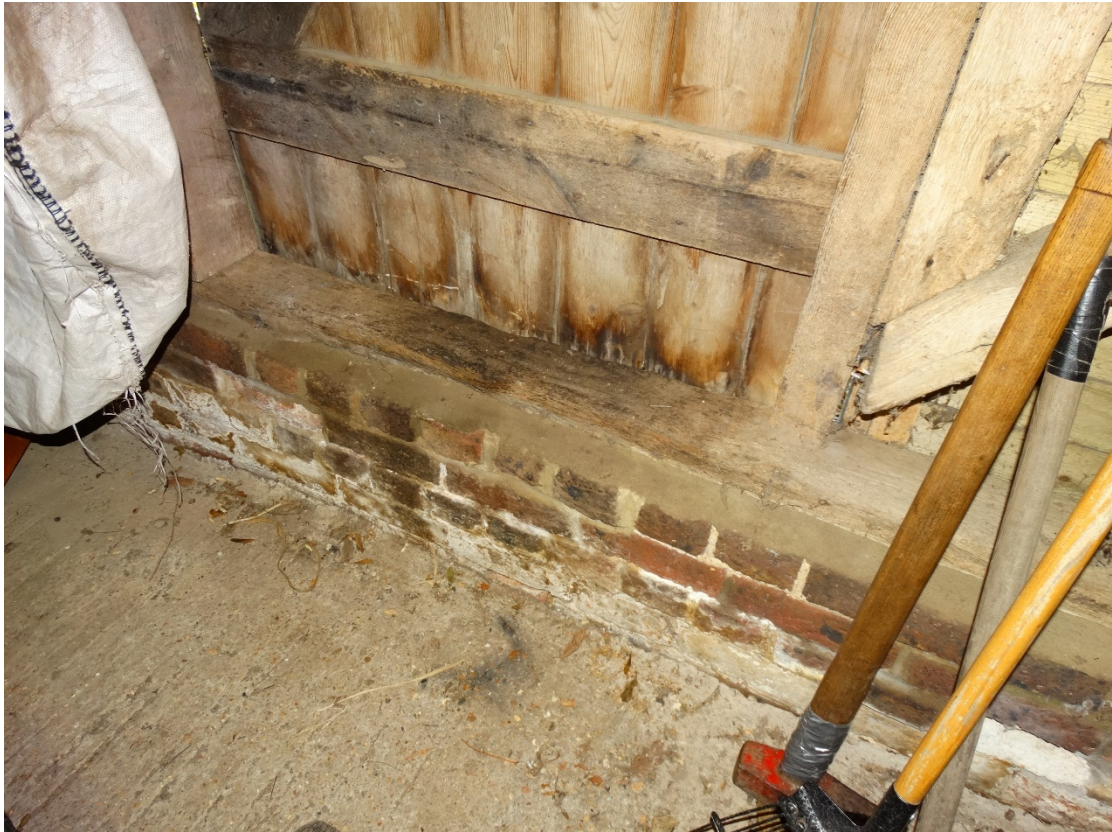
The only section of original sole plate is retained on the north end, but the plinth wall is heavily butchered underneath, especially on the outer face.

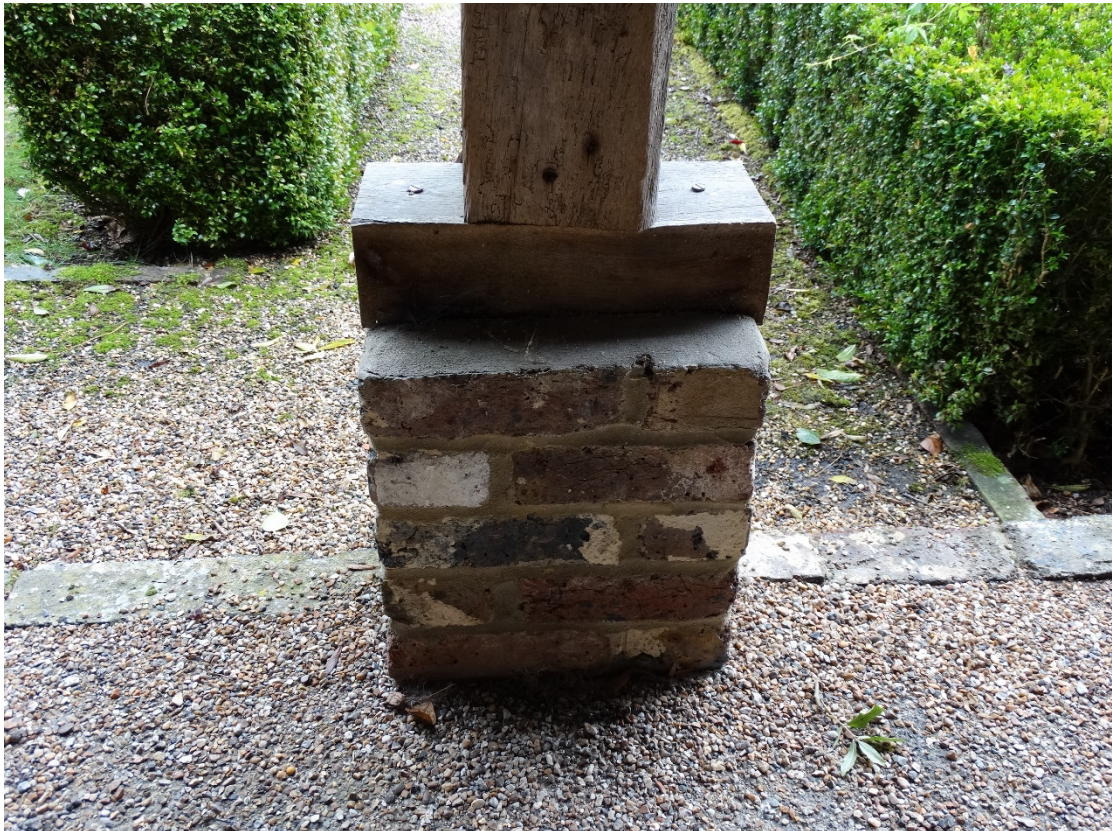
The frontage bay posts were also cut back to sound timber and stood upon masonry plinths, with wooden sole blocking, probably due to the deterioration of the bay post feet.

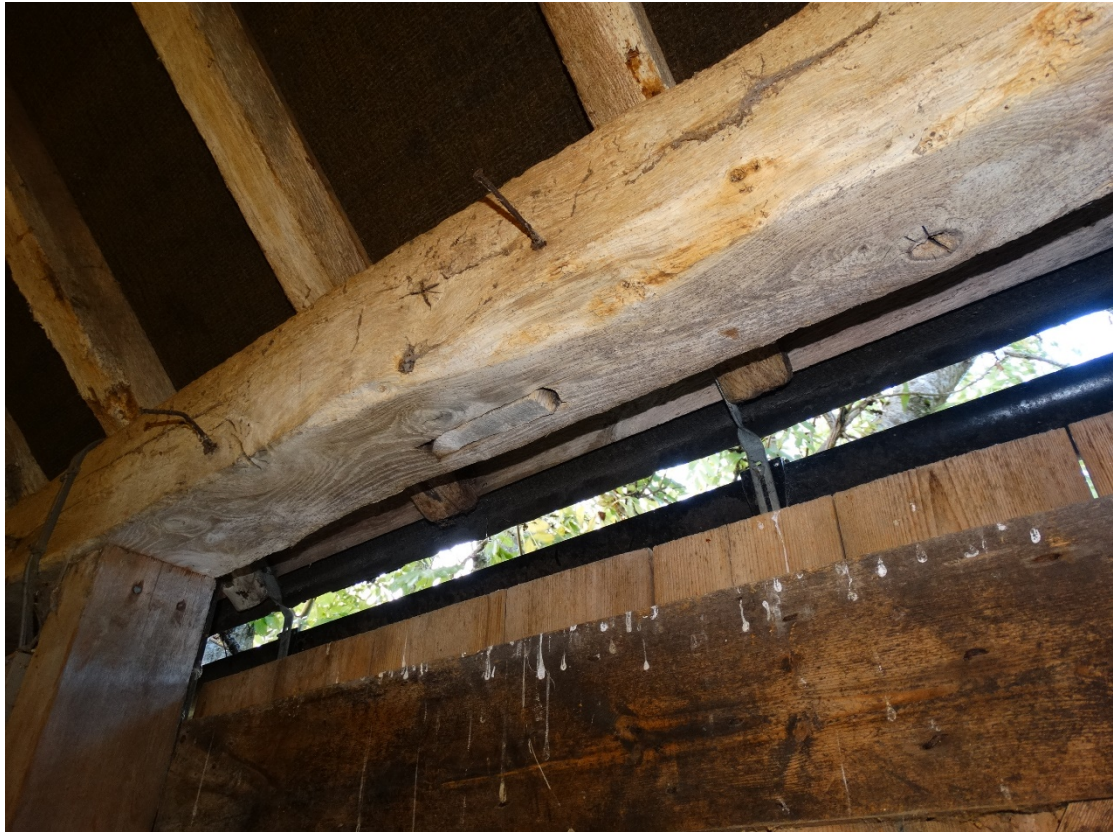
Earlier in the building's life, there was some minimal loss of fabric when a doorway was created in the northern wall. The central stud was removed and its mortice can still be seen.

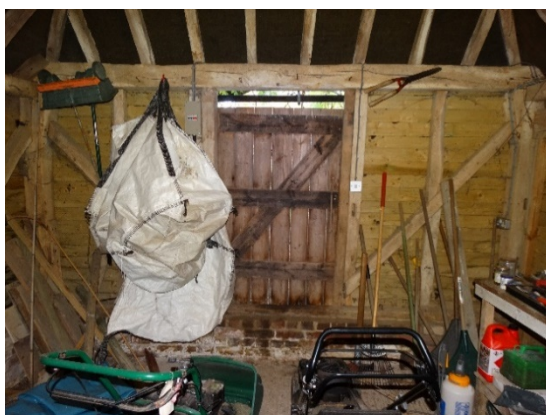
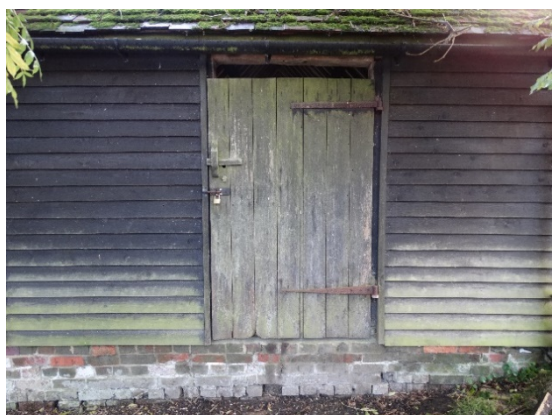
Later timber stud framing was inserted adjacent to the existing studs to form the frame of the door and the existing diagonal braces were slightly shortened to allow for the insertion.

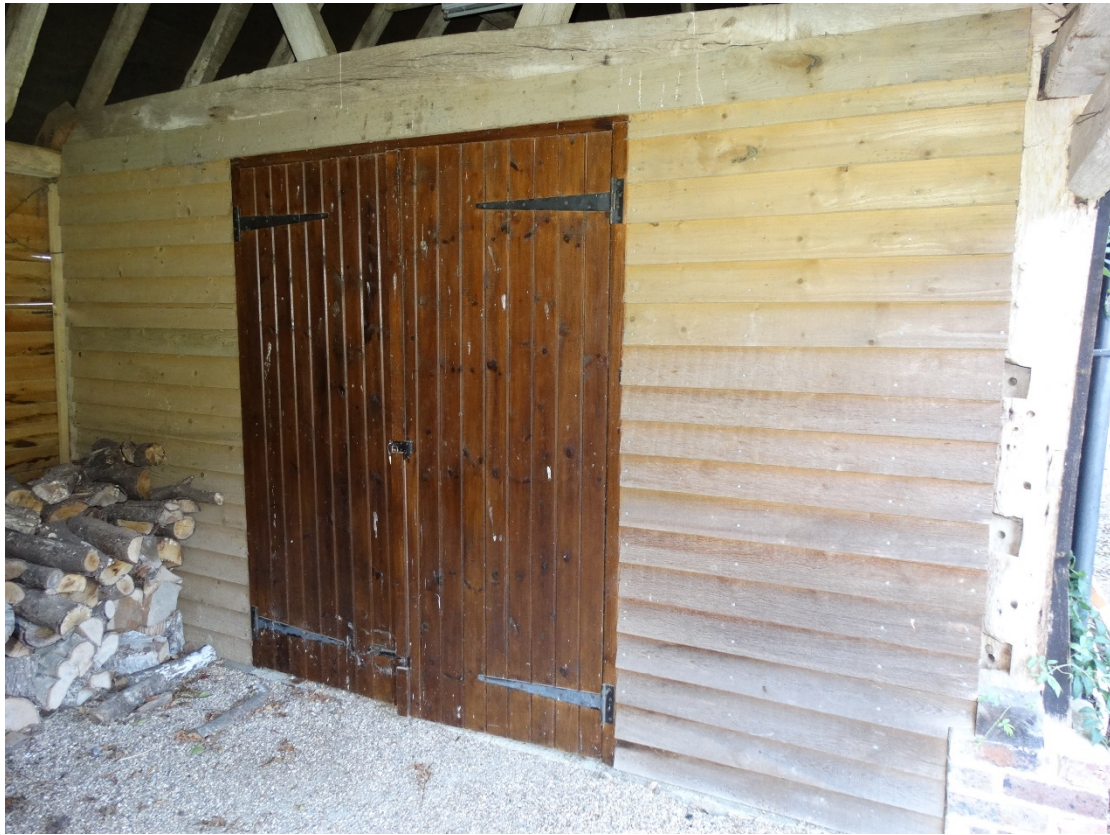
Modern alterations have since enclosed the north end bay with an internal softwood partition (below). The date of the inclusion is not known, but it most likely appeared at the same time as the 2005-6 restoration.

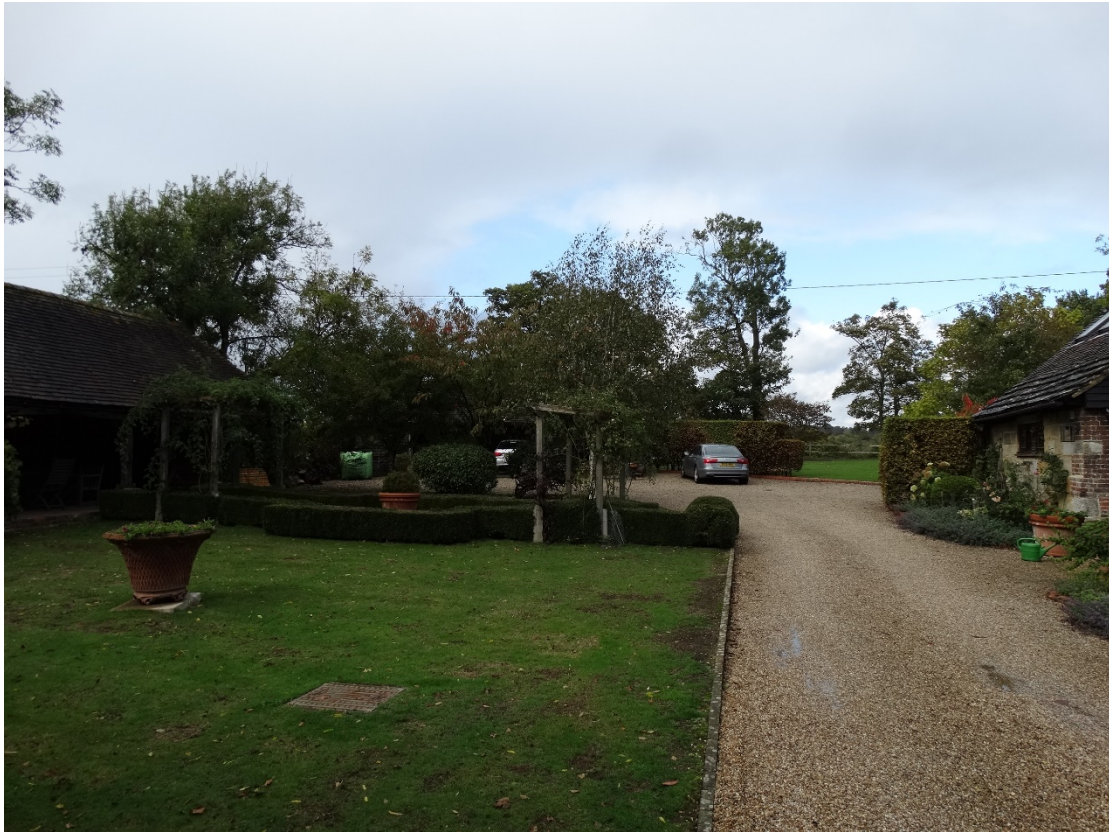
The present situation of the building has not changed a great deal, apart from the courtyard being much more of a formal driveway and garden than the former open yard will have been.

The space is quite intimate and despite the modern hedges on the northern boundary of the yard, the vista out towards the pond and fields can still be conjured.

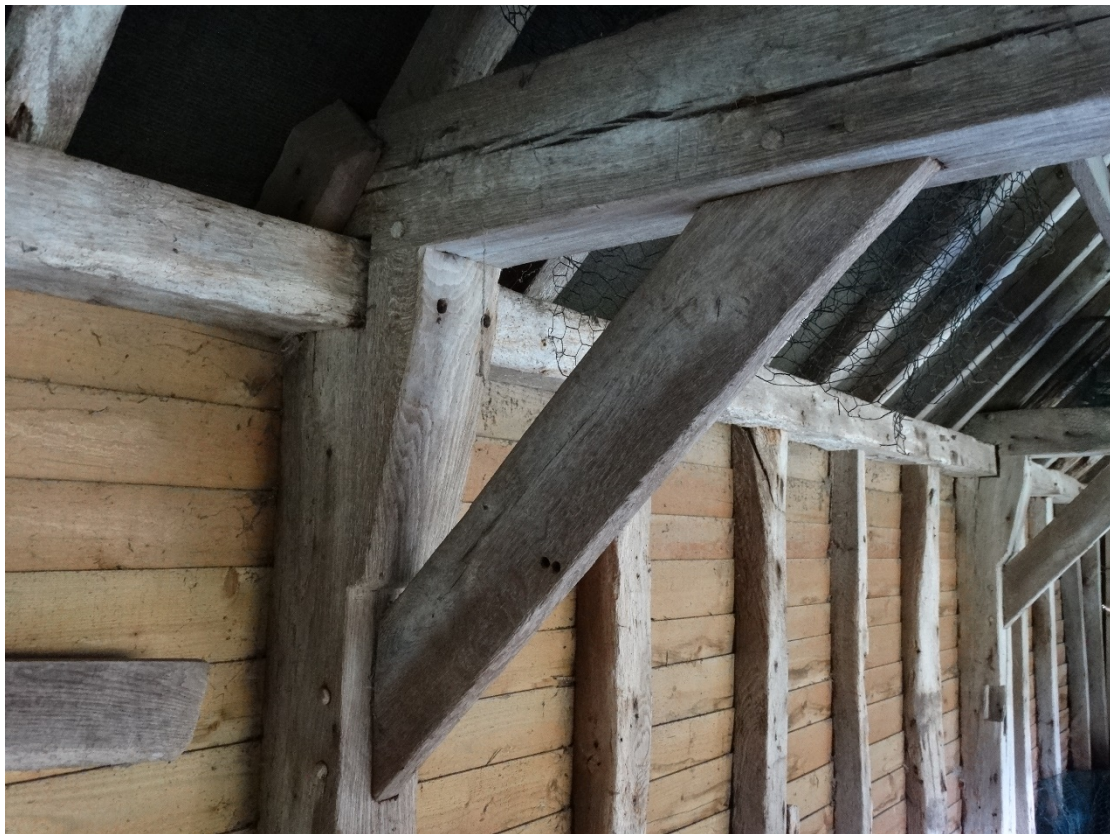
The interior insulated cladding to the main walls will not extend much past the inner face of the studs and, therefore, the bay posts to the rear of the unit should remain just visible.

We note that the partitions for the two flanking rooms are in line with, but very slightly offset from, the bay posts (probably sufficient to rest the plasterboard directly against the face of the braces?). If this assertion is correct, this would reduce the visual impact of the trusses. Ideally, any internal partitioning should be away from the bay post trusses by around 60-100mm to allow for these truss arrangements to be seen, unencumbered, from within the entrance vestibule room. If the proposal is to clad the truss braces within the linings, then this too would lead to a reduction in visual impact, internally.
