**Project:** 25\_VTA\_02\_10  
**Site:** Fleur-de-lis, 2 Bolnore Road, Haywards Heath, West Sussex RH16 4WH  
**Client:** Pegasus

| Document Title: | Tree Safety Survey & Management Plan |
| Project Title: | Fleur-de-lis, 2 Bolnore Road, Haywards Heath, West Sussex<br>RH16 4WH |

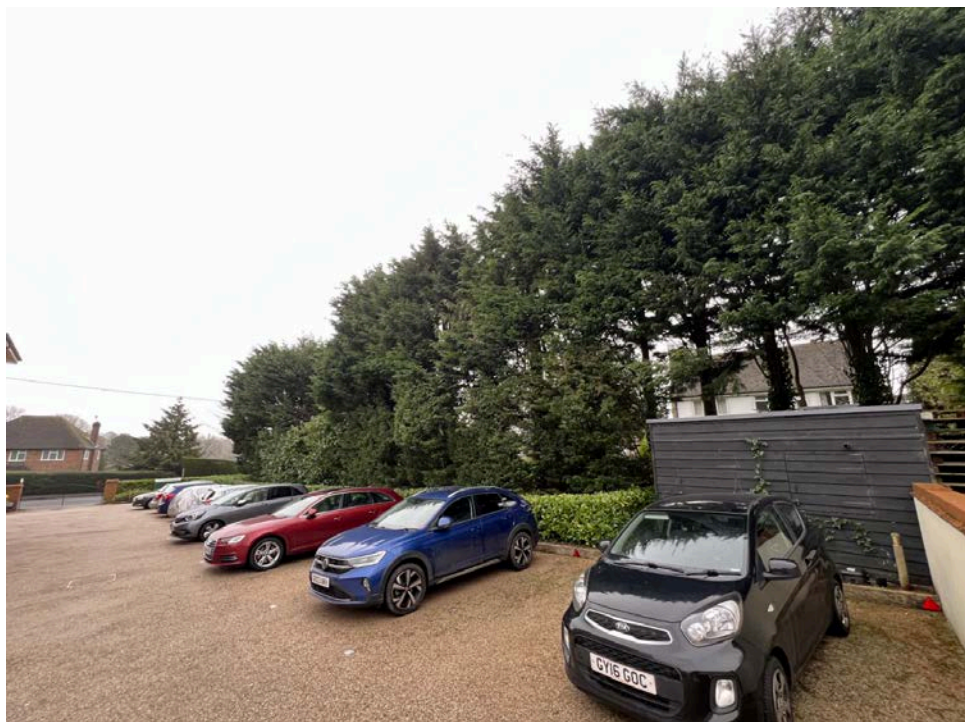
Photographic plate showing H41752. (ROAVR, 2025)

| Tree ID | Species | Tree Height | Maturity | DBH | Life Expectancy | Phys Cond | Defects | Defect details | Management Recommendations | Priority | Date Works Completed |
|---|---|---|---|---|---|---|---|---|---|---|---|
| 41752 | <i>X Cupressocyparis leylandii</i> (Leyland Cypress) | 12 | 250 | M | 20+ | Good | Ivy on tree. | Minor deadwood throughout hedgerow. | Reduce by 1.5m in height to allow more light into the carpark area and residents windows. | 6-12 months | |

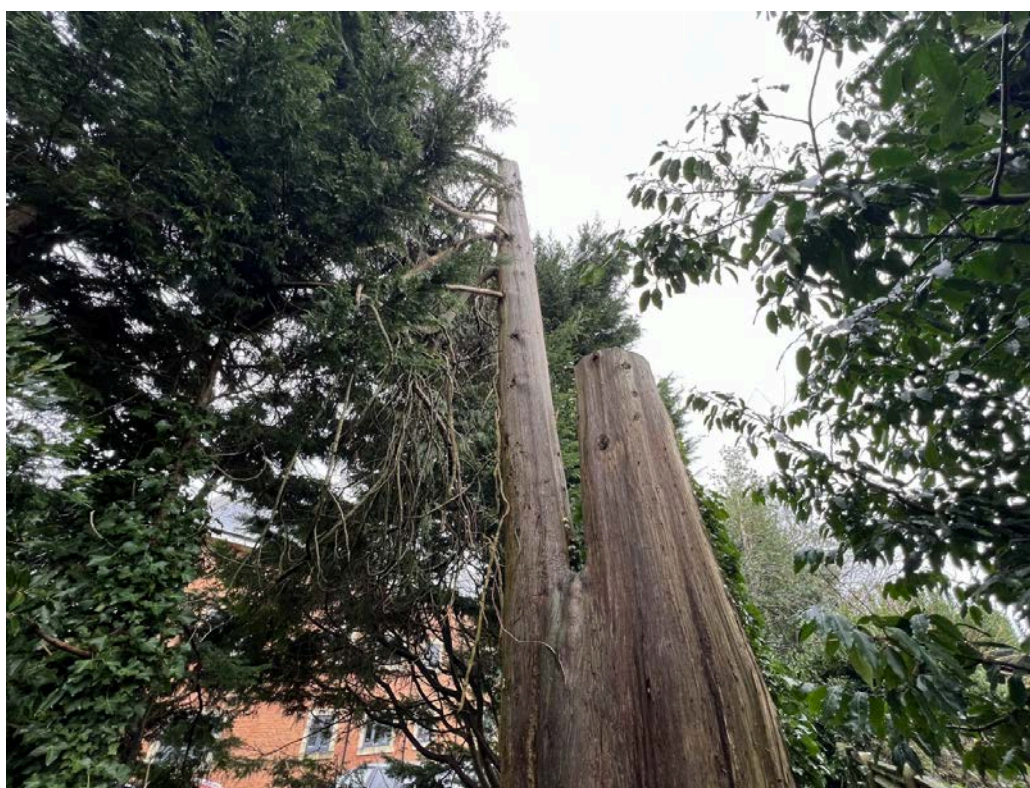
Photographic plate showing T41753. (ROAVR, 2025)

| Tree ID | Species | Tree Height | Maturity | DBH | Life Expectancy | Phys Cond | Defects | Defect details | Management Recommendations | Priority | Date Works Completed |
|---|---|---|---|---|---|---|---|---|---|---|---|
| 41753 | <i>X Cupressocyparis leylandii</i> (Leyland Cypress) | 11 | 1000 | OM | <10 | Poor | Low vitality. Declining. Dieback in crown. Low bud/leaf density. Major deadwood in crown. | Has been topped to 3m on the south side, Crown mass north, Crown mass dead and caught within H41753 | Reduce to 3m standing stem to match the southern stem. | 3-6 months | |

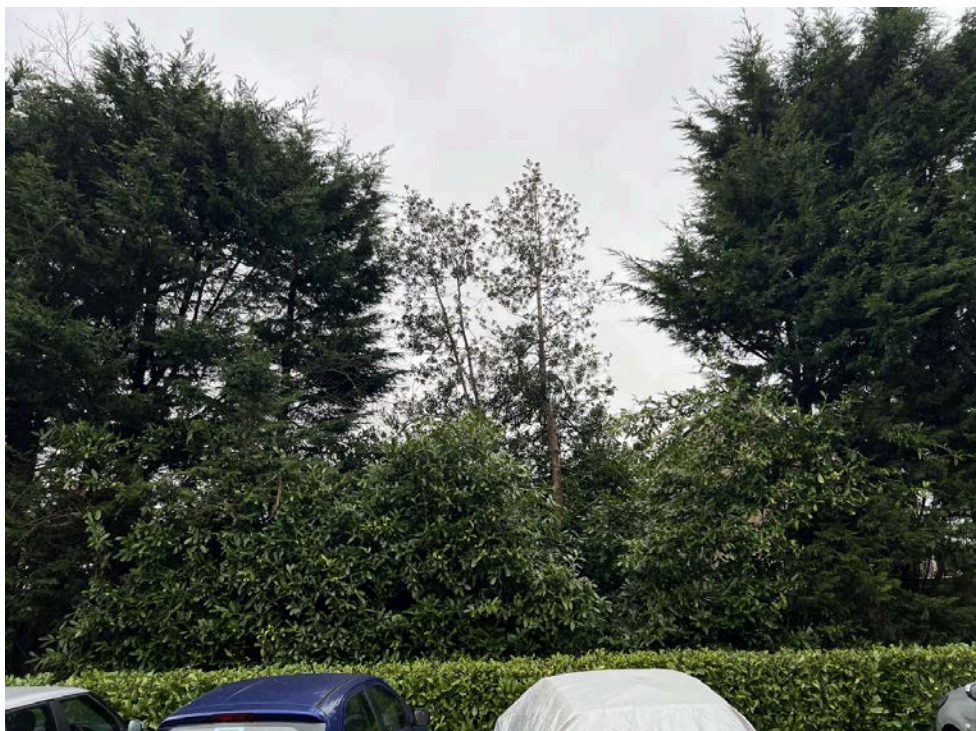
Photographic plate showing T41754 (centre). (ROAVR, 2025)

| Tree ID | Species | Tree Height | Maturity | DBH | Life Expectancy | Phys Cond | Defects | Defect details | Management Recommendations | Priority | Date Works Completed |
|---|---|---|---|---|---|---|---|---|---|---|---|
| 41754 | <i>Ilex aquifolium</i> (Holly) | 9 | 200 | M | 10+ | Fair | Low vitality. Dieback in crown. Low bud/leaf density. | Stress showing with the crown. | Annually inspect. | 12-24 months | |

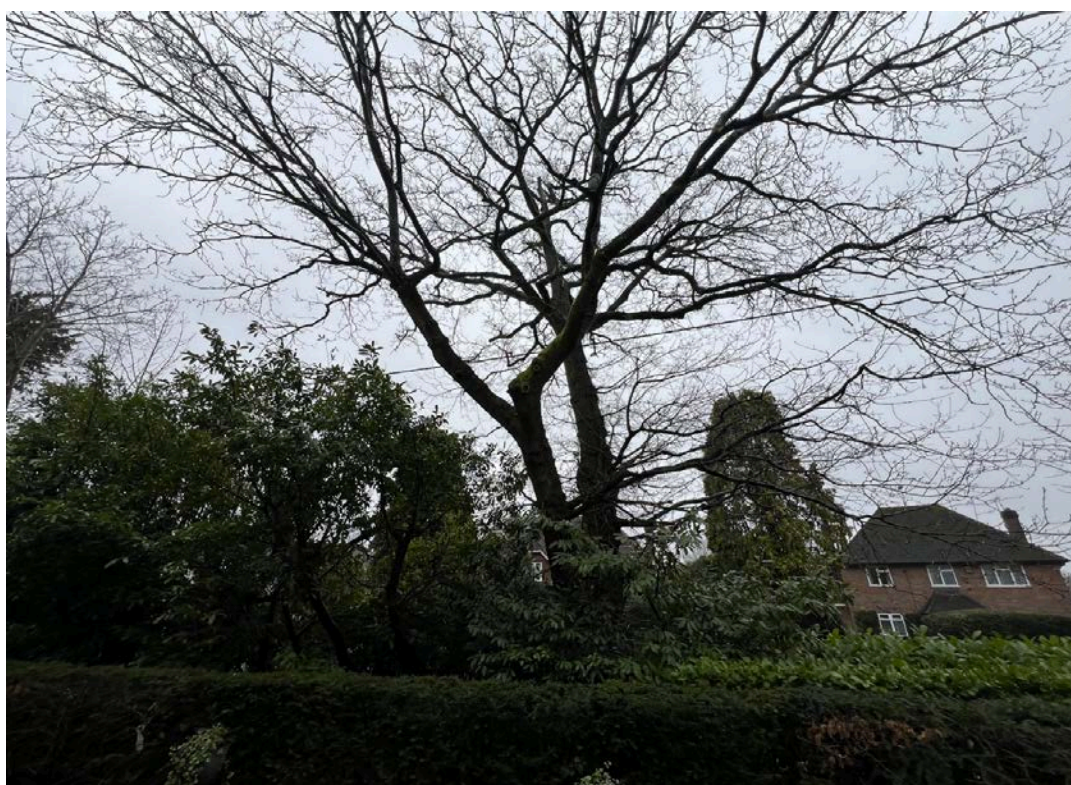
Photographic plate showing T41757 (centre). (ROAVR, 2025)

| Tree ID | Species | Tree Height | Maturity | DBH | Life Expectancy | Phys Cond | Defects | Defect details | Management Recommendations | Priority | Date Works Completed |
|---|---|---|---|---|---|---|---|---|---|---|---|
| 41757 | <i>Quercus robur</i> (Common Oak) | 16 | 500 | M | 40+ | Good | Stem divides at ground level. Branches encroaching upon building. | No works required. | Prune to clear building by 1 metre | within 3 years | |

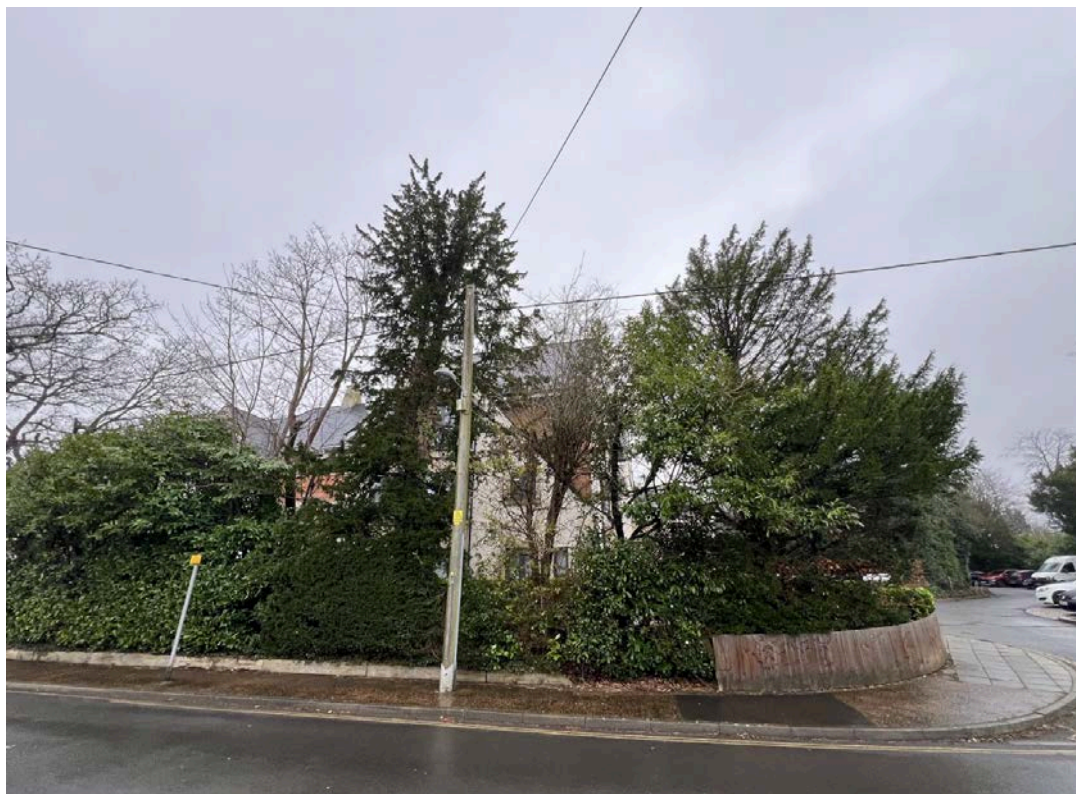
Photographic plate showing T41758 (left) to T41761 (right). (ROAVR, 2025)

| Tree ID | Species | Tree Height | Maturity | DBH | Life Expectancy | Phys Cond | Defects | Defect details | Management Recommendations | Priority | Date Works Completed |
|---|---|---|---|---|---|---|---|---|---|---|---|
| 41758 | <i>Acer pseudoplatanus</i> (Sycamore) | 15 | 250 | M | 20+ | Good | Cavity on stem. Branches encroaching upon building. | Pruning wound cavity at 4.5m West. | Prune clear of phone lines by 1 metre | 6-12 months | |
| 41760 | <i>Crataegus monogyna</i> (Hawthorn), <i>Ilex aquifolium</i> (Holly) | 6 | 150 | EM | 10+ | Fair | None | Crown touching phone line. | Prune clear of phone lines by 1 metre | 12-24 months | |

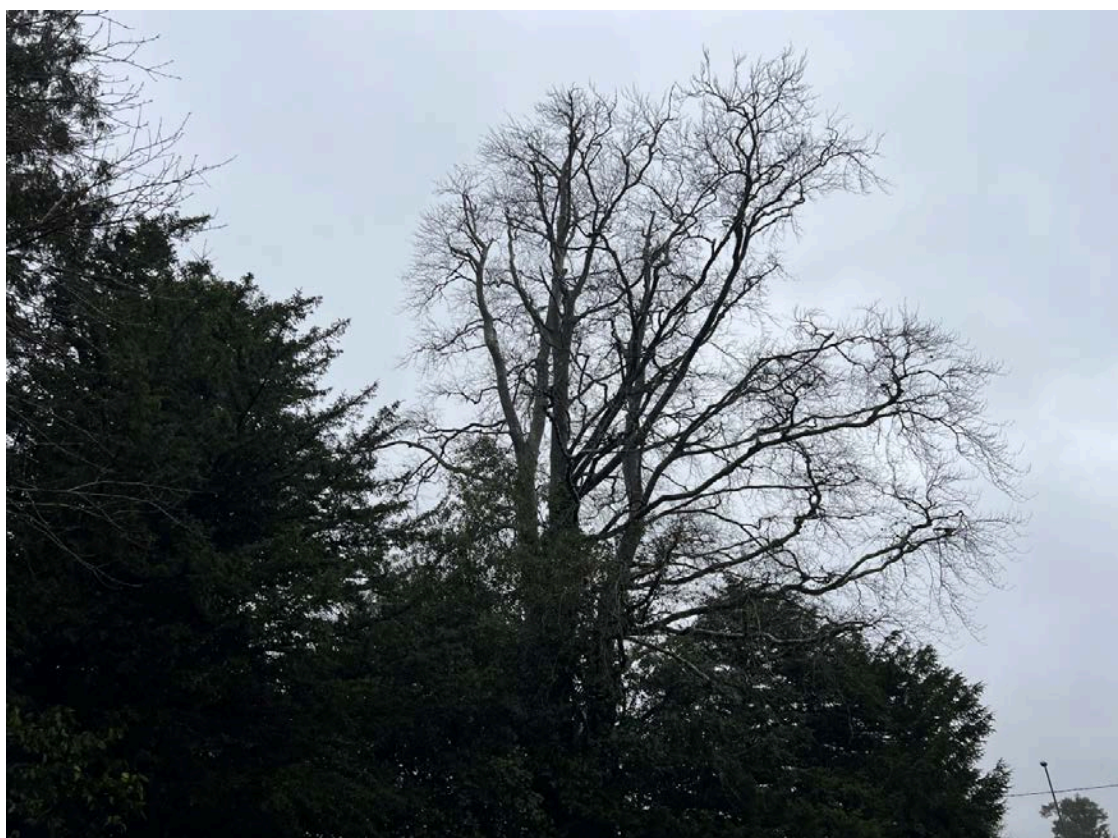
Photographic plate showing T41762 (centre). (ROAVR, 2025)

| Tree ID | Species | Tree Height | Maturity | DBH | Life Expectancy | Phys Cond | Defects | Defect details | Management Recommendations | Priority | Date Works Completed |
|---|---|---|---|---|---|---|---|---|---|---|---|
| 41762 | <i>Fagus sylvatica</i> (Beech) | 20 | 900 | M | 40+ | Good | None | Has been reduced within the last couple of years, no works required. | No works required. | n/a | |
