# JAMES CLAGUE

## ARCHITECTS

### Tanyard Manor, Sharpthorne - Site investigation photographs June 2025 version 2

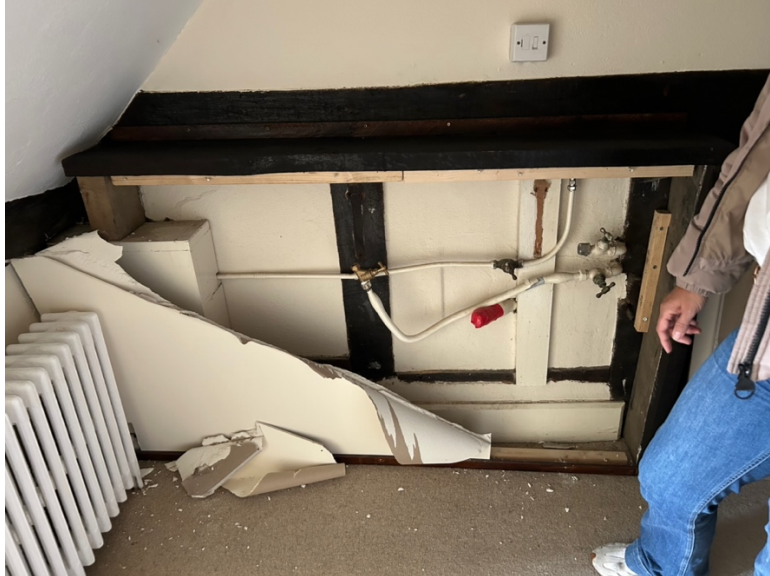
*Figure 1 modern plasterboard to boxing in to 2<sup>nd</sup> floor bedroom revealing previous pipework*

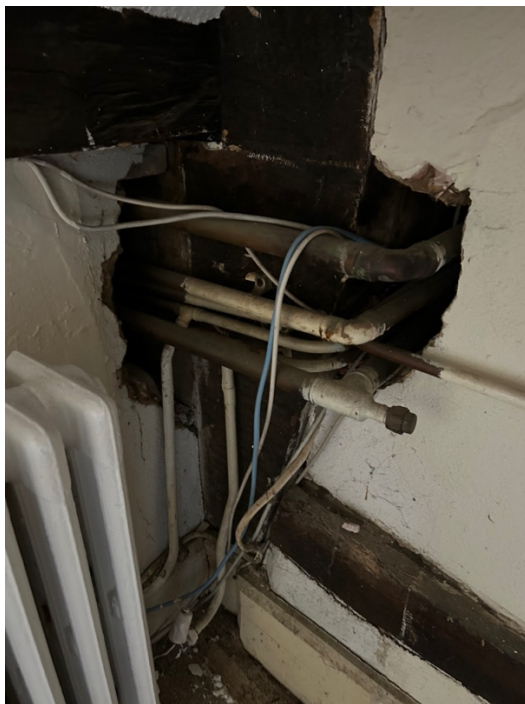
*Figure 2 boxing removed*

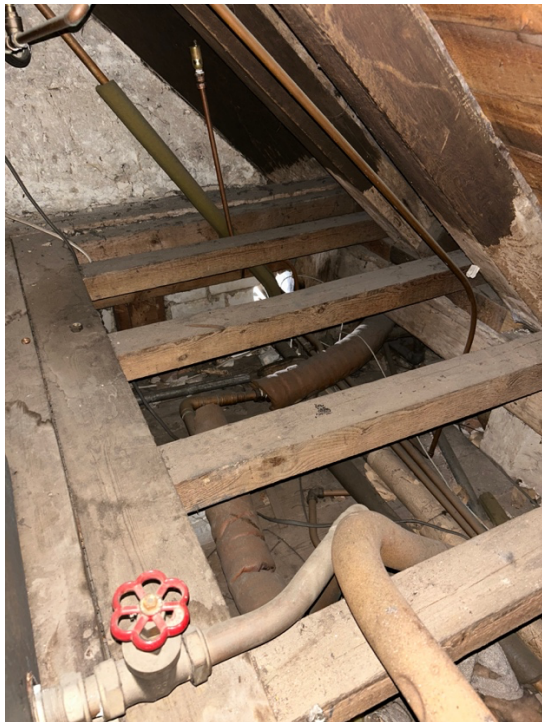
Figure 3 attic void to rear of partition showing opening

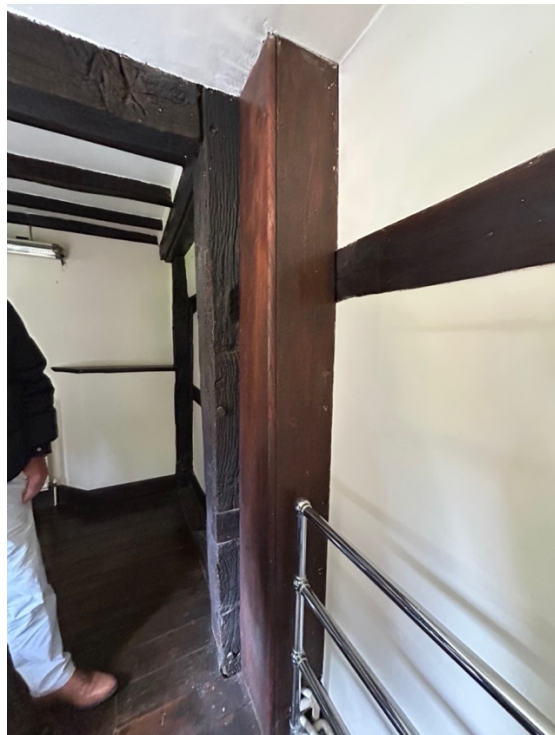
Figure 4 soil stack in bathroom below

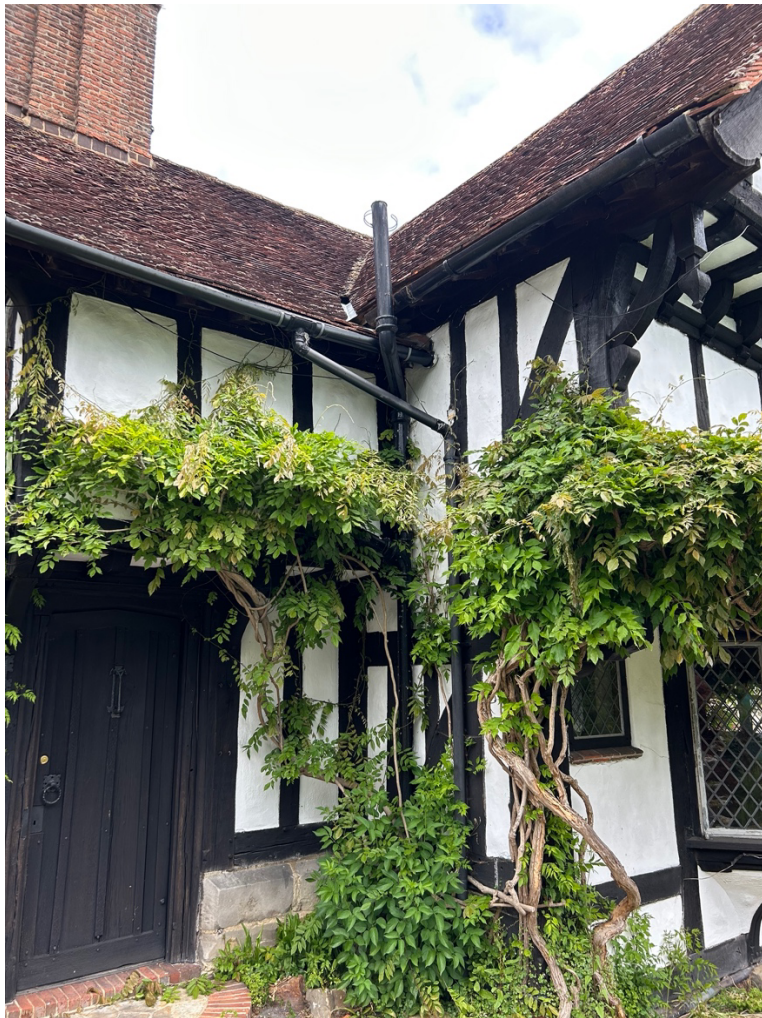
Figure 5 external soil vent pipe

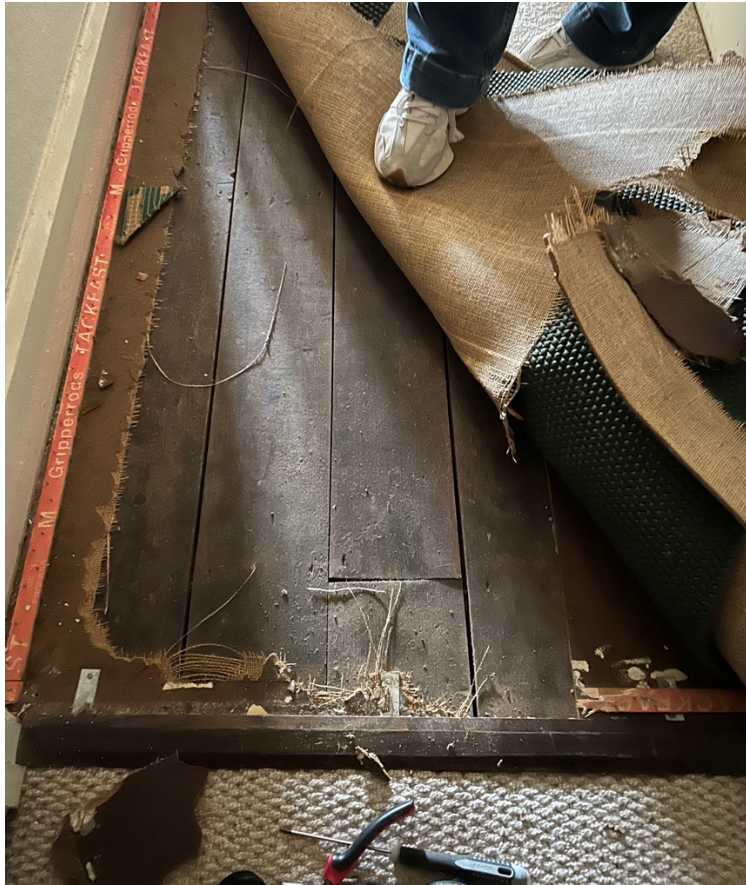
Figure 6 circa C20th machine sawn regular t&g boards in attic room fixed with nails

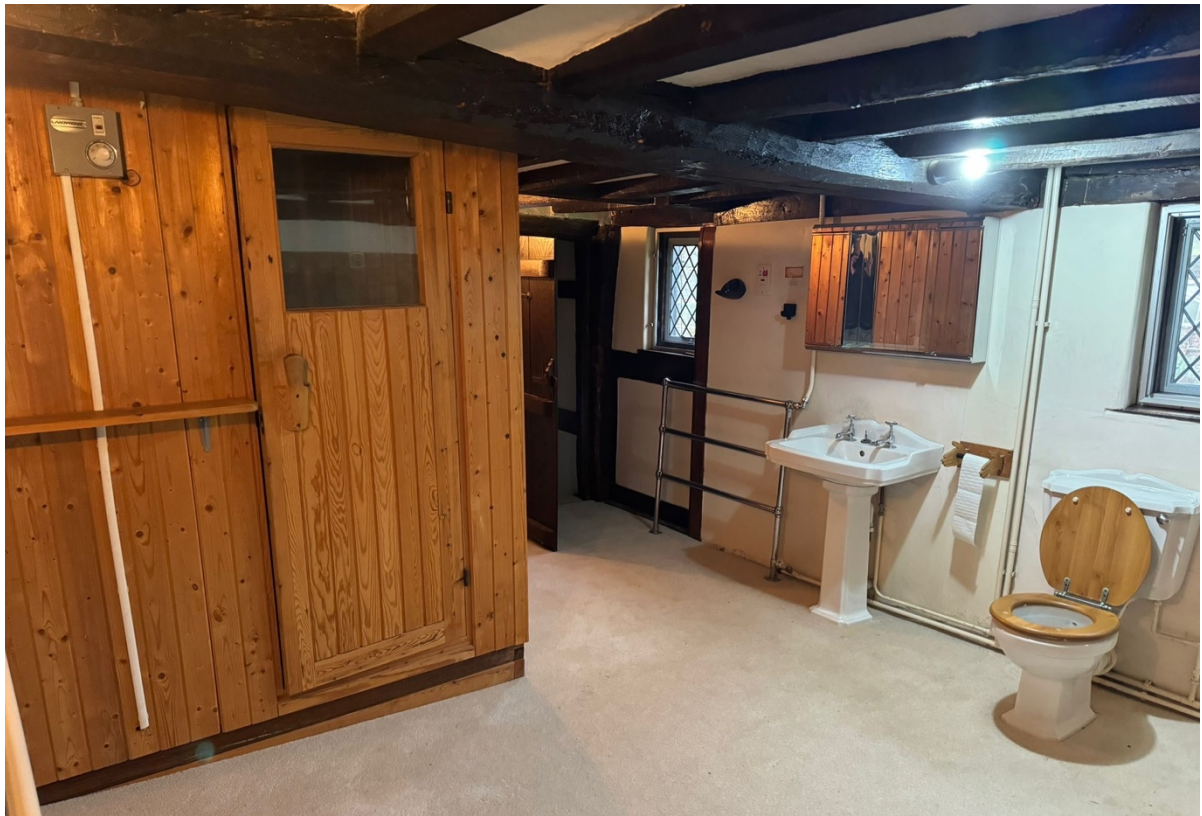
Figure 7 sauna before removal

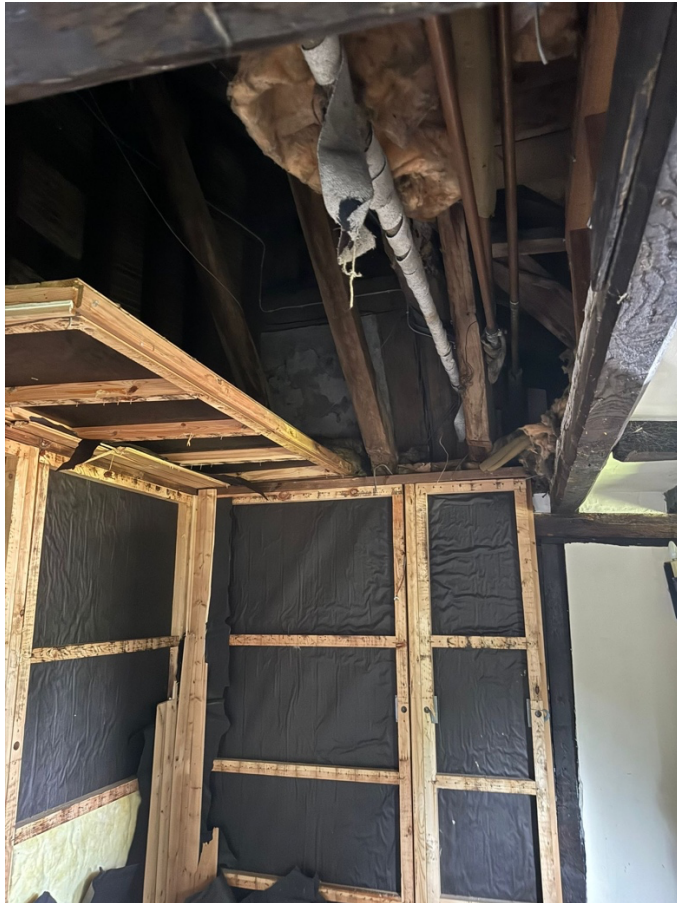
*Figure 8 sauna removed and framed lining in progress of removal revealing roof void and missing ceiling joists*

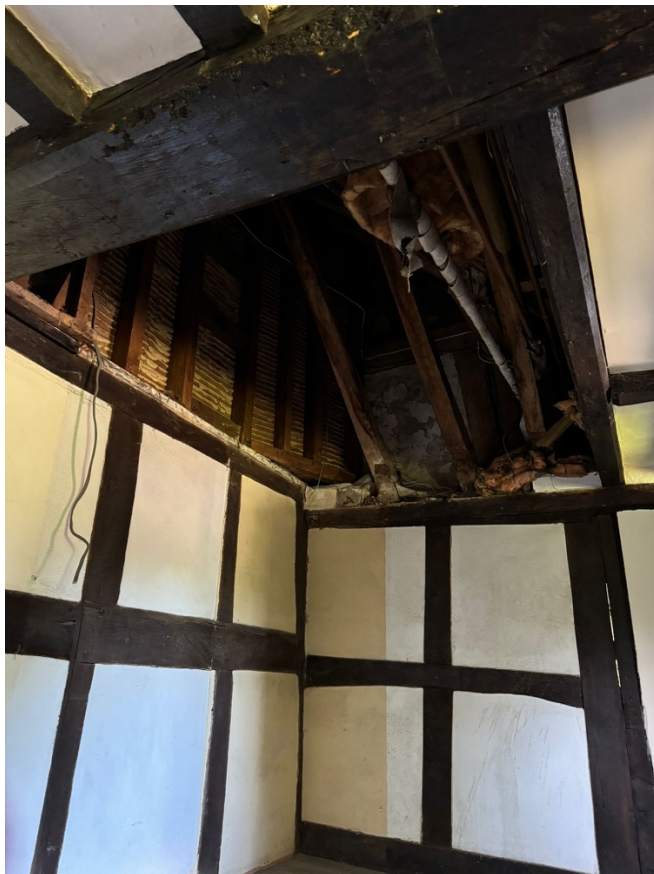
*Figure 9 sauna frame removed revealing wall frame*

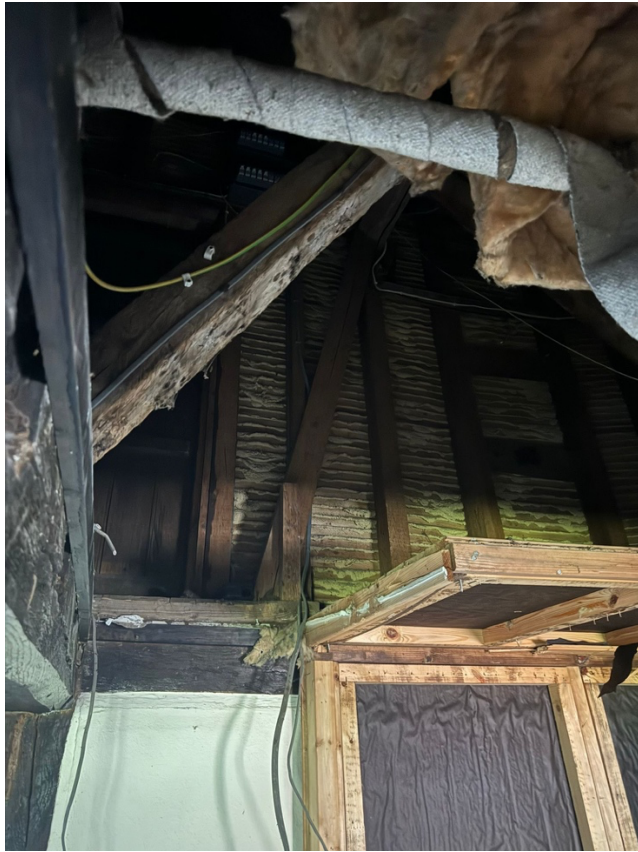
*Figure 10 void in loft from sauna removal – note mortices for floor joists in beam*

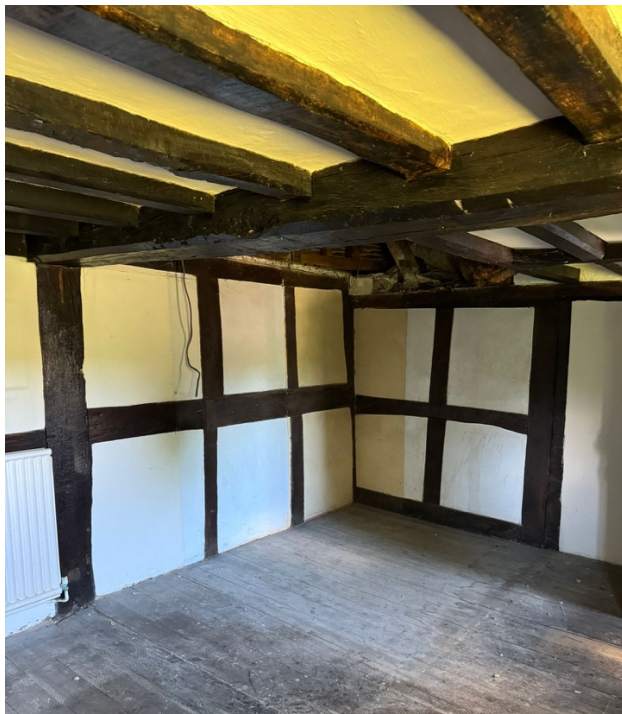
*Figure 11 floor joists correspond with mortices on opposing side of beam*
