Tree Survey Schedule  
Site: 17 Lewes Road, Haywards Heath, Rh17 7:  
Ref: 2335  
Date: October 2025

17 Lewes Road

Tree Constraints plan

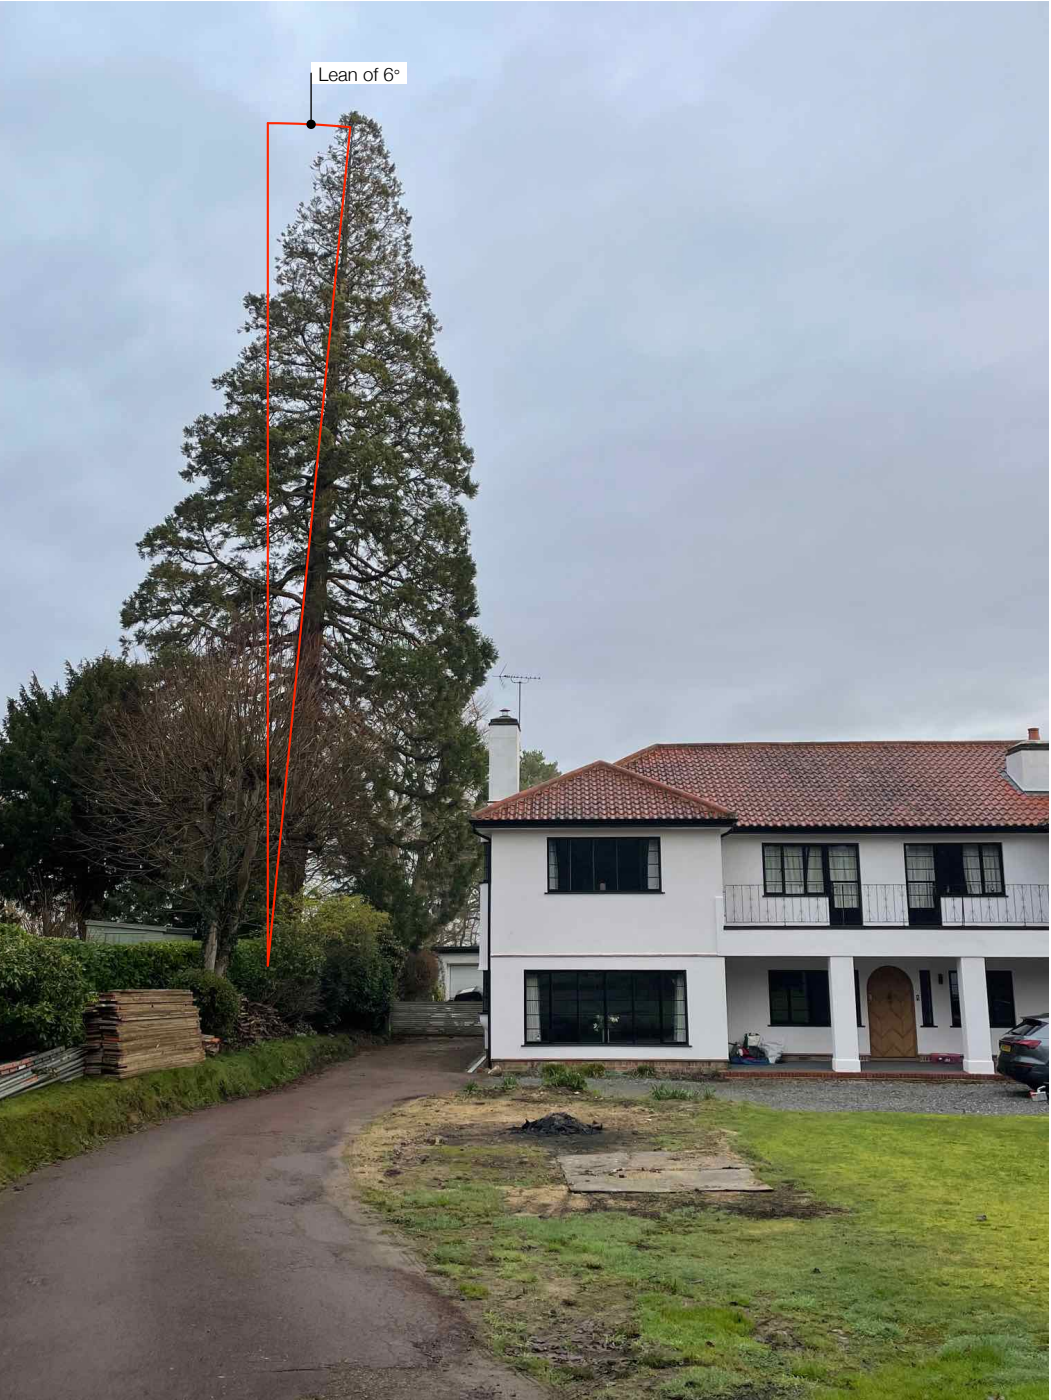
| Ref. | Species | Description | Measurements | Survey Notes | Condition | Structural | Inspect Period | Risk Rating | Timescale | Discussion / Recommendations |
|---|---|---|---|---|---|---|---|---|---|---|
| T001 | Giant Sequoia<br>(Sequoiadendron giganteum) | Large tree located in the grounds of 15 Lewes Road. 2m from the boundary of 17 Lewes road with a lean to the north east towards the property at 17 Lewes Road. | Height (m): 30<br>Crown Radius (m): 8<br>DBH (mm): 1830<br>Trees: 1<br>Life Stage: Mature | Very large tree located on ground which is >1m higher than the patio and drive within 17 Lewes Road. The topography of the ground may have impacted the structural integrity of the root plate.<br>Tree has a lean towards the property at 17 Lewes road with sparse canopy cover on the northwest aspect.<br>At ground level a void on the northeast aspect was observed with a depth of 300mm and dead wood present.<br>Badgers are known to be in the area with signs of digging activity around the base. | Fair | Fair | 1 Year | High | 1 year | <p><b>Location</b></p> <p>The Giant Sequoia located between 15 and 17 Lewes Road exhibits a pronounced lean towards the property at 17 Lewes Road. The tree stands on elevated ground relative to the property, with voiding noted around the root plate and evidence of mammal activity (likely badger disturbance) contributing to possible root instability.</p> <p><b>Canopy</b></p> <p>While the tree retains some canopy vitality, the combination of structural lean, elevated ground position, and observed voiding presents a foreseeable risk of partial or total failure towards the dwelling at 17 Lewes Road. Given the tree's size and proximity to residential areas, any such failure could result in significant harm to persons or property.</p> <p><b>Root-plate instability indicators</b></p> <p>The combination of slope loading, lean and mammal excavation constitutes evidence of differential root-plate movement. According to BS 5837 Annex A and AFAG 401, trees on raised ground adjacent to excavation or erosion should be regarded as higher risk for rotational failure.</p> <p><b>Soil moisture and seasonal heave</b></p> <p>Given the elevated position and the property's lower ground level, soil moisture variation could accelerate downslope movement during prolonged wet periods.<br/>This connects the lean and voiding to foreseeable seasonal triggers.</p> <p><b>Mass and target severity</b></p> <p>At an estimated mass exceeding 25 t, even partial failure of the main stem or root-plate could cause structural damage to the dwelling or present life-threatening injury to occupants, placing this tree within the 'high consequence' category under the HSE's tree-safety zoning principles (SIM 01/2007/05).</p> <p><b>Further surveys</b></p> <p>Further investigation by sonic tomography or static load testing may assist in quantifying the extent of any internal decay or root-plate compromise.</p> <p><b>Recommendations</b></p> <p>In accordance with the duty of care placed upon landowners and occupiers under the Occupiers' Liability Acts 1957 and 1984, the tree owner should take reasonable steps to identify and manage risks associated with trees on their land. In this instance, appropriate and proportionate risk management would include:</p> <p>Carry out a crown reduction (up to 20% or 1.6m from each aspect) to reduce sail area and loading on the root plate. The crown reduction will leave a crown radius of 6.4m</p> <p>Reinspection following significant meteorological events (e.g. wind speeds exceeding Beaufort Scale 6) and at least annually, or sooner if further ground movement or canopy change is observed.", and after any remedial works, to monitor for further ground movement or canopy decline.</p> <p>All operations should comply with BS 3998:2010 – Tree Work – Recommendations</p> |

Giant Sequoia as seen from front garden of 17 Lewes Road.

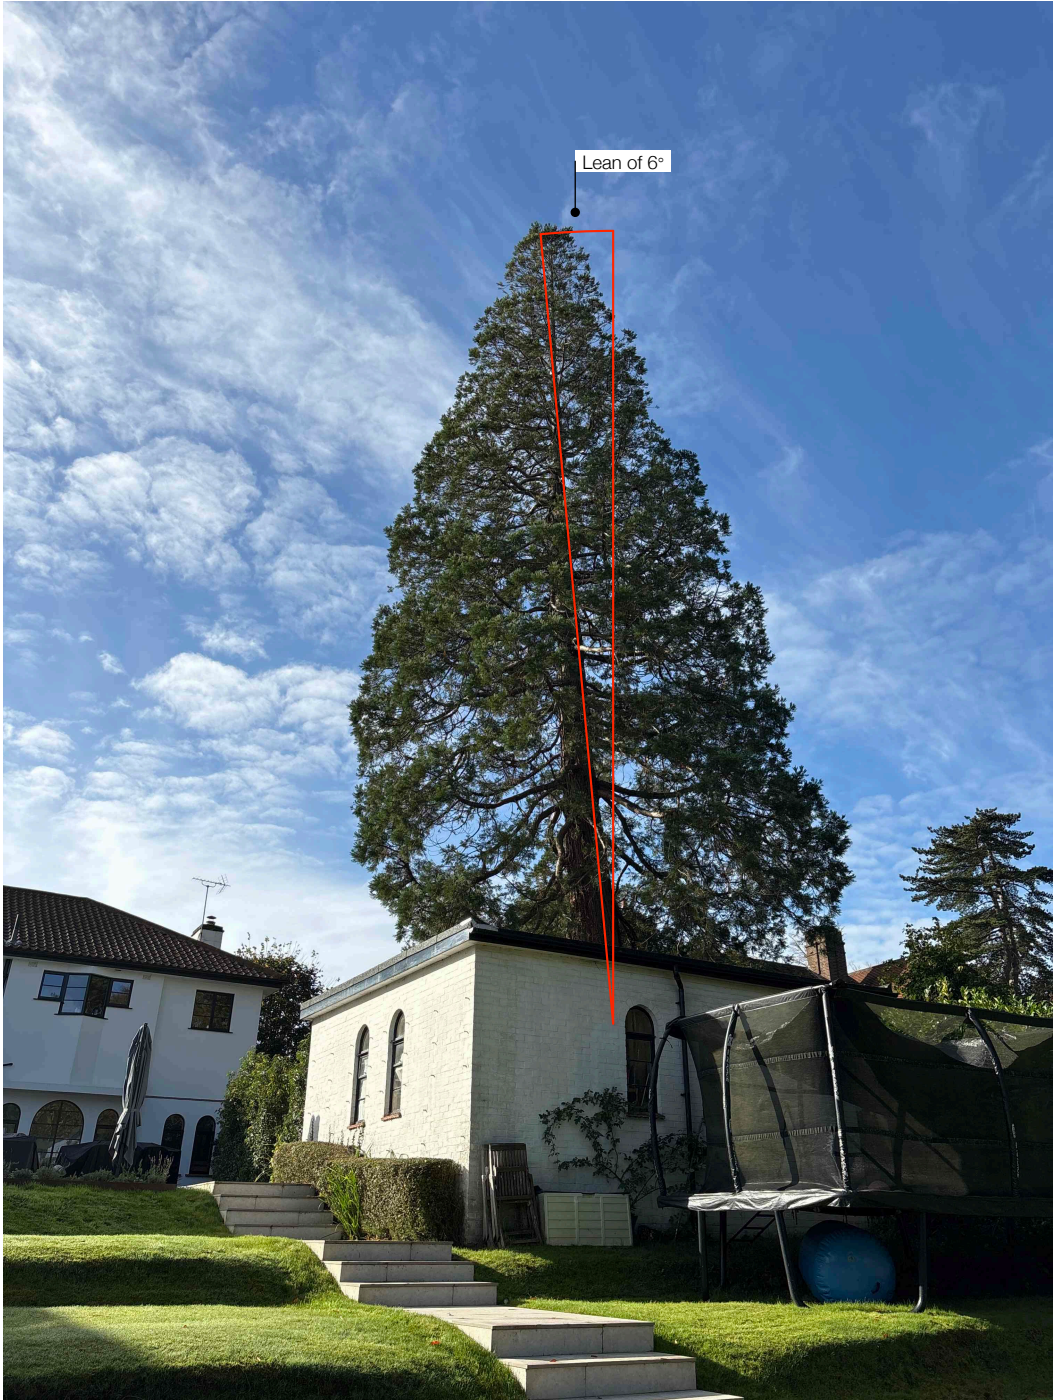
Giant Sequoia as seen from rear garden of 17 Lewes Road.
