# Arboricultural Consultancy for Royal & Sun Alliance

| Insured | Mrs Susan Keymer | Address | 1 Calbourne , Haywards Heath , RH16 4AQ | | |
| Client | Subsidence Management Services | Contact | Richard Bryant | Claim No. | IFS-RSA-SUB-25-0116647 |

## 2. Property and Damage Description

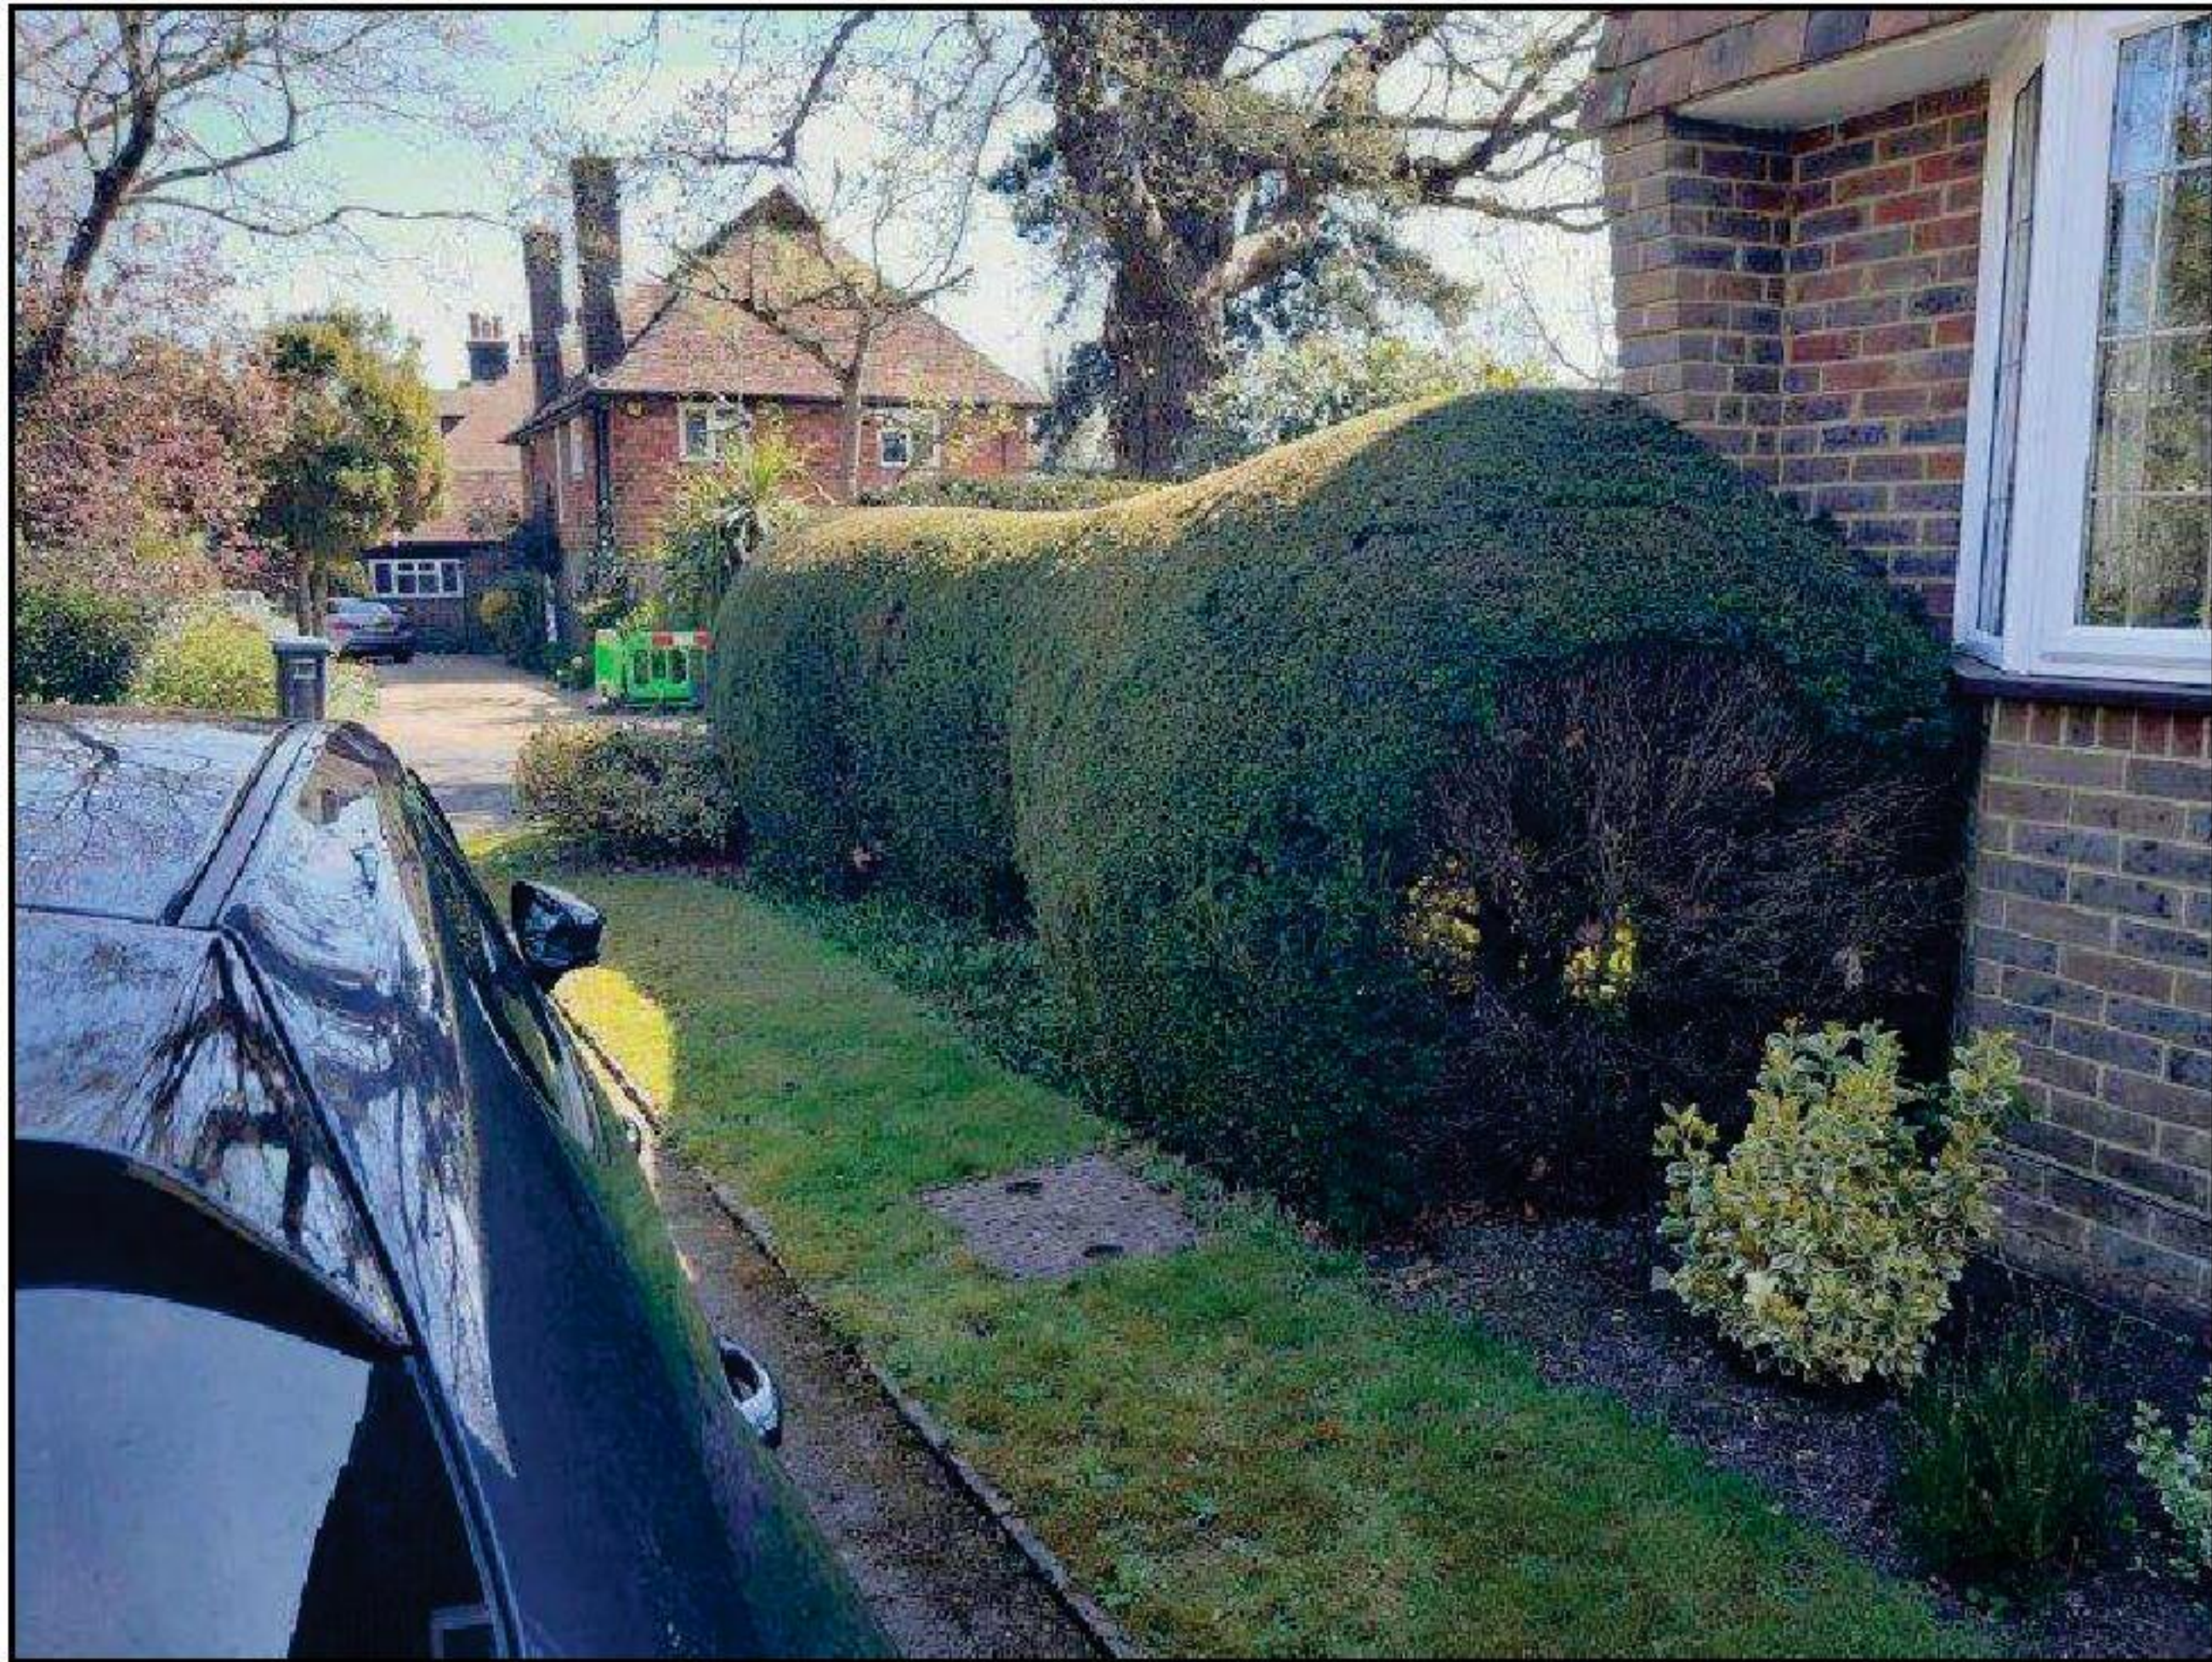
H1 - Yew

| Tree No. | Species | Age Cat | Approx. Height (m) | Distance to Building (m) * | Ownership | Action | Requirement |
|---|---|---|---|---|---|---|---|
| H1 | Yew (Common) | 1 | 2 | 0.6 | C - Insured | Action to avoid future risk | Subject to regular management; maintain at broadly current dimensions by way of regular pruning. |

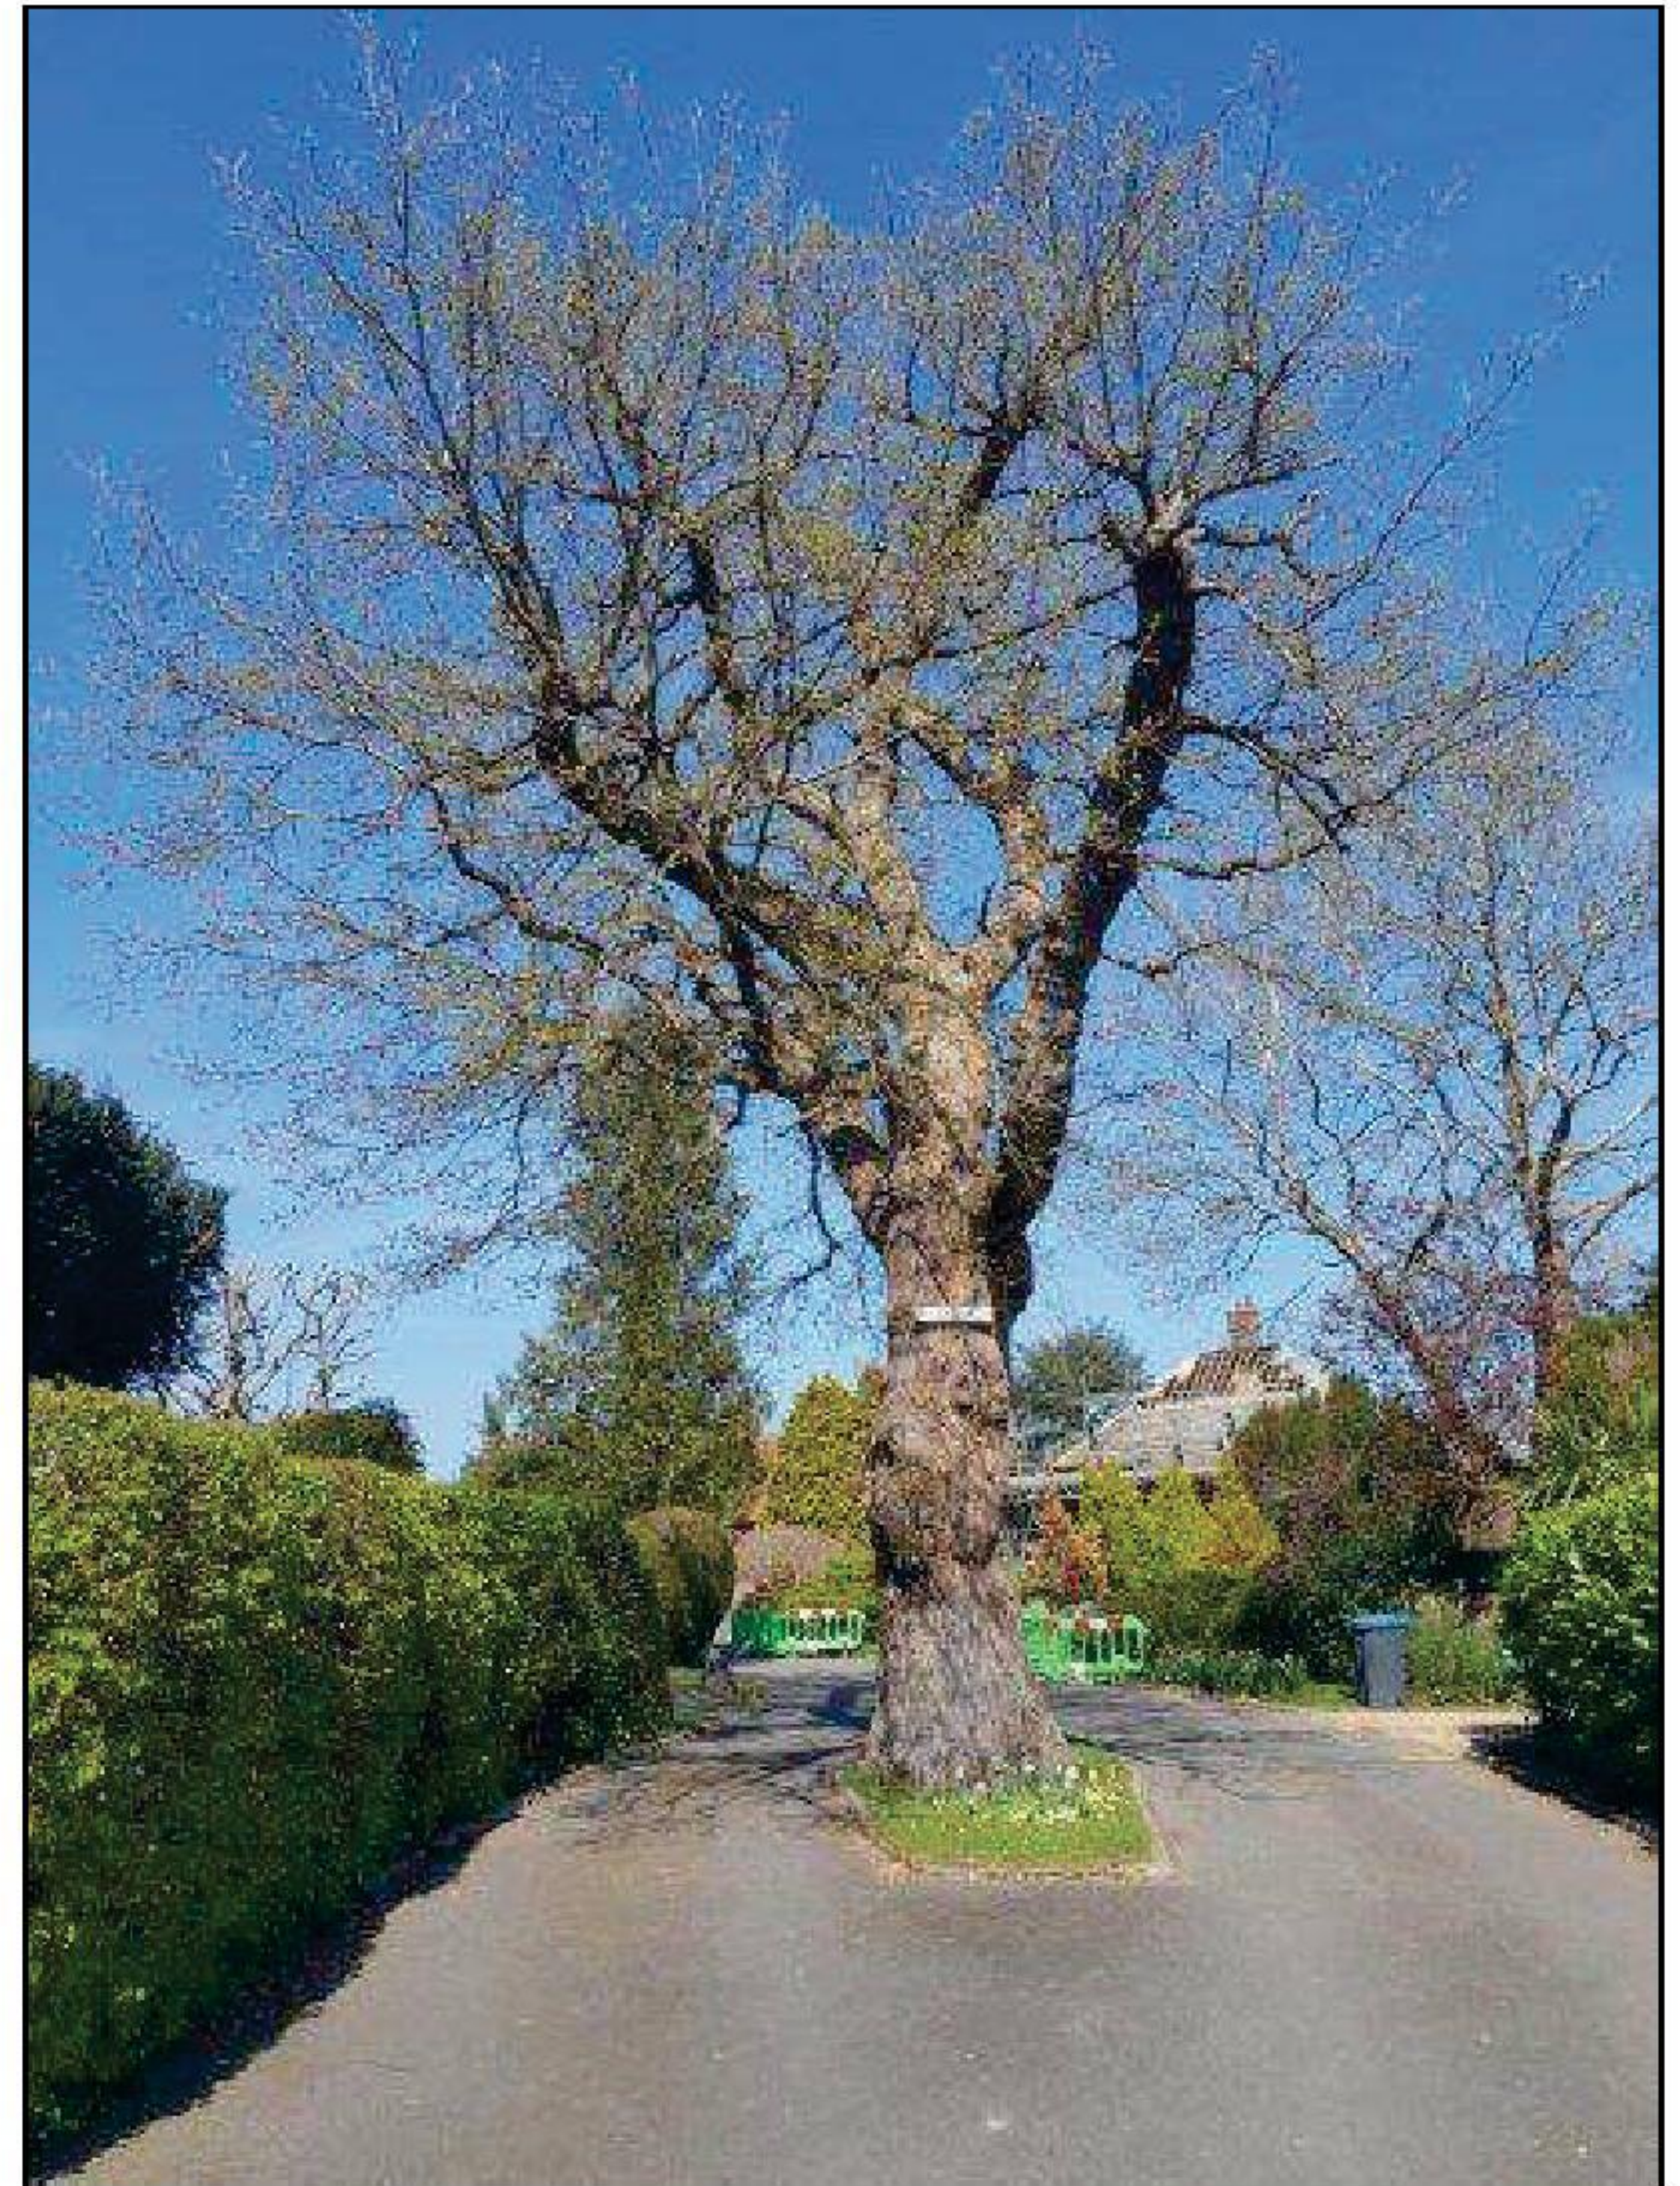
T3 - Oak

With due regards to species profile, size and proximity, T3 (Oak (English)) is considered the dominant feature proximate to the focal area(s) of movement, the source of the Quercus spp. roots identified and accordingly, where vegetation is confirmed as being causal, we have identified it as the primary cause of the current subsidence damage.

| Tree No. | Species | Age Cat | Approx. Height (m) | Distance to Building (m) * | Ownership | Action | Requirement |
|---|---|---|---|---|---|---|---|
| T3 | Oak (English) | 3 | 14.5 | 11.5 | B - Local Authority | Maintain as detailed | See section 5. |

The primary causal vegetation has been noted to be under the ownership / control of the Local Authority, who should be notified of the current building damage and requested to effectively mitigate soil drying (from T3) below the subject property.

Given the above, we accept that it is for third parties (who have the expertise) to determine how they should prevent ongoing damage and nuisance; management options could include complete removal followed by replacement planting, crown reduction in accordance with BRE IP7/06 followed by re-pruning on a maximum three yearly cycle (but frequently biennially) or pollarding (where appropriate).

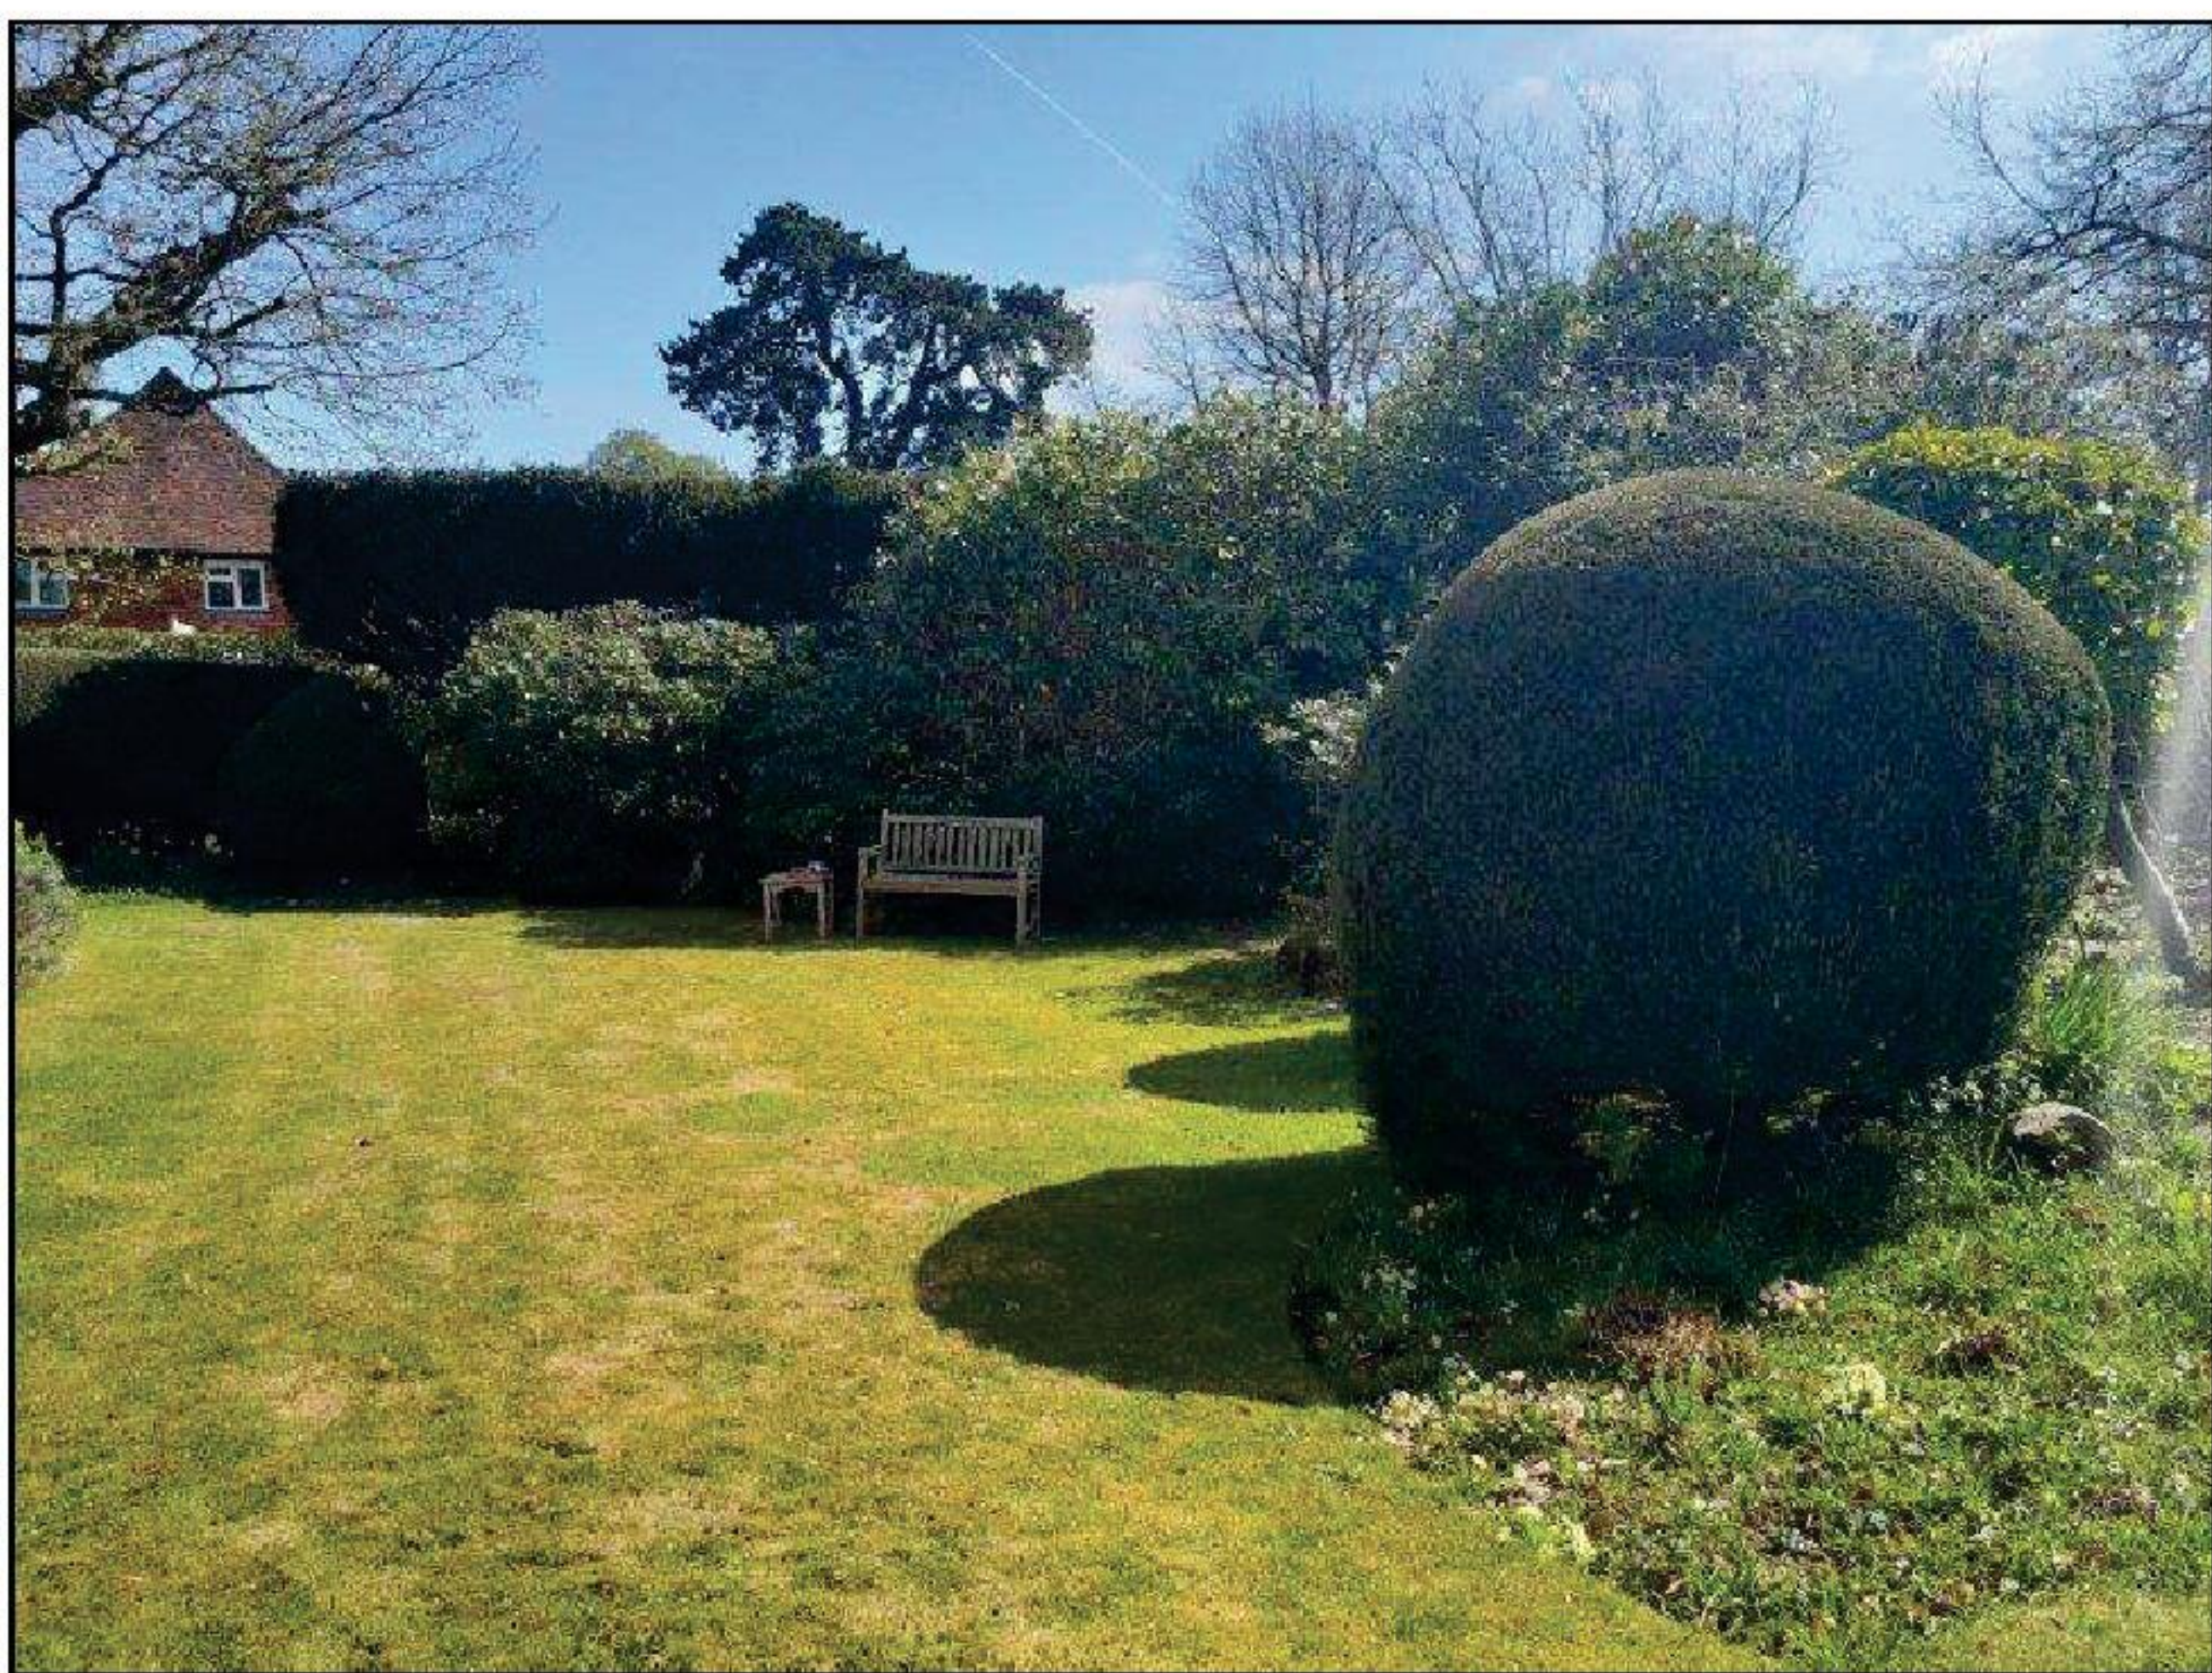
SG2 - Mixed Species Group

| Tree No. | Species | Age Cat | Approx. Height (m) | Distance to Building (m) * | Ownership | Action | Requirement |
|---|---|---|---|---|---|---|---|
| SG2 | Mixed species shrubs: includes Yew. Rhododendron, Laurel (Cherry and Portuguese), Cypress, Holly, Pittosporum and Acer. | 1 | 4.6 | 5.8 | C - Insured | Action to avoid future risk | Subject to regular management; maintain at broadly current dimensions by way of regular pruning. |

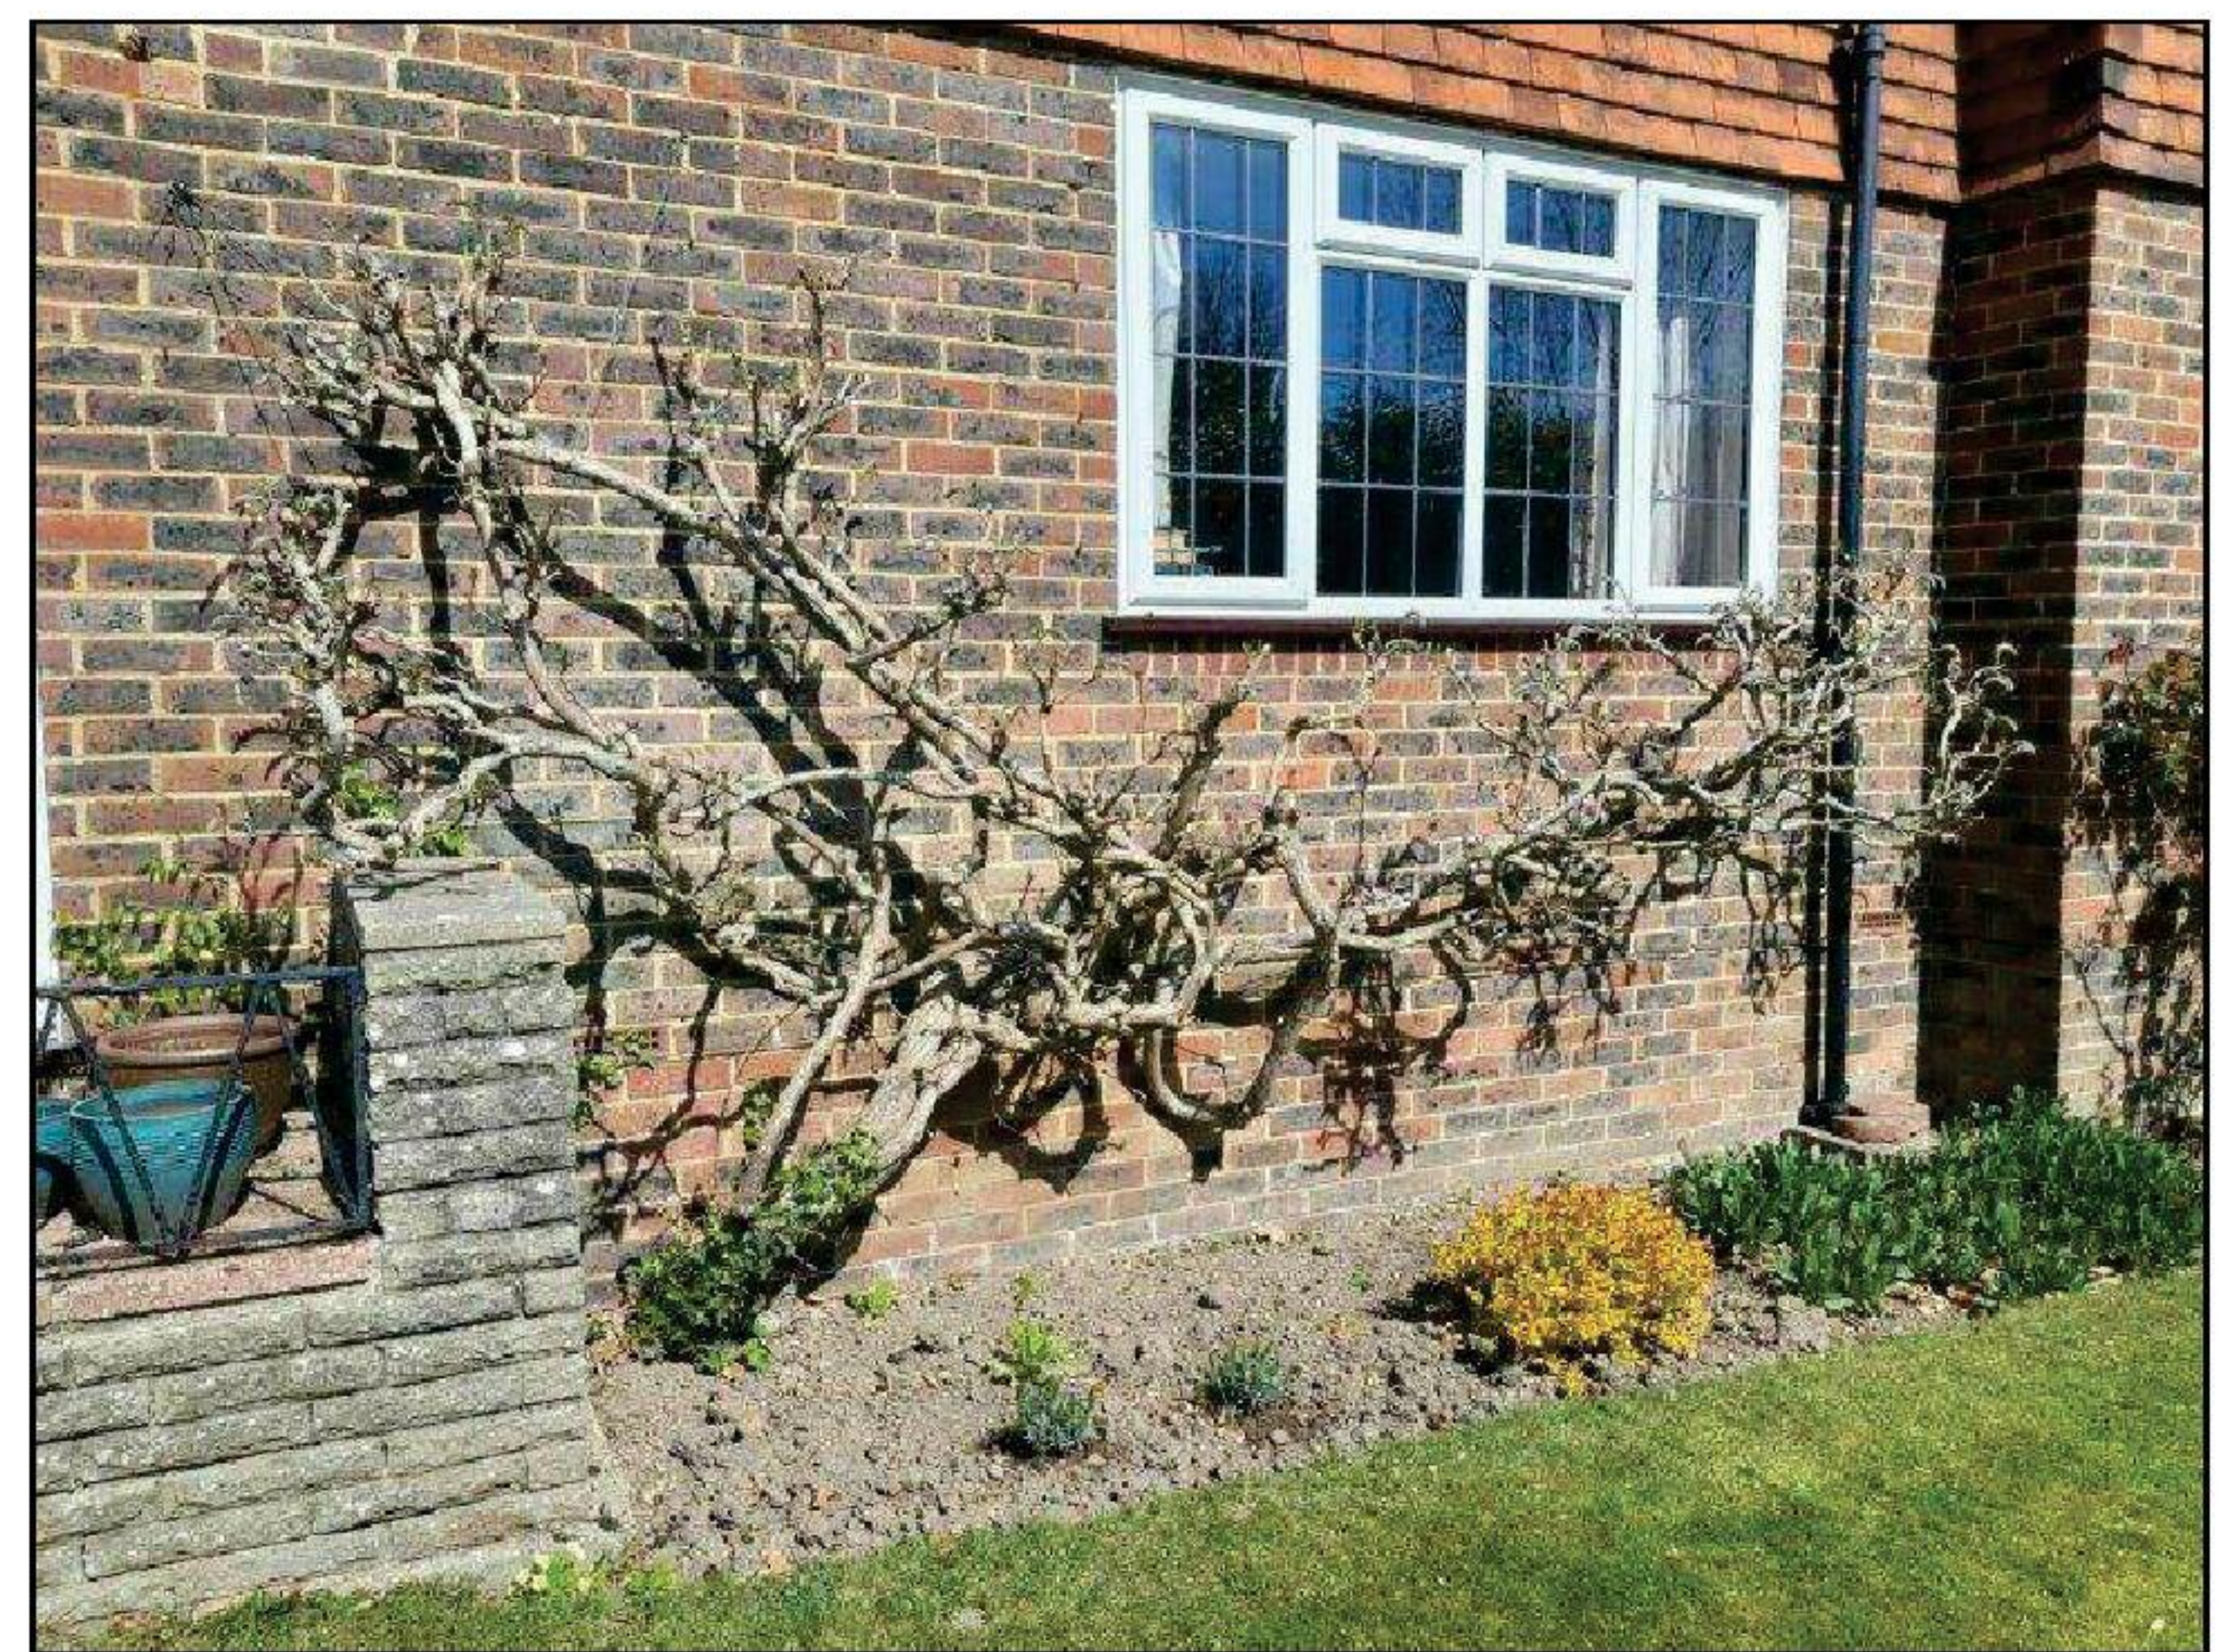
C1 - Wisteria

| Tree No. | Species | Age Cat | Approx. Height (m) | Distance to Building (m) * | Ownership | Action | Requirement |
|---|---|---|---|---|---|---|---|
| C1 | Wisteria | 1 | 2.3 | 0 | C - Insured | Action to avoid future risk | Subject to regular management; maintain at broadly current dimensions by way of regular pruning. |

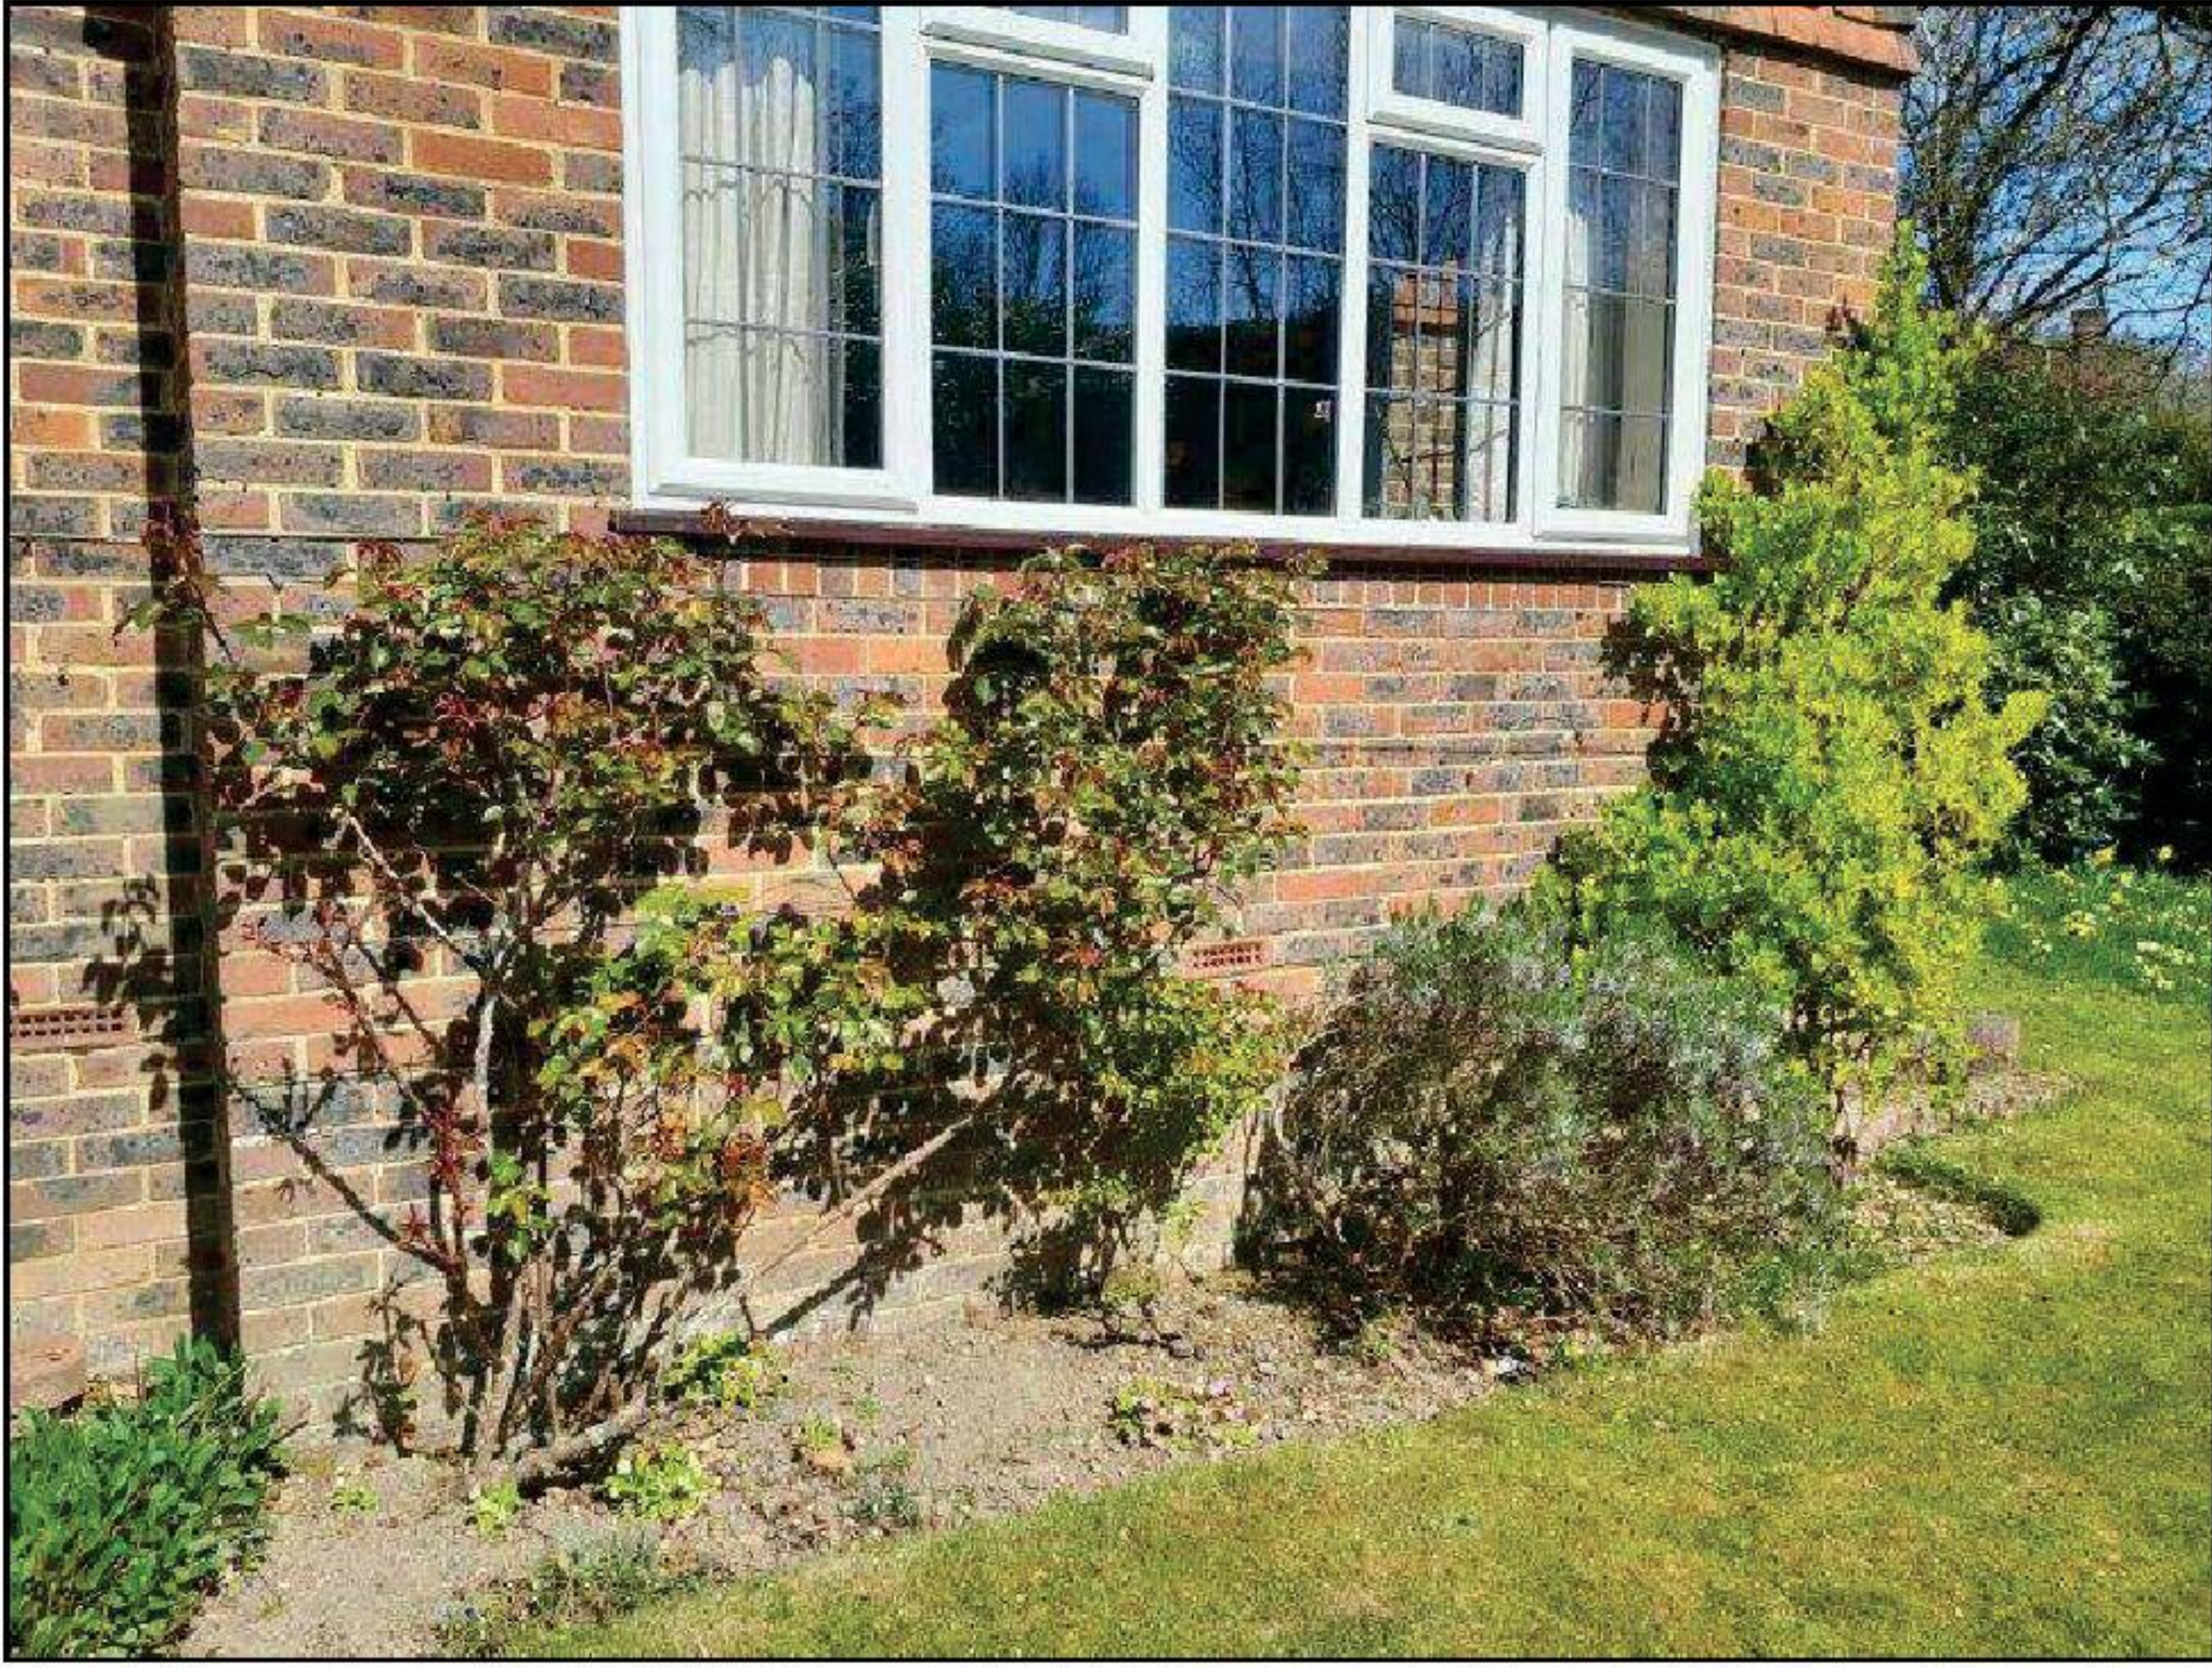
SG1 - Mixed Species Group

| Tree No. | Species | Age Cat | Approx. Height (m) | Distance to Building (m) * | Ownership | Action | Requirement |
|---|---|---|---|---|---|---|---|
| SG1 | Mixed species shrubs: Euonymus, Lavender and Rose. | 1 | 2.5 | 0.2 | C - Insured | Action to avoid future risk | Subject to regular management; maintain at broadly current dimensions by way of regular pruning. |
