# Arboricultural Consultancy for Royal & Sun Alliance

| Insured | Mrs Susan Keymer | Address | 1 Calbourne , Haywards Heath , RH16 4AQ | | |
| Client | Subsidence Management Services | Contact | Richard Bryant | Claim No. | IFS-RSA-SUB-25-0116647 |

## 2. Property and Damage Description

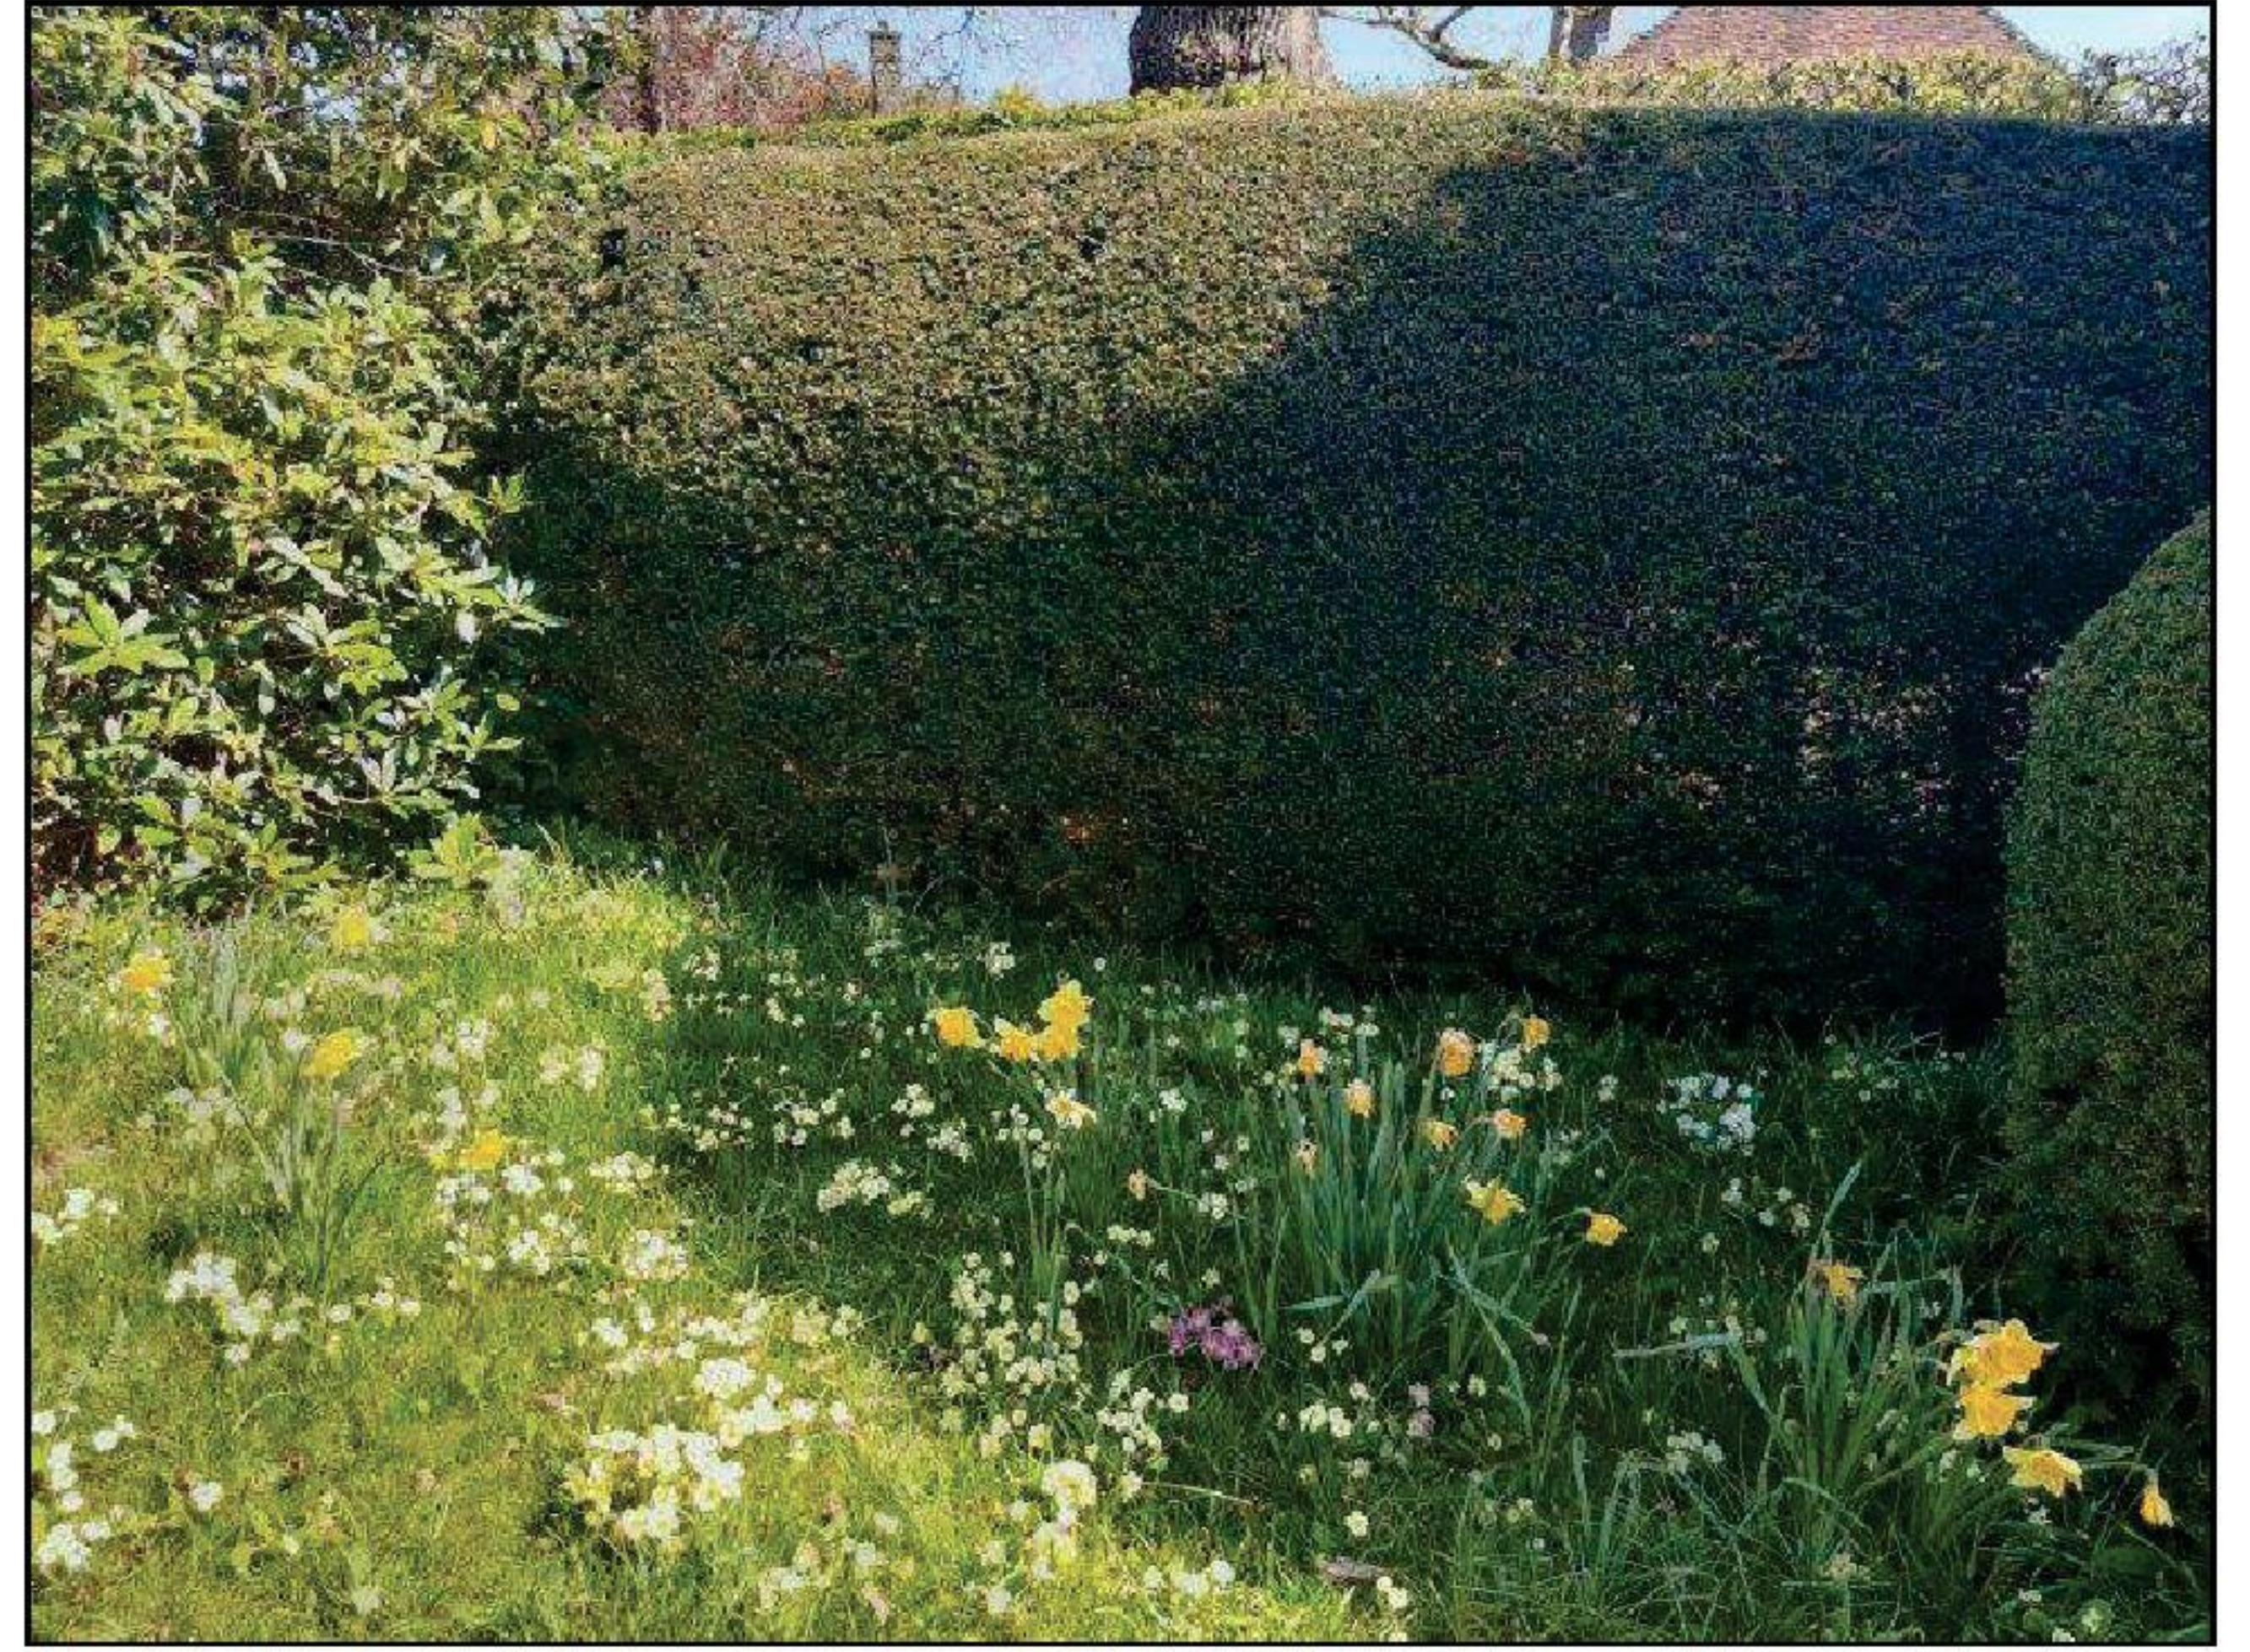
H2 - Yew

| Tree No. | Species | Age Cat | Approx. Height (m) | Distance to Building (m) * | Ownership | Action | Requirement |
|---|---|---|---|---|---|---|---|
| H2 | Yew (Common) | 1 | 2.2 | 5.7 | C - Insured | Action to avoid future risk | Subject to regular management; maintain at broadly current dimensions by way of regular pruning. |

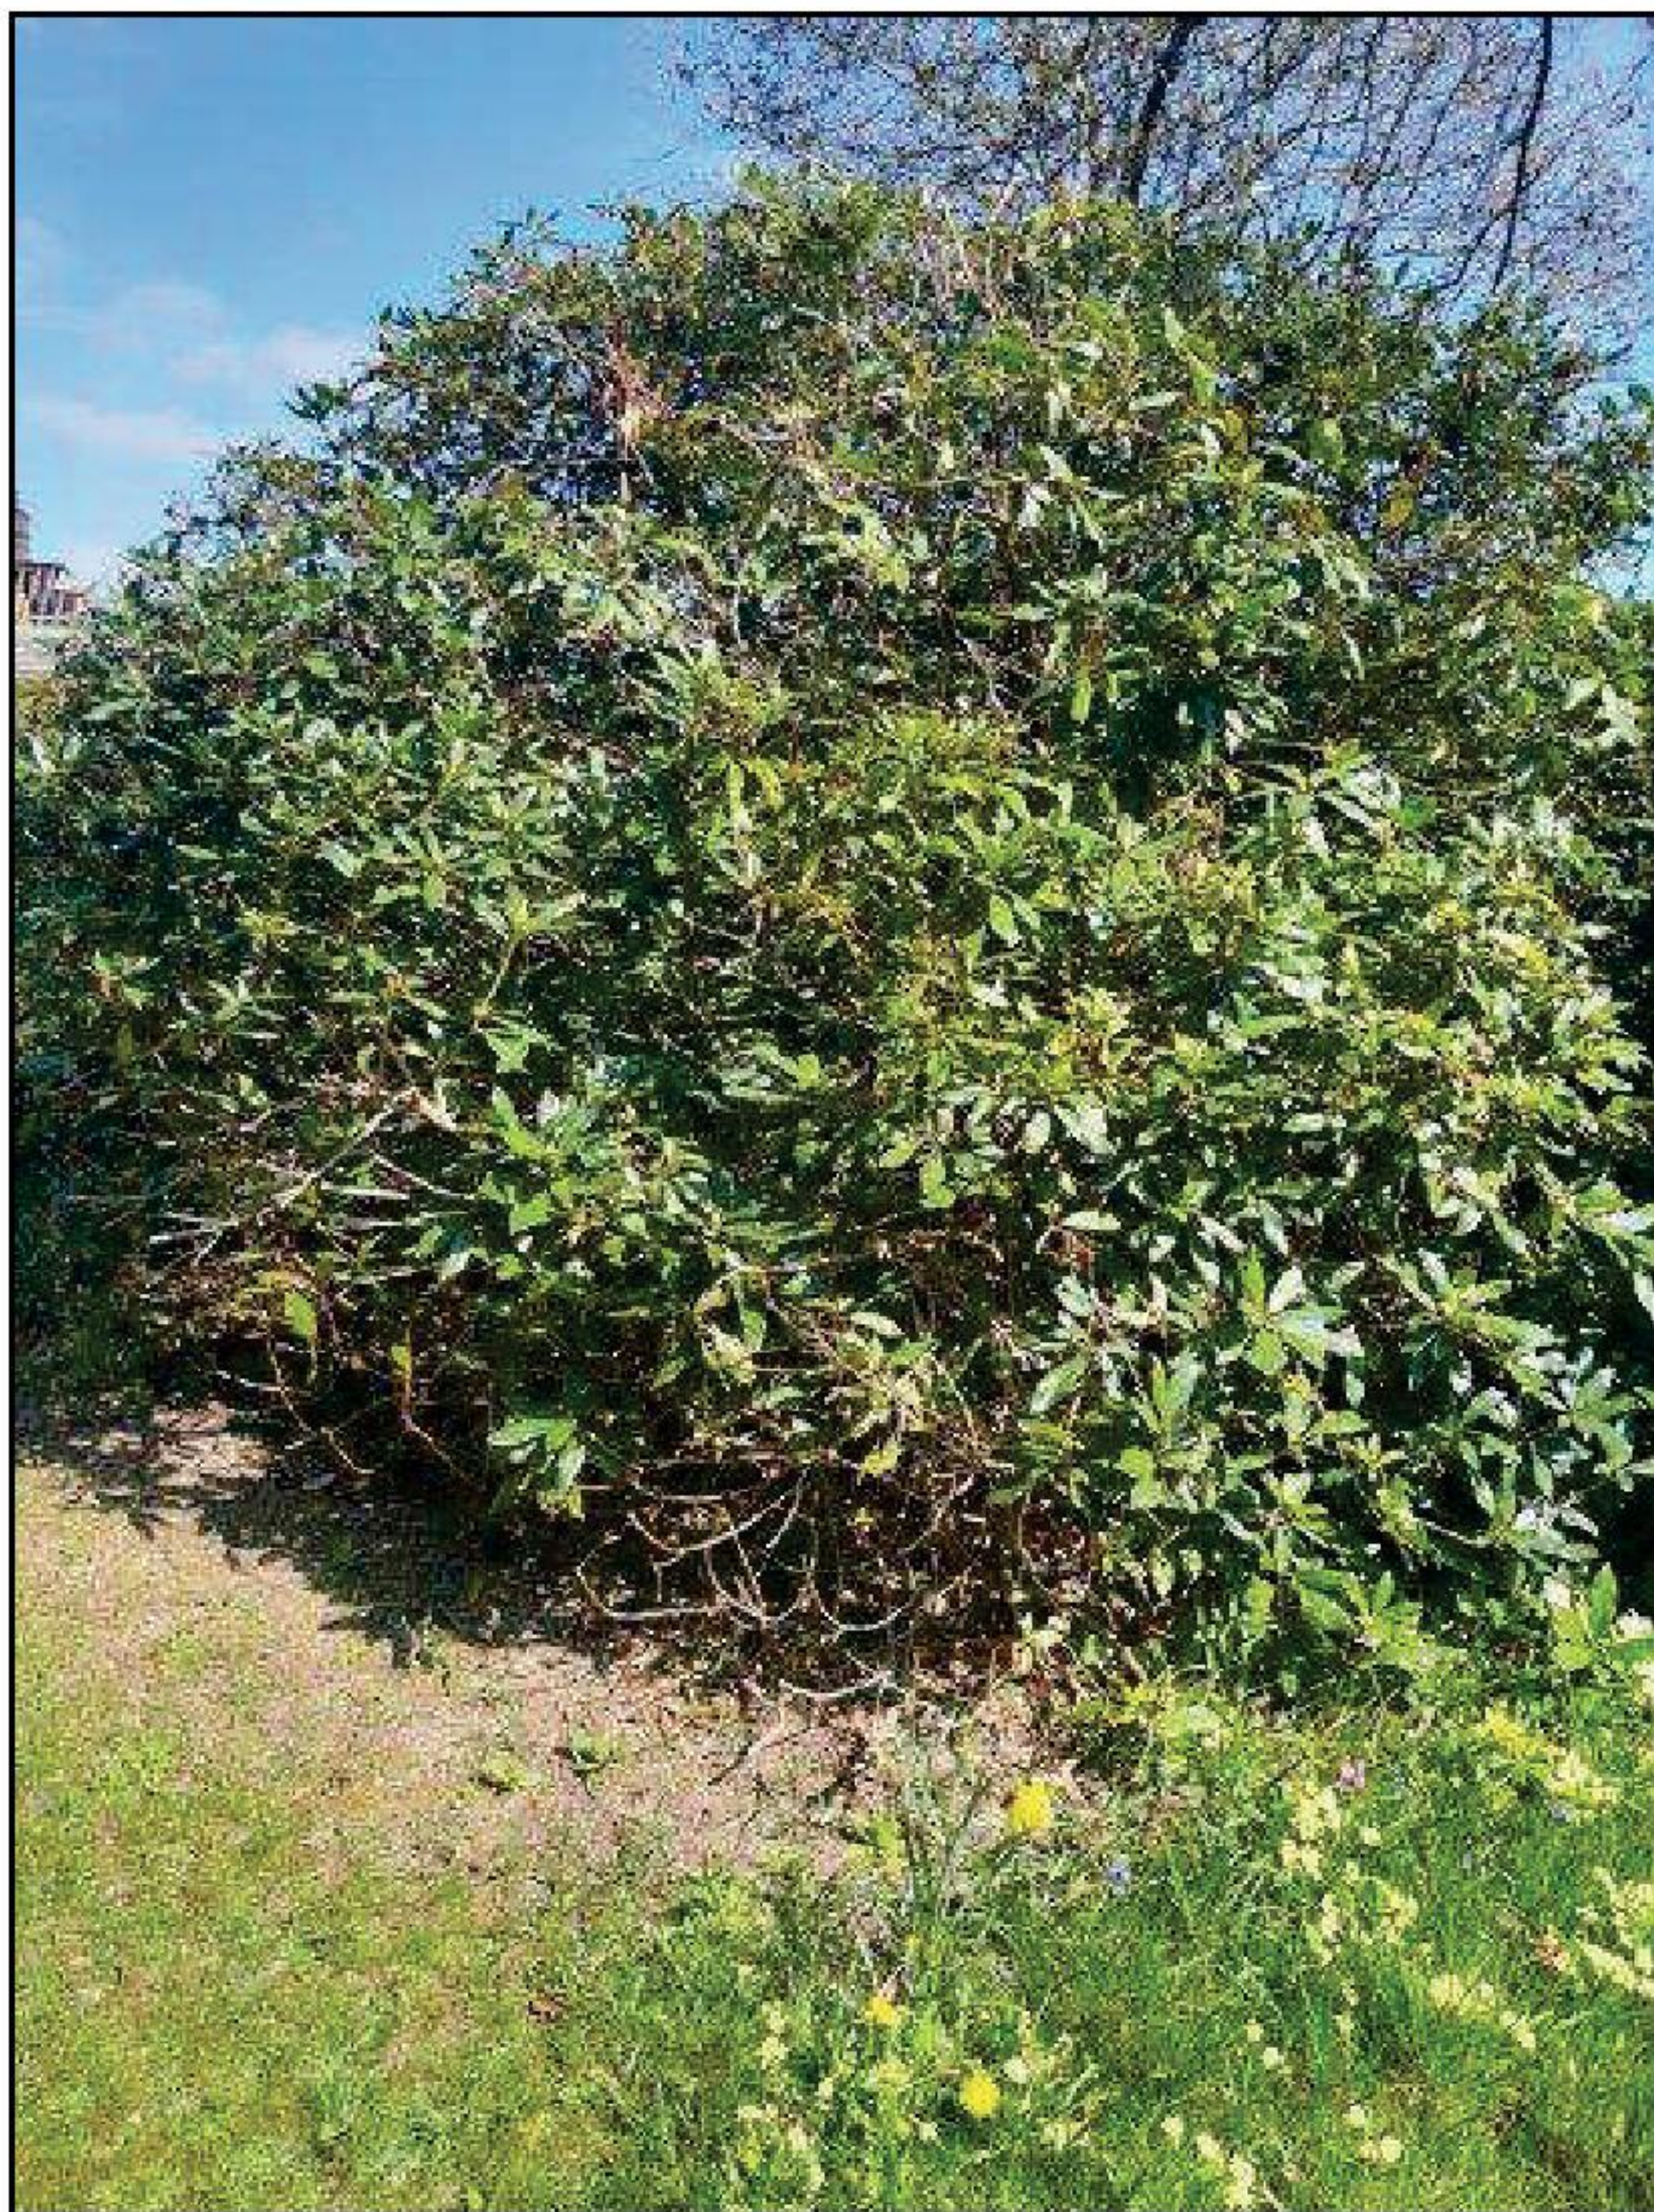
S1 - Rhododendron

| Tree No. | Species | Age Cat | Approx. Height (m) | Distance to Building (m) * | Ownership | Action | Requirement |
|---|---|---|---|---|---|---|---|
| S1 | Rhododendron | 1 | 3 | 5.7 | C - Insured | Action to avoid future risk | Maintain at broadly current dimensions by way of regular pruning. |

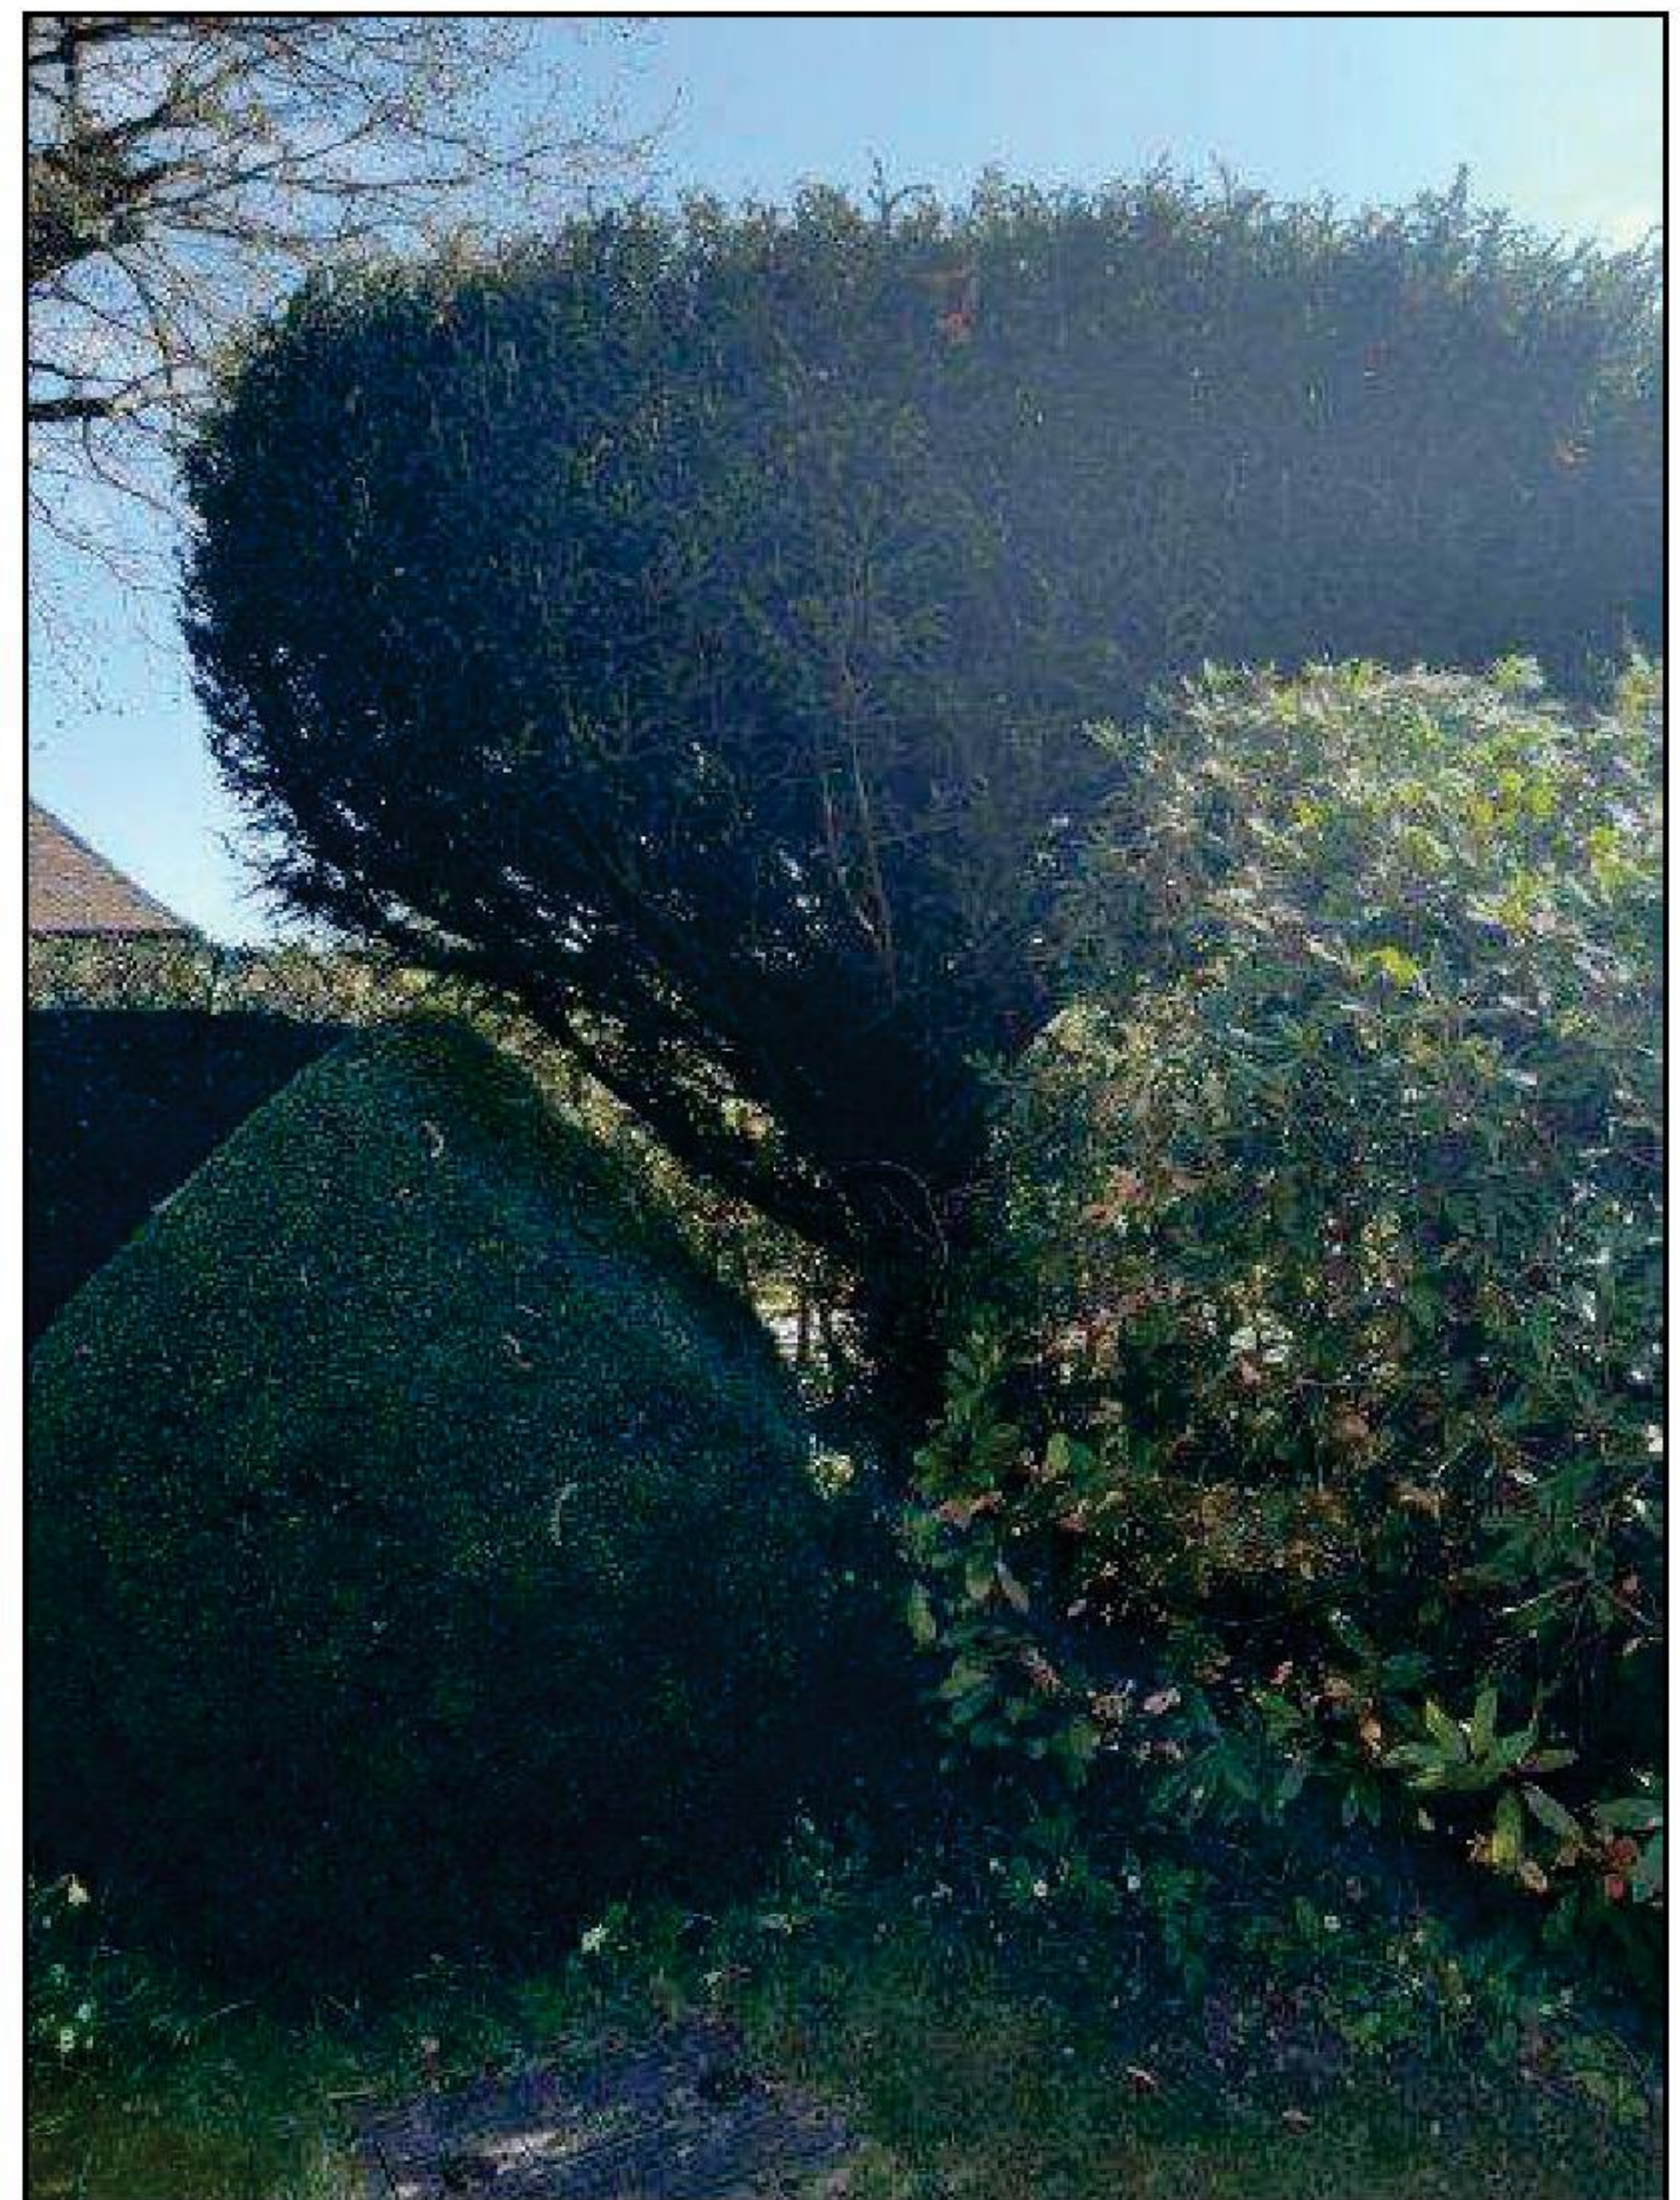
T1 & T2 (Yew)

Given the presence of Taxus spp. roots, the heavily pruned Yew (T1) cannot be discounted as contributing to the overall level of soil drying proximate to the advised area of damage and is therefore also considered to be exerting a contributory influence, albeit in a limited / localised capacity when compared to T3.

| Tree No. | Species | Age Cat | Approx. Height (m) | Distance to Building (m) * | Ownership | Action | Requirement |
|---|---|---|---|---|---|---|---|
| T1 | Yew (Common) | 1 | 3.8 | 7.4 | C - Insured | Remove | Remove close to ground level; do not treat stump due to translocation risk. Where such a risk exists, we advise that any emergent regrowth is removed annually. |

| Tree No. | Species | Age Cat | Approx. Height (m) | Distance to Building (m) * | Ownership | Action | Requirement |
|---|---|---|---|---|---|---|---|
| T2 | Yew (Common) | 1 | 2.2 | 5.5 | C - Insured | Action to avoid future risk | Subject to regular management; maintain at broadly current dimensions by way of regular pruning. |

With regards to T1 (Yew) we have advocated its complete removal as this will offer the most certain / reliable long-term solution.

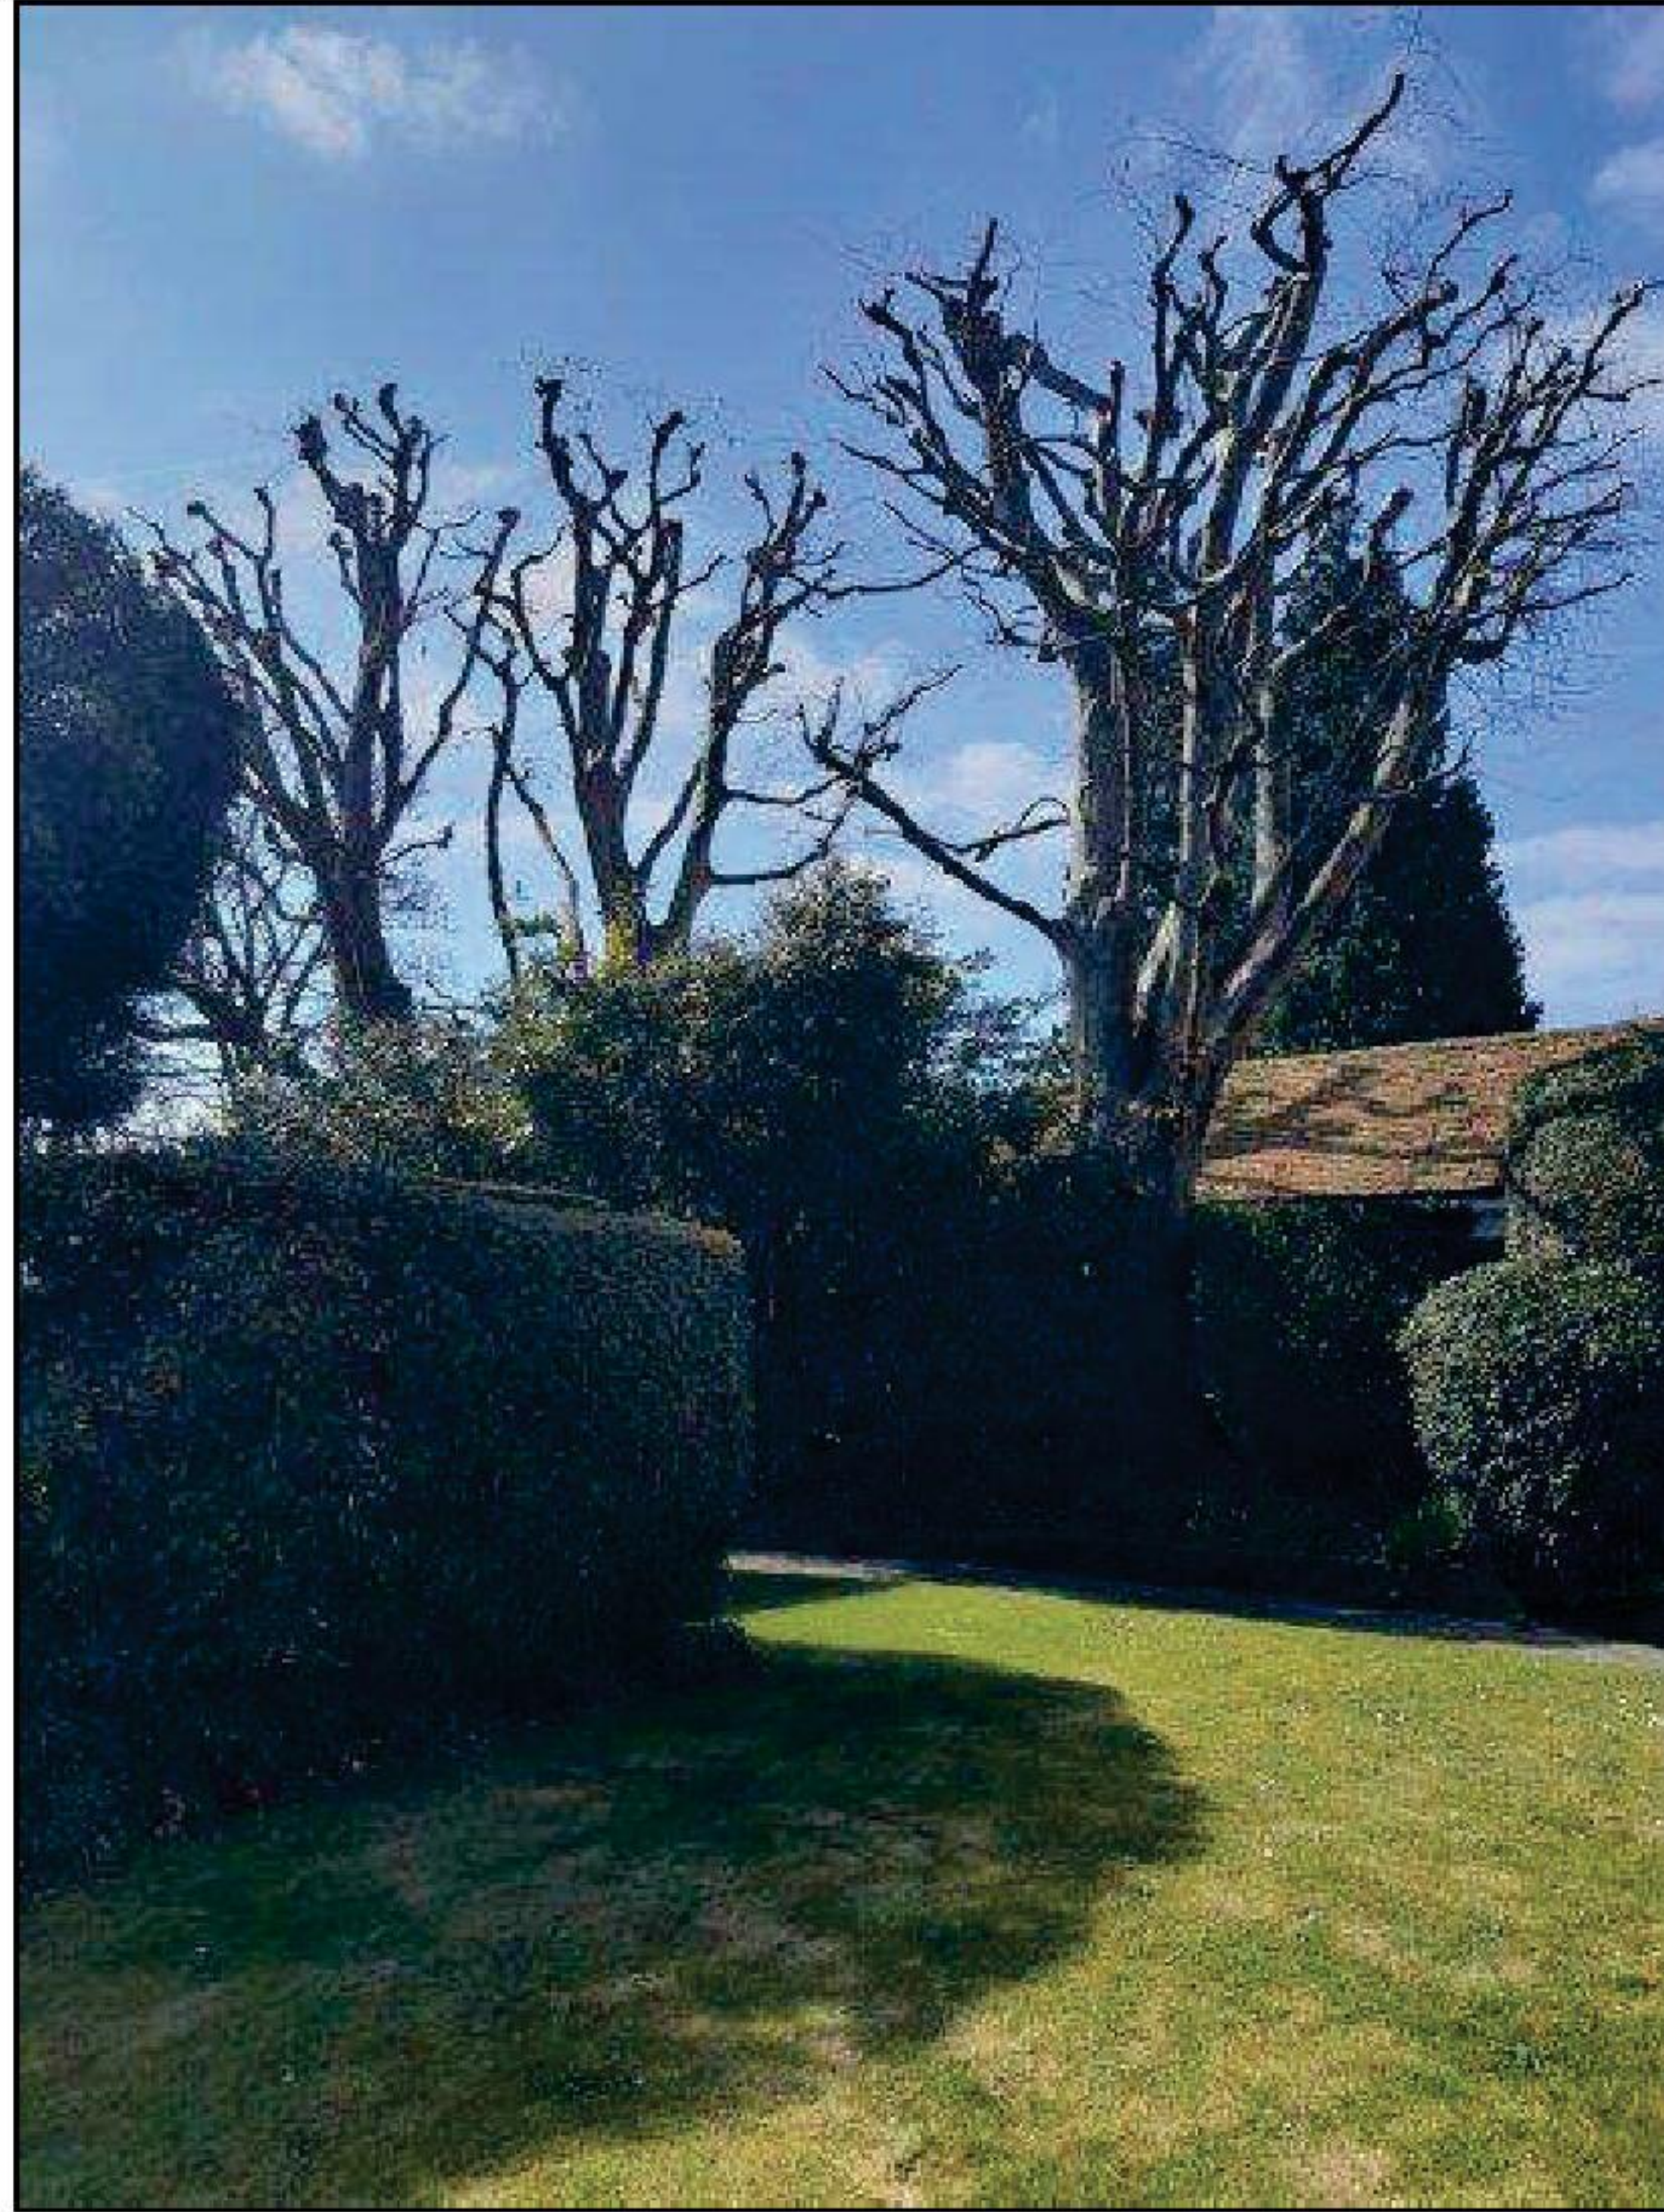
TG1 - Beech

| Tree No. | Species | Age Cat | Approx. Height (m) | Distance to Building (m) * | Ownership | Action | Requirement |
|---|---|---|---|---|---|---|---|
| TG1 | Beech | 2 | 11.2 | 14.7 | C - Insured | Action to avoid future risk | Recently reduced: maintain at reduced dimensions by way of routine re-pruning to restrict regrowth below pre-pruning dimensions. |

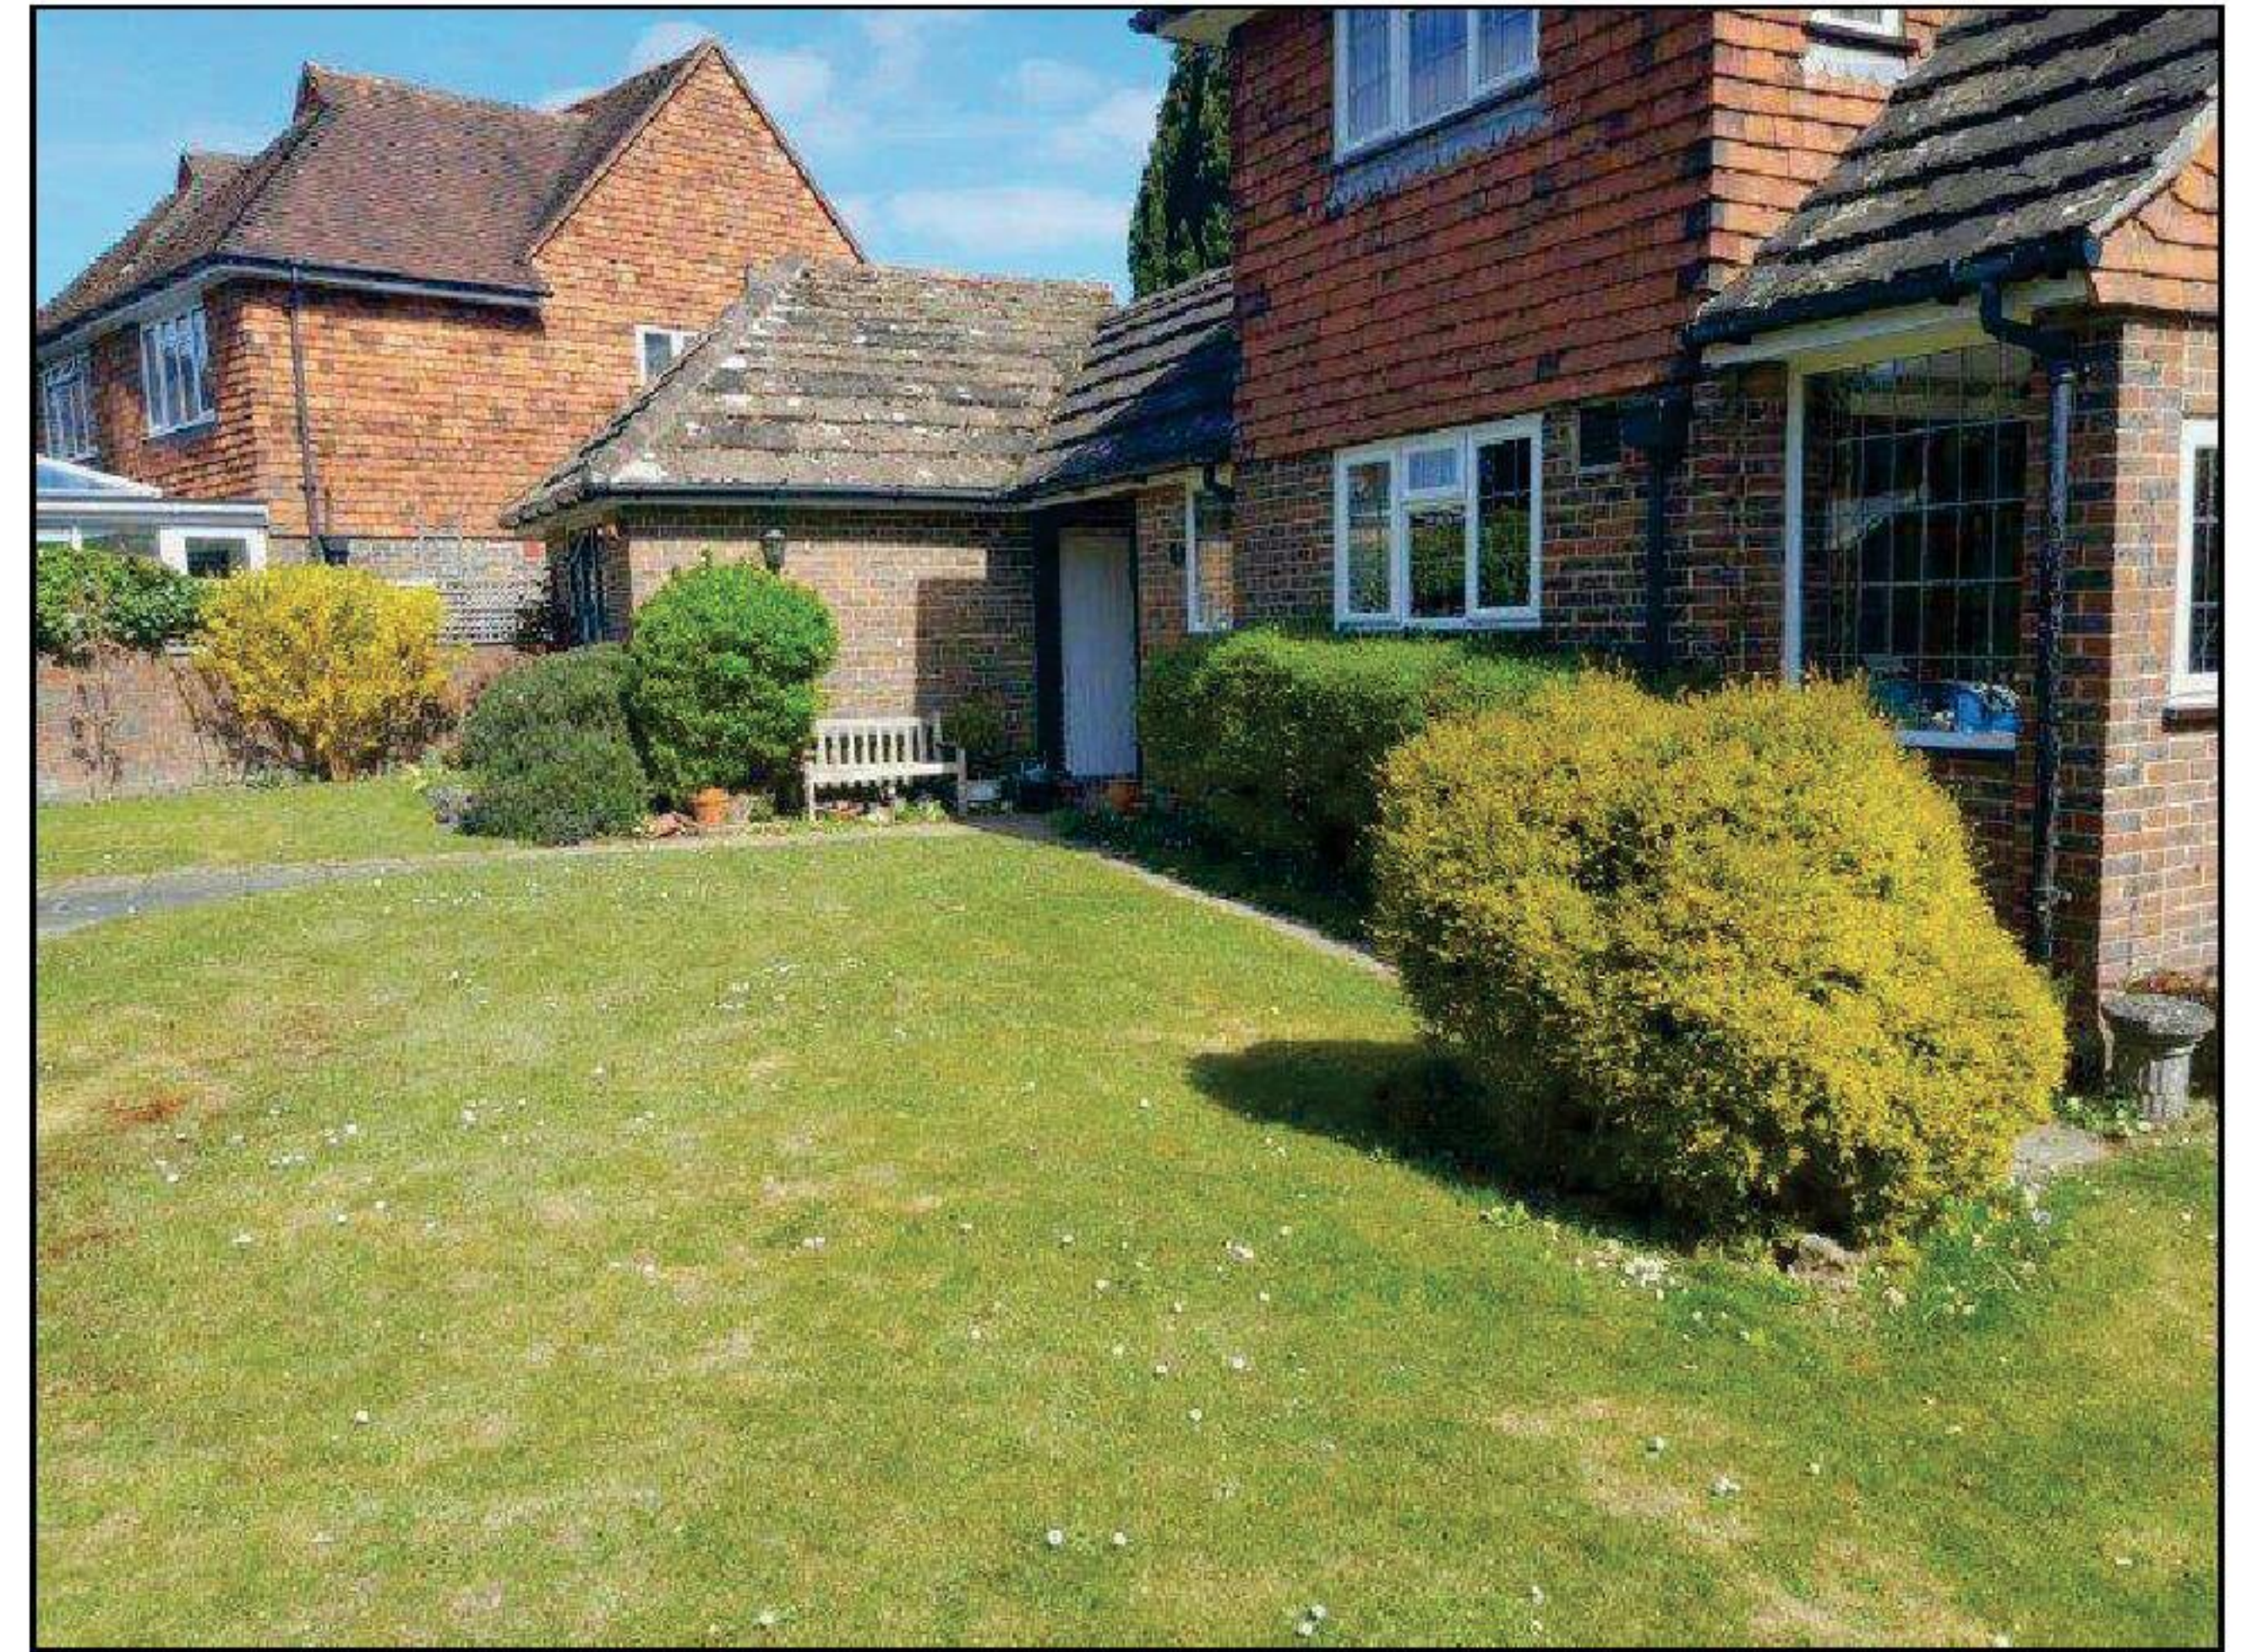
SG3 - Mixed Species Shrubs

| Tree No. | Species | Age Cat | Approx. Height (m) | Distance to Building (m) * | Ownership | Action | Requirement |
|---|---|---|---|---|---|---|---|
| SG3 | Mixed species shrubs: includes Jasmine, Lonicera, Euonymus, Lavender, Rose & Pyracantha. | 1 | 2 | 0.1 | C - Insured | Action to avoid future risk | Subject to regular management; maintain at broadly current dimensions by way of regular pruning. |
