# Arboricultural Consultancy for Royal & Sun Alliance

| Insured | Mrs Susan Keymer | Address | 1 Calbourne , Haywards Heath , RH16 4AQ | | |
| Client | Subsidence Management Services | Contact | Richard Bryant | Claim No. | IFS-RSA-SUB-25-0116647 |

## 2. Property and Damage Description

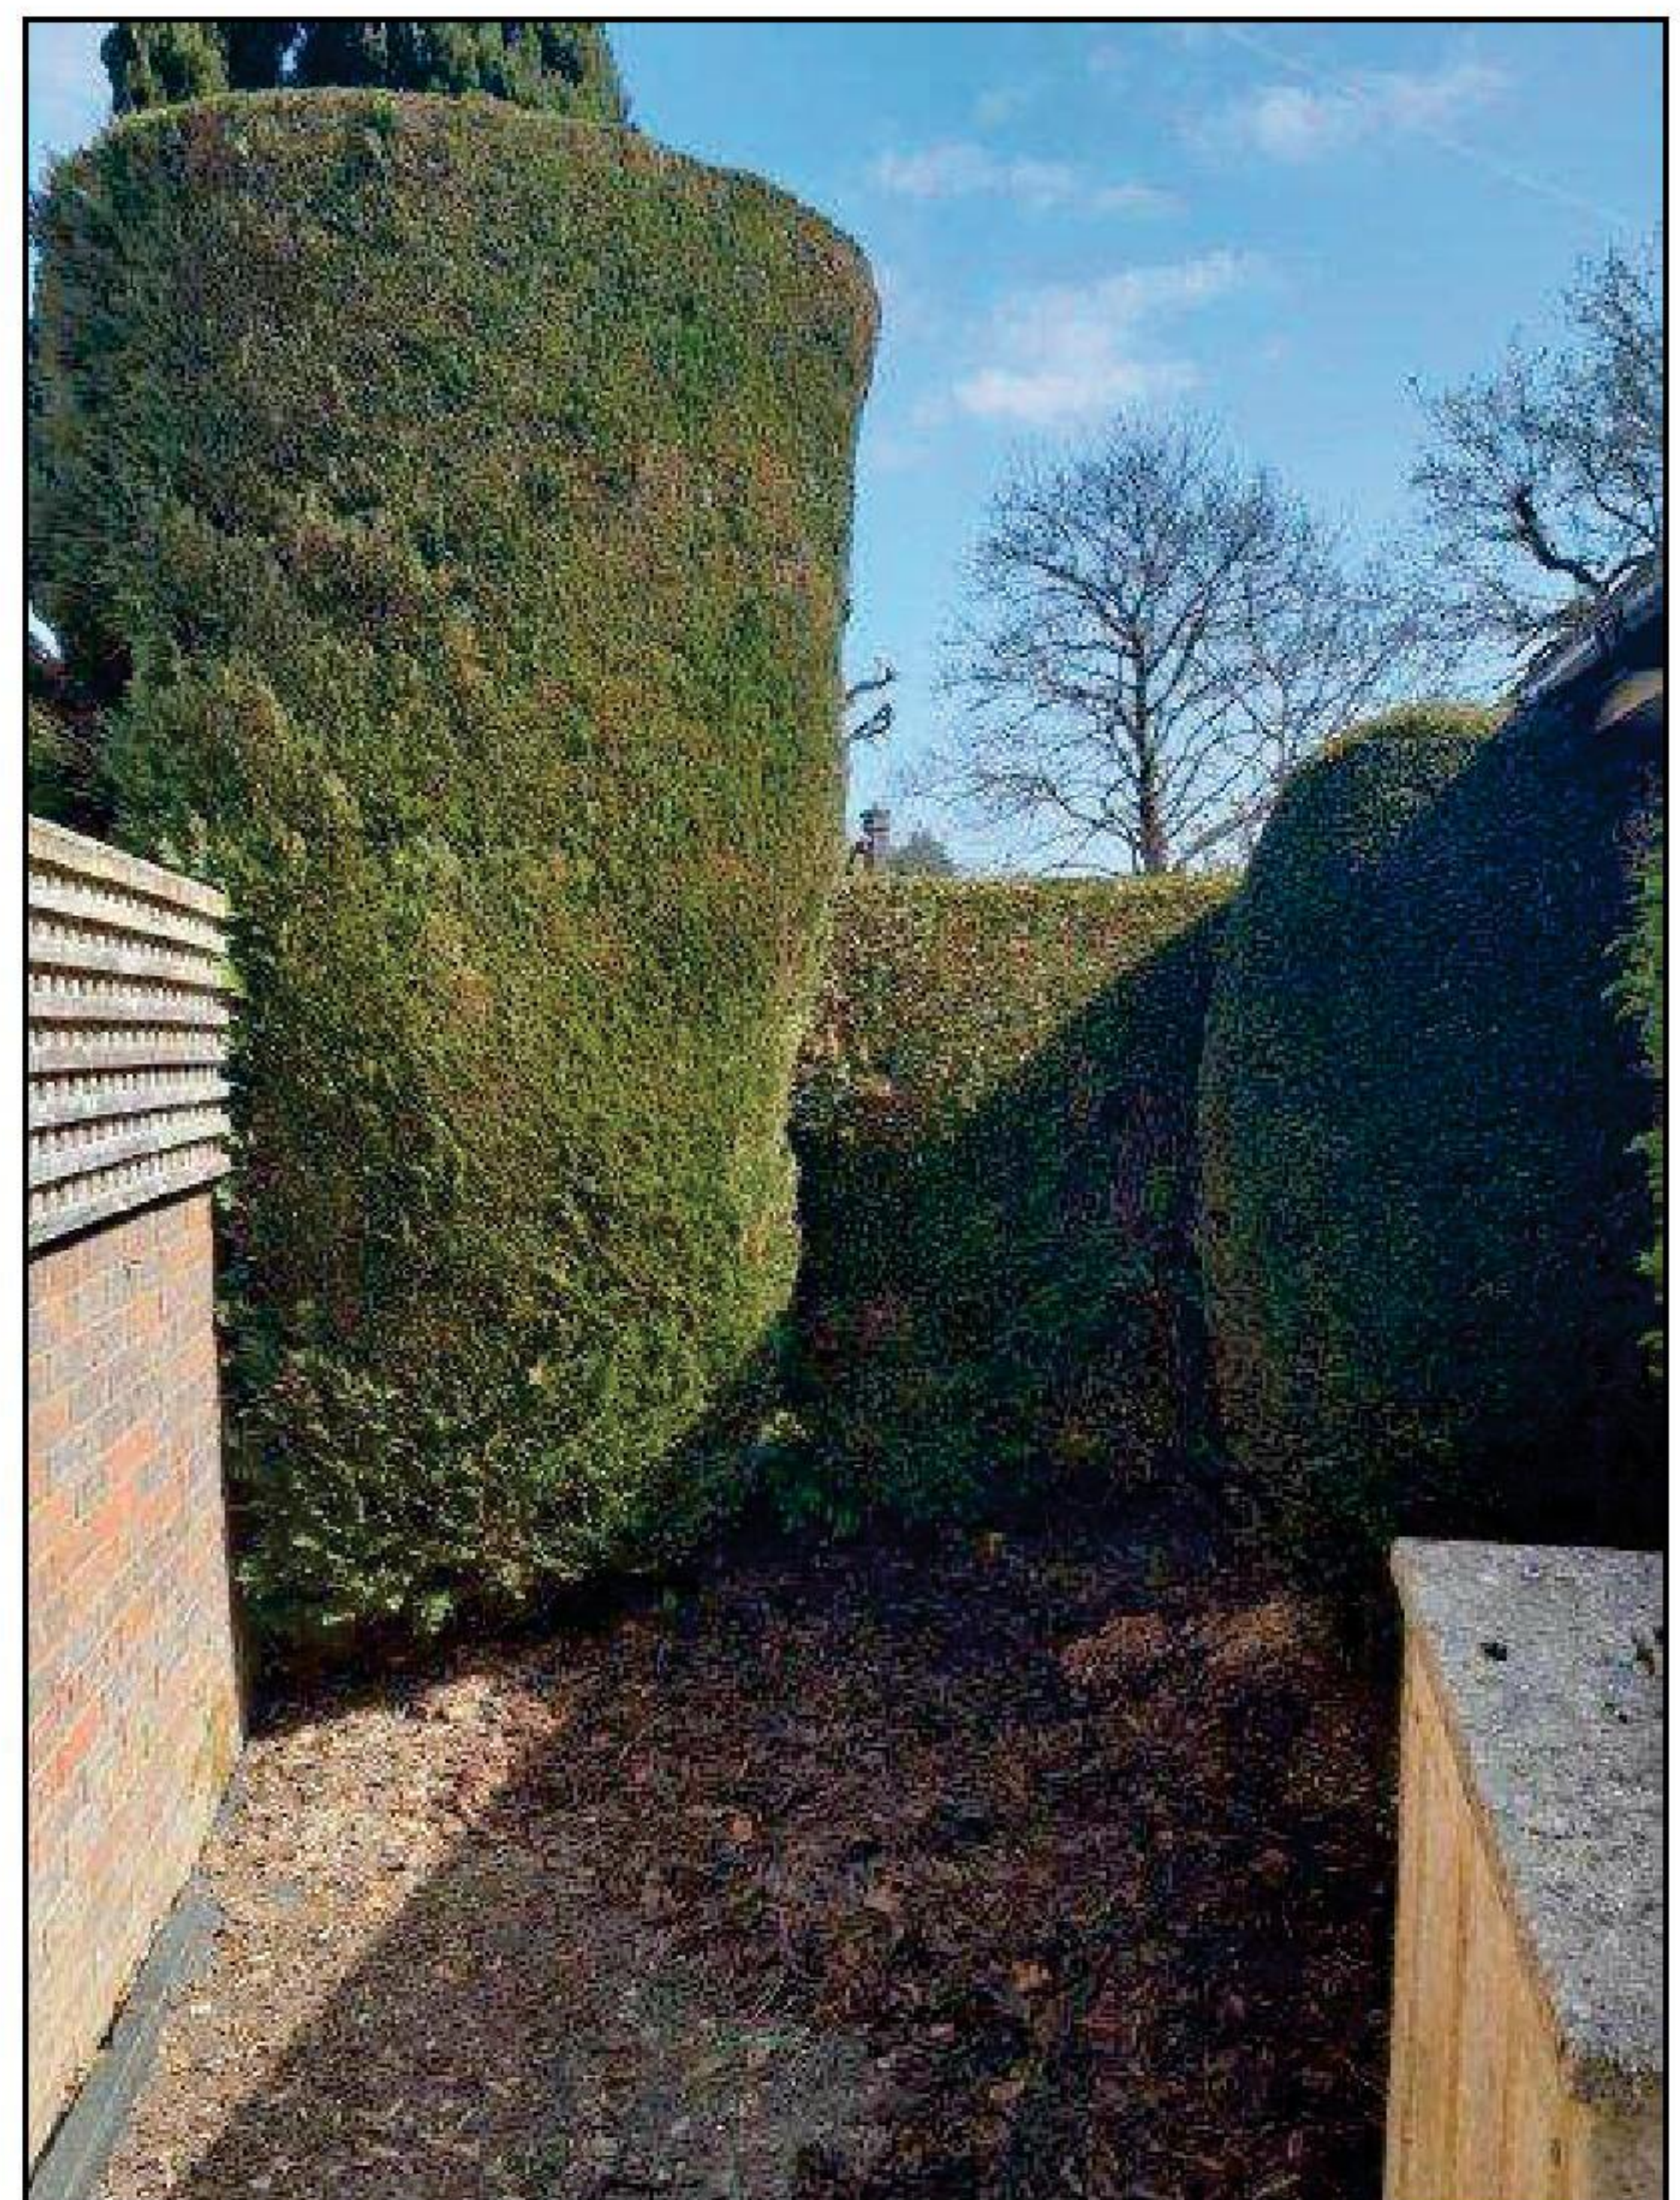
TG2 - Mixed Conifer Group

| Tree No. | Species | Age Cat | Approx. Height (m) | Distance to Building (m) * | Ownership | Action | Requirement |
|---|---|---|---|---|---|---|---|
| TG2 | Mixed coniferous group: Cypress and Yew group | 1 | 3.8 | 0.1 | C - Insured | Action to avoid future risk | Subject to regular management; maintain at broadly current dimensions by way of regular pruning. |

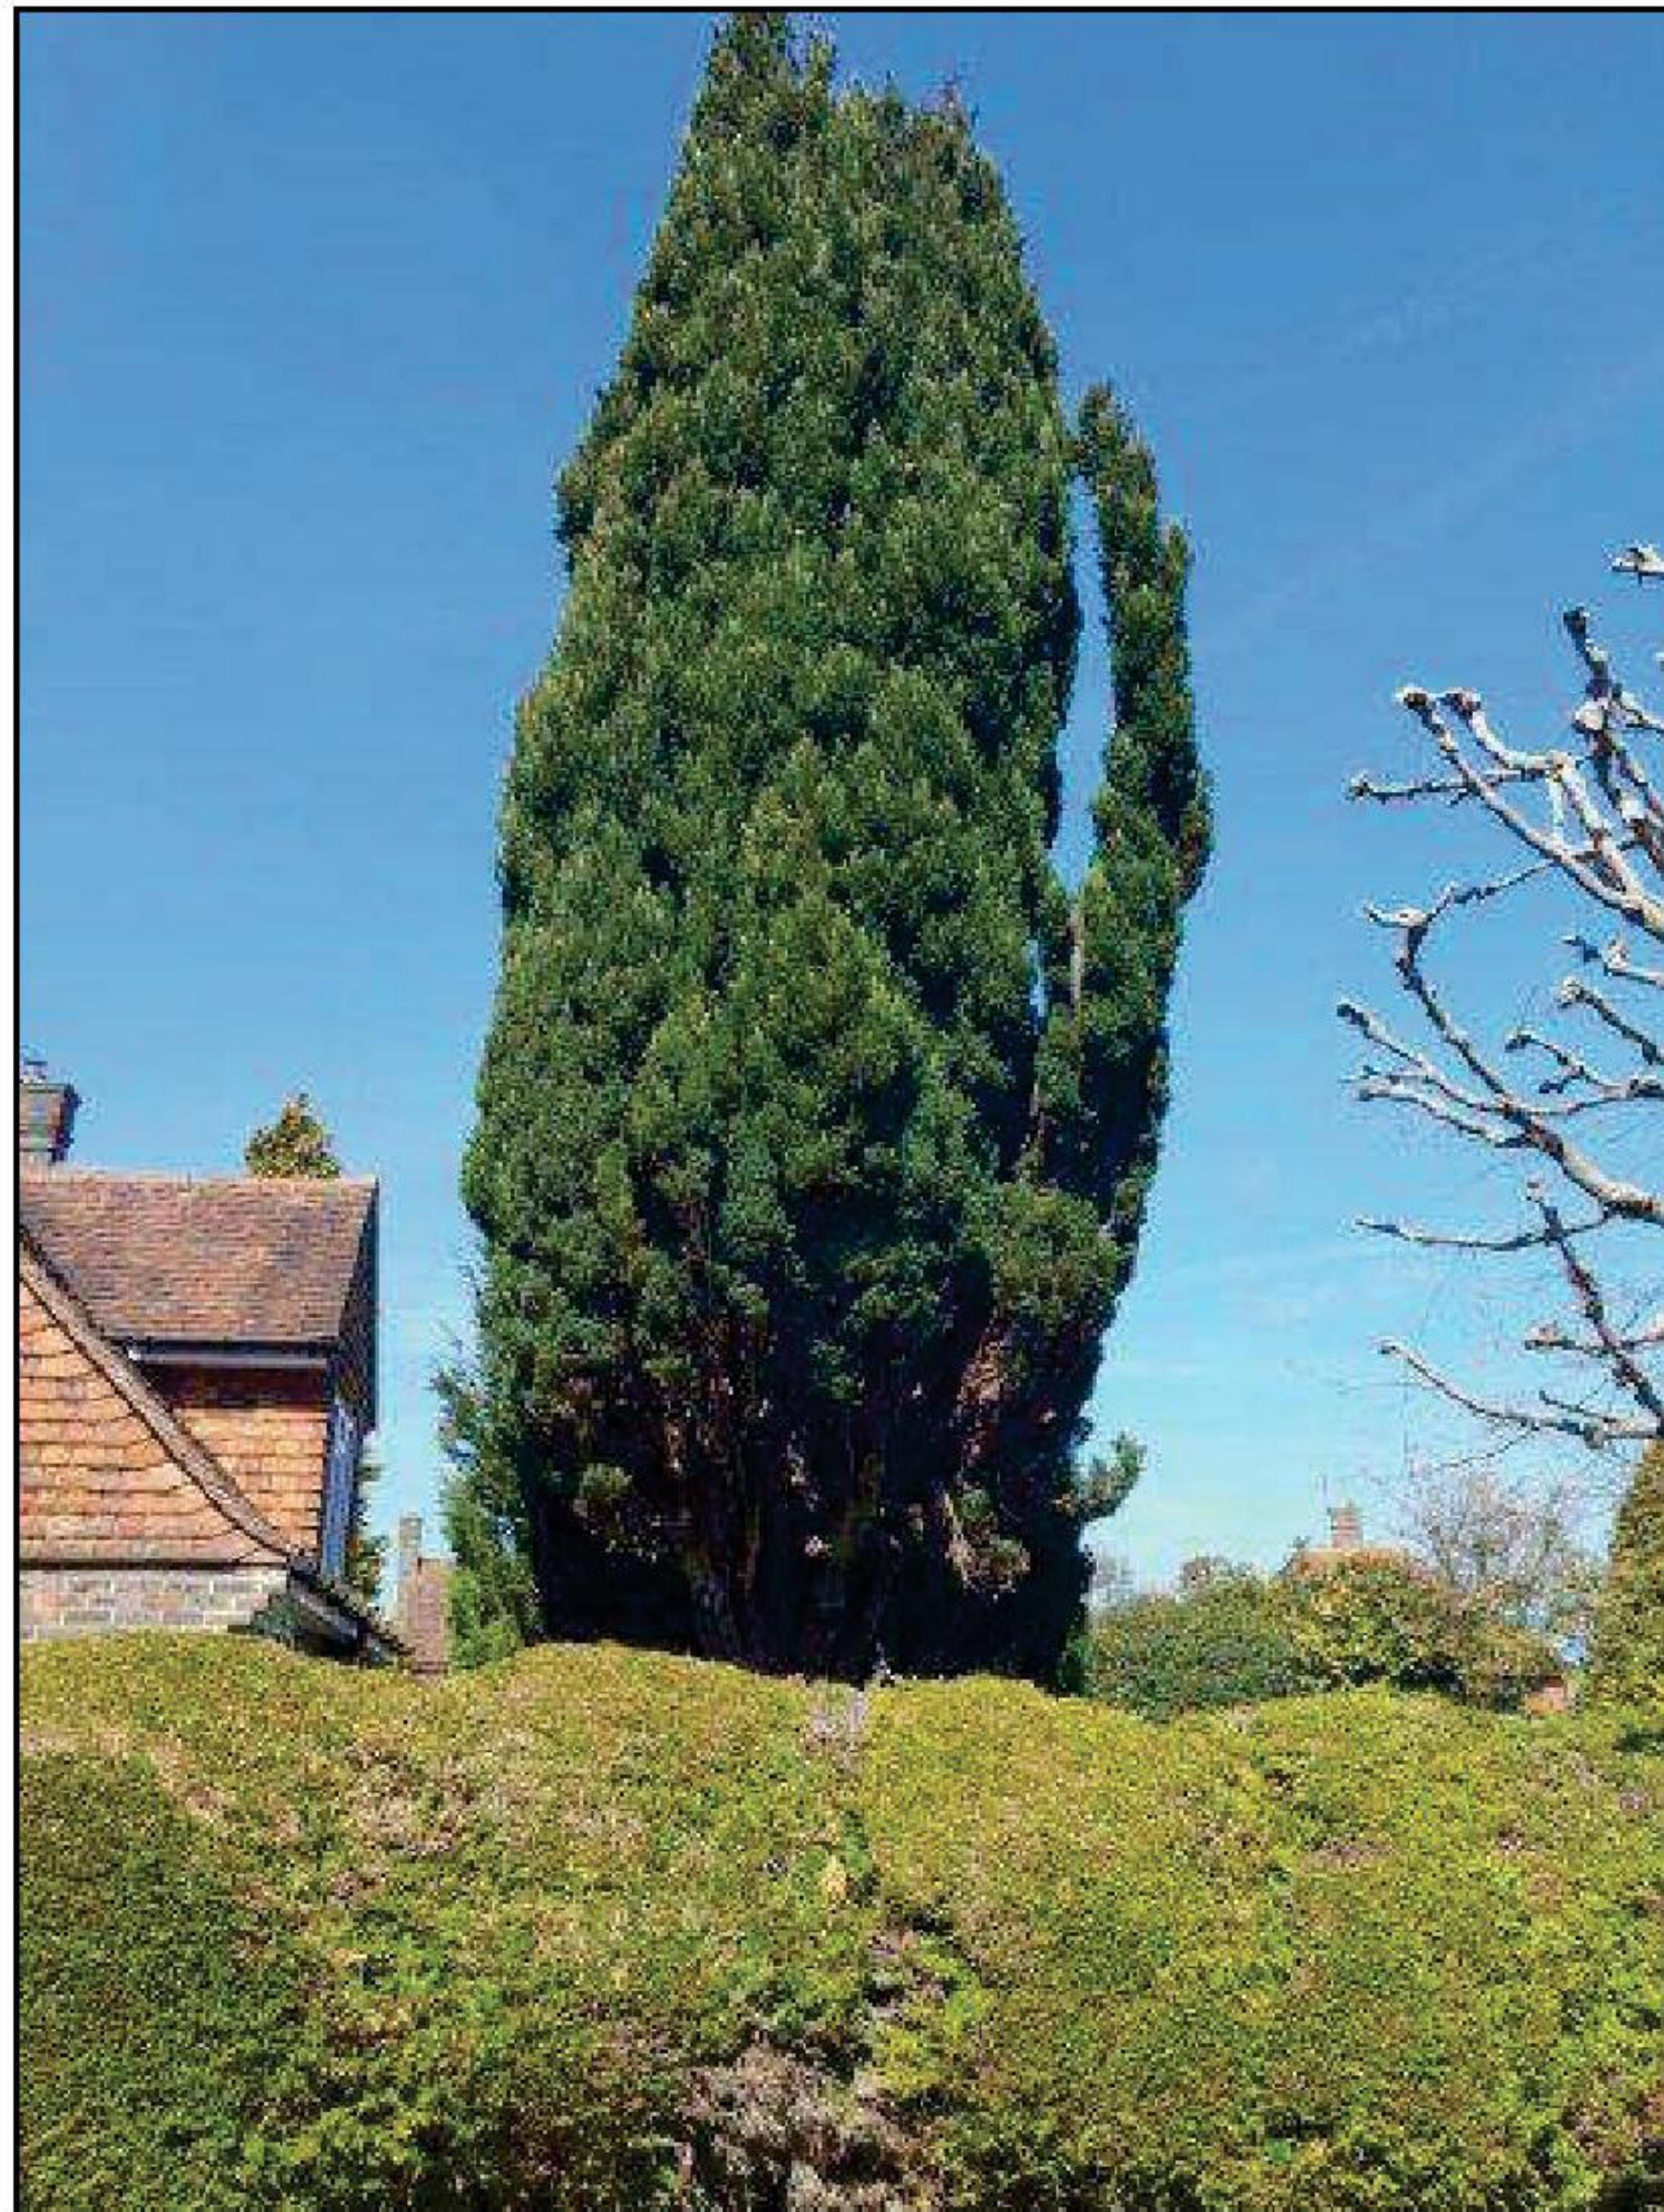
T4 - Cypress

| Tree No. | Species | Age Cat | Approx. Height (m) | Distance to Building (m) * | Ownership | Action | Requirement |
|---|---|---|---|---|---|---|---|
| T4 | Cypress | 1 | 10.2 | 7.8 | A - Third Party | Action to avoid future risk | Do not allow to exceed current dimensions by way of regular pruning. |

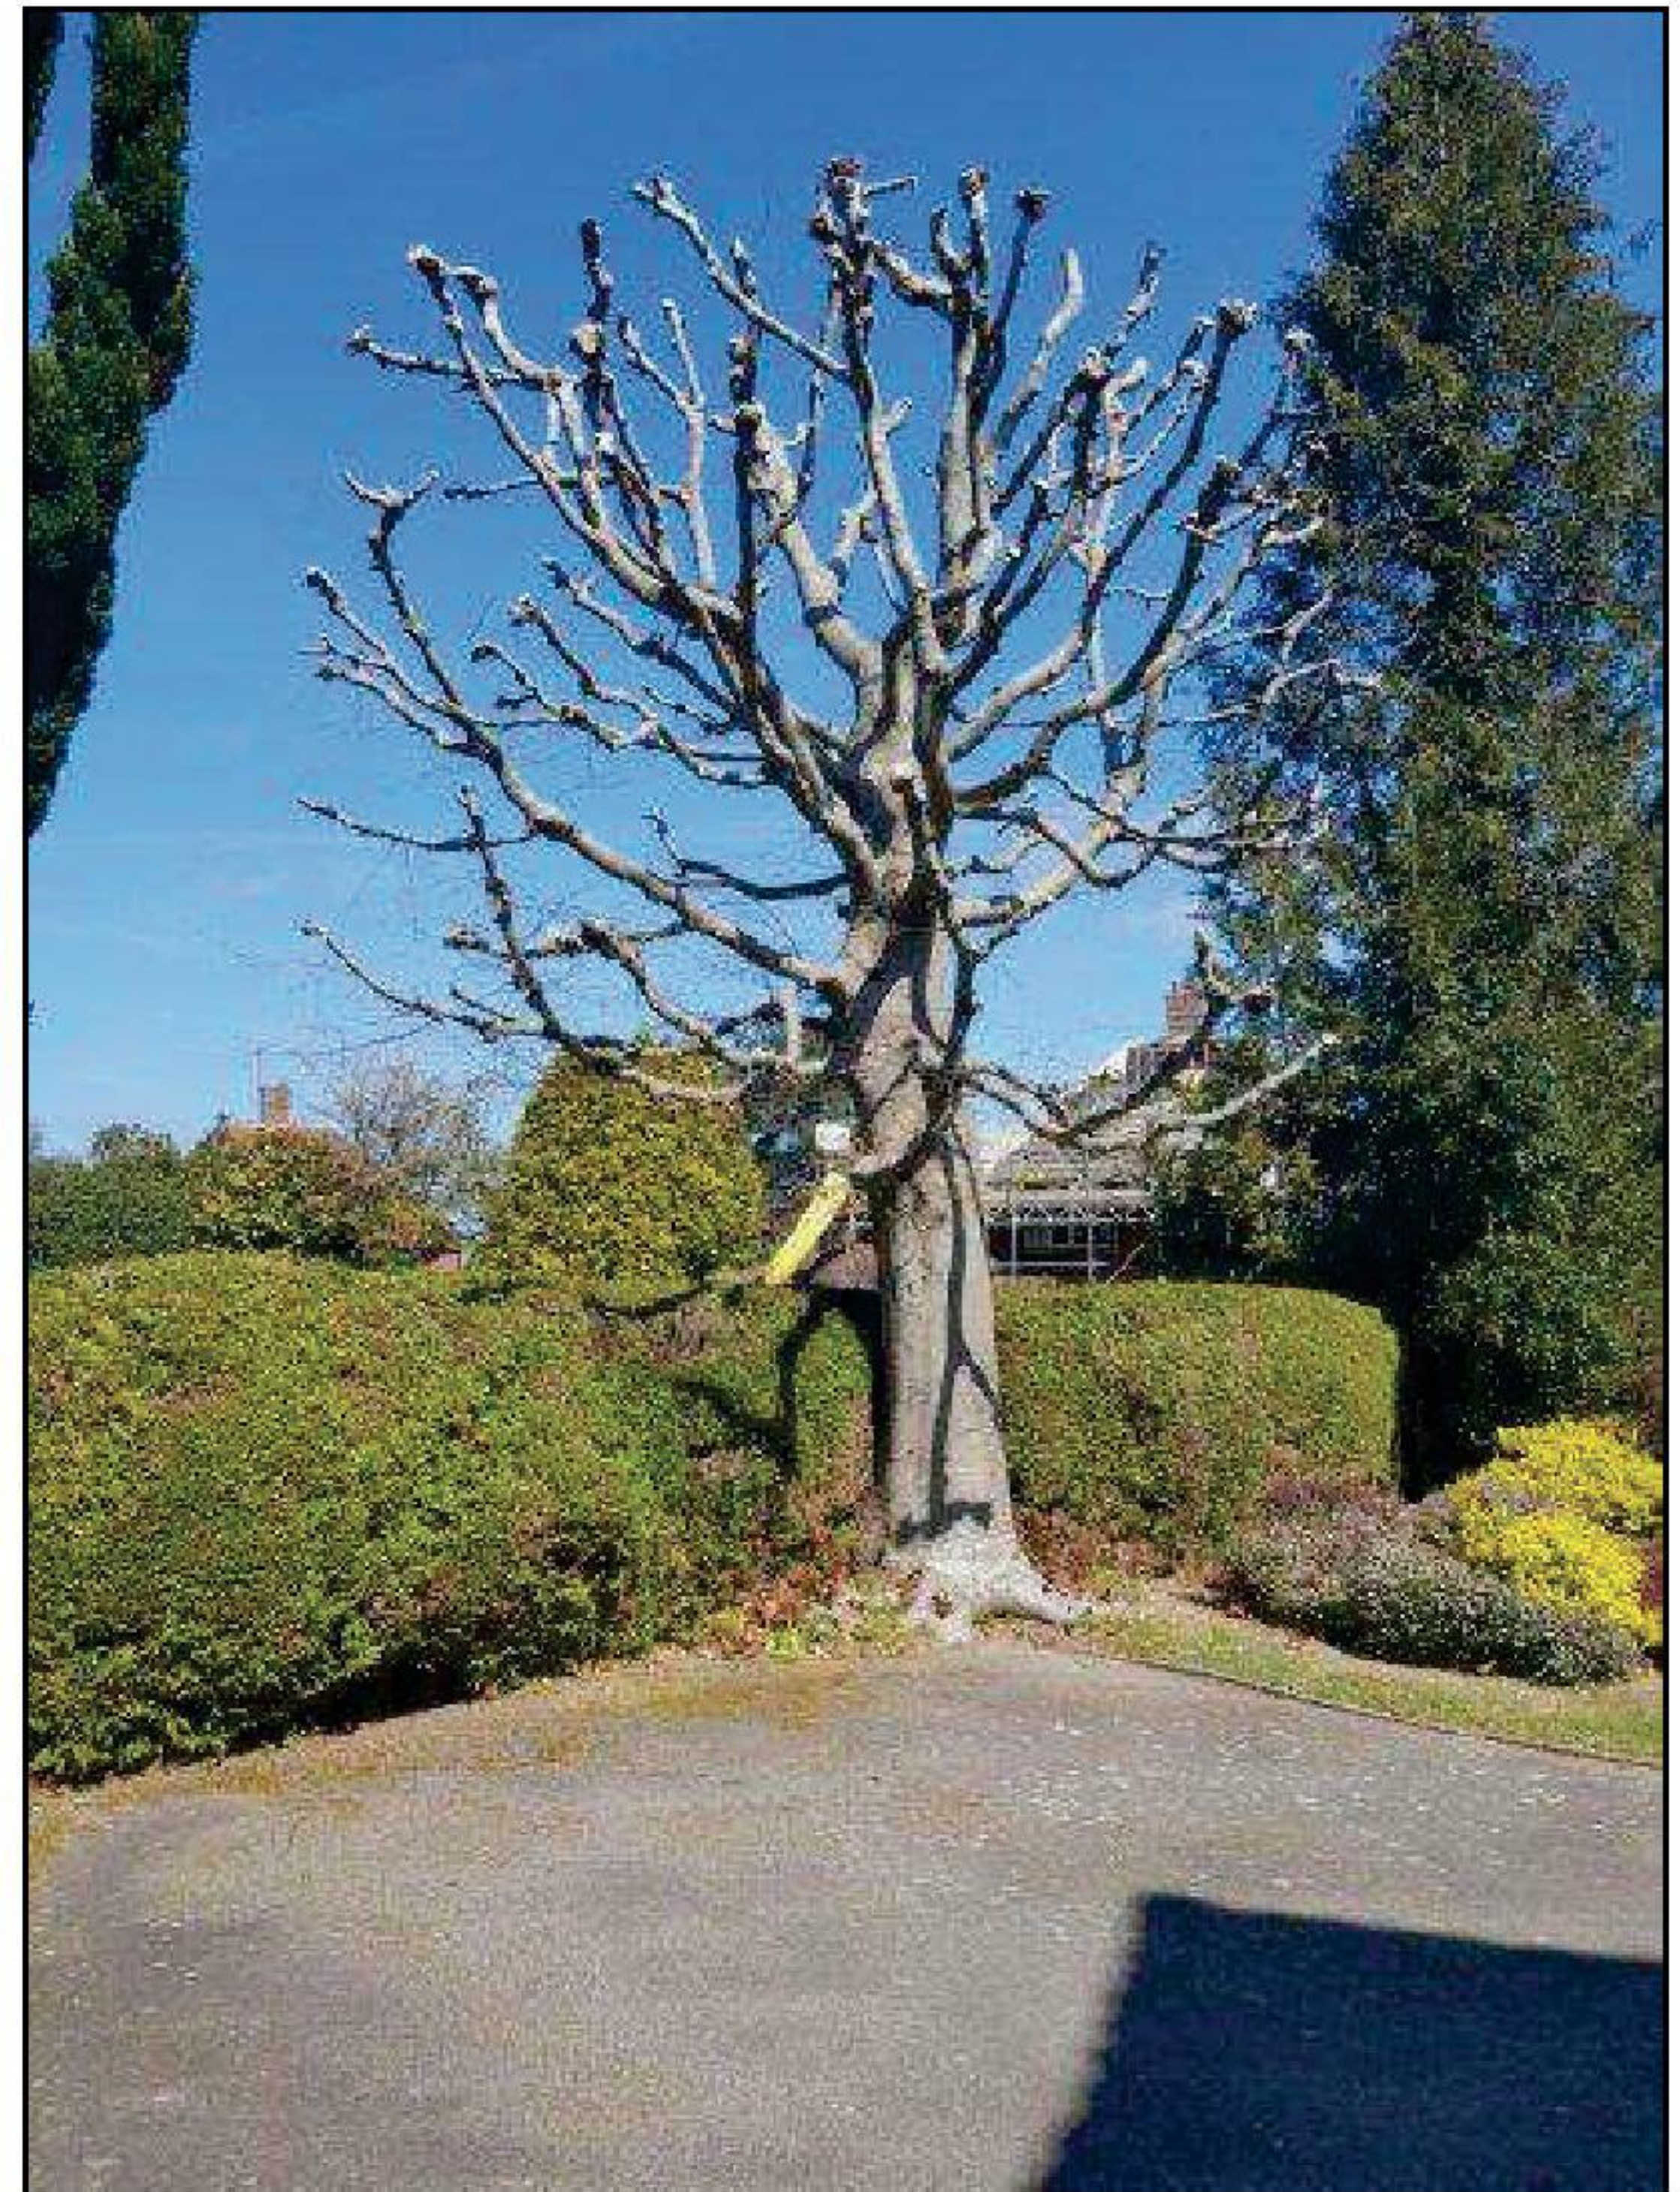
T5 - Beech

| Tree No. | Species | Age Cat | Approx. Height (m) | Distance to Building (m) * | Ownership | Action | Requirement |
|---|---|---|---|---|---|---|---|
| T5 | Beech (Copper/Purple) | 1 | 7 | 11.6 | C - Insured | Action to avoid future risk | Recently reduced: maintain at reduced dimensions by way of routine re-pruning to restrict regrowth below pre-pruning dimensions. |

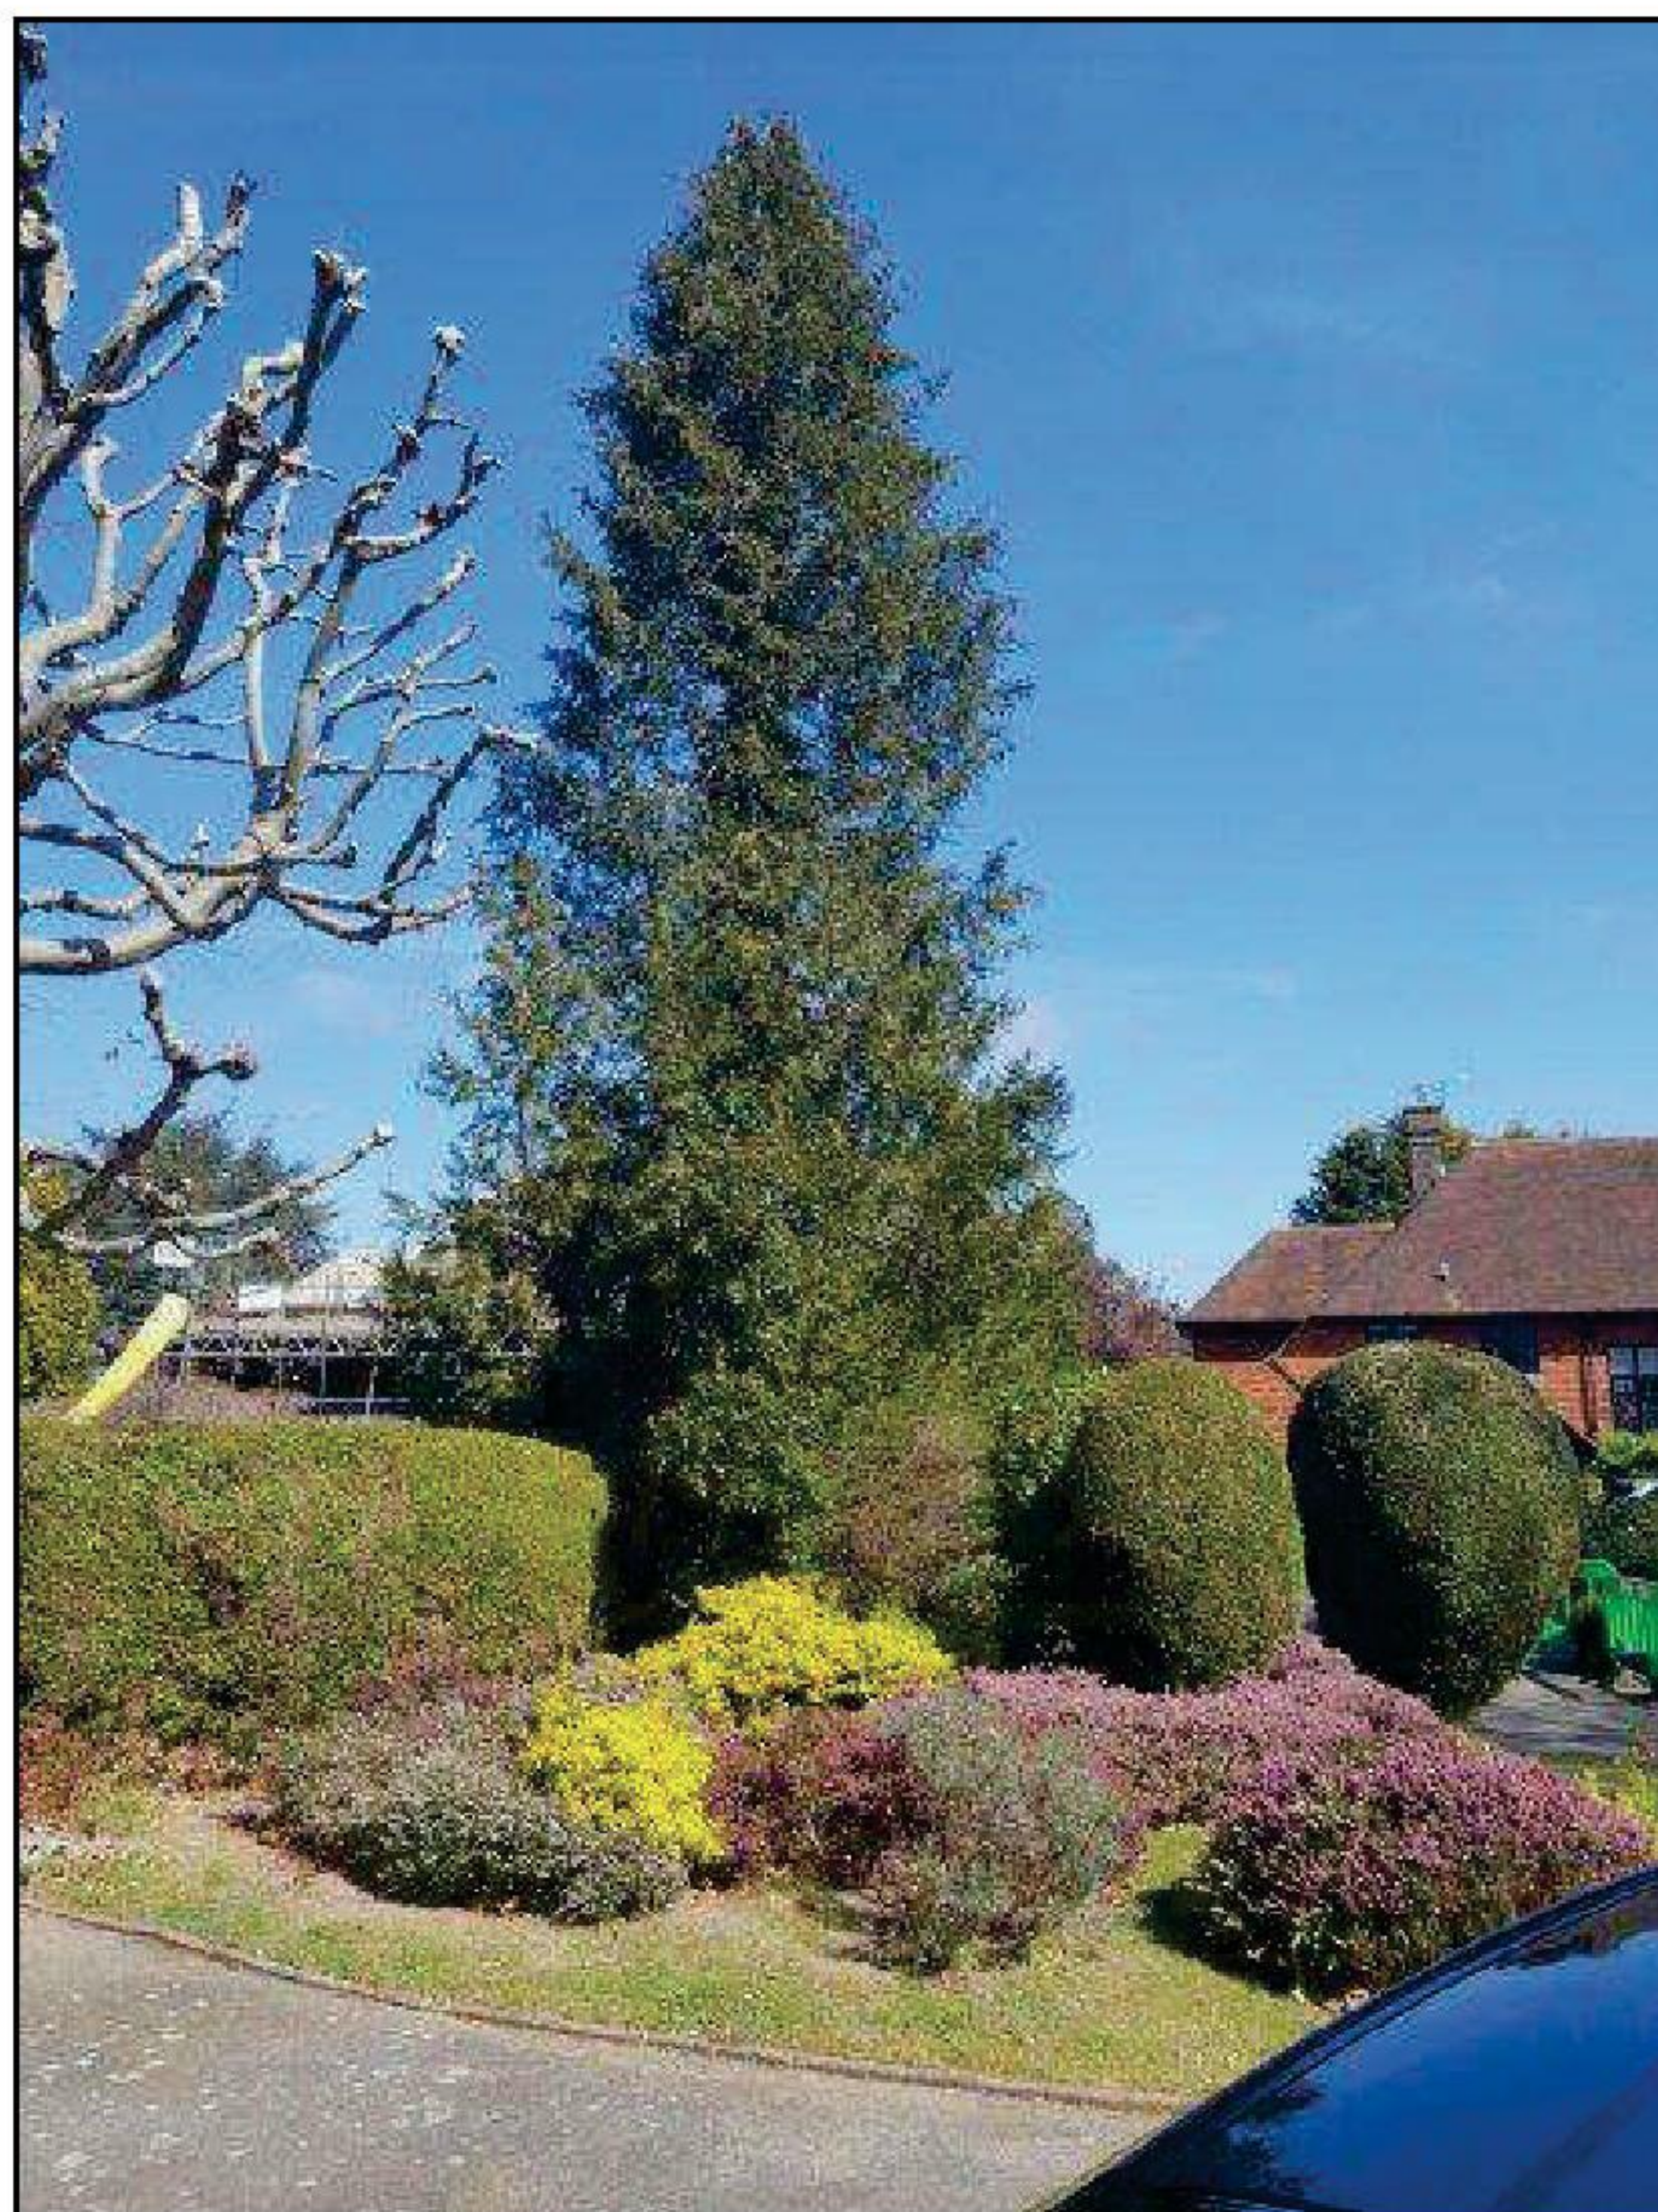
T6 - Cypress

| Tree No. | Species | Age Cat | Approx. Height (m) | Distance to Building (m) * | Ownership | Action | Requirement |
|---|---|---|---|---|---|---|---|
| T6 | Cypress | 1 | 13 | 15 | E - Boundary Veg (ownership to be confirmed) | Action to avoid future risk | Maintain at broadly current dimensions by way of regular pruning. |

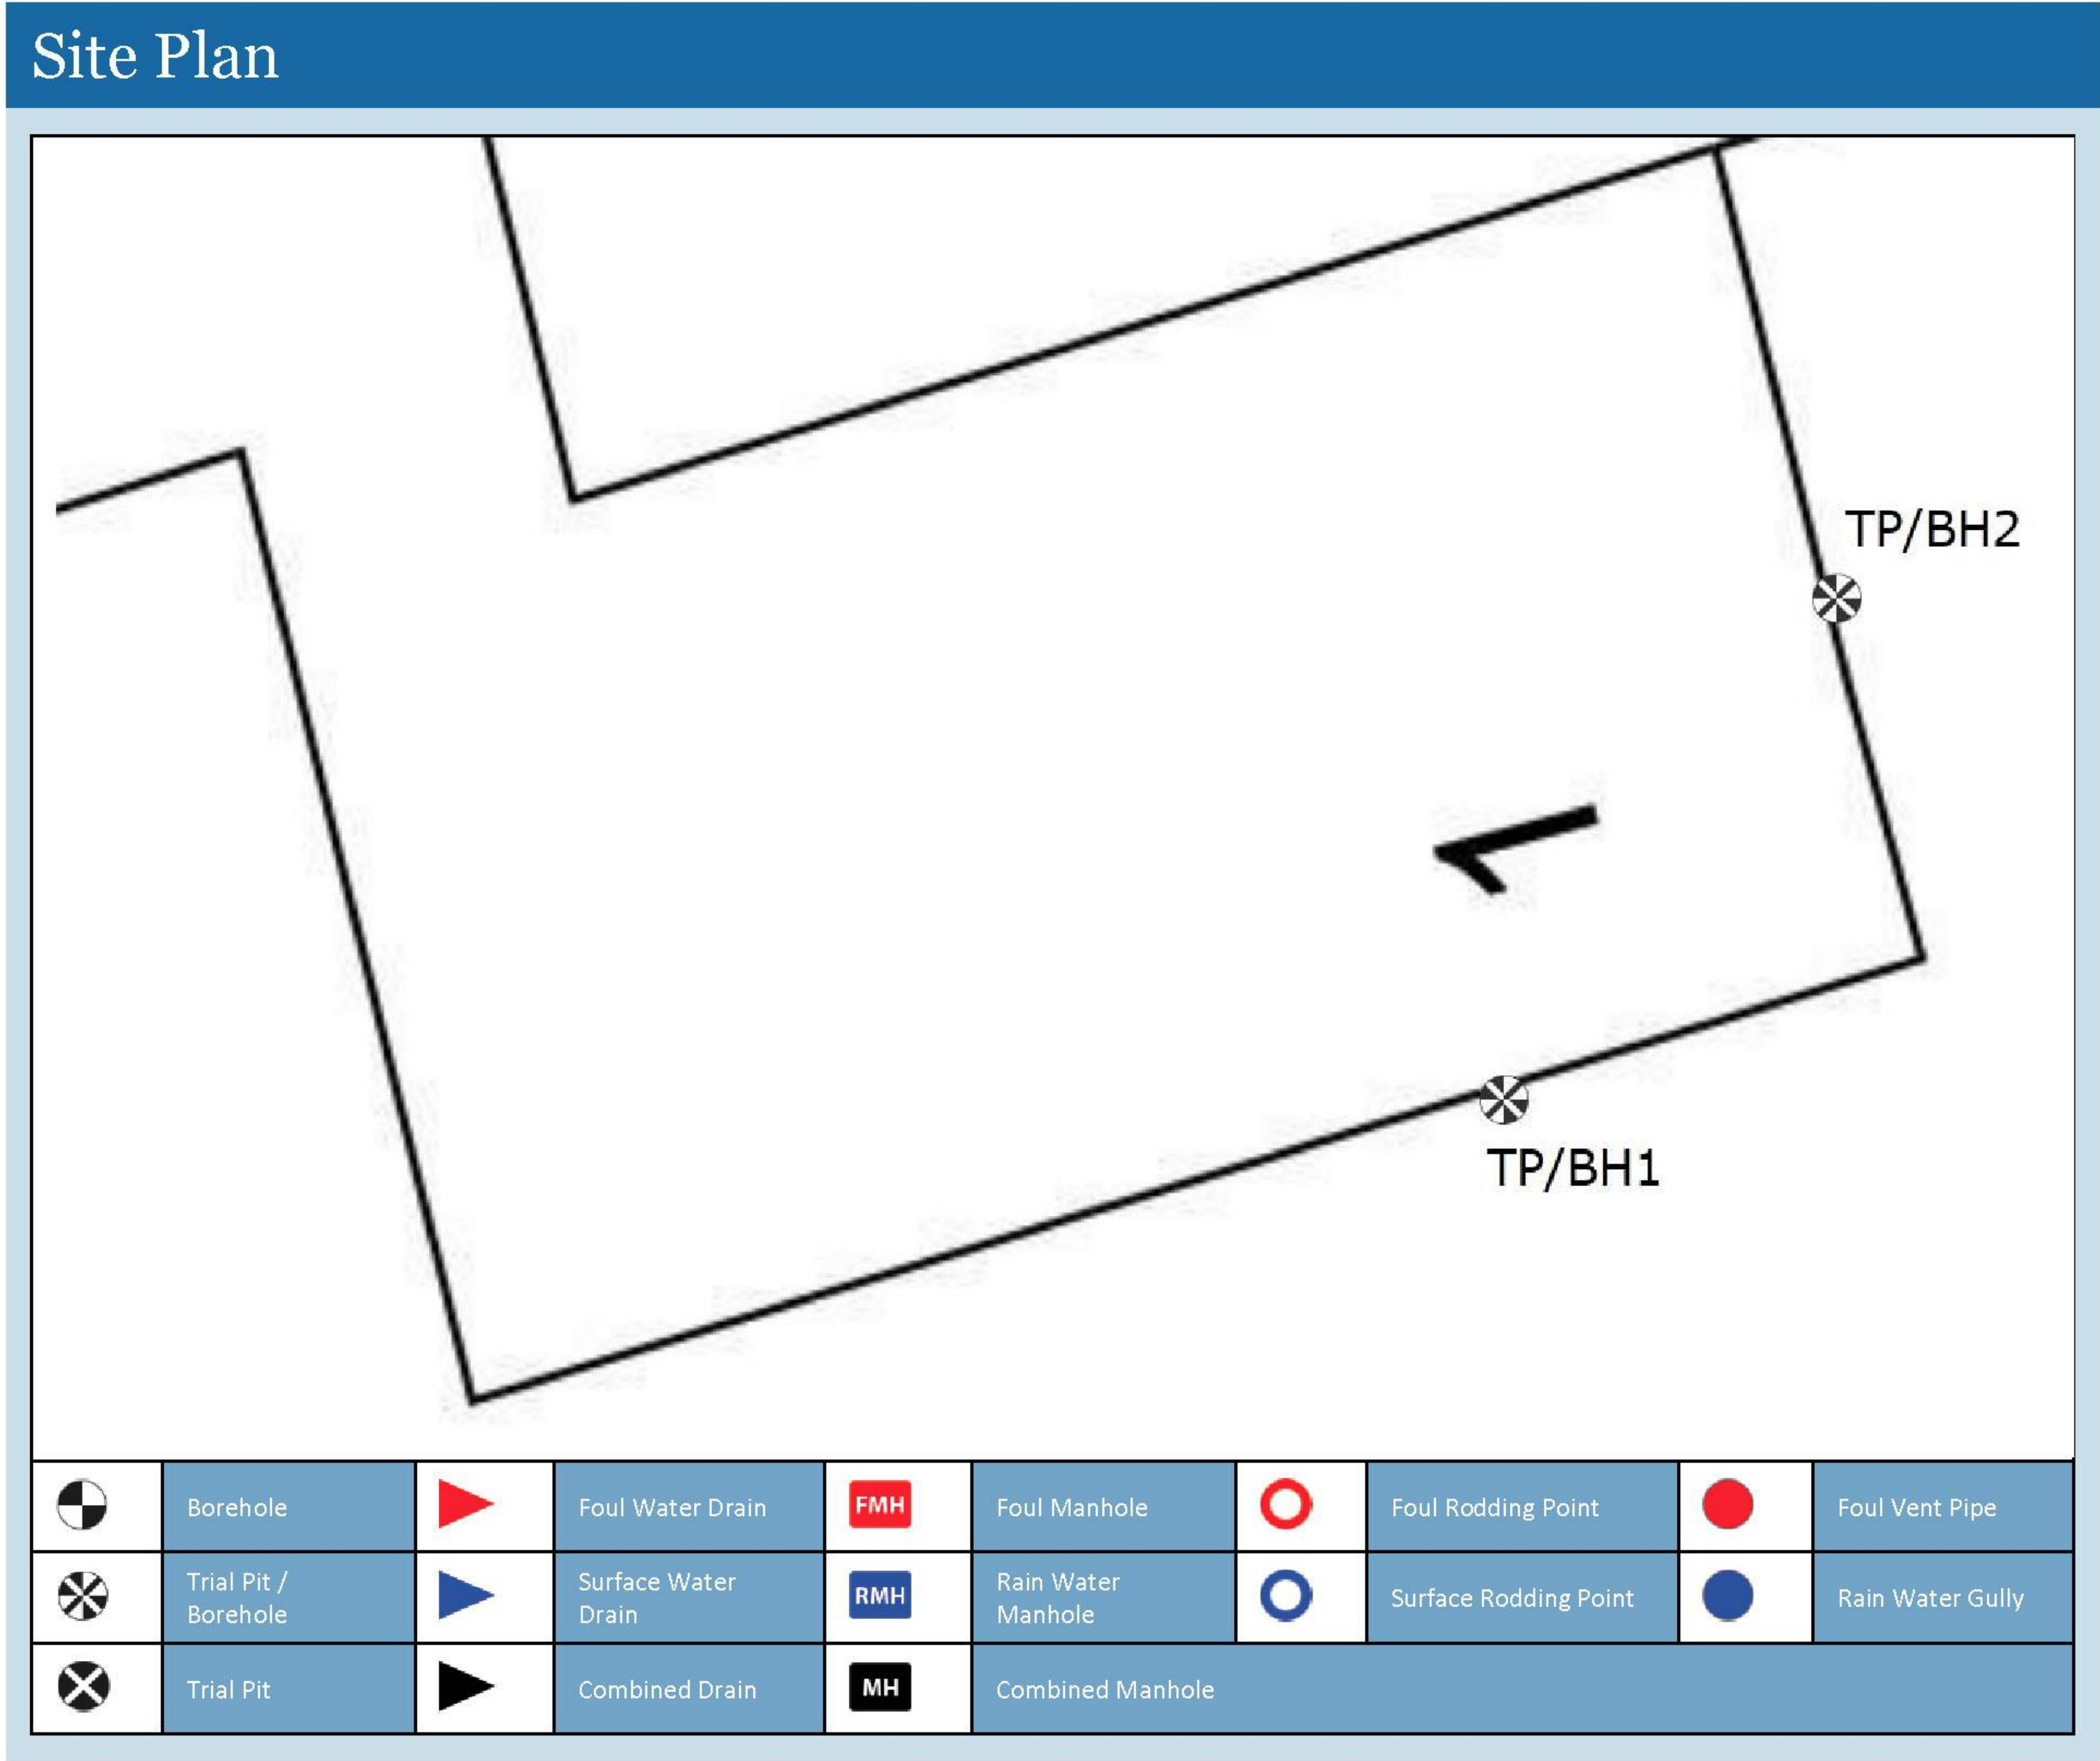
TP/BH1 Foundation Detail and Borehole Log

House foundation comprised of brick wall to 400mm bgl, bearing on concrete to 700mm bgl, with a total projection of 150mm from the elevation. Underside of foundation (USF) was exposed to 100mm back from the face of the foundation and probed 500mm back from the face of the foundation.

Trial pit excavated to 0.80m bgl. Borehole completed by mech window sampler. Roots encountered to 2.8m bgl. Groundwater strikes not encountered. PEN = Hand Penetrometer (kg/sq cm).
