# Infiltration Test Report

**Project Name:** Wickenden Farm, Chilling Street

**Project ID:** J16090

**Report Date:** 13 November 2025

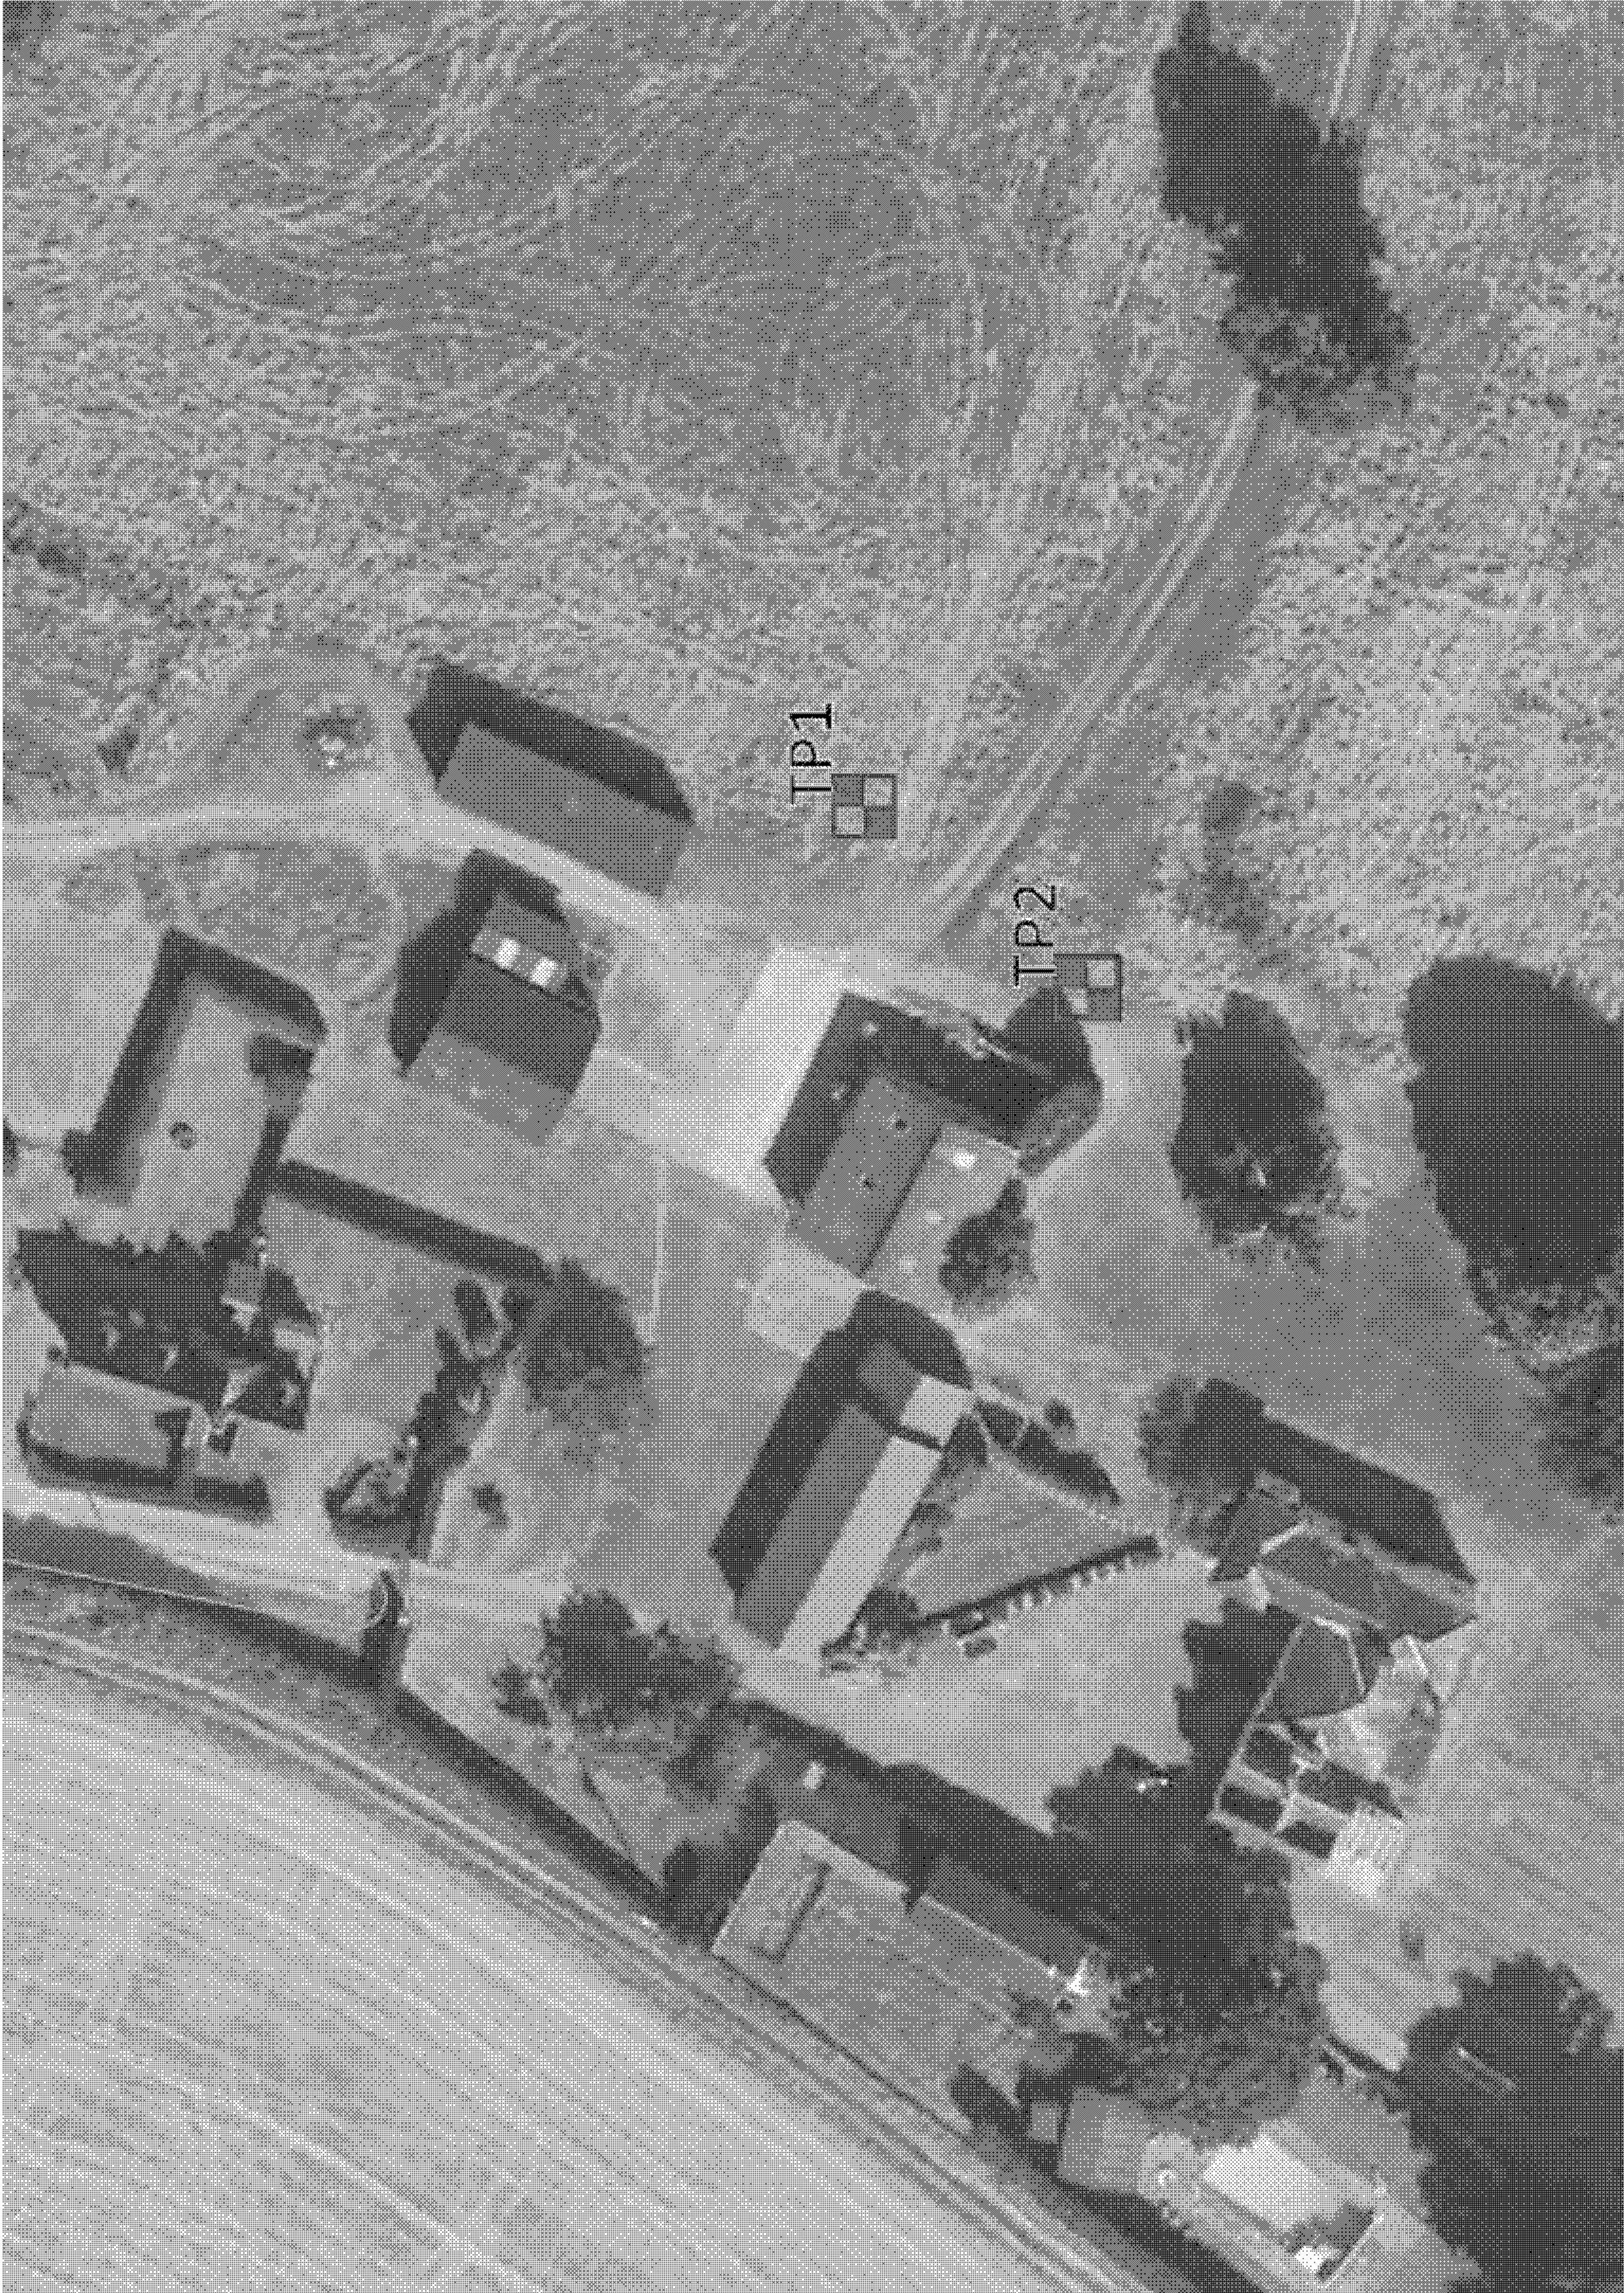
Fig No: 2

A total of five soakage tests were carried out, in two trial pits (TP1 and TP2), at the locations shown on the attached site plan Figure 2 (in Appendix A). The full results of the soakage tests are presented within Appendix B.

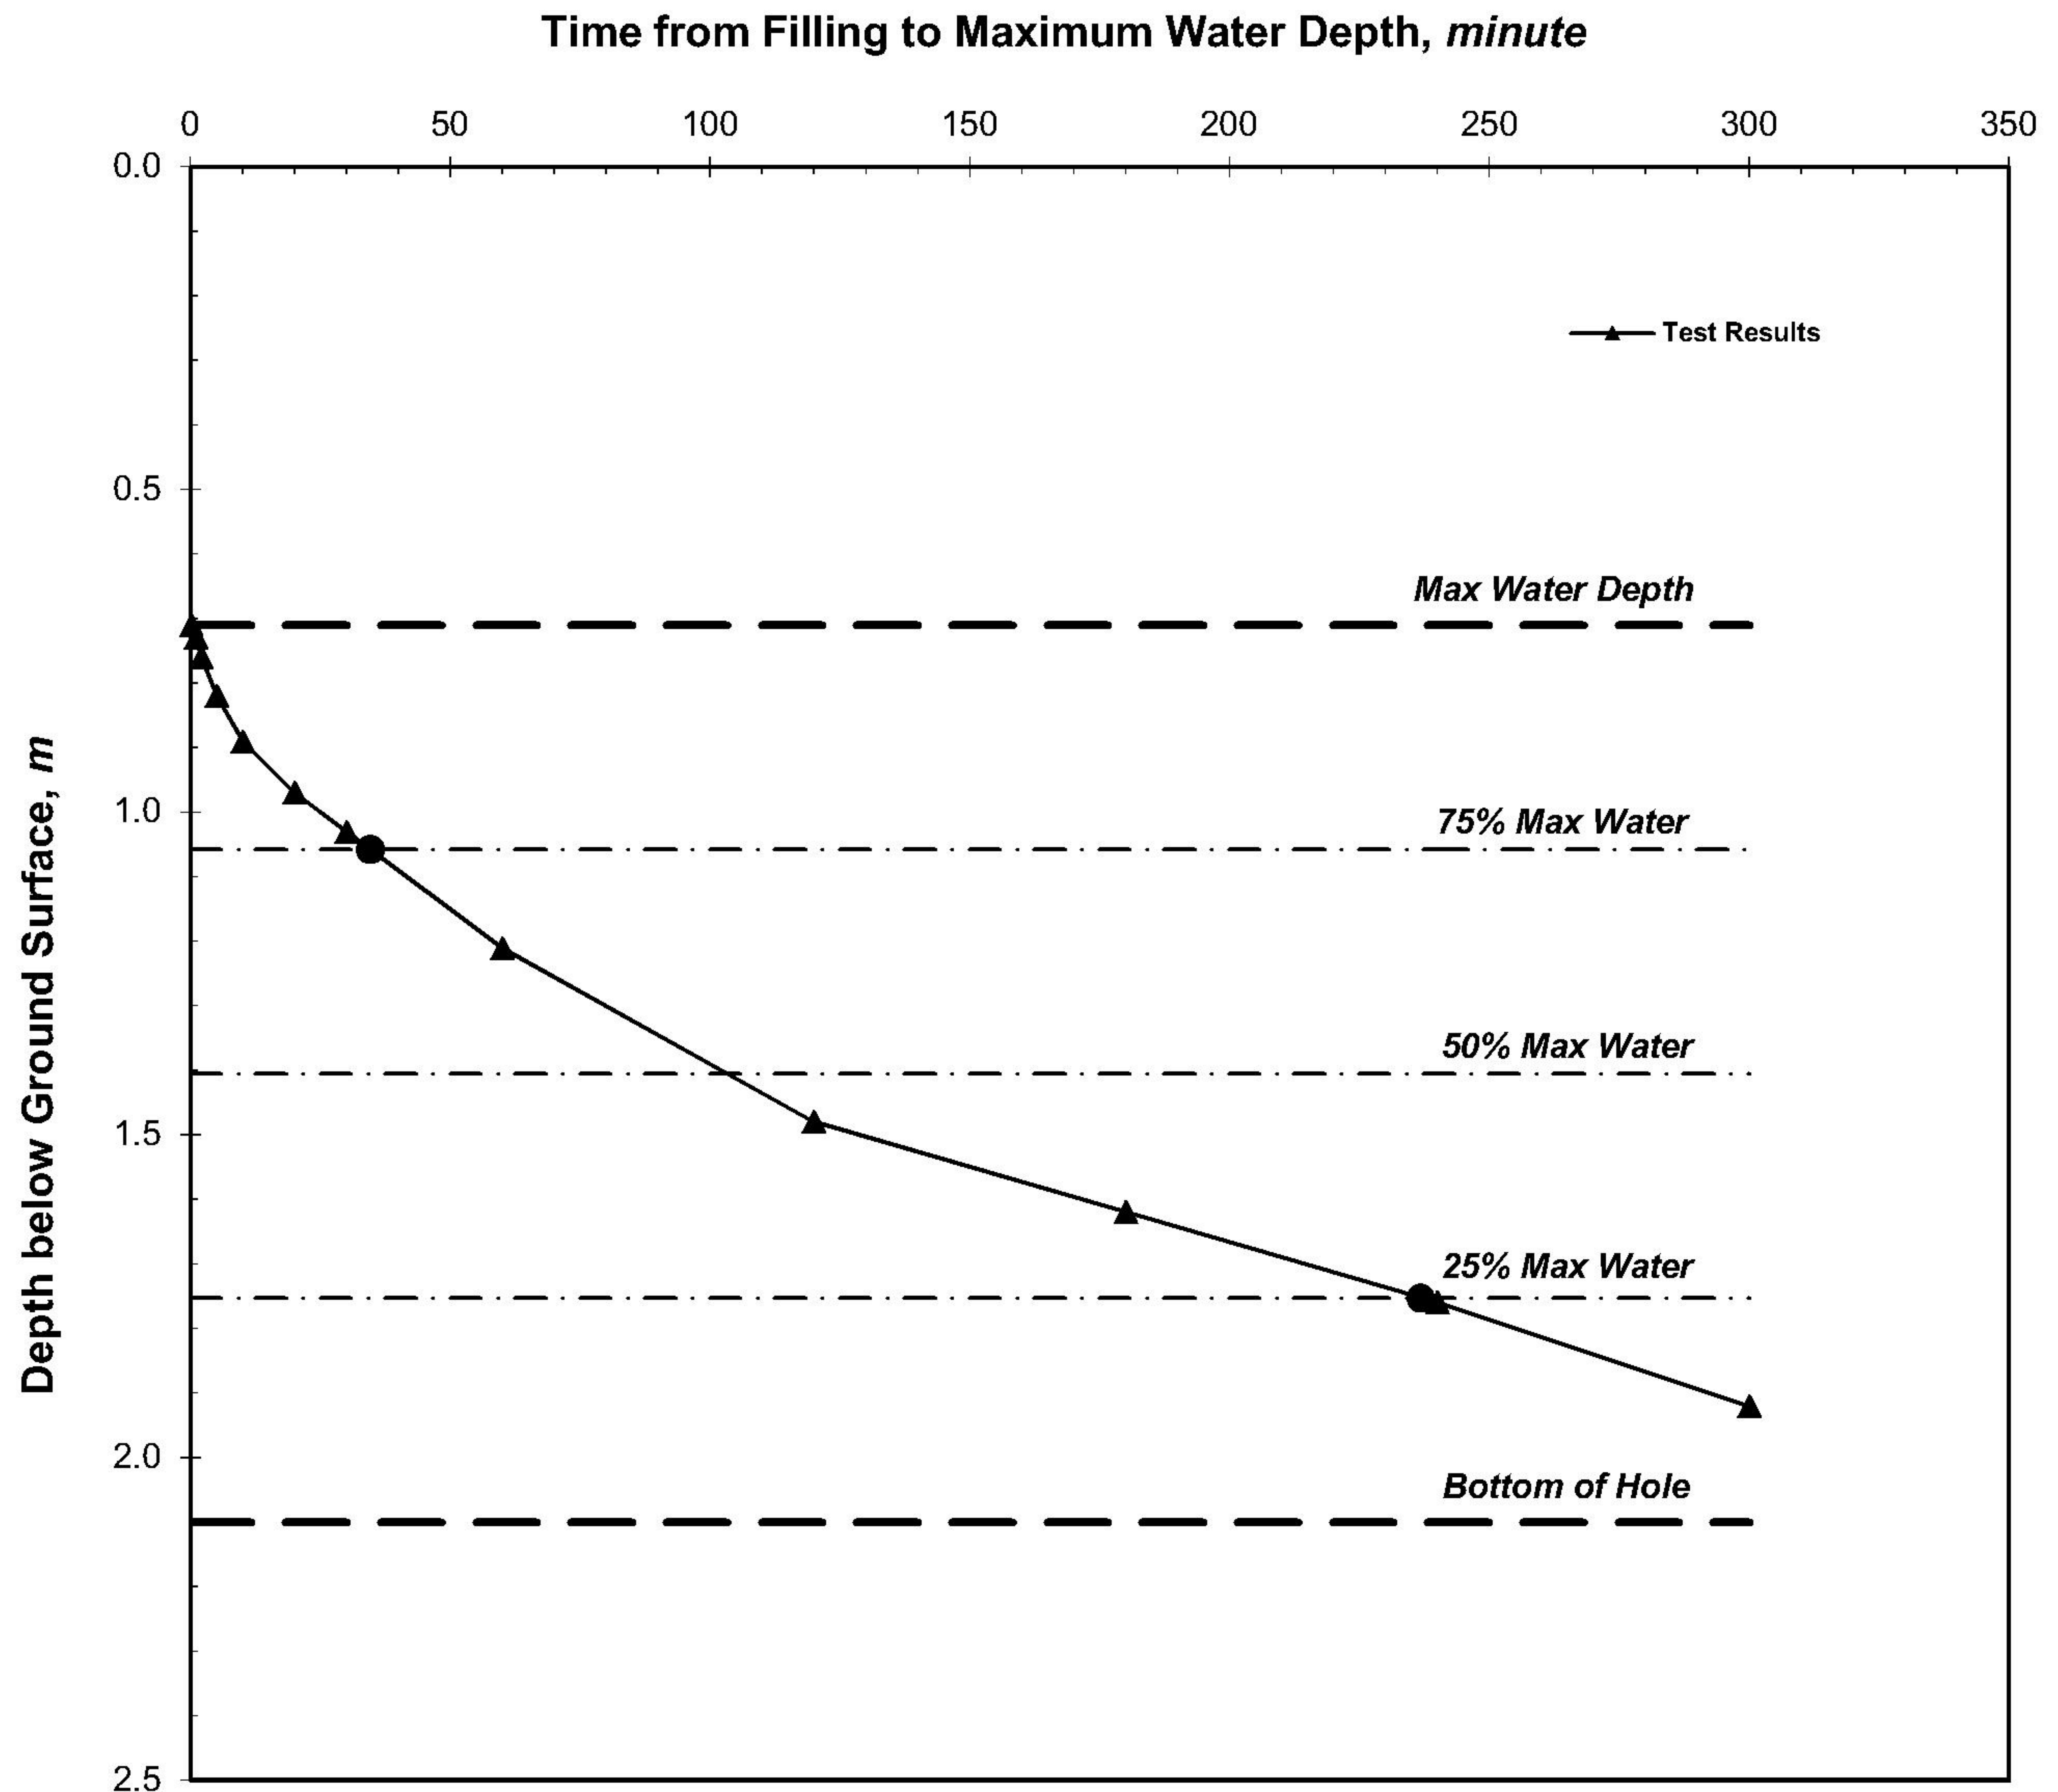
Test Hole No: TP1  
Test No: Test No 1 (Initial)

| Test ID | Test Depth (mbgl) | Design Infiltration Rate | | Notes |
|---|---|---|---|---|
| TP1<br>(Initial filling) | 2.1 | 0.294 | $4.90 \times 10^{-6}$ | Pit was nearly emptied at finish of test. |

| Voids Assumed for Granular Fill, % | 40% | BRE Soil Infiltration Rate, m/sec | <b>4.90E-06</b> |

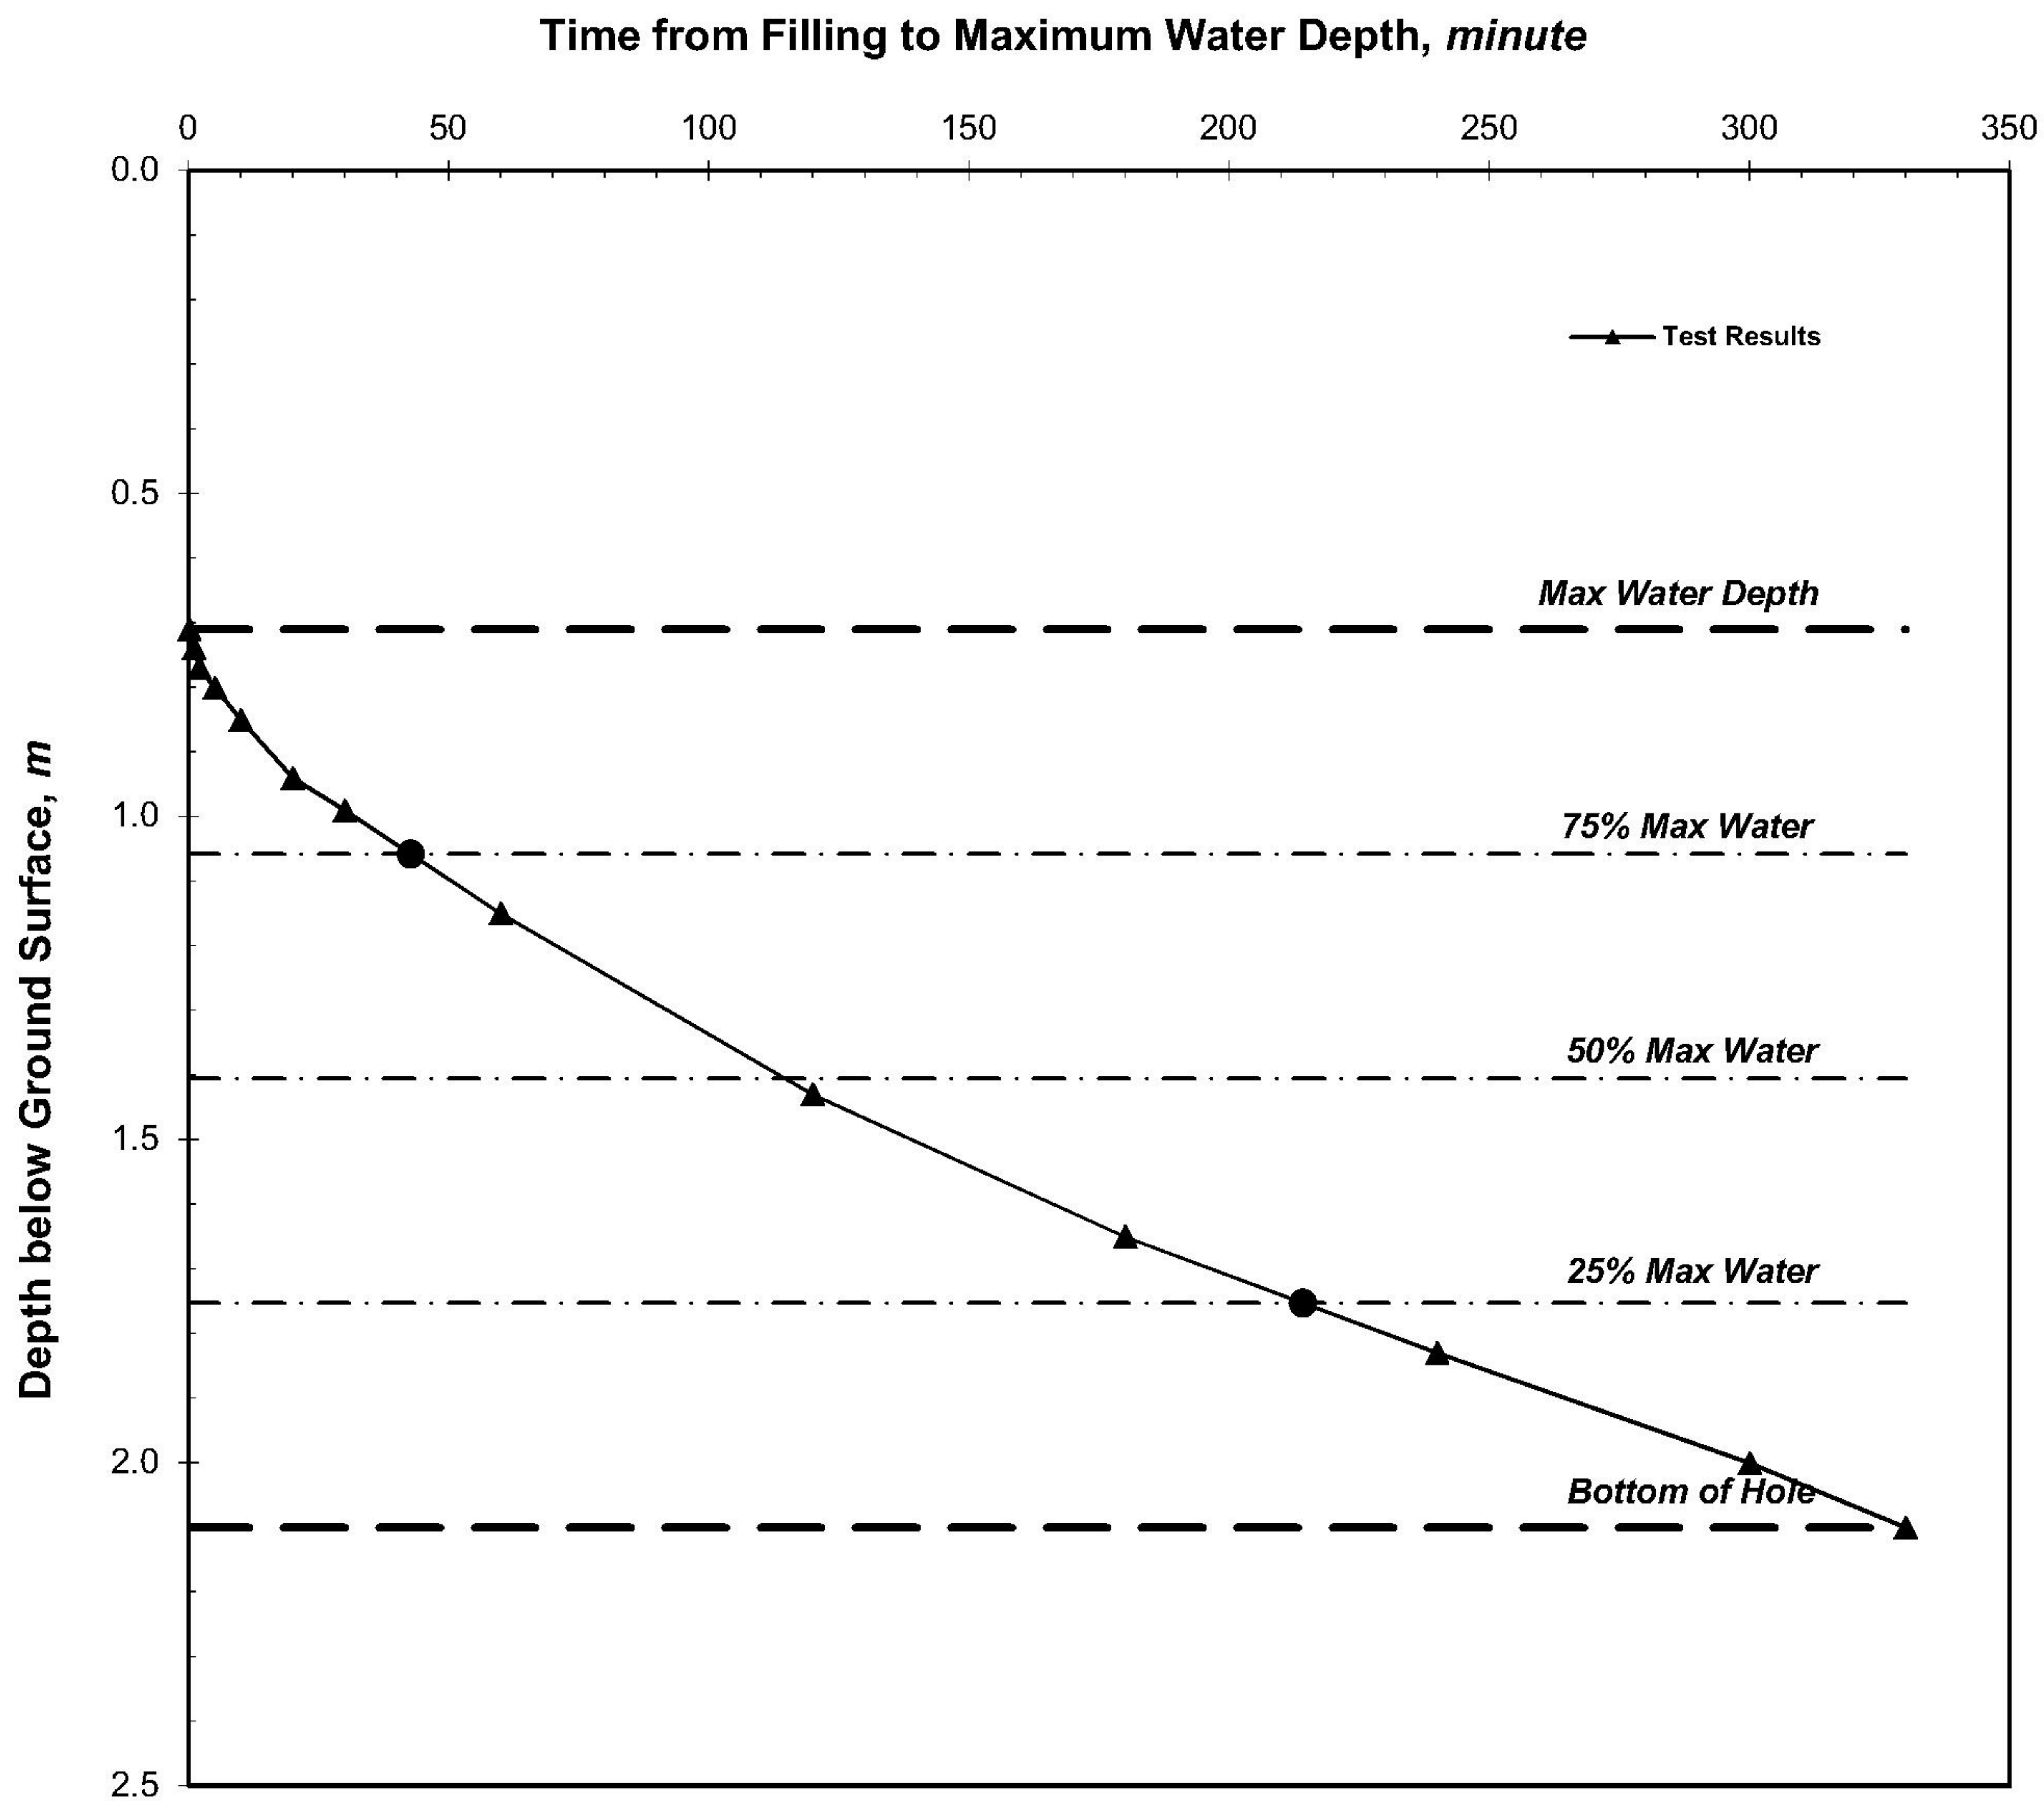
Test Hole No: TP1  
Test No: Test No 2 (Repeated)

| Test ID | Test Depth (mbgl) | Design Infiltration Rate | | Notes |
|---|---|---|---|---|
| TP1<br>(Repeat filling, Test No. 2) | 2.1 | 0.347 | $5.78 \times 10^{-6}$ | Pit was emptied at finish of test. |

| Voids Assumed for Granular Fill, % | 40% | BRE Soil Infiltration Rate, m/sec | <b>5.78E-06</b> |

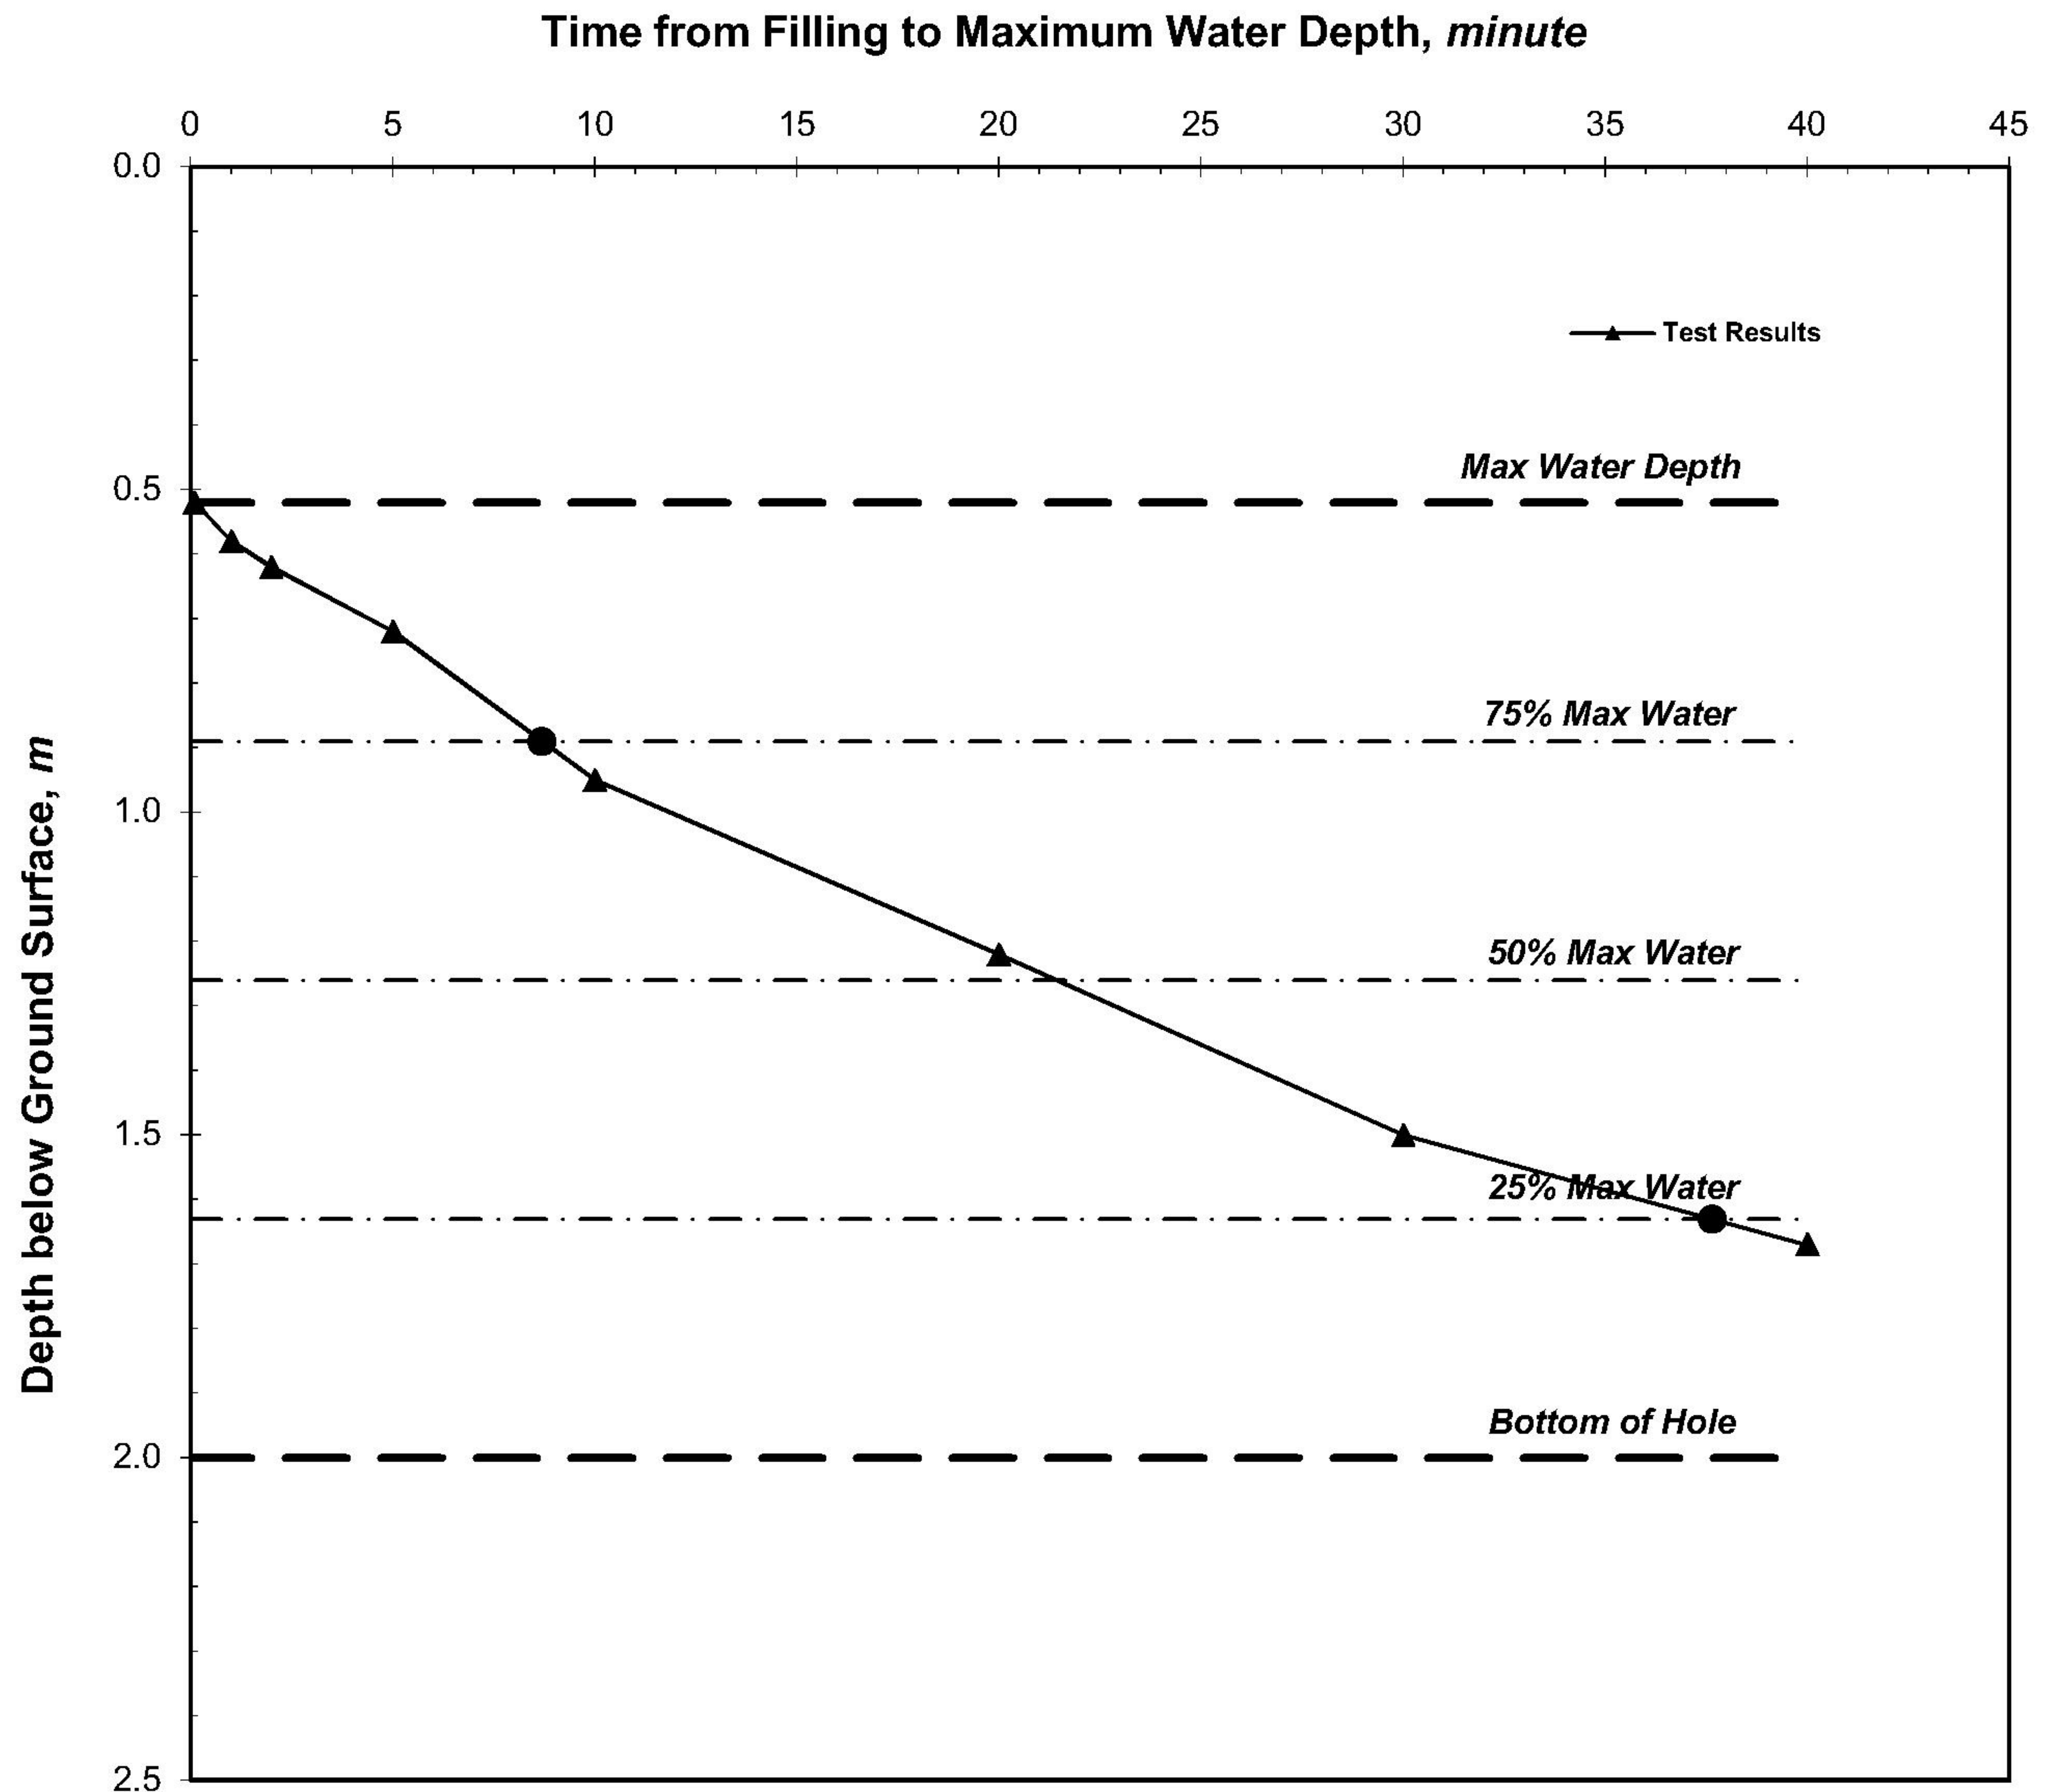
Test Hole No: TP2  
Test No: Test No 1 (Initial)

| Test ID | Test Depth (mbgl) | Design Infiltration Rate | | Notes |
|---|---|---|---|---|
| TP2<br>(Initial filling) | 2.0 | 2.02 | $3.37 \times 10^{-5}$ | Pit was nearly emptied at finish of test. |

| Voids Assumed for Granular Fill, % | 40% | BRE Soil Infiltration Rate, <i>m/sec</i> | <b>3.37E-05</b> |

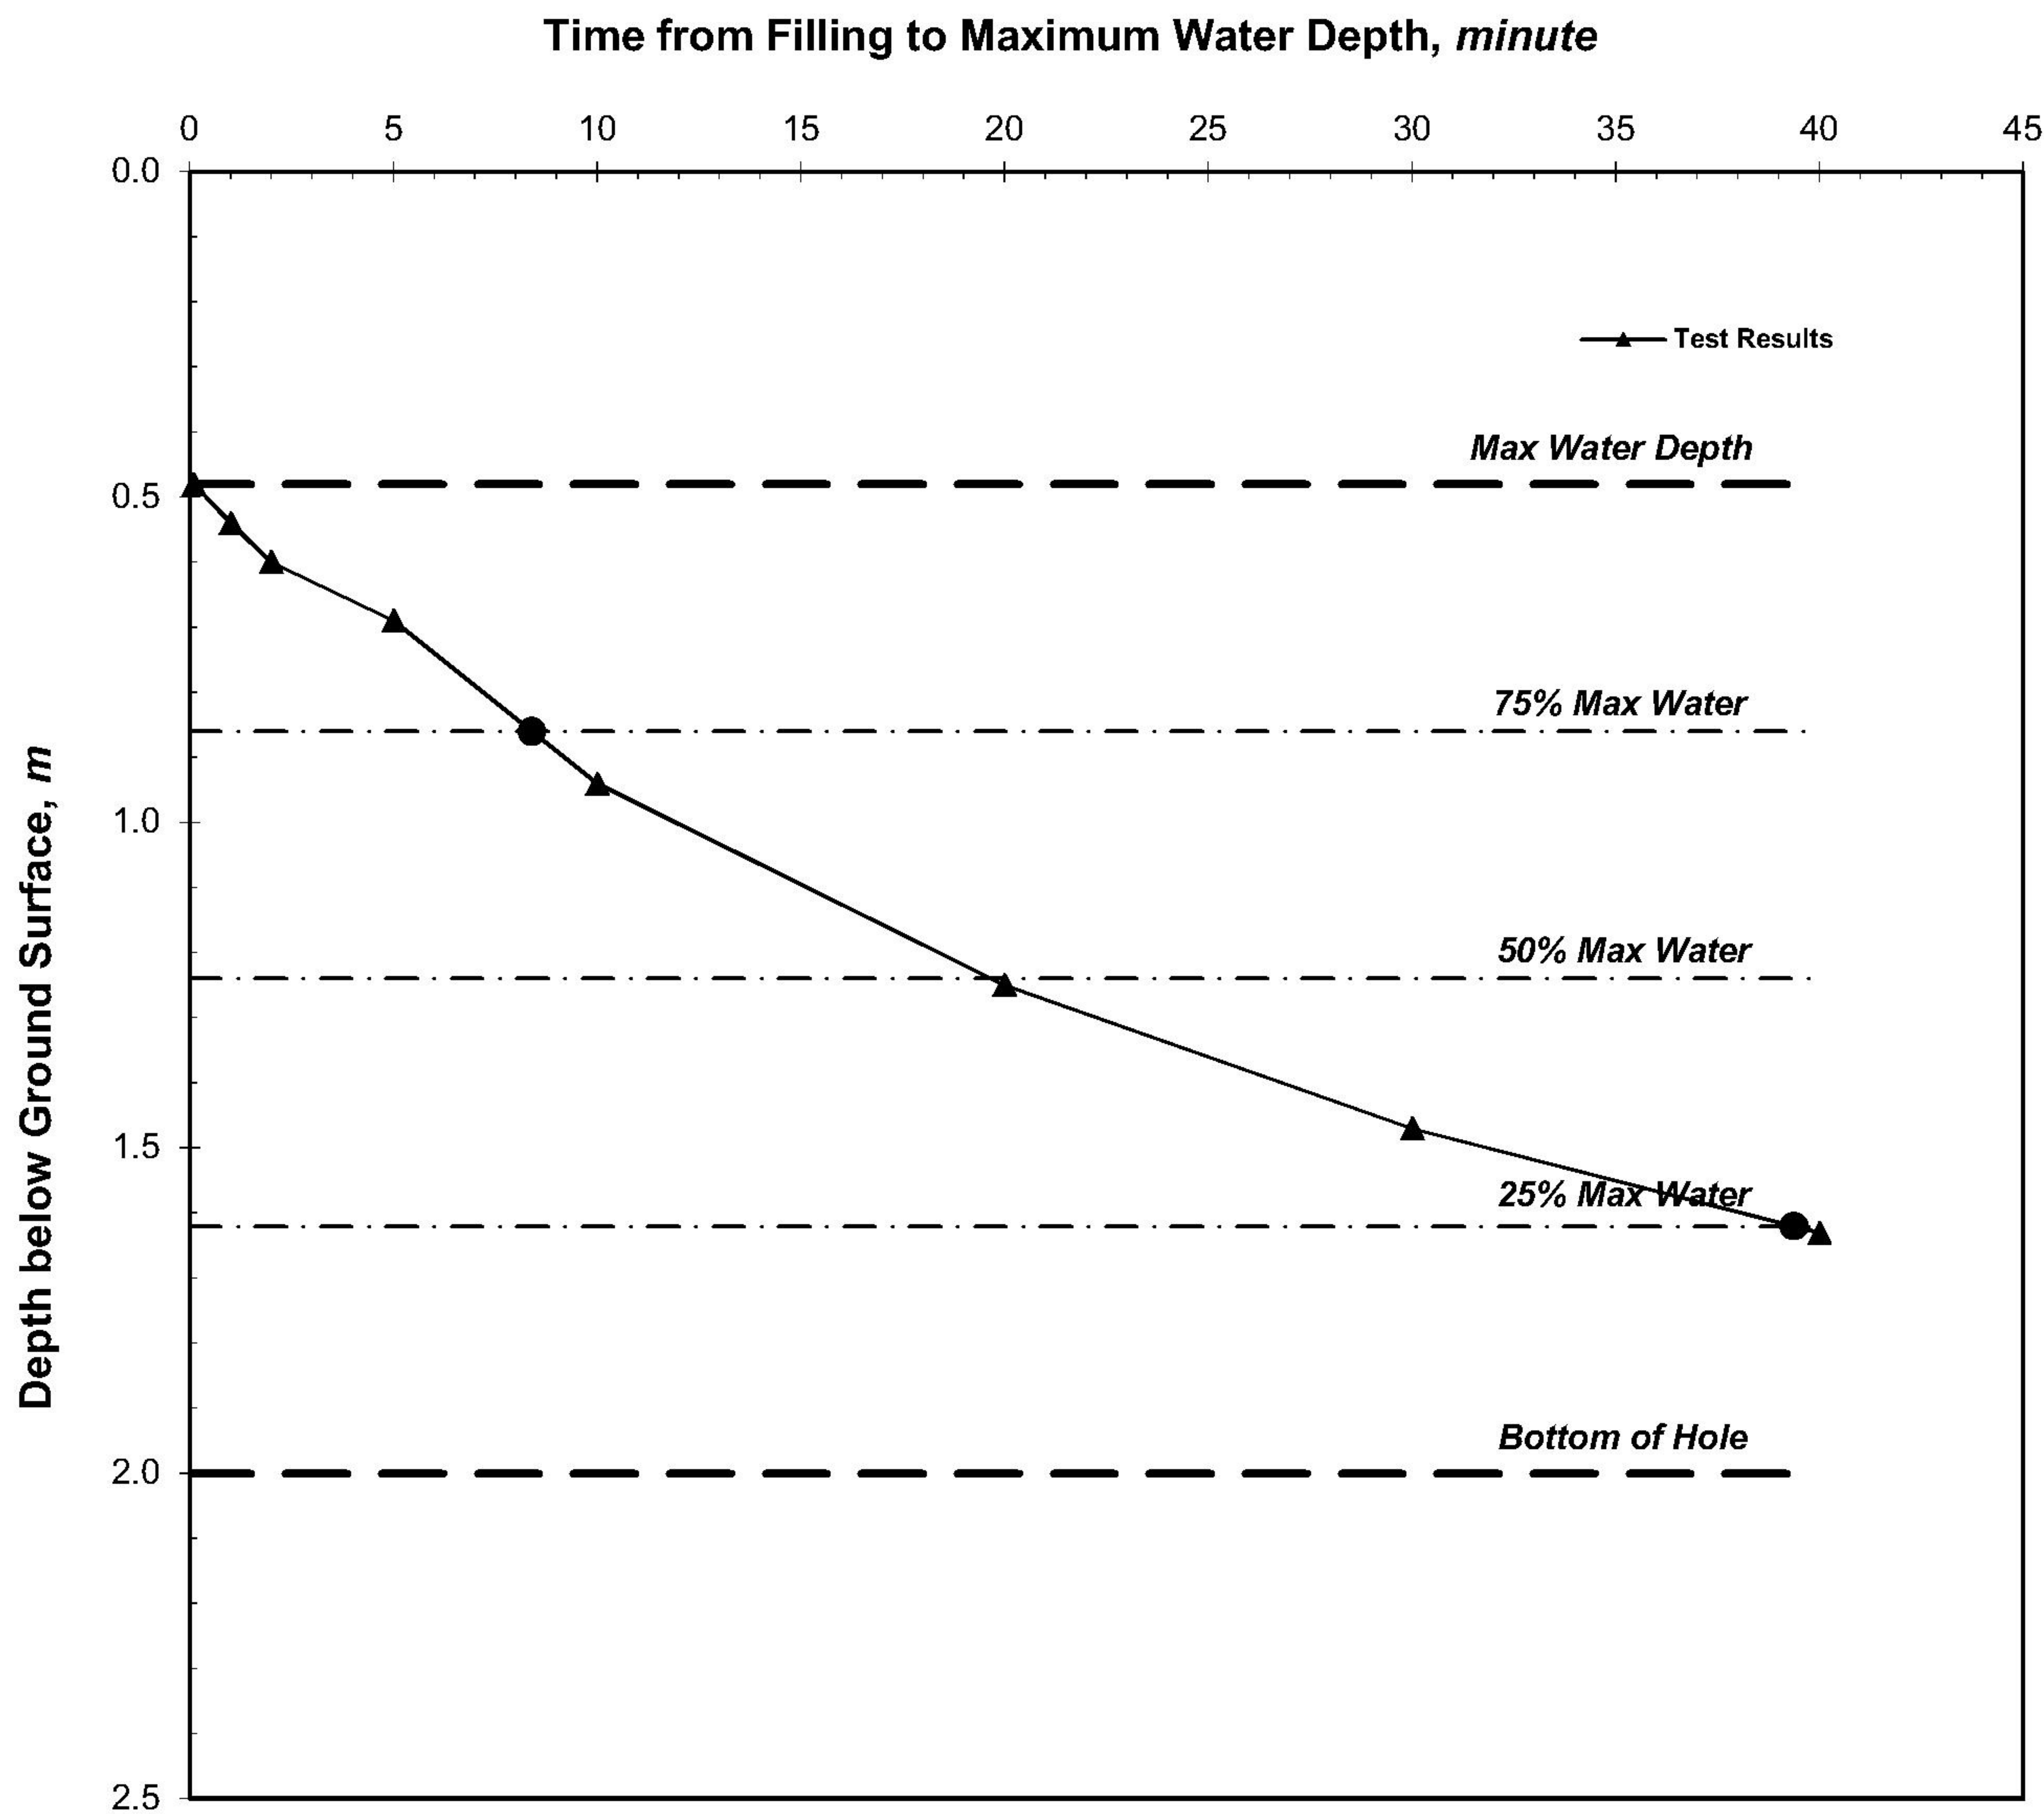
Test Hole No: TP2  
Test No: Test No 2 (Repeated)

| Test ID | Test Depth (mbgl) | Design Infiltration Rate | | Notes |
|---|---|---|---|---|
| TP2<br>(Repeat filling, Test No. 2) | 2.0 | 1.90 | $3.17 \times 10^{-5}$ | Pit was nearly emptied at finish of test. |

| Voids Assumed for Granular Fill, % | 40% | BRE Soil Infiltration Rate, m/sec | 3.17E-05 |

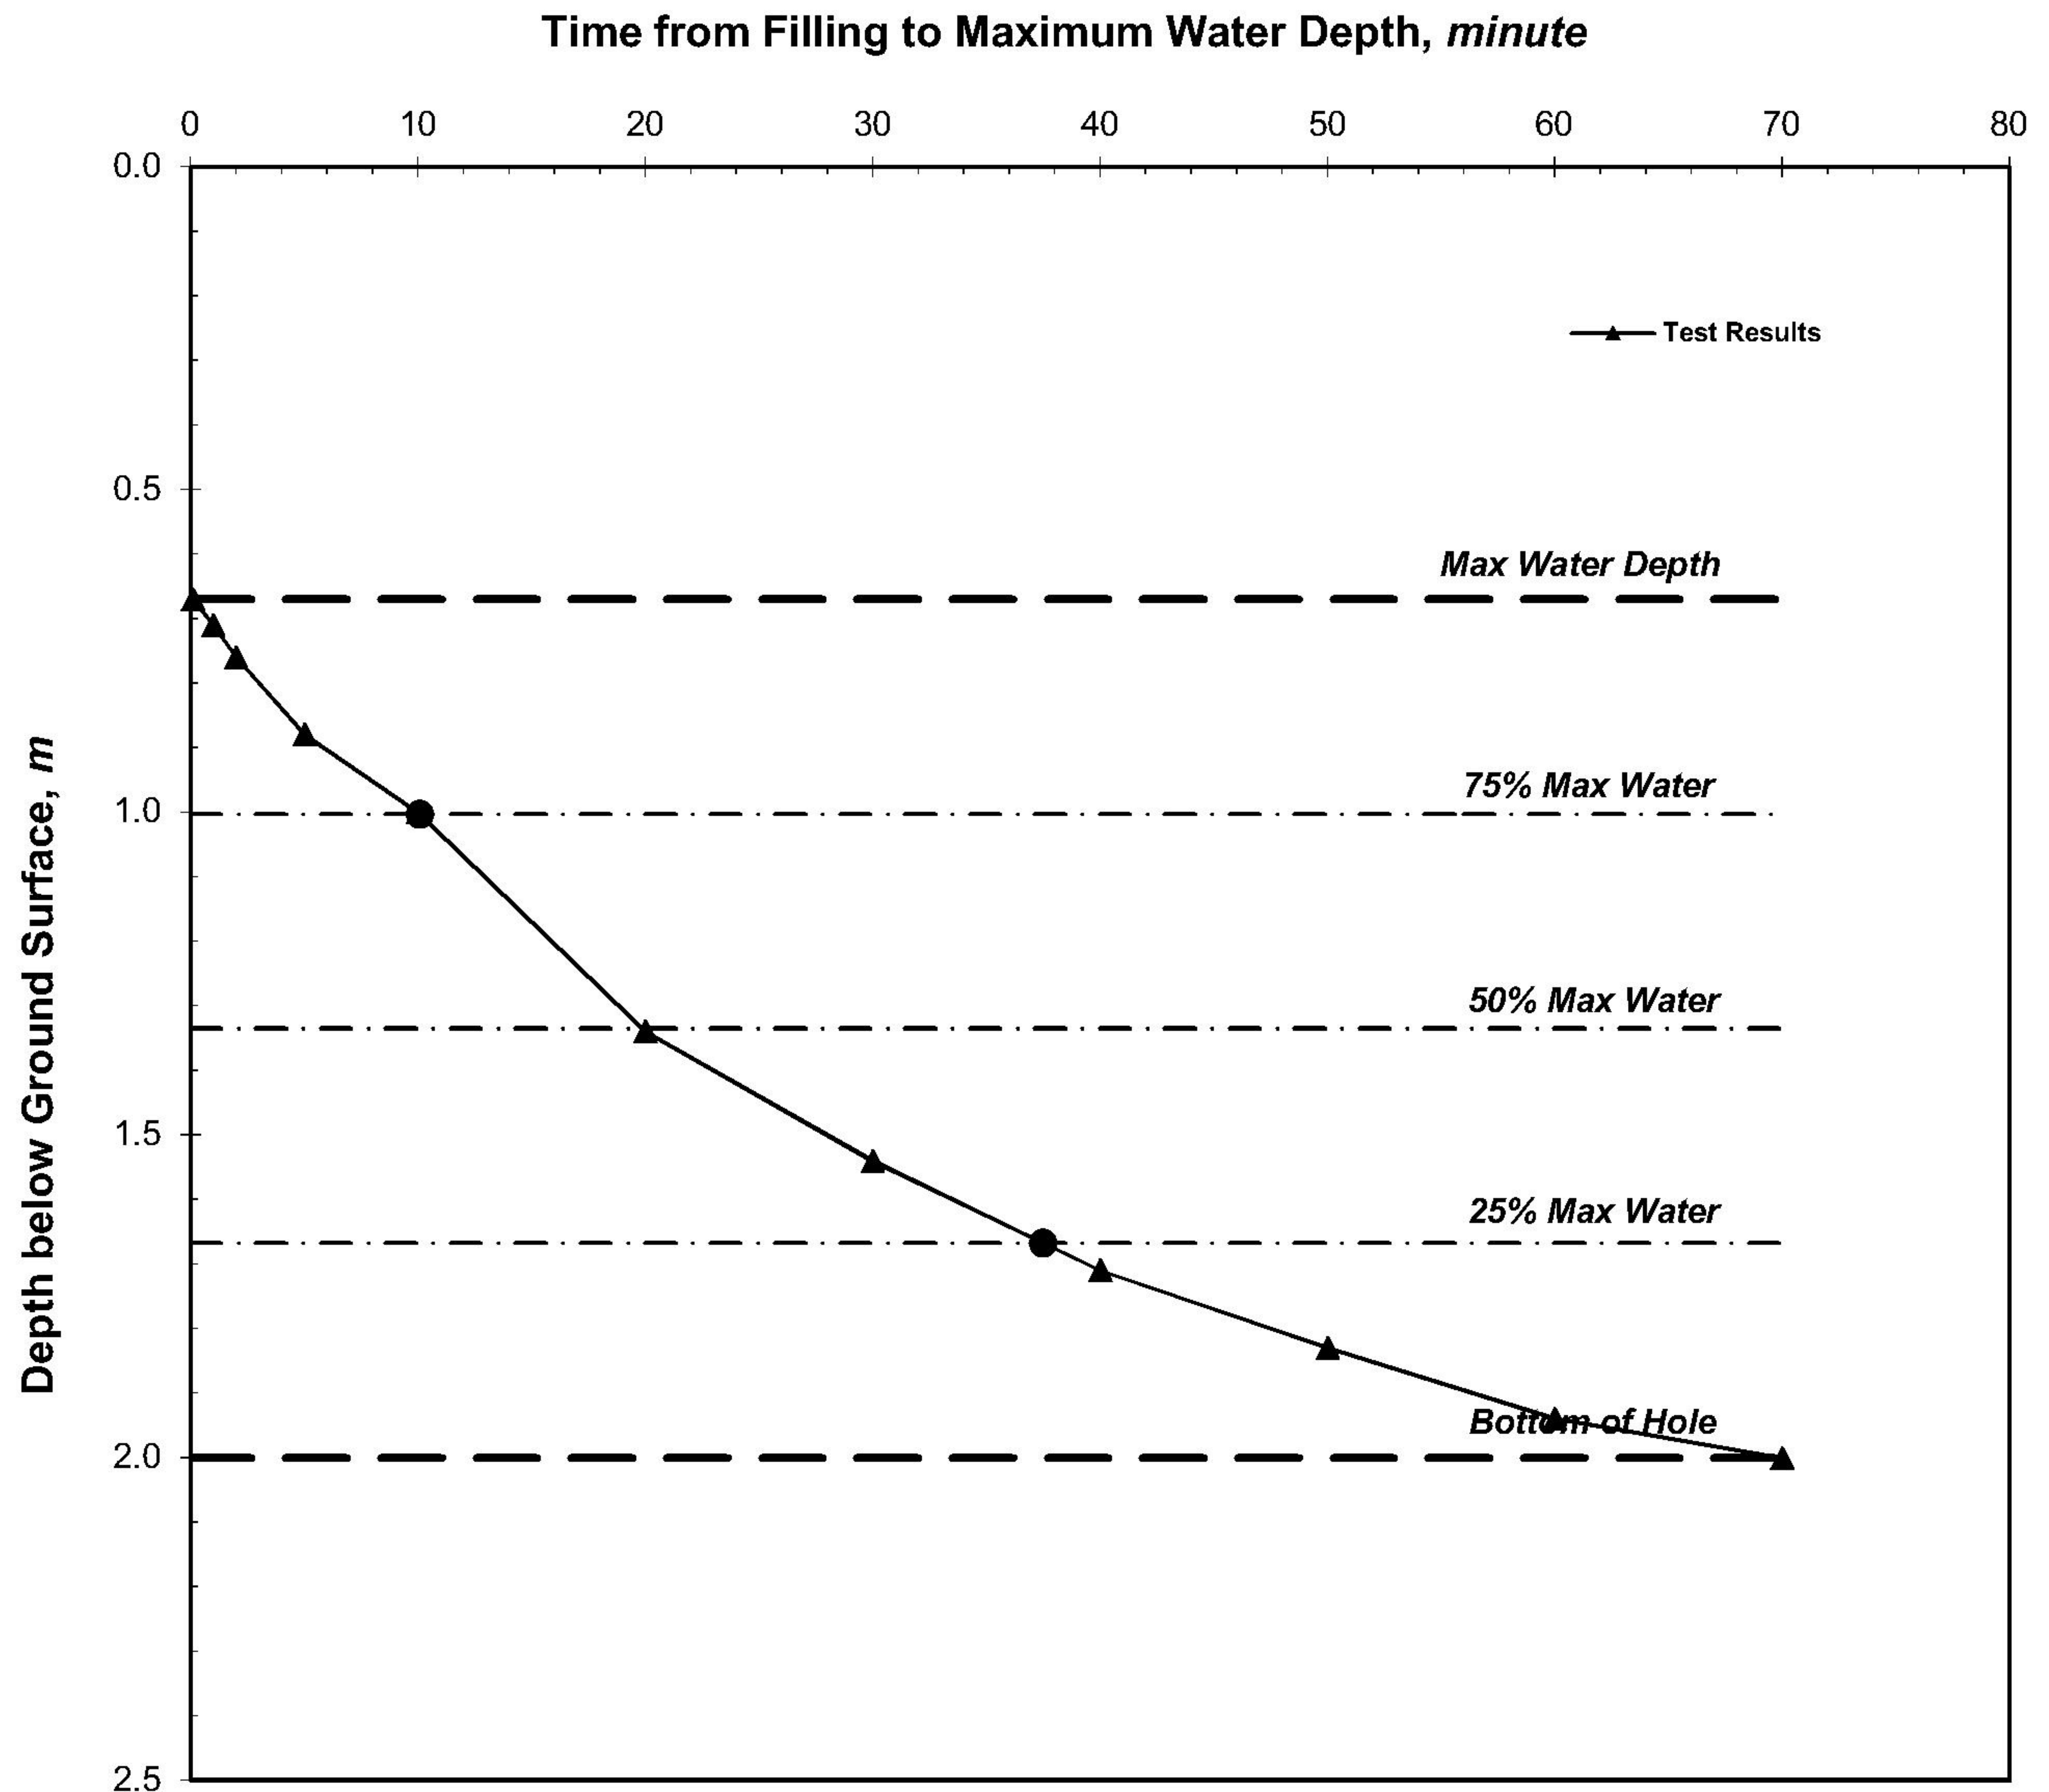
Test No: Test No 3 (Repeated)

| Test ID | Test Depth (mbgl) | Design Infiltration Rate | | Notes |
|---|---|---|---|---|
| TP2<br>(Repeat filling, Test No. 3) | 2.0 | 2.09 | $3.48 \times 10^{-5}$ | Pit was emptied at finish of test. |

| Voids Assumed for Granular Fill, % | 40% | BRE Soil Infiltration Rate, m/sec | <b>3.48E-05</b> |
