**Tree Survey and Arboricultural Impact Assessment  
In Accordance with BS 5837:2012**

| <b>Project No<br/>11353</b> | <b>Field Adjacent to Rocky Lane S5 11e, Roundway, Haywards Heath,<br/>RH16 4TW</b> | | |
| Client: | | Circet UK Wireless | |
| Date of Report: | 12/02/2025 | Revision: | A |

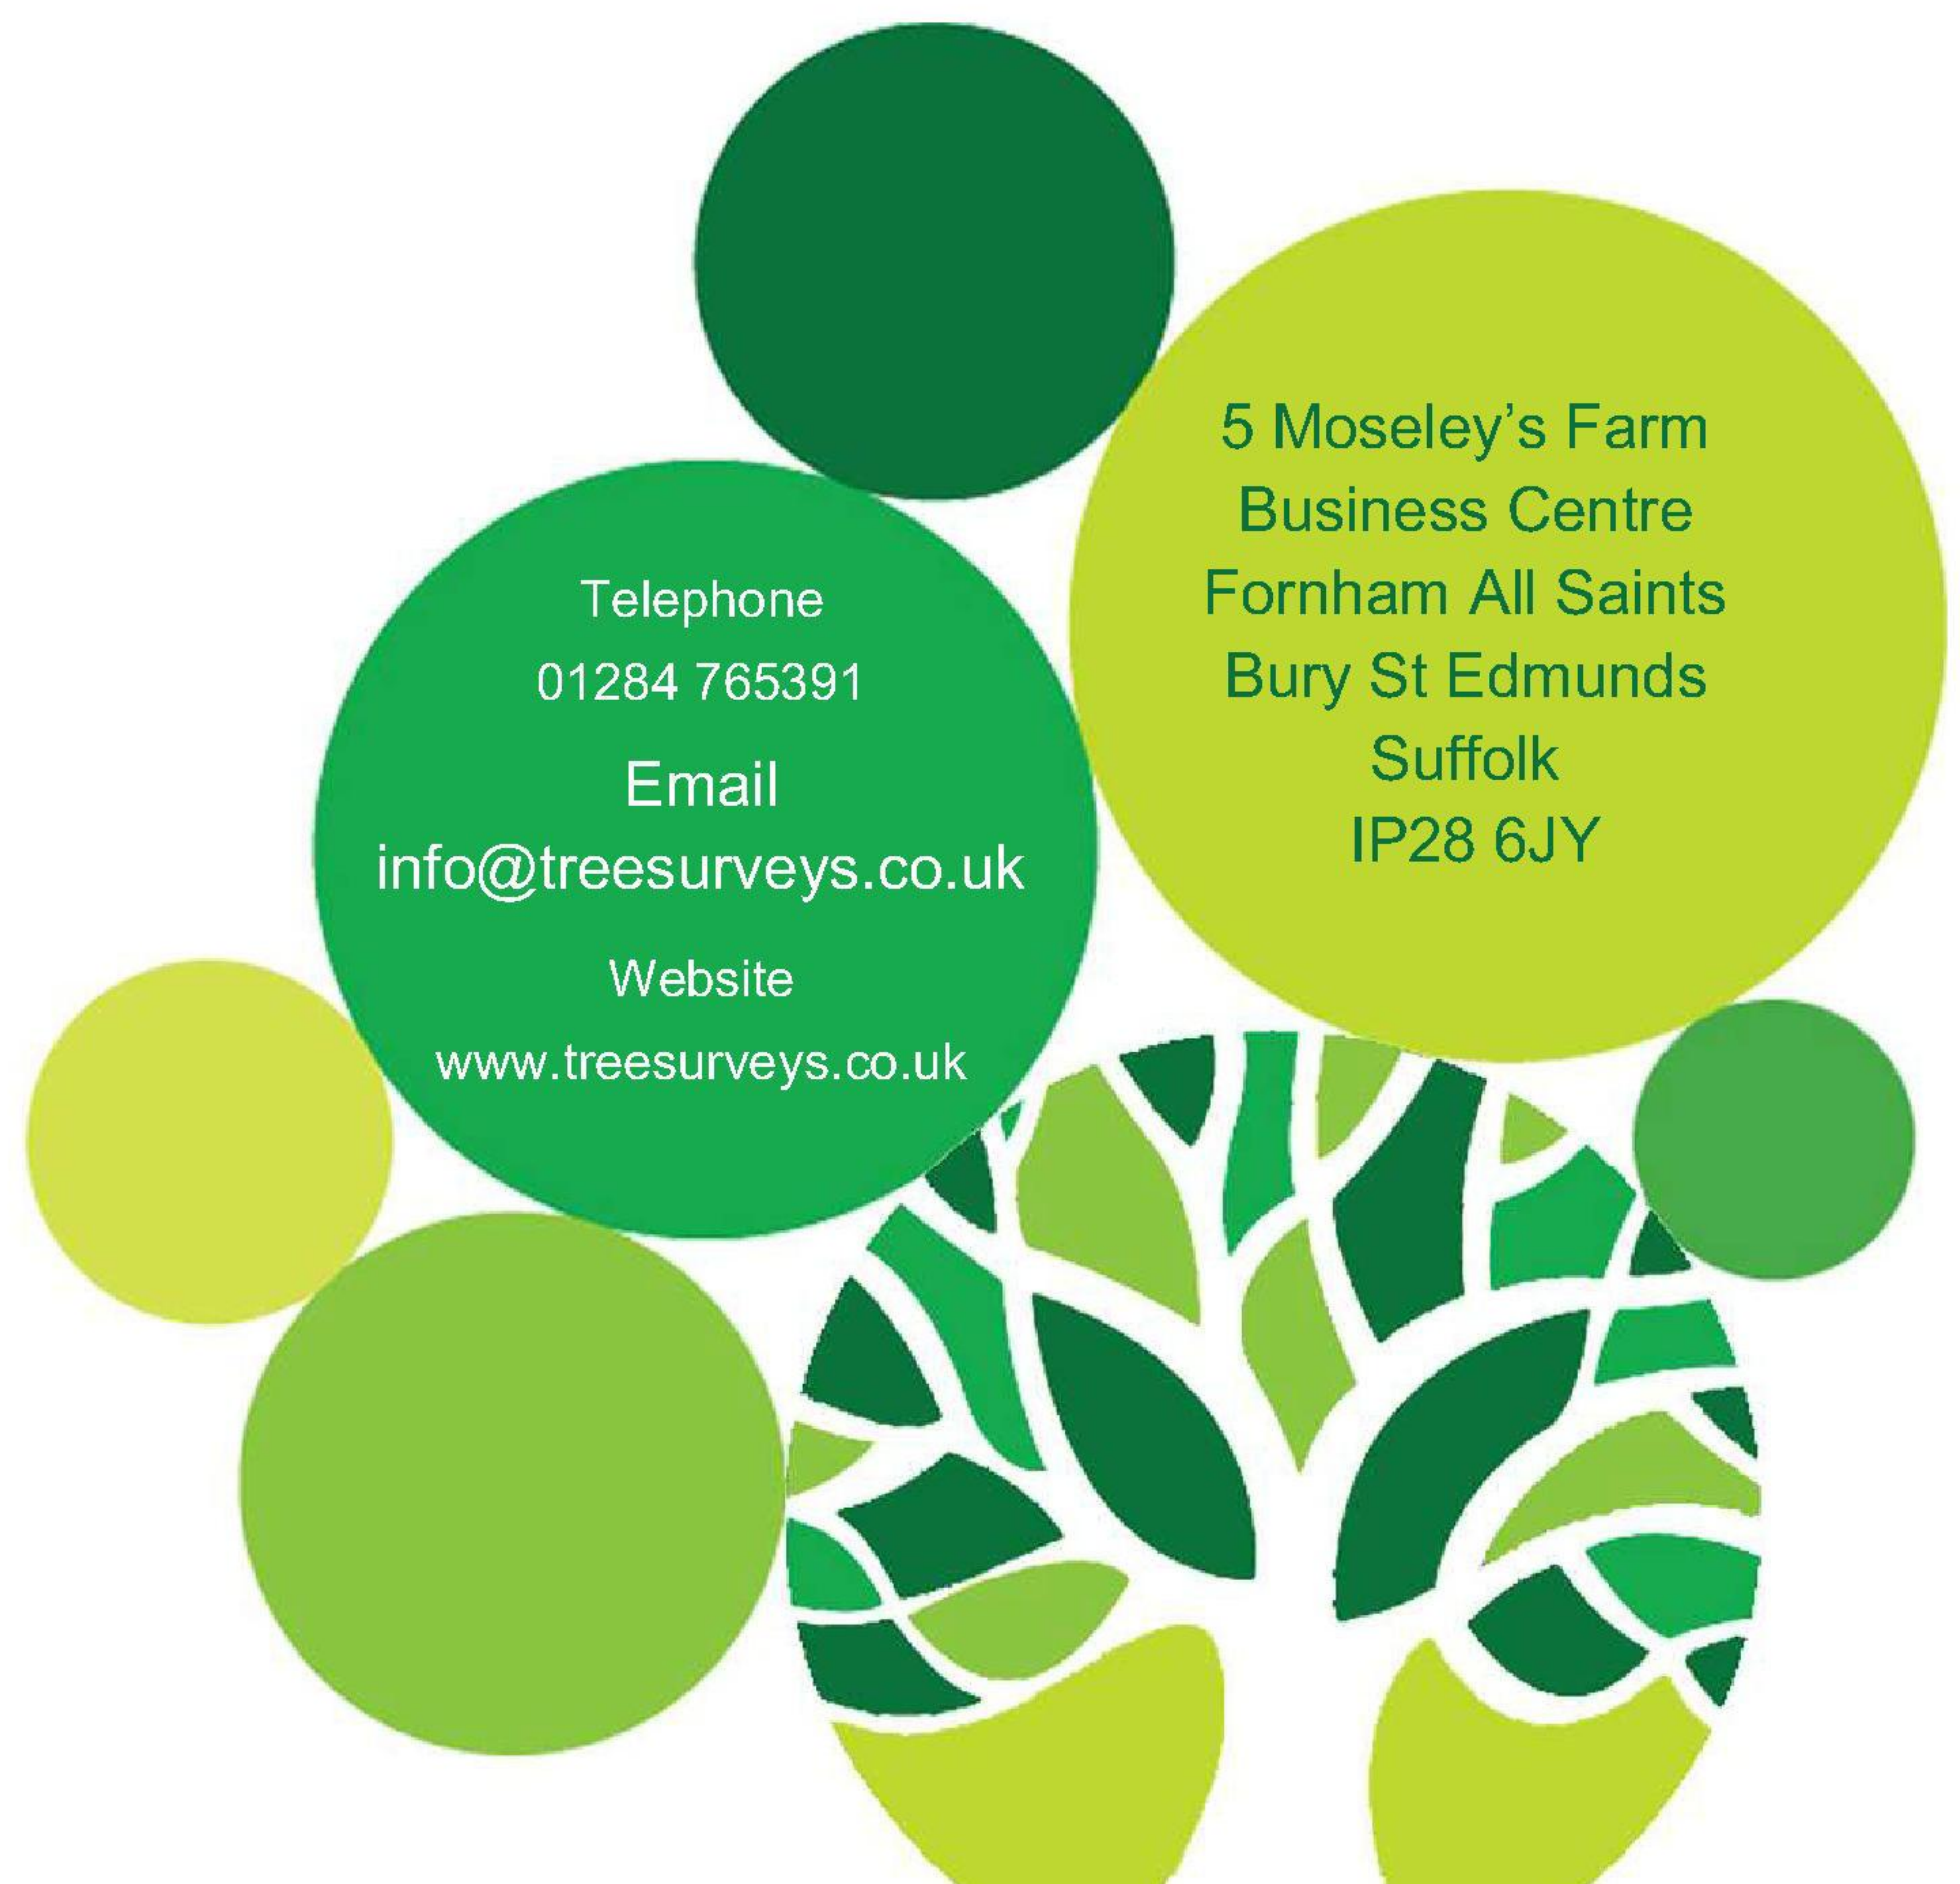
## Appendix H

- 4.1.1 Construction of the new site access / junction encroaches within a small portion of the RPA of T002. Given the minor extent of the intrusion that occurs at the periphery of its RPA, at this location it is considered appropriate to undertake linear root pruning as part of the access facilitation pruning (AFP) works. The earth will be excavated by hand to the depth of the proposed construction and any roots exposed will be cleanly severed using secateurs or a handsaw, ensuring that all wounds are left as small as possible and free from ragged ends.

| TreeNo | Species | DBH | Height | | Visual | Crown Spread | Problems / Comments | BS Cat | Work Required (TS) | Priority (TS) | Work Required (AIA) | Priority (AIA) |
|---|---|---|---|---|---|---|---|---|---|---|---|---|
| T002 | Oak | 1140 | 23 | | High | N7.5, E13.5, S15, W12.5 | Integral component of roadside tree belt. No evidence of fungal fruiting bodies around base or on lower stem. Tapping lower stem with a sounding hammer did not reveal presence of notable decay. Multi-stemmed from circa. 6m agl, dense lvy impeded a detailed inspection of unions. Major deadwood (size) throughout crown and overhanging adjacent highway. Low crown over potential site access. | A2 | Remove deadwood. | 2 | Undertake linear root pruning at location shown on drawing no. 11353-D-AIA rev. A | 0 |

- 4.7.1 Protective fencing will be erected at the locations shown on the attached drawing no. 11353-D-AIA rev. A prior to the commencement of construction.
