## BS:5837 ARBORICULTURAL REPORT

ARBORICULTURAL SURVEY, IMPACT ASSESSMENT &  
METHOD STATEMENT

15 SANDY VALE  
HAYWARDS HEATH  
WEST SUSSEX  
RH16 4JH

Ref: AIA/AMS 06573 / 2024

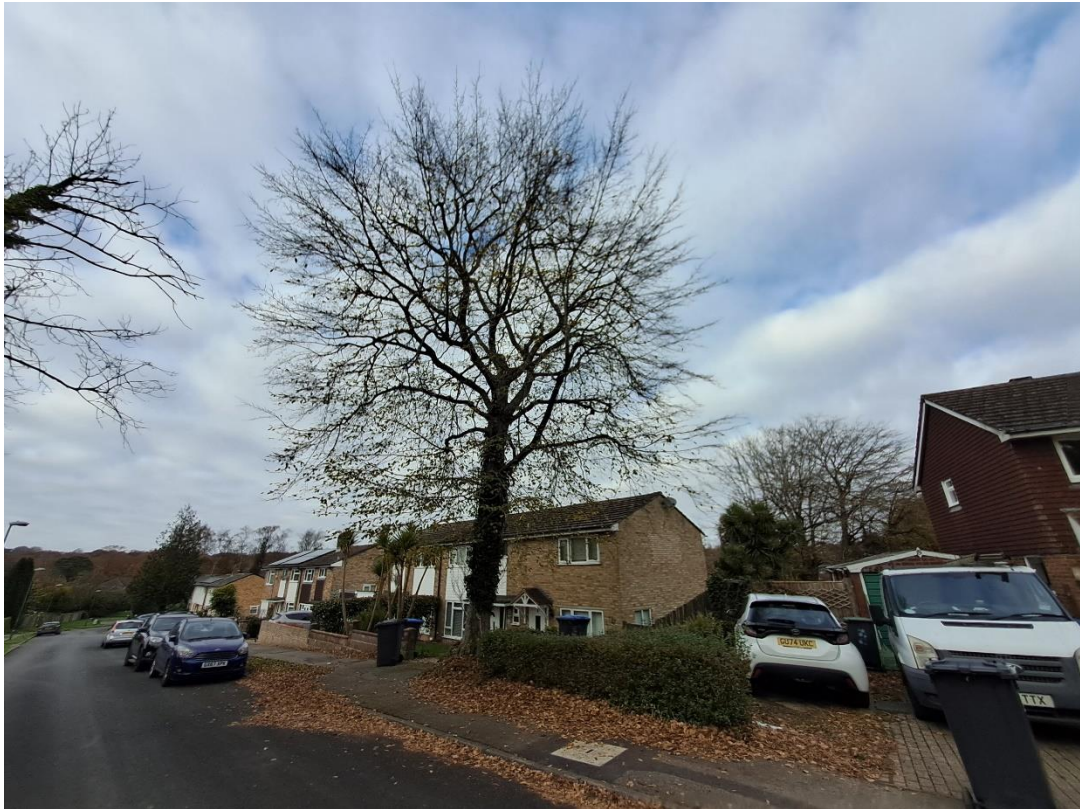
The most visually significant trees in relation to 15 Sandy Vale are T001 (Hornbeam) and T002 (Oak). T001 (Hornbeam) is within a neighbouring residential property, T002 (Oak) is growing within the highway verge. Both trees are well-formed and visually prominent landscape features which are important to the amenity provided by trees in the Local Area. The identified Root Protection Areas of both T001 & T002 are likely to extend into the front garden area of 15 Sandy Vale and may therefore be vulnerable during the proposed building works. In view of this, tree protection measures are required.

Photo 1 – T001 (Hornbeam) growing within the neighbouring residential property

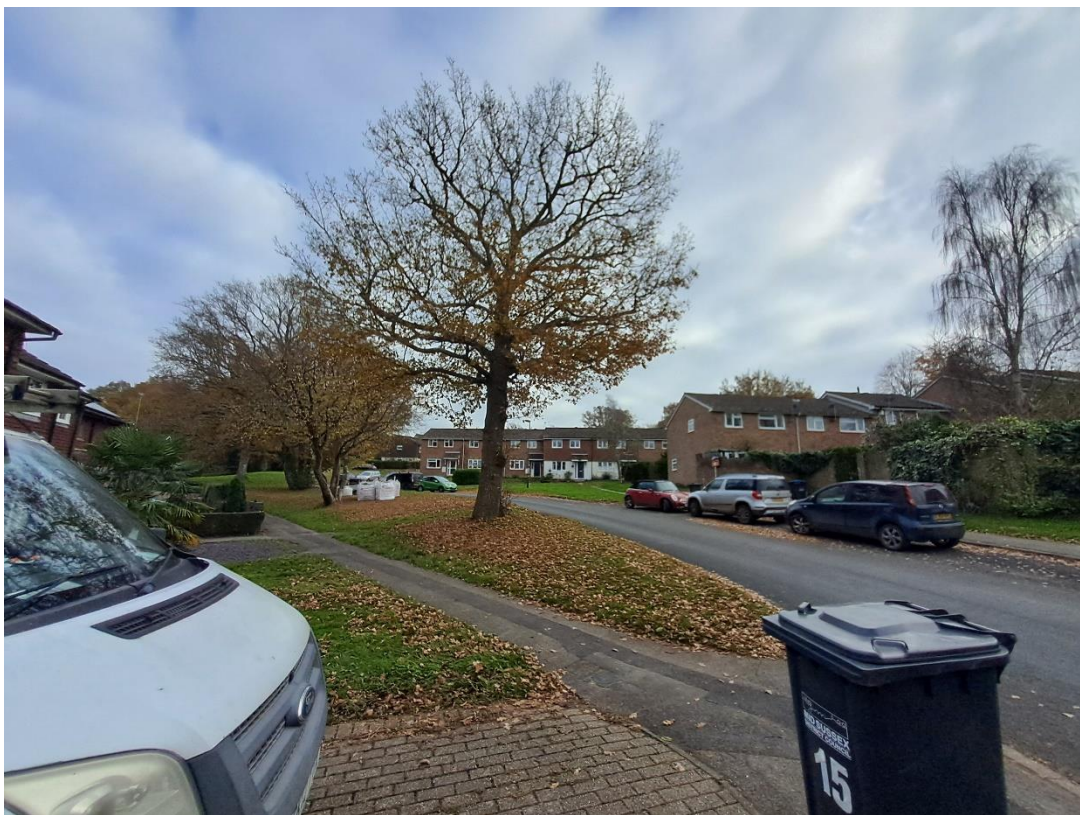
Photo 2 – T002 (Oak) growing within the highway verge

Parking space #3 is a planning requirement but in reality will be used infrequently. The parking space requires a small incursion of 9.7m<sup>2</sup> within the offset rooting area of T002 (Oak). As a lightweight structure this parking space will be constructed from reinforced turf such as Golpa cells or similar, installed using a no-dig methodology. This will provide a porous, load bearing structure whilst maintaining the amenity and green landscaping at the front of the property.

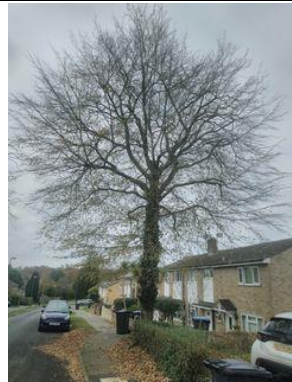
| Ref. | Species | Measurements | Spread | General Observations | Retention Category | RPA | Summary | Photo |
|---|---|---|---|---|---|---|---|---|
| T001 | Hornbeam<br>(Carpinus betulus) | Height (m): 11<br>Stem Diam(mm): 420<br>Crown Clearance (m): 2<br>Life Stage: Mature<br>Rem. Contrib.: 40+ Years | N:5.5<br>E:6<br>S:5.5<br>W:5 | Compaction at base. Ivy clad tree on raised earth bund. Epicormic growth from base. Stump at base from felled stem. Ivy clad trunk. Reasonable form and vitality. | B1 | Radius: 5.0m.<br>Area: 79 sq m. | Physiological Condition: Good<br>Structural Condition: Fair<br>Public Amenity Value: High<br>Inspection Limitations: Off-site | |

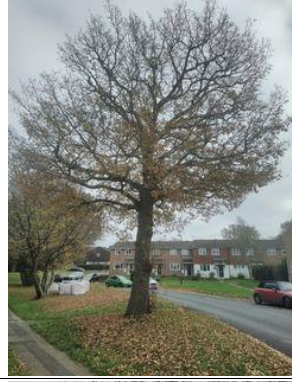
| Ref. | Species | Measurements | Spread | General Observations | Retention Category | RPA | Summary | Photo |
|---|---|---|---|---|---|---|---|---|
| T002 | Pedunculate oak<br>(Quercus robur) | Height (m): 11<br>Stem Diam(mm): 560<br>Crown Clearance (m): 4<br>Rem. Contrib.: 40+ Years | N:5.5<br>E:6<br>S:5.5<br>W:4 | Small tree, compact crown. Within amenity verge. Epicormic shoots from base and lower trunk. Good form and vitality. | A1 | Radius: 6.7m.<br>Area: 141 sq m. | Physiological Condition: Good<br>Structural Condition: Good<br>Public Amenity Value: High | |

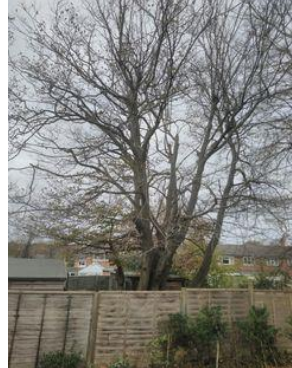
| Ref. | Species | Measurements | Spread | General Observations | Retention Category | RPA | Summary | Photo |
|---|---|---|---|---|---|---|---|---|
| T003 | Hornbeam<br>(Carpinus betulus) | Height (m): 10<br>4 stems, avg.(mm): 300<br>Crown Clearance (m): 2<br>Life Stage: Over Mature<br>Rem. Contrib.: <10 years | N:5<br>E:6<br>S:4.5<br>W:4 | Large, lapsed coppice stool. Significant decay pockets and Dieback in crown. Previously reduced. Dead branch stubs and bark necrosis in crown. | U | No RPA due to Retention Category of U. | Physiological Condition: Poor<br>Structural Condition: Physical Defect<br>Public Amenity Value: Moderate<br>Inspection Limitations: Access | |

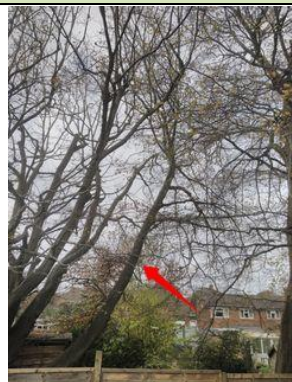
| Ref. | Species | Measurements | Spread | General Observations | Retention Category | RPA | Summary | Photo |
|---|---|---|---|---|---|---|---|---|
| T004 | Hornbeam<br>(Carpinus betulus) | Height (m): 11<br>Stem Diam(mm): 350<br>Crown Clearance (m): 2<br>Life Stage: Mature<br>Rem. Contrib.: 20+ Years | N:7<br>E:2<br>S:2<br>W:3.5 | Swept low steel to north. Upper canopy resumes vertical growth. Good vitality in crown. | C2 | Radius: 4.2m.<br>Area: 55 sq m. | Physiological Condition: Poor<br>Structural Condition: Physical Defect<br>Public Amenity Value: Moderate<br>Inspection Limitations: Access | |

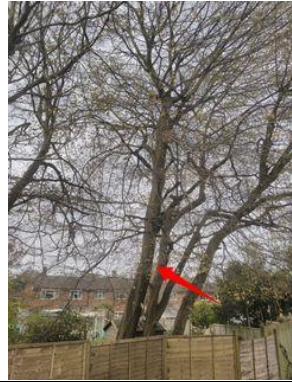
| Ref. | Species | Measurements | Spread | General Observations | Retention Category | RPA | Summary | Photo |
|---|---|---|---|---|---|---|---|---|
| T005 | Hornbeam<br>(Carpinus betulus) | Height (m): 12<br>Stem Diam(mm): 500<br>Crown Clearance (m): 3<br>Life Stage: Mature<br>Rem. Contrib.: 40+ Years | N:4.5<br>E:5<br>S:5<br>W:4.5 | Single swept stem leaning into crown of T006 | B | Radius: 6.0m.<br>Area: 113 sq m. | Physiological Condition: Fair<br>Structural Condition: Unknown<br>Public Amenity Value: Moderate<br>Inspection Limitations: Access | |

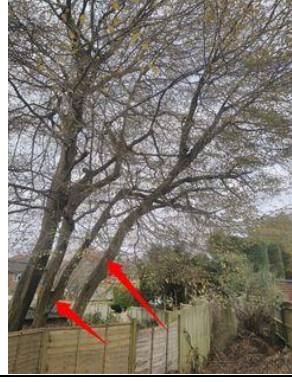
| Ref. | Species | Measurements | Spread | General Observations | Retention Category | RPA | Summary | Photo |
|---|---|---|---|---|---|---|---|---|
| T006 | Hornbeam<br>(Carpinus betulus) | Height (m): 12<br>2 stems, avg.(mm): 300<br>Crown Clearance (m): 2<br>Life Stage: Mature<br>Rem. Contrib.: 40+ Years | N:5<br>E:7.5<br>S:5<br>W:3 | Two stems group ground level. Swept stems northeast suppressed by canopy of T005. Decay pockets in old pruning cuts. Reasonable vitality. | B | Radius: 5.1m.<br>Area: 82 sq m. | Physiological Condition: Fair<br>Structural Condition: Unknown<br>Public Amenity Value: Moderate<br>Inspection Limitations: Access | |
