Re DM/25/2661|Outline planning application (with all matters reserved except for access) comprising a residential development of up to 210 dwellings (Use Class C3); with associated access; landscaping; amenity space; drainage and associated works. Land At Coombe Farm London Road Sayers Common West Sussex

I writing to request that you contact WSCC LLFA to advise of some serious surface water flooding that took place at the above site on 27th January 2026. I believe it is important for them to know of the extent of this flooding in order for them to be able to make an informed consultation response on the above development.

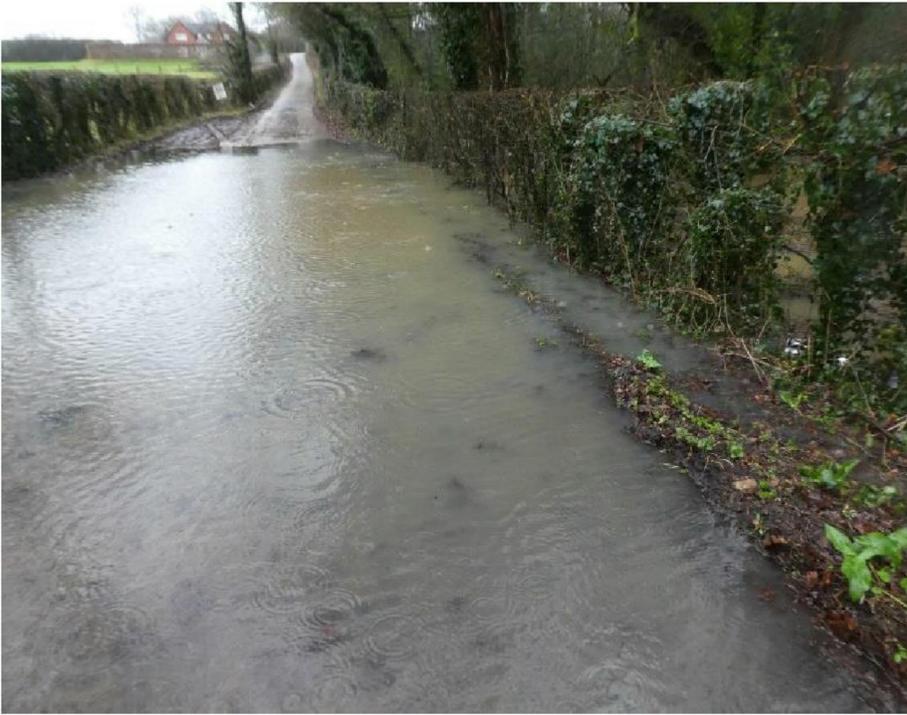
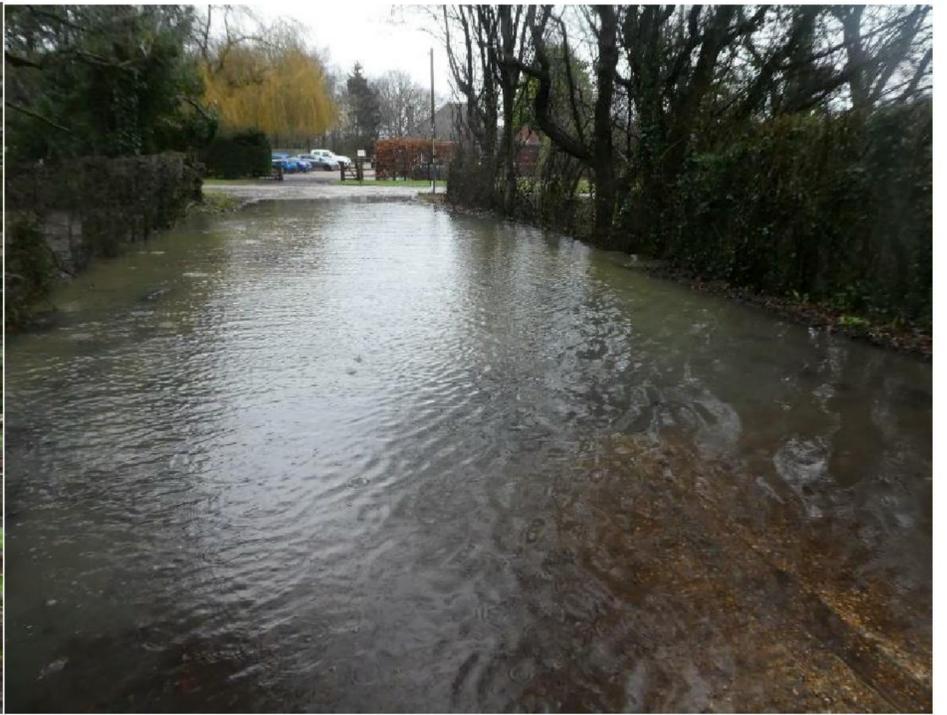
Location A - Photographs taken at the entrance to the bridleway 86HU by the B2118 London Road looking eastwards

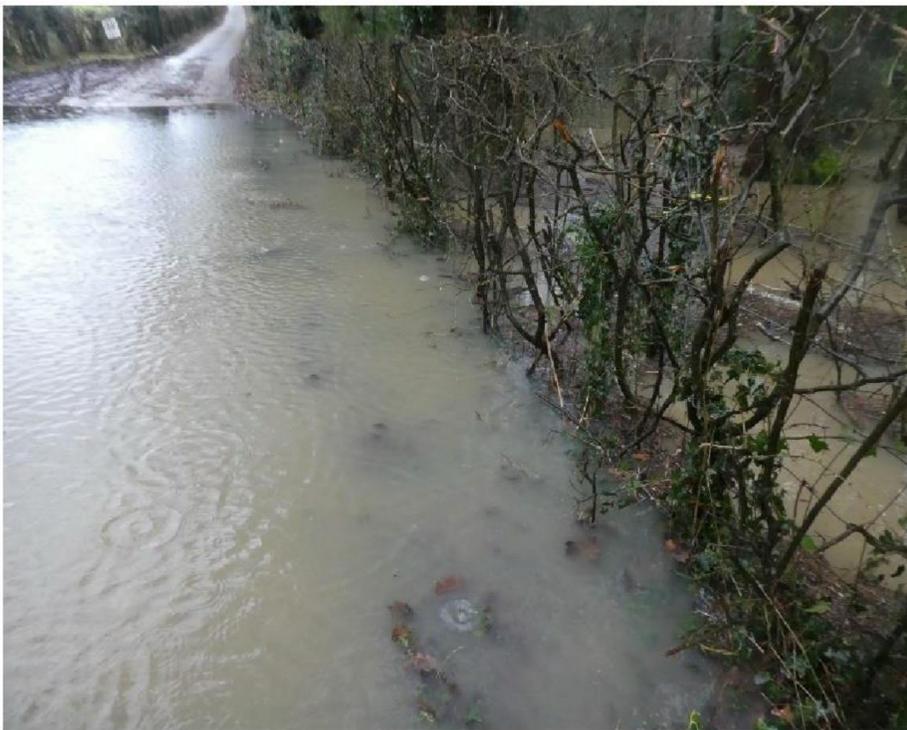
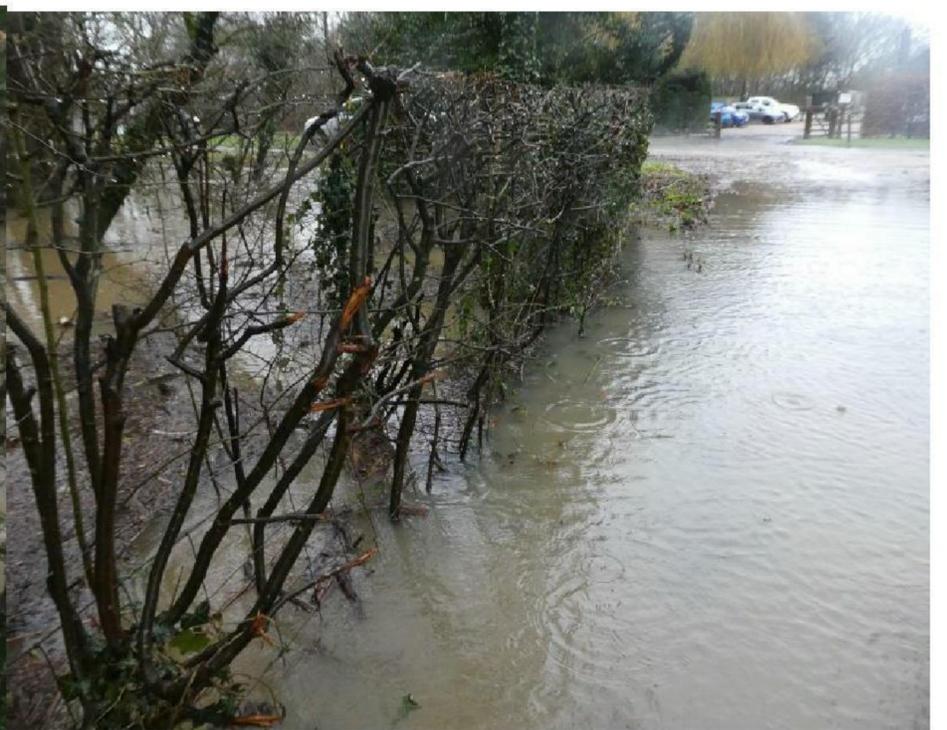
Location A – These Photographs show at least 10metres of flooding at a depth of 20cm or more at its deepest points. Left, photo taken looking eastwards and right photo taken looking westwards

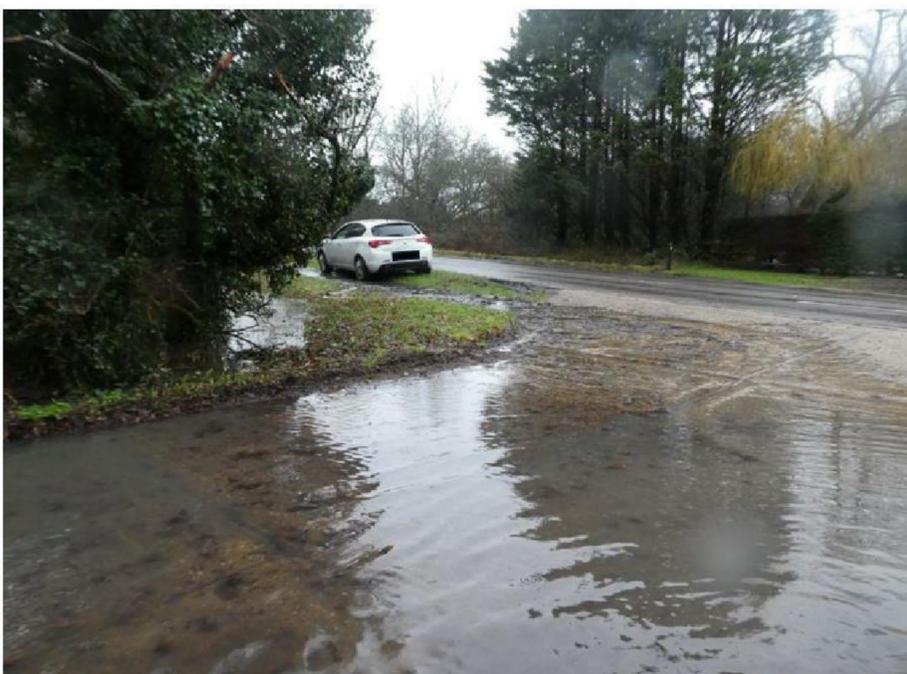
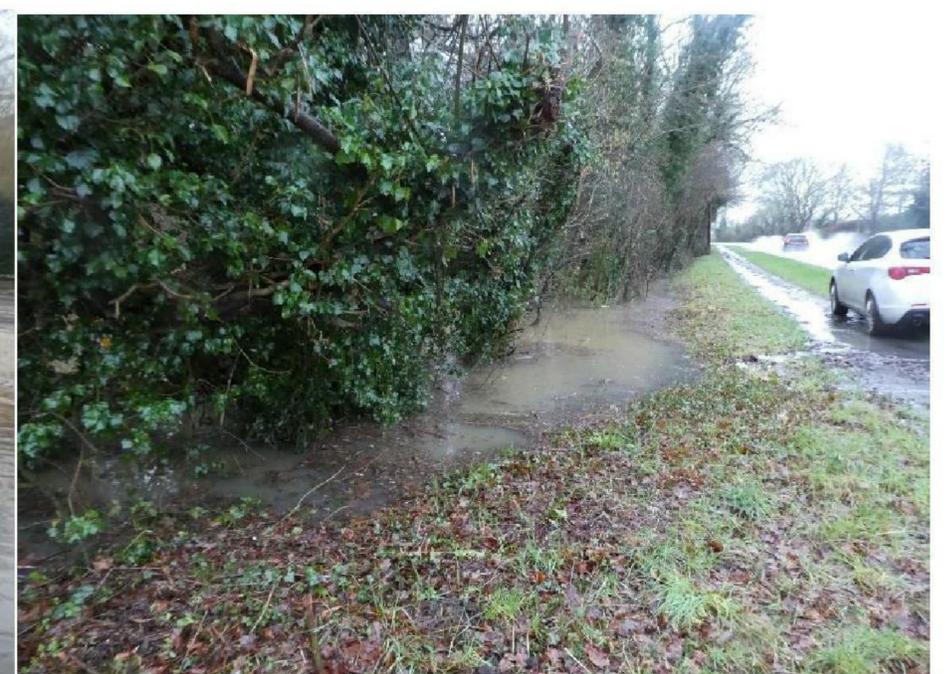
Location A – The floodwater was flowing from the Ancient Wood of Coombe Wood that sits along the south side of the bridleway 86HU. Left photo looking eastwards, right photo looking westwards.

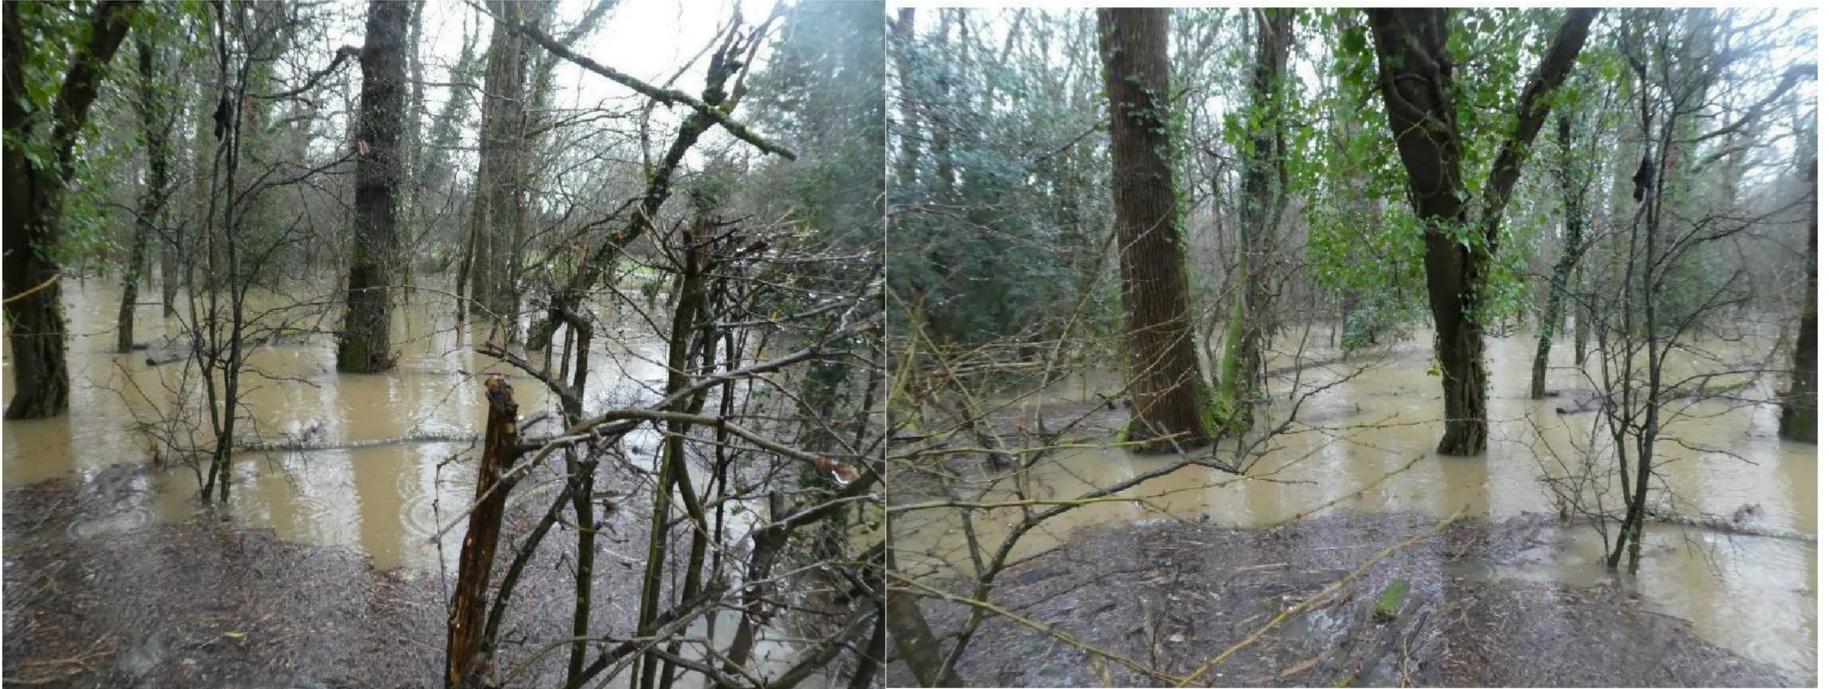
Location A – The Floodwater was so deep that residents wishing to access the properties on the bridleway 86HU had to leave their cars parked at the bottom on the B2118.

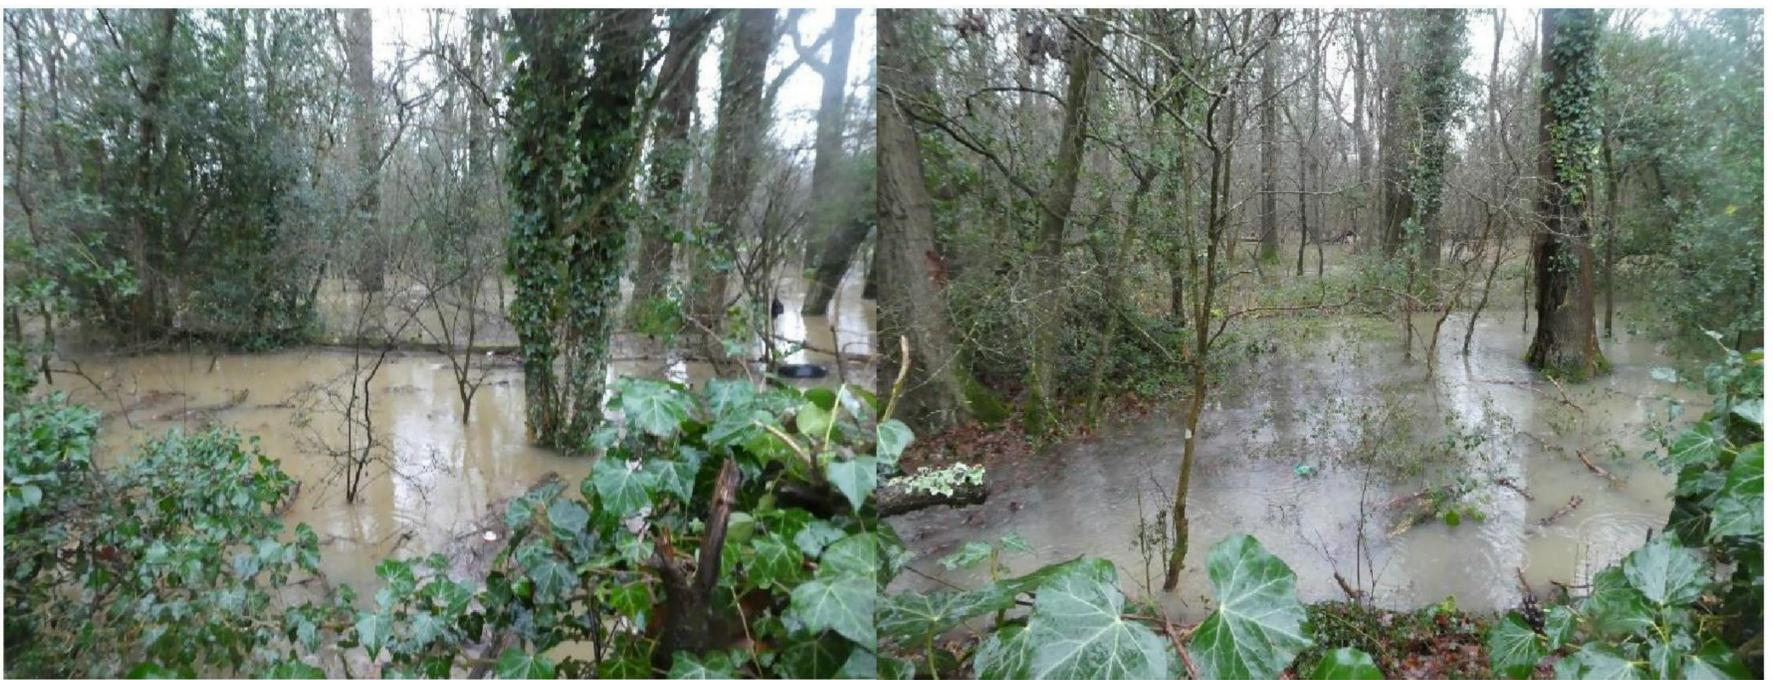
Location B – Flooding of the Ancient Wood of Coombe Wood along the southern side of the bridleway 86HU at its western end.

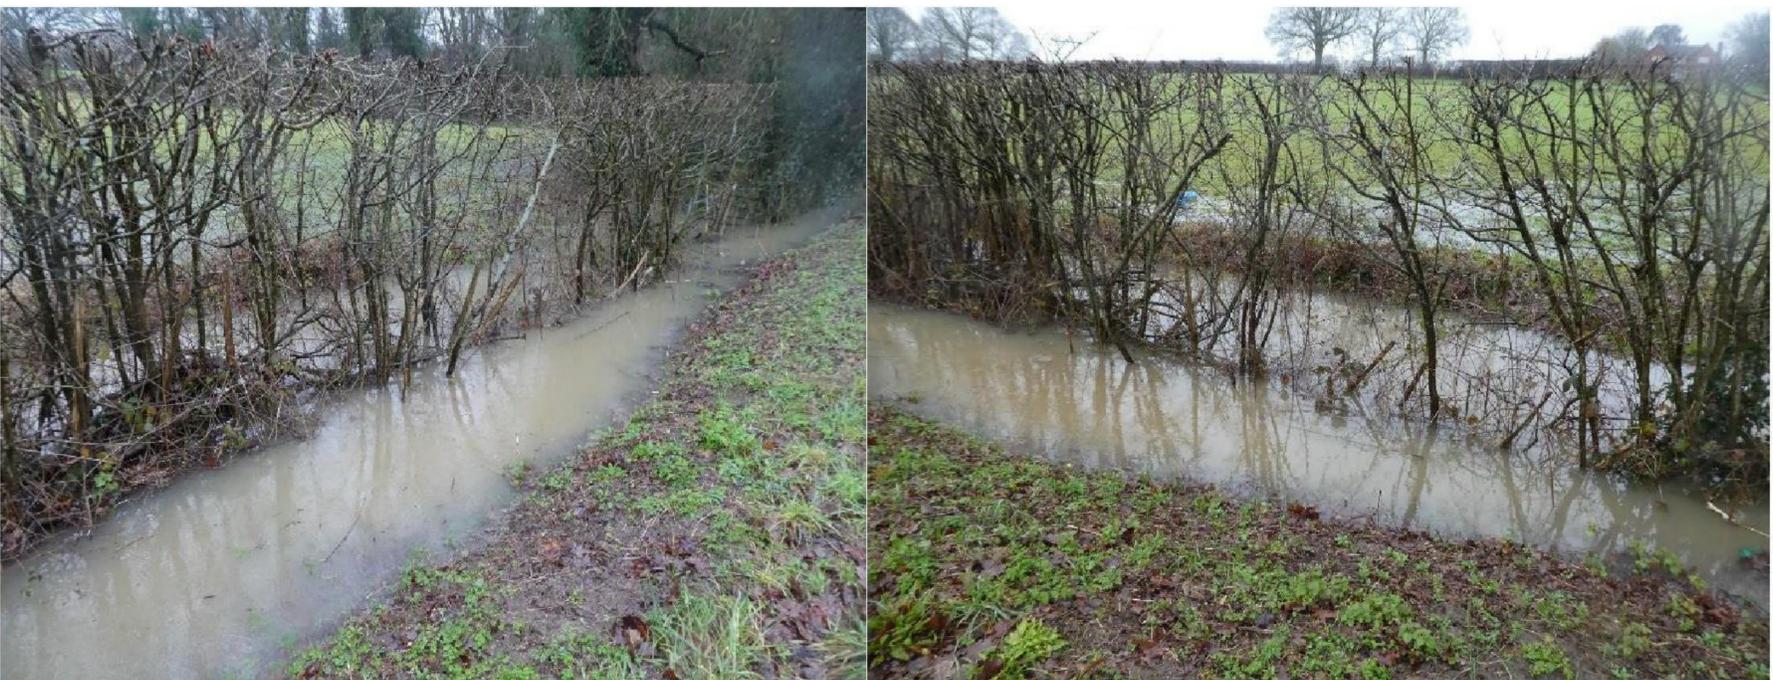
Location B – Further pictures of the flooding of the Ancient Wood of Coombe Wood. Most of the floodwater comes from the higher land above the southwest corner of the site and down Coombe Hill. That higher land is not under the applicant’s control. There is a culvert that runs south to north under bridleway 86HU that should carry this water away from the wood but it does not have the capacity to do this. The floodwater therefore build up to the point that it is so high it flows over the bridleway.

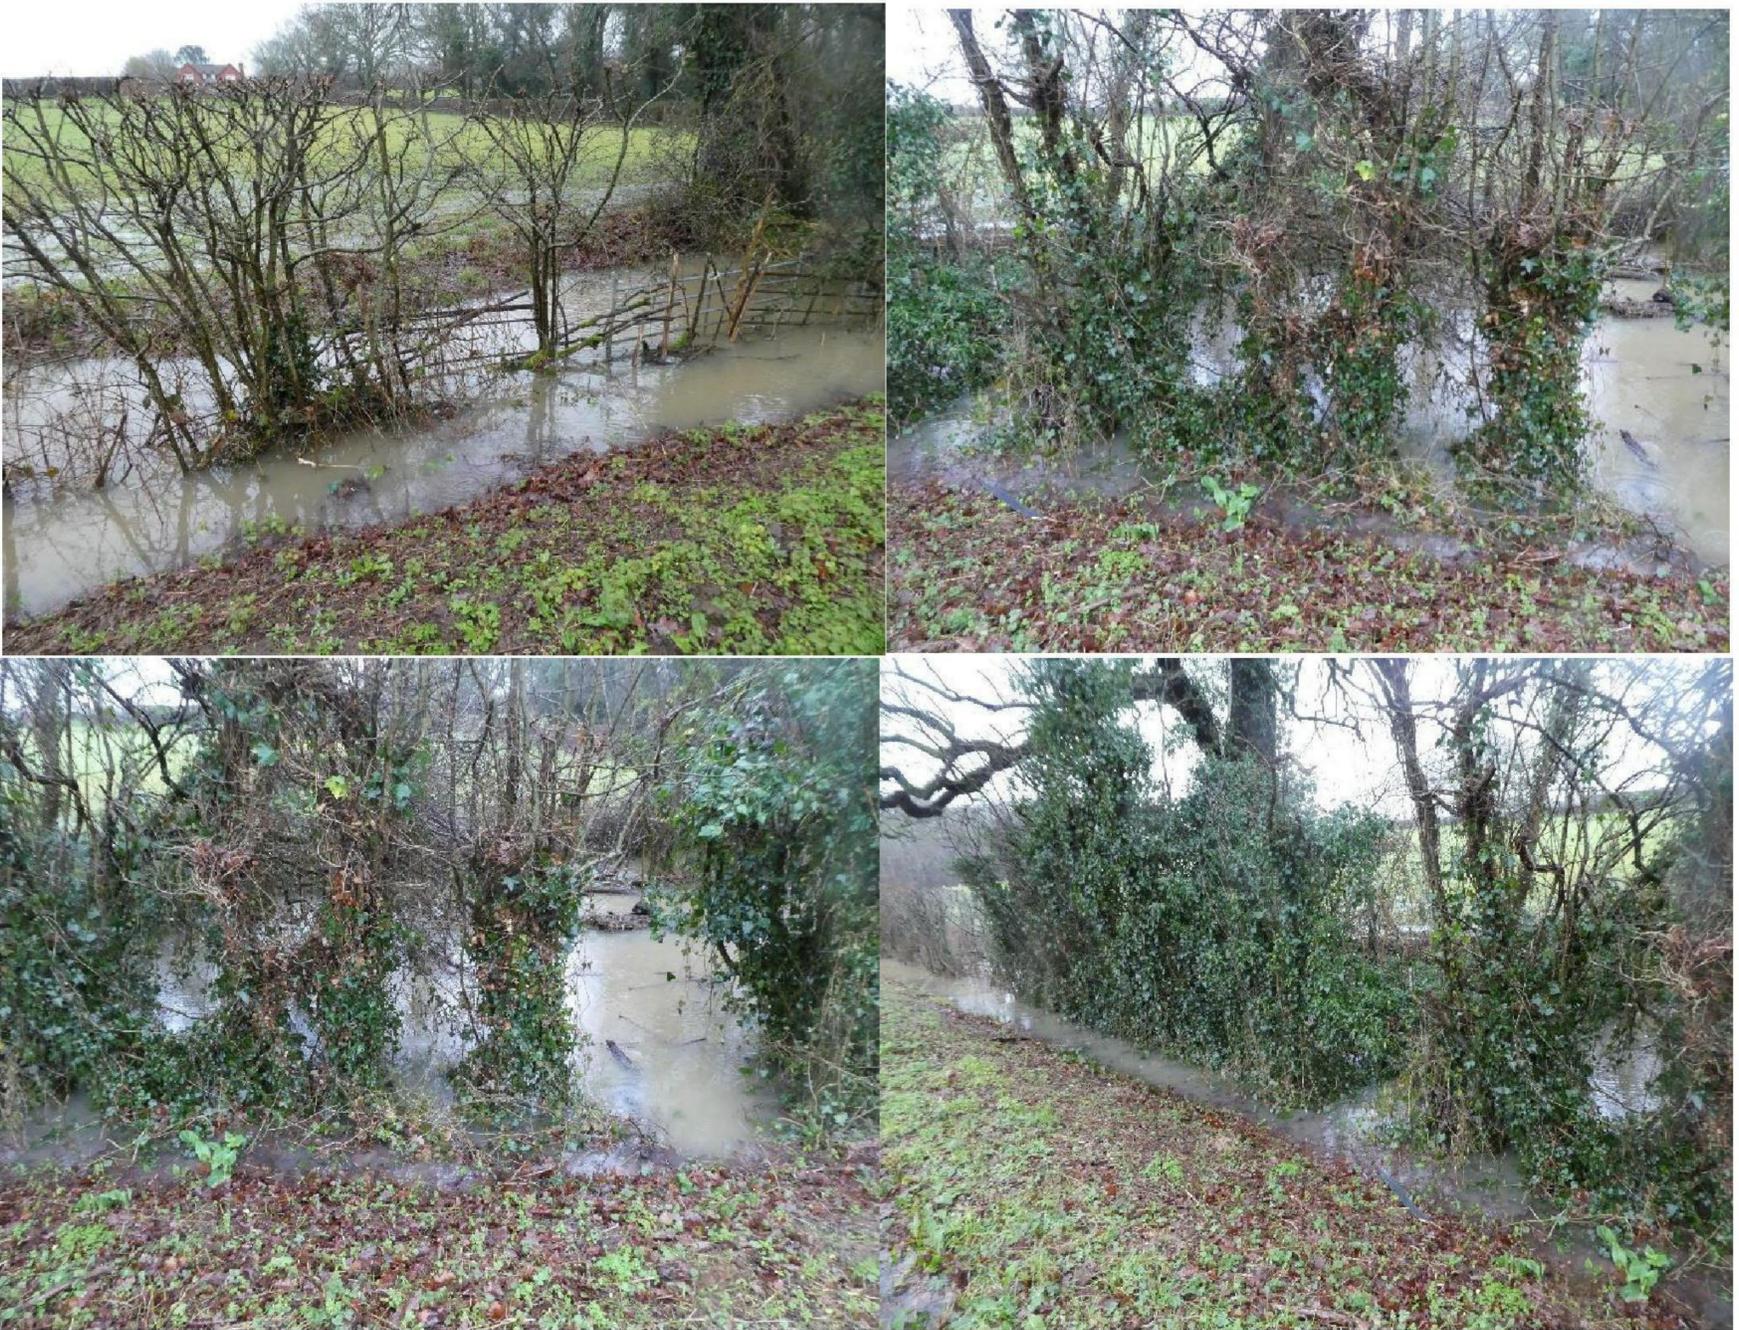
Location C – The Flooding continued along the western boundary of the site besides the B2118 Roadway.

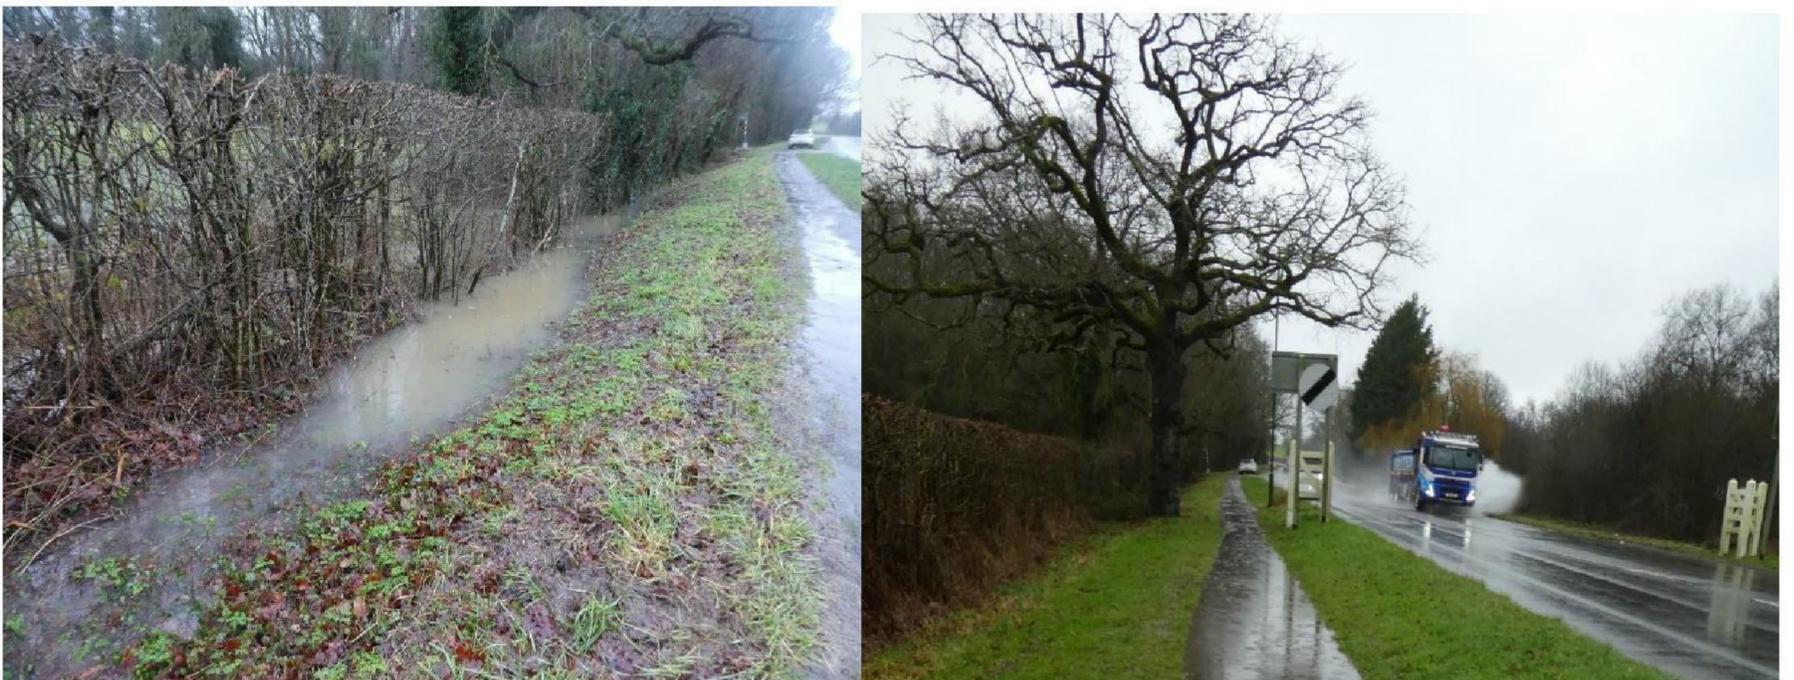
Location C – Further photos of the flooding continuing along the western boundary of the site with the B2118 Roadway

Location C -The B2118 roadway surface sits about 40cm higher than the bottom of the western boundary edge of the site, and it too suffers from surface water flooding that can cover over half of the roadway.

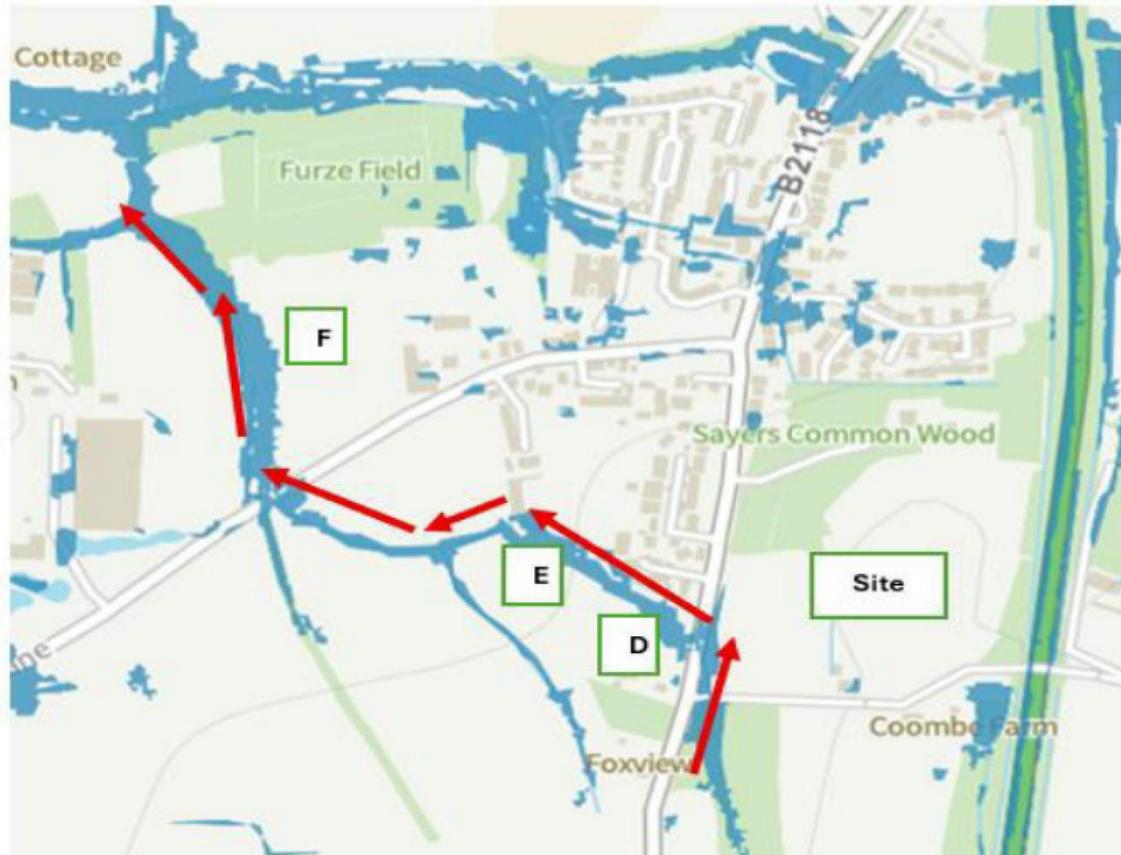
The watercourse that carries the floodwater south to north along the western boundary of the site is then culverted westwards under the B2118 and continues to flow, first westwards and then north, to eventually join the Adur River just before it reaches Mock Bridge. At the same time that this flooding of the site took place there was also continual flooding further down the watercourse as shown below.

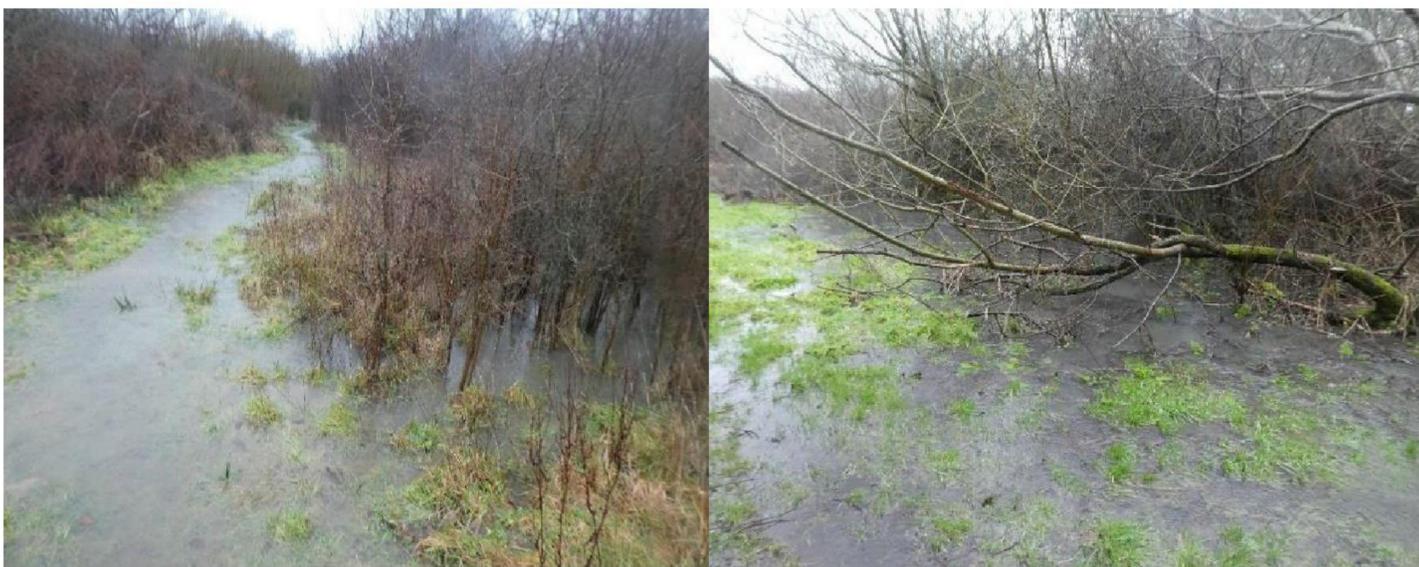
Location D – The footpath 11HU going through the field on the western side of the B2118 opposite the site.

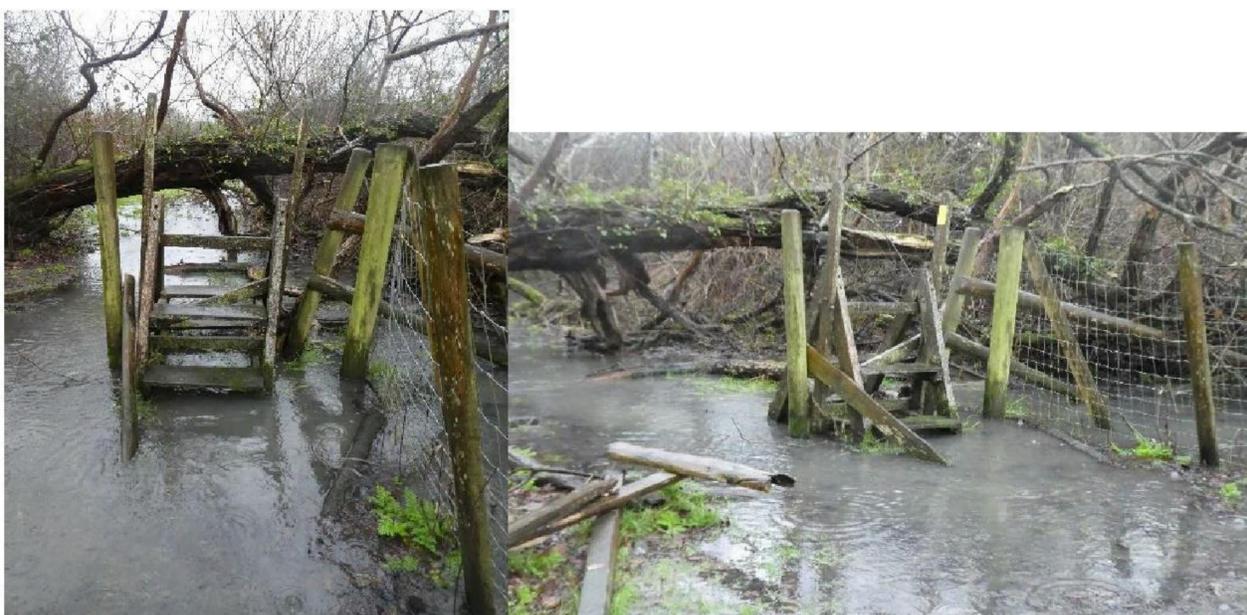
The footpath 11HU and stile in the middle between locations D & E

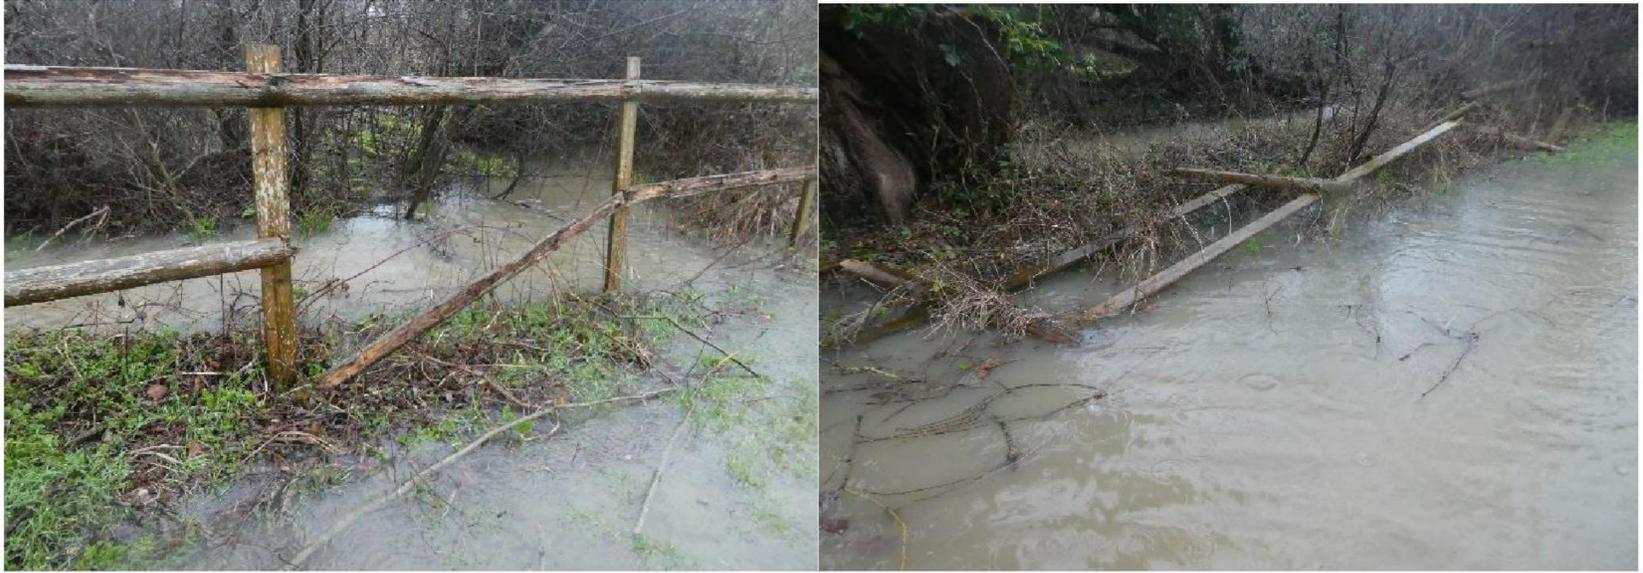
Location E – the watercourse overflowing and flooding footpath 11HU

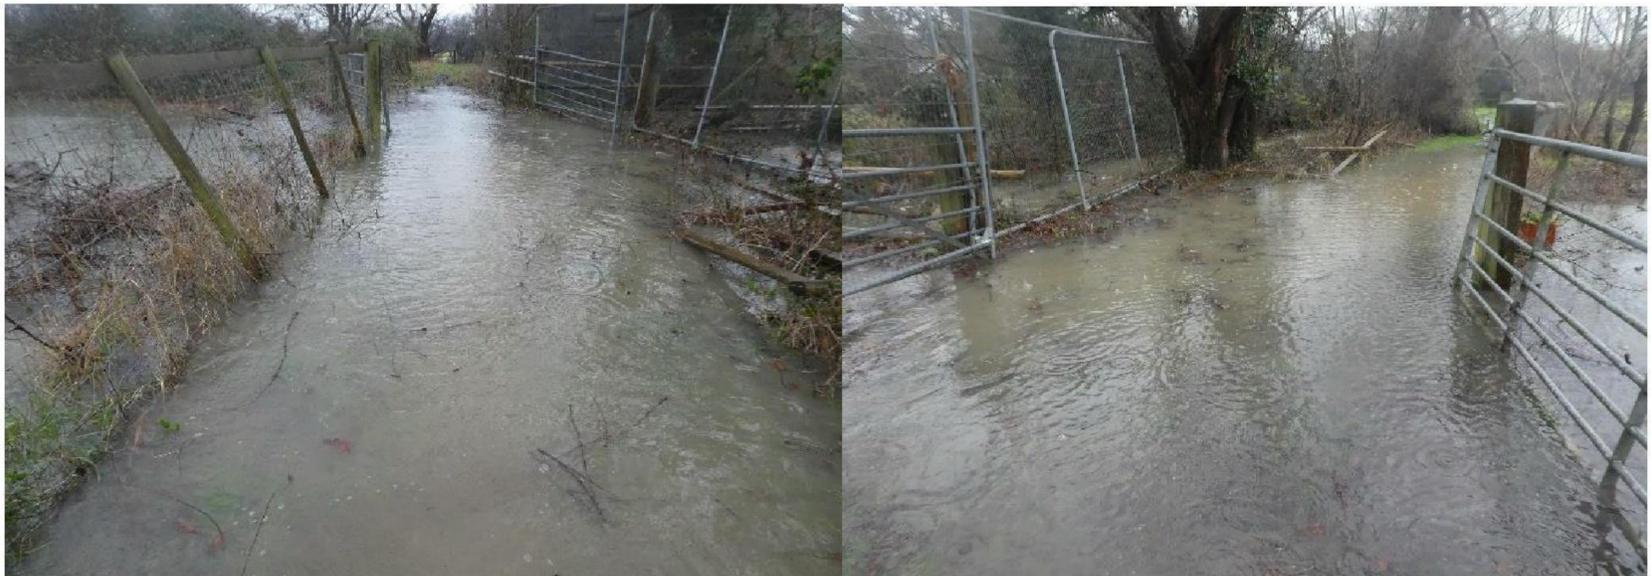
Location E – Footpath 11HU flooded to depths of up to 20cm

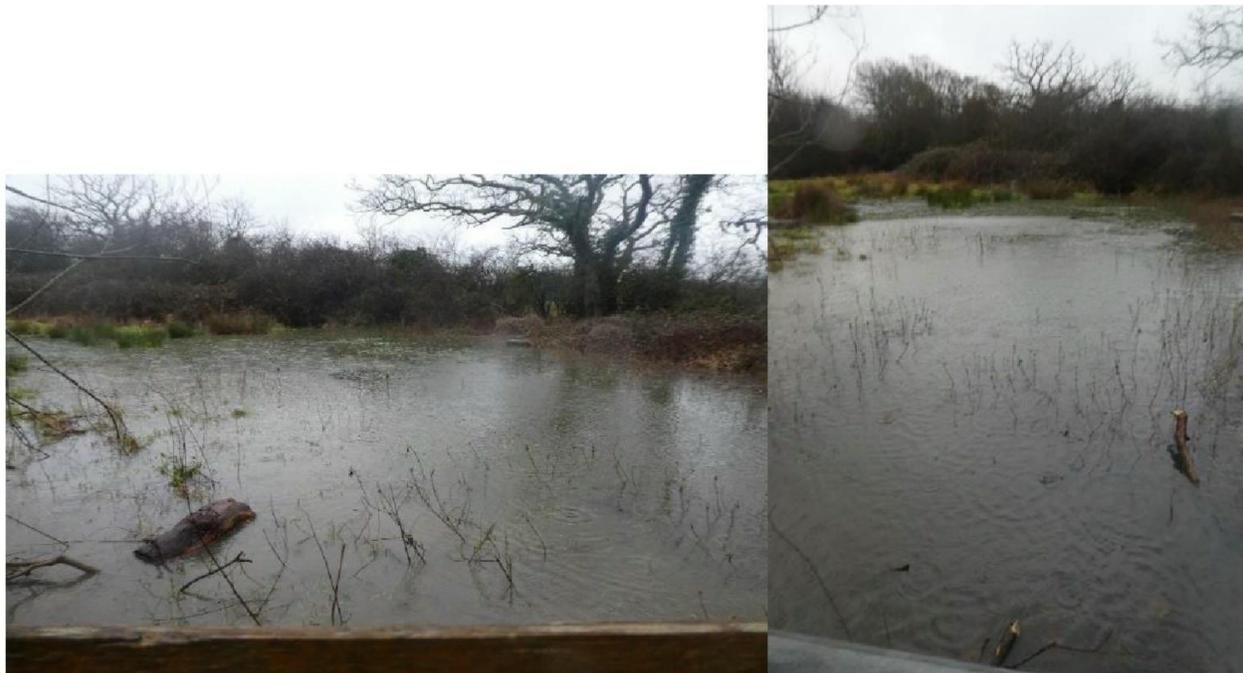
Location E – Flooded land on the south side of footpath 11HU

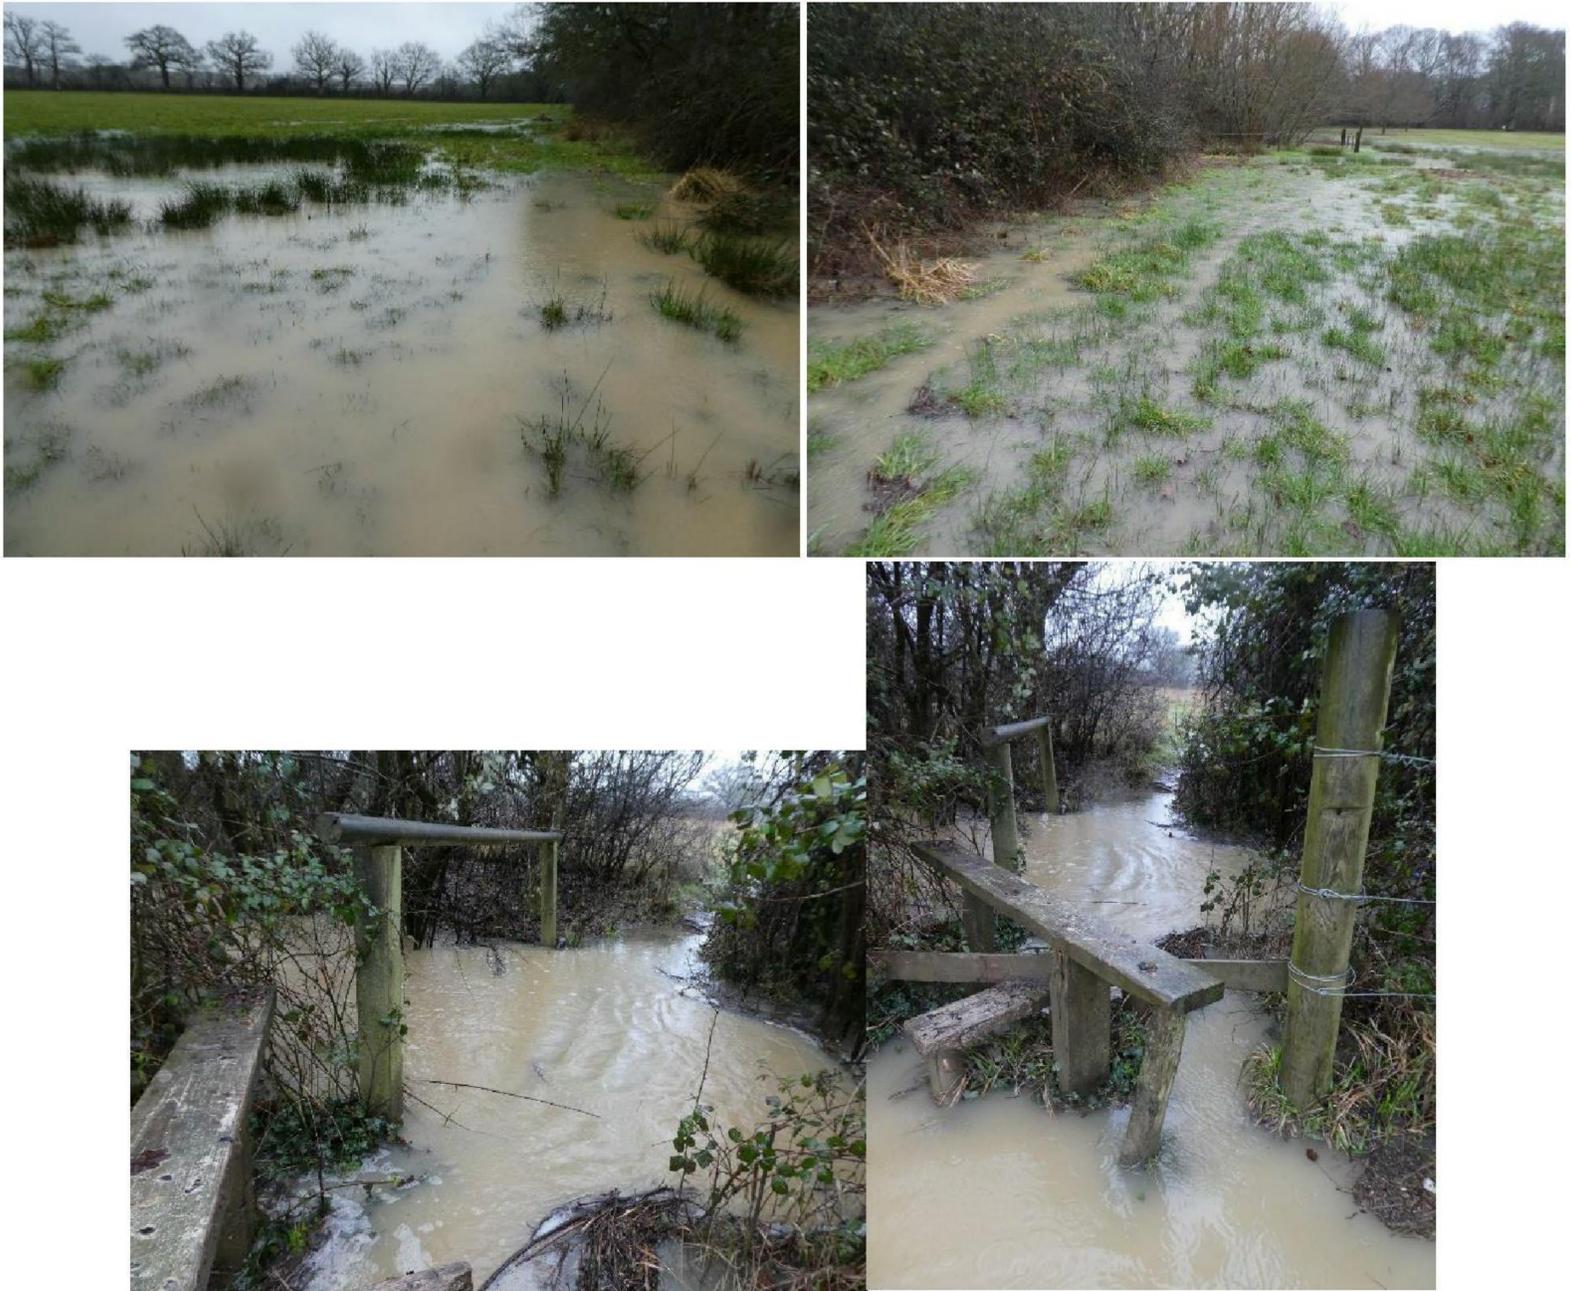
Location F - Flooding not only of the field that footpath 1AL goes through but also the footbridge that carries it across the watercourse which has been completely submerged by the floodwater.

It was raining at the time of these photographs and continued to do so afterwards. The water levels were continuing to rise and did so for some time until the after the full effects of the rain had been felt.
