# North Heath, Carmelstead Close, RH16 3AT

BS 5837 Arboricultural Impact  
Assessment Report (AIA)

28th February 2025

| Report reference: | DTE #RF23256 |

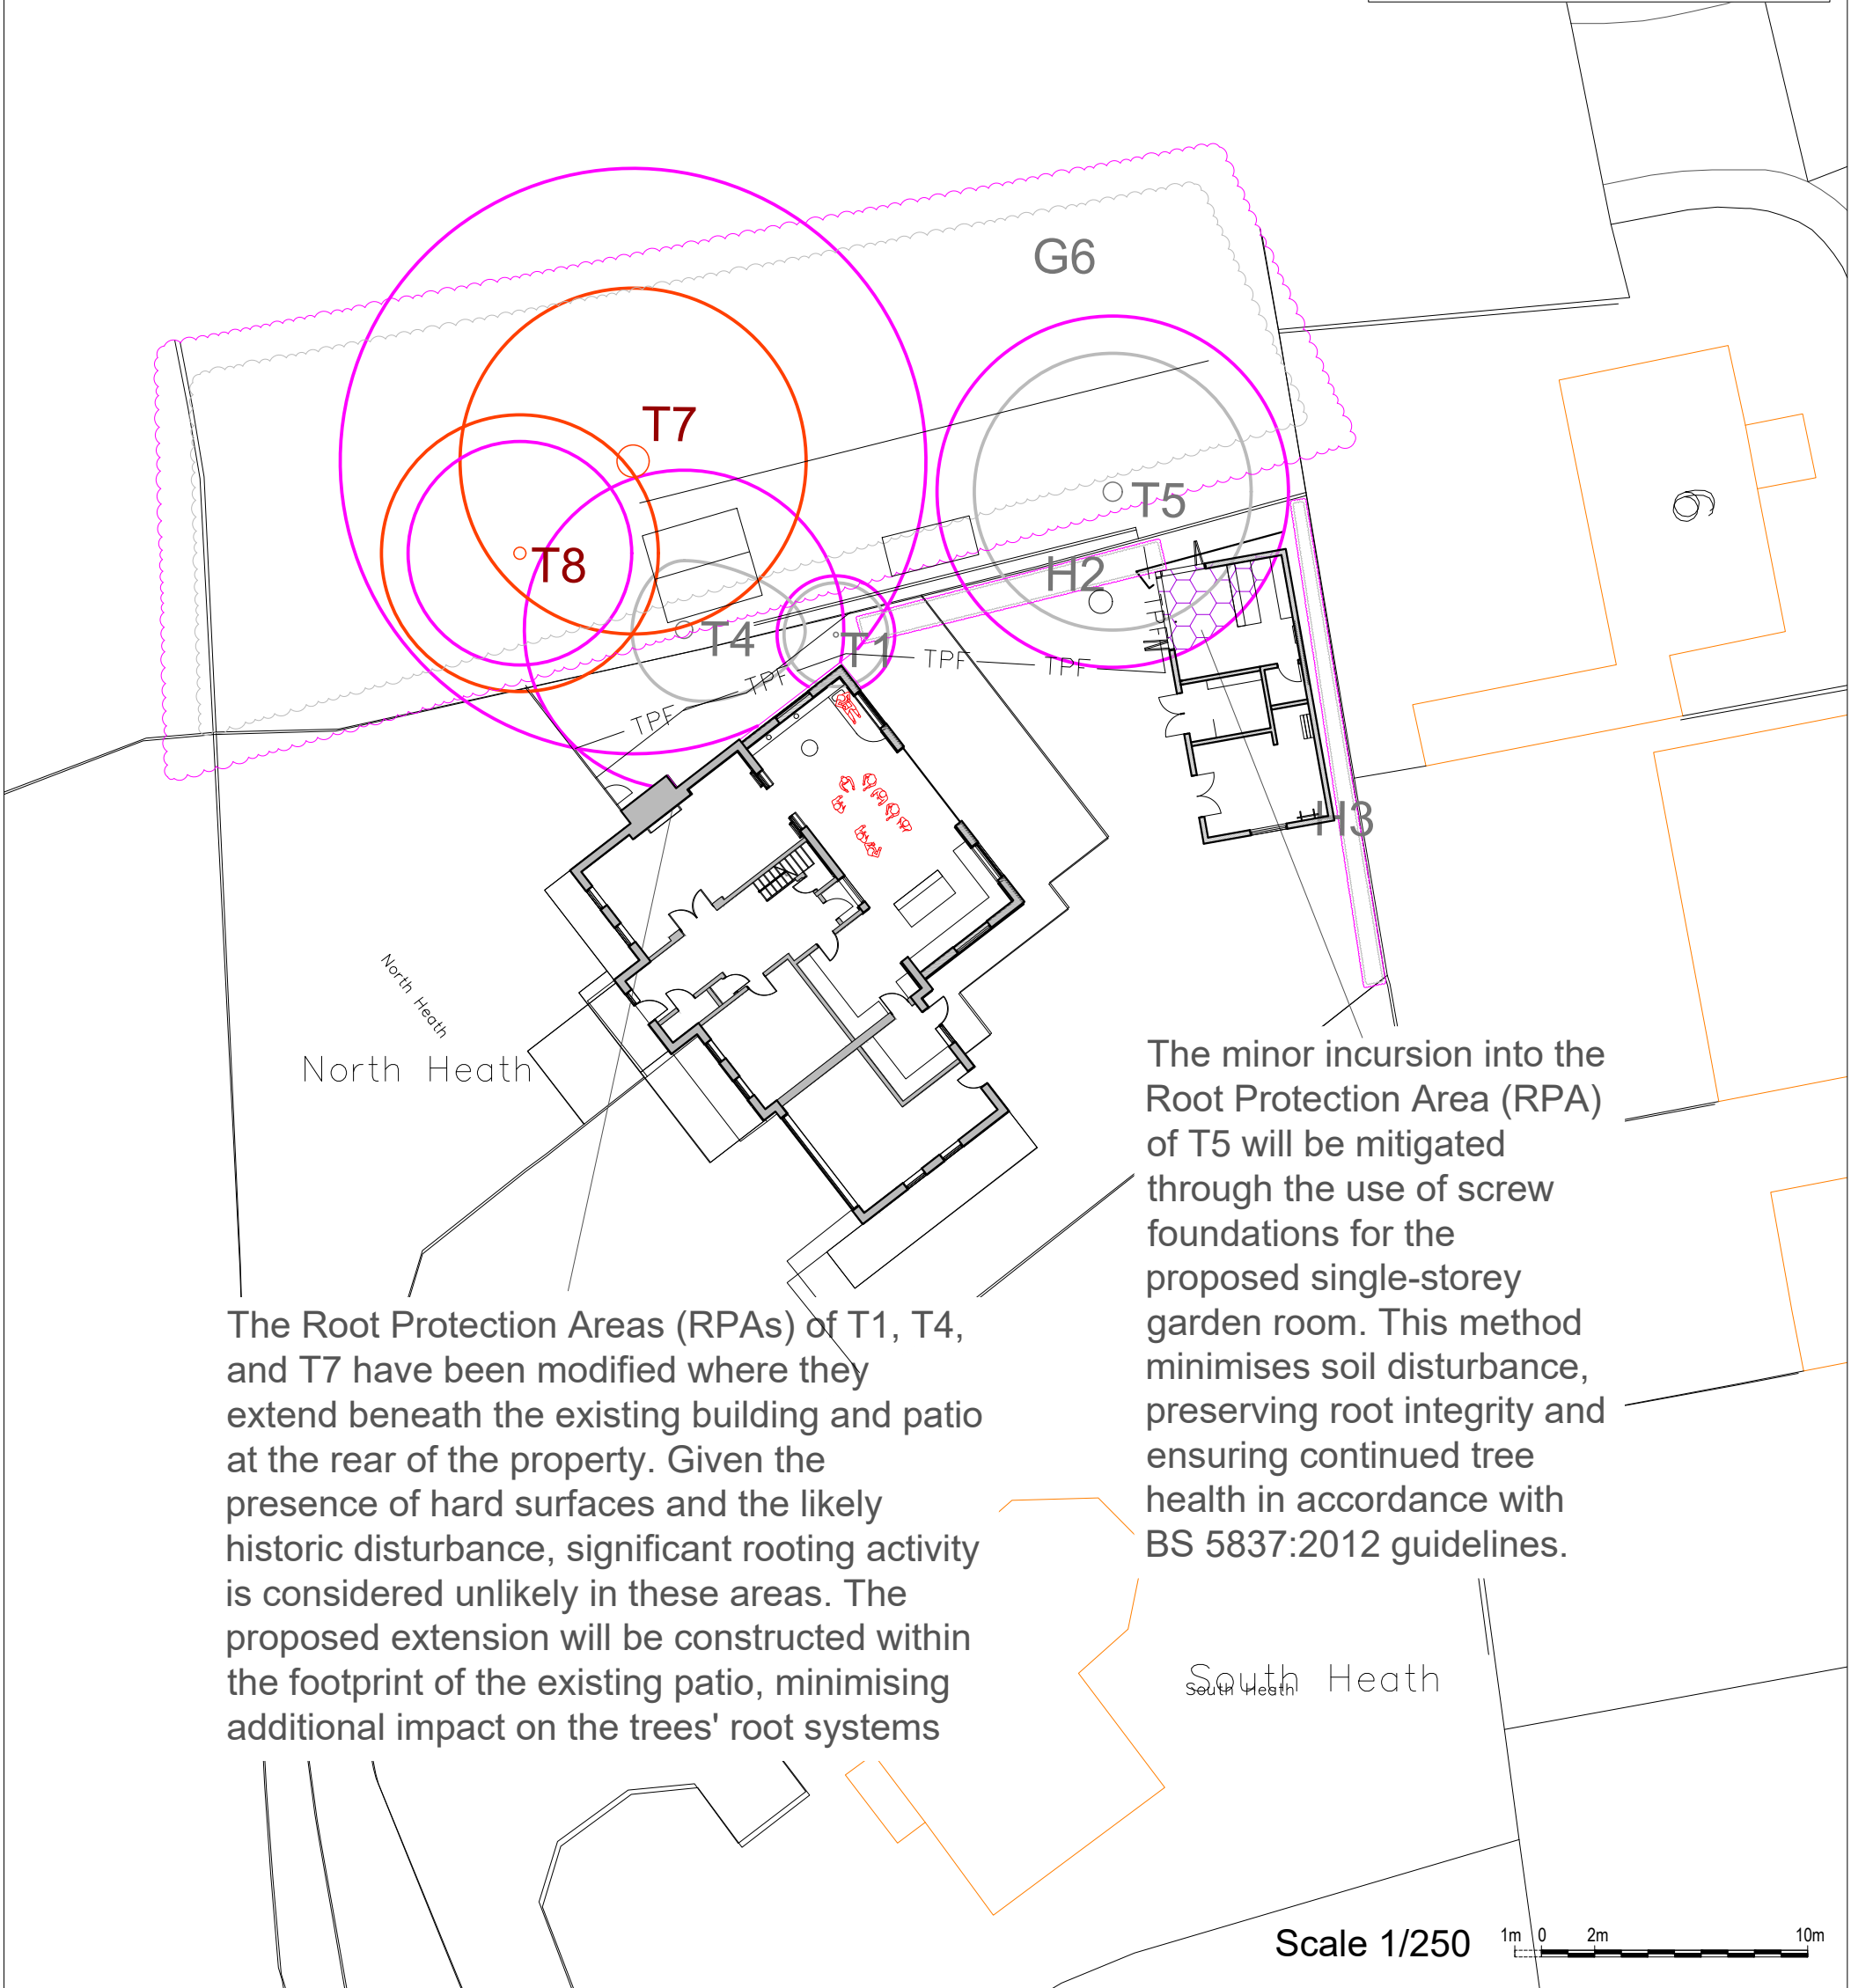
<table><tr><td>Site</td><td>North Heath</td></tr><tr><td>Drawing no.</td><td>TPP/#RF23256/28-02-25</td></tr></table>

- 6.1.1** The proposed development will not require the removal of any trees. However, there will be modifications to the RPAs of two trees (T1 and T4) where they extend beneath the existing building and patio at the rear of the property. Given the presence of hard surfaces and historic disturbance, significant rooting activity in these areas is considered unlikely. Additionally, a minor incursion into the RPA of T5 will occur due to the construction of a single-storey garden room, but this will be mitigated through the use of screw foundations to preserve root integrity.

- 4.3.1 Barriers are to be positioned around the perimeter of the Root Protection Areas (RPAs), establishing the Construction Exclusion Zone (CEZ) as outlined in the Tree Protection Plan.

- 7.1.1** The proposed extension will be constructed within the footprint of the existing patio, minimising further impact on tree root systems. To mitigate the minor incursion into the RPA of T5, screw pile foundations will be used to avoid excessive soil disturbance, ensuring the tree's continued health and stability. Root investigations will be conducted prior to construction using hand tools to assess potential impacts, with minor root pruning undertaken under arboricultural supervision if necessary. A 'no-dig' solution could also be considered if required. (See [Appendix 5 - for methods of work close to trees](#)).

- 7.2.1** To safeguard retained trees, protective fencing must be installed around all RPAs before any site works begin. This will prevent compaction, accidental damage, or disturbance to tree root zones. All protection measures must comply with BS 5837:2012. (See [Appendix 3 – Tree Protection Plan](#)).
