### TREE DEVELOPMENT REPORT

(BS5837:2012 ARBORICULTURAL IMPACT ASSESSMENT)

| SITE | The Middle House, Twineham Lane, Albourne, BN6 9JP |
| DATE | 11/09/2025 |

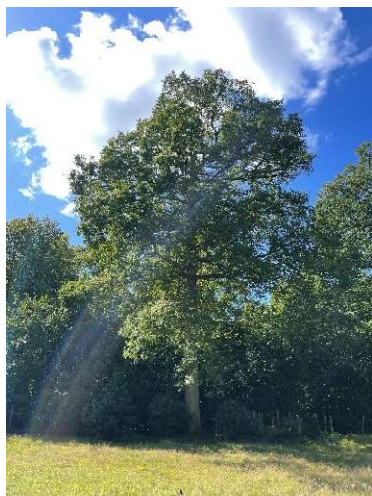
Photograph of T001

| Ref. | Species | Full Structure | Measurements | Retention Category | RPA | Comments | Measurements2 | Recommendations |
|---|---|---|---|---|---|---|---|---|
| T001 | Pedunculate oak<br>( <i>Quercus robur</i> ) | Tree | Height (m): 19<br>Stem Diam(mm): 830<br>Spread (m): 7N, 7E, 7S, 7W<br>Lowest Branch (m): 6(NE)<br>Life Stage: Mature<br>Rem. Contrib.: 40+ Years | A | Radius: 10.0m.<br>Area: 314 sq m. | A single-stemmed specimen exhibiting good overall form and balanced crown structure. Well developed buttresses. | Physiological Condition: Good<br>Structural Condition: Good<br>Public Amenity Value: Low<br>Inspection Limitations: None<br>Bat Habitat: Unknown | No action required. |

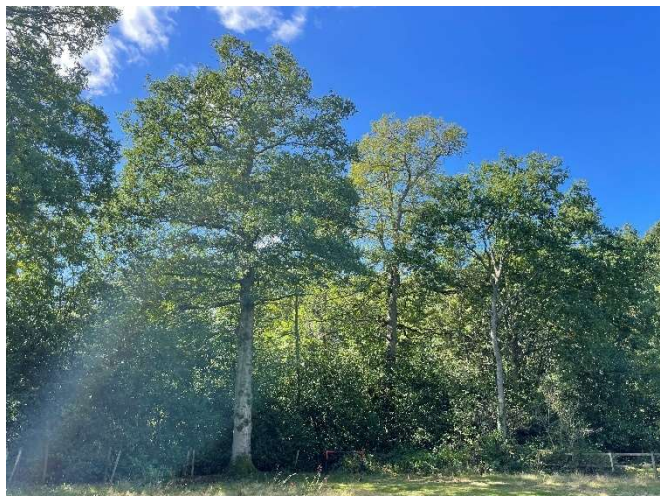
Photograph of T002, T003, T004 T005

| Ref. | Species | Full Structure | Measurements | Retention Category | RPA | Comments | Measurements2 | Recommendations |
|---|---|---|---|---|---|---|---|---|
| T002 | Pedunculate oak<br>( <i>Quercus robur</i> ) | Tree | Height (m): 20<br>Stem Diam(mm): 840<br>Spread (m): 6N, 7E, 6S, 7W<br>Lowest Branch (m): 7(SE)<br>Life Stage: Mature<br>Rem. Contrib.: 40+ Years | A | Radius: 10.1m.<br>Area: 320 sq m. | Major deadwood is present but appears stable. The tree has an upright growth habit and displays good overall form and structural integrity. | Physiological Condition: Good<br>Structural Condition: Good<br>Public Amenity Value: Low<br>Inspection Limitations: None<br>Bat Habitat: Unknown | No action required. |
| T003 | Pedunculate oak<br>( <i>Quercus robur</i> ) | Tree | Height (m): 14<br>Stem Diam(mm): 210<br>Spread (m): 1N, 0.5E, 3S, 3W<br>Lowest Branch (m): 6(S)<br>Life Stage: Young<br>Rem. Contrib.: 40+ Years | C | Radius: 2.5m.<br>Area: 20 sq m. | The tree has a drawn-up form due to shading and competition from nearby trees. | Physiological Condition: Good<br>Structural Condition: Good<br>Public Amenity Value: Low<br>Inspection Limitations: None<br>Bat Habitat: Unknown | No action required. |
| T004 | Pedunculate oak<br>( <i>Quercus robur</i> ) | Tree | Height (m): 20<br>Stem Diam(mm): 830<br>Spread (m): 7N, 7E, 7S, 7W<br>Lowest Branch (m): 6(S)<br>Life Stage: Mature<br>Rem. Contrib.: 40+ Years | A | Radius: 10.0m.<br>Area: 314 sq m. | Prominent buttress formation at the base. Main stem bifurcates at approximately 10 metres in height. A woodpecker hole is visible in the upper crown. | Physiological Condition: Good<br>Structural Condition: Good<br>Public Amenity Value: Low<br>Inspection Limitations: None<br>Bat Habitat: Unknown | No action required. |
| T005 | Pedunculate oak<br>( <i>Quercus robur</i> ) | Tree | Height (m): 12<br>Stem Diam(mm): 340<br>Spread (m): 6N, 5E, 5S, 5W<br>Lowest Branch (m): 6(N)<br>Life Stage: Young<br>Rem. Contrib.: 40+ Years | B | Radius: 4.1m.<br>Area: 53 sq m. | Historically a twin-stemmed tree from ground level; the northern stem has been removed, leaving a 200mm high stump that is now naturally decaying. | Physiological Condition: Good<br>Structural Condition: Good<br>Public Amenity Value: Low<br>Inspection Limitations: None<br>Bat Habitat: Unknown | No action required. |

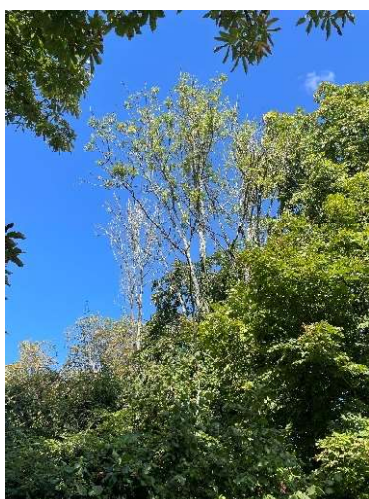
Photograph of T025 and T031 with Ash dieback

| Ref. | Species | Full Structure | Measurements | Retention Category | RPA | Comments | Measurements2 | Recommendations |
|---|---|---|---|---|---|---|---|---|
| T025 | Common ash<br>( <i>Fraxinus excelsior</i> ) | Tree | Height (m): 15<br>Stem Diam(mm): 200<br>Spread (m): 3N, 3E, 3S, 3W<br>Lowest Branch (m): 5(E)<br>Life Stage: Young<br>Rem. Contrib.: <10 years | U | Radius: 2.4m.<br>Area: 18 sq m. | Twin-stemmed from ground level, exhibiting advanced stages of Ash dieback. | Physiological Condition: Poor<br>Structural Condition: Poor<br>Public Amenity Value: Low<br>Inspection Limitations: None<br>Bat Habitat: Unknown | Remove tree. |

| Ref. | Species | Full Structure | Measurements | Retention Category | RPA | Comments | Measurements2 | Recommendations |
|---|---|---|---|---|---|---|---|---|
| T031 | Common ash<br>( <i>Fraxinus excelsior</i> ) | Tree | Height (m): 14<br>Stem Diam(mm): 200<br>Spread (m): 2N, 2E, 2S, 2W<br>Lowest Branch (m): 7(SE)<br>Life Stage: Dead | U | Radius: 2.4m.<br>Area: 18 sq m. | Standing dead, likely due to advanced Ash dieback. | Physiological Condition: Dead<br>Structural Condition: Poor<br>Public Amenity Value: Low<br>Inspection Limitations: None<br>Bat Habitat: Unknown | Remove tree. |
