# Connick Tree Consultants

## TREE DEVELOPMENT REPORT

(BS5837:2012 ARBORICULTURAL IMPACT ASSESSMENT)

| SITE | White Cottage, Park Road, Slaughtam, RH17 6AQ |

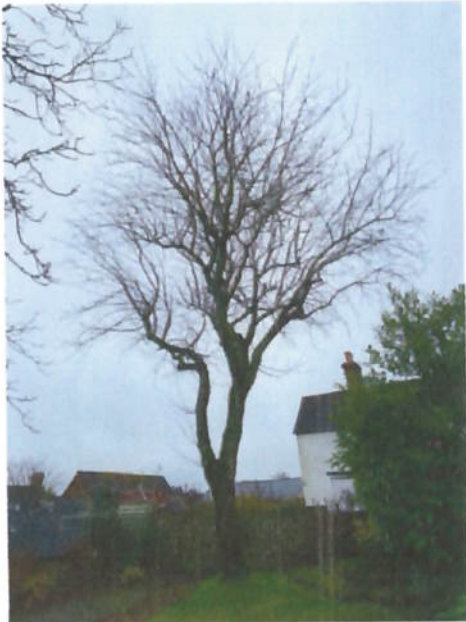
T1 will require a minor cutback to facilitate the construction of the rear extension. However, it should undergo further crown reduction under proper arboricultural management. The tree has previously been heavily reduced and crown-lifted, resulting in large pruning wounds that have created weak attachment points and minor decay. A careful approach to pruning and maintenance will be necessary to ensure the tree's health and structural integrity.

Image showing T1.

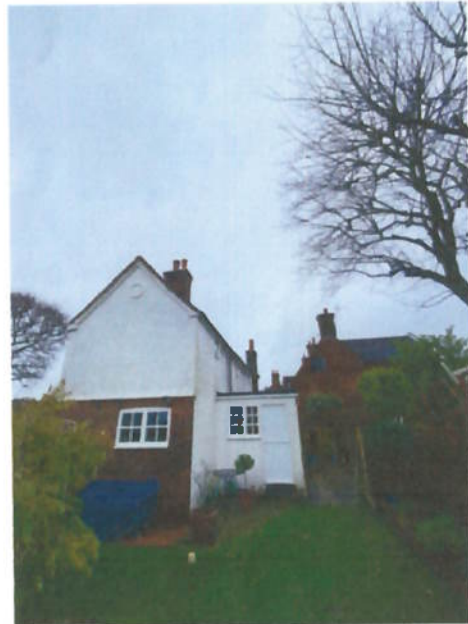
Image showing current crown clearance between T1 and the existing cottage.

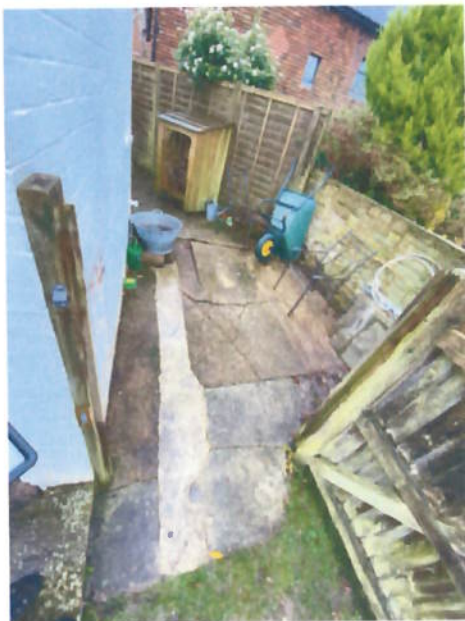
Image showing existing hard standing.

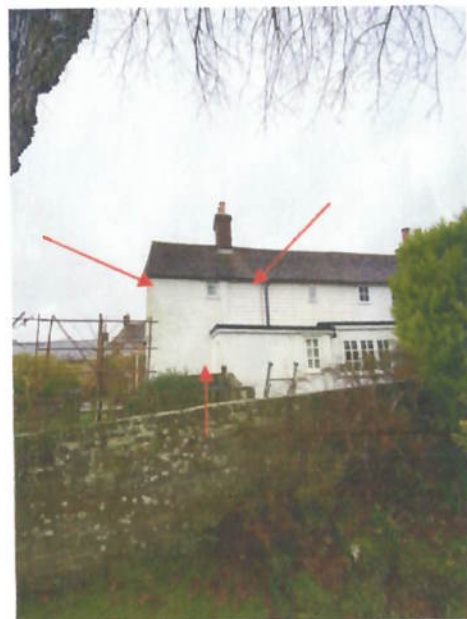
Image showing the location of the proposed rear extension.

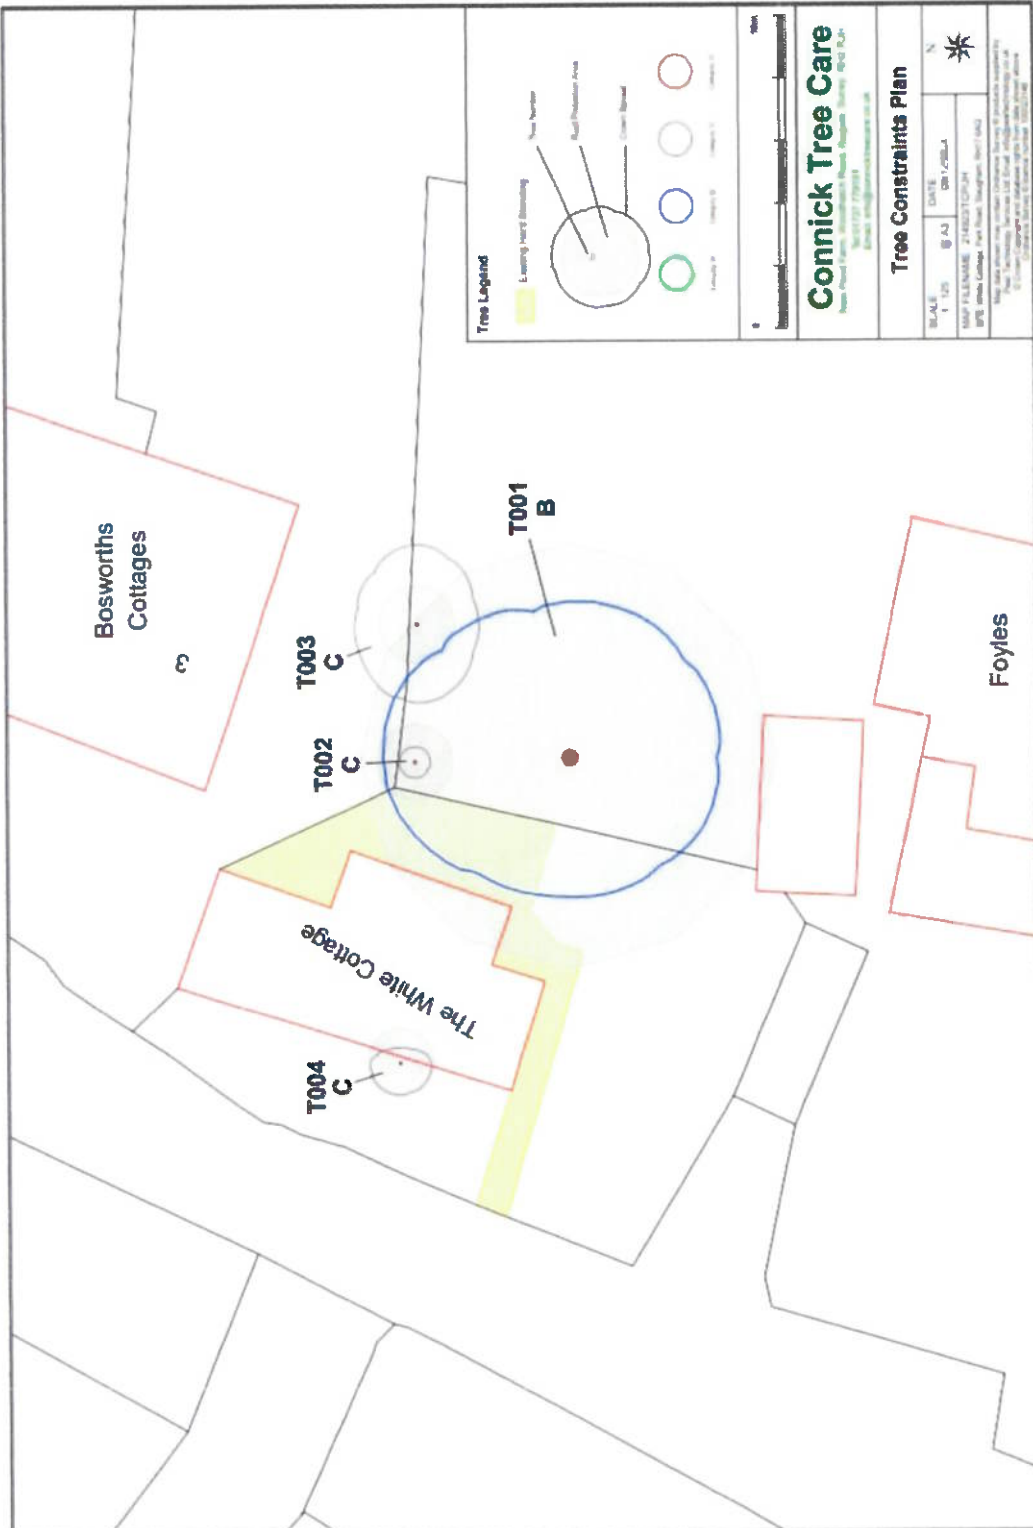
**Tree Constraints Plan**

The tree will require a minor cutback to facilitate the construction of the rear extension. However, it should undergo further crown reduction under proper arboricultural management. The tree has previously been heavily reduced and crown-lifted, resulting in large pruning wounds that have created weak attachment points and minor decay. A careful approach to pruning and maintenance will be necessary to ensure the tree's health and structural integrity.

Temporary ground protection (minimum 12mm thick timber sheeting) will be positioned over the RPA of T1 between the construction area and the boundary wall for the duration of all works.

Excavations for the proposed extension will be carried out under Arboricultural supervision.

Any demolishing and excavations within the RPAs will be observed by the appointed arboriculturist. Should a large volume of fibrous or structural roots be found the work must stop and a decision would be taken by the arboriculturist on the appropriate action.

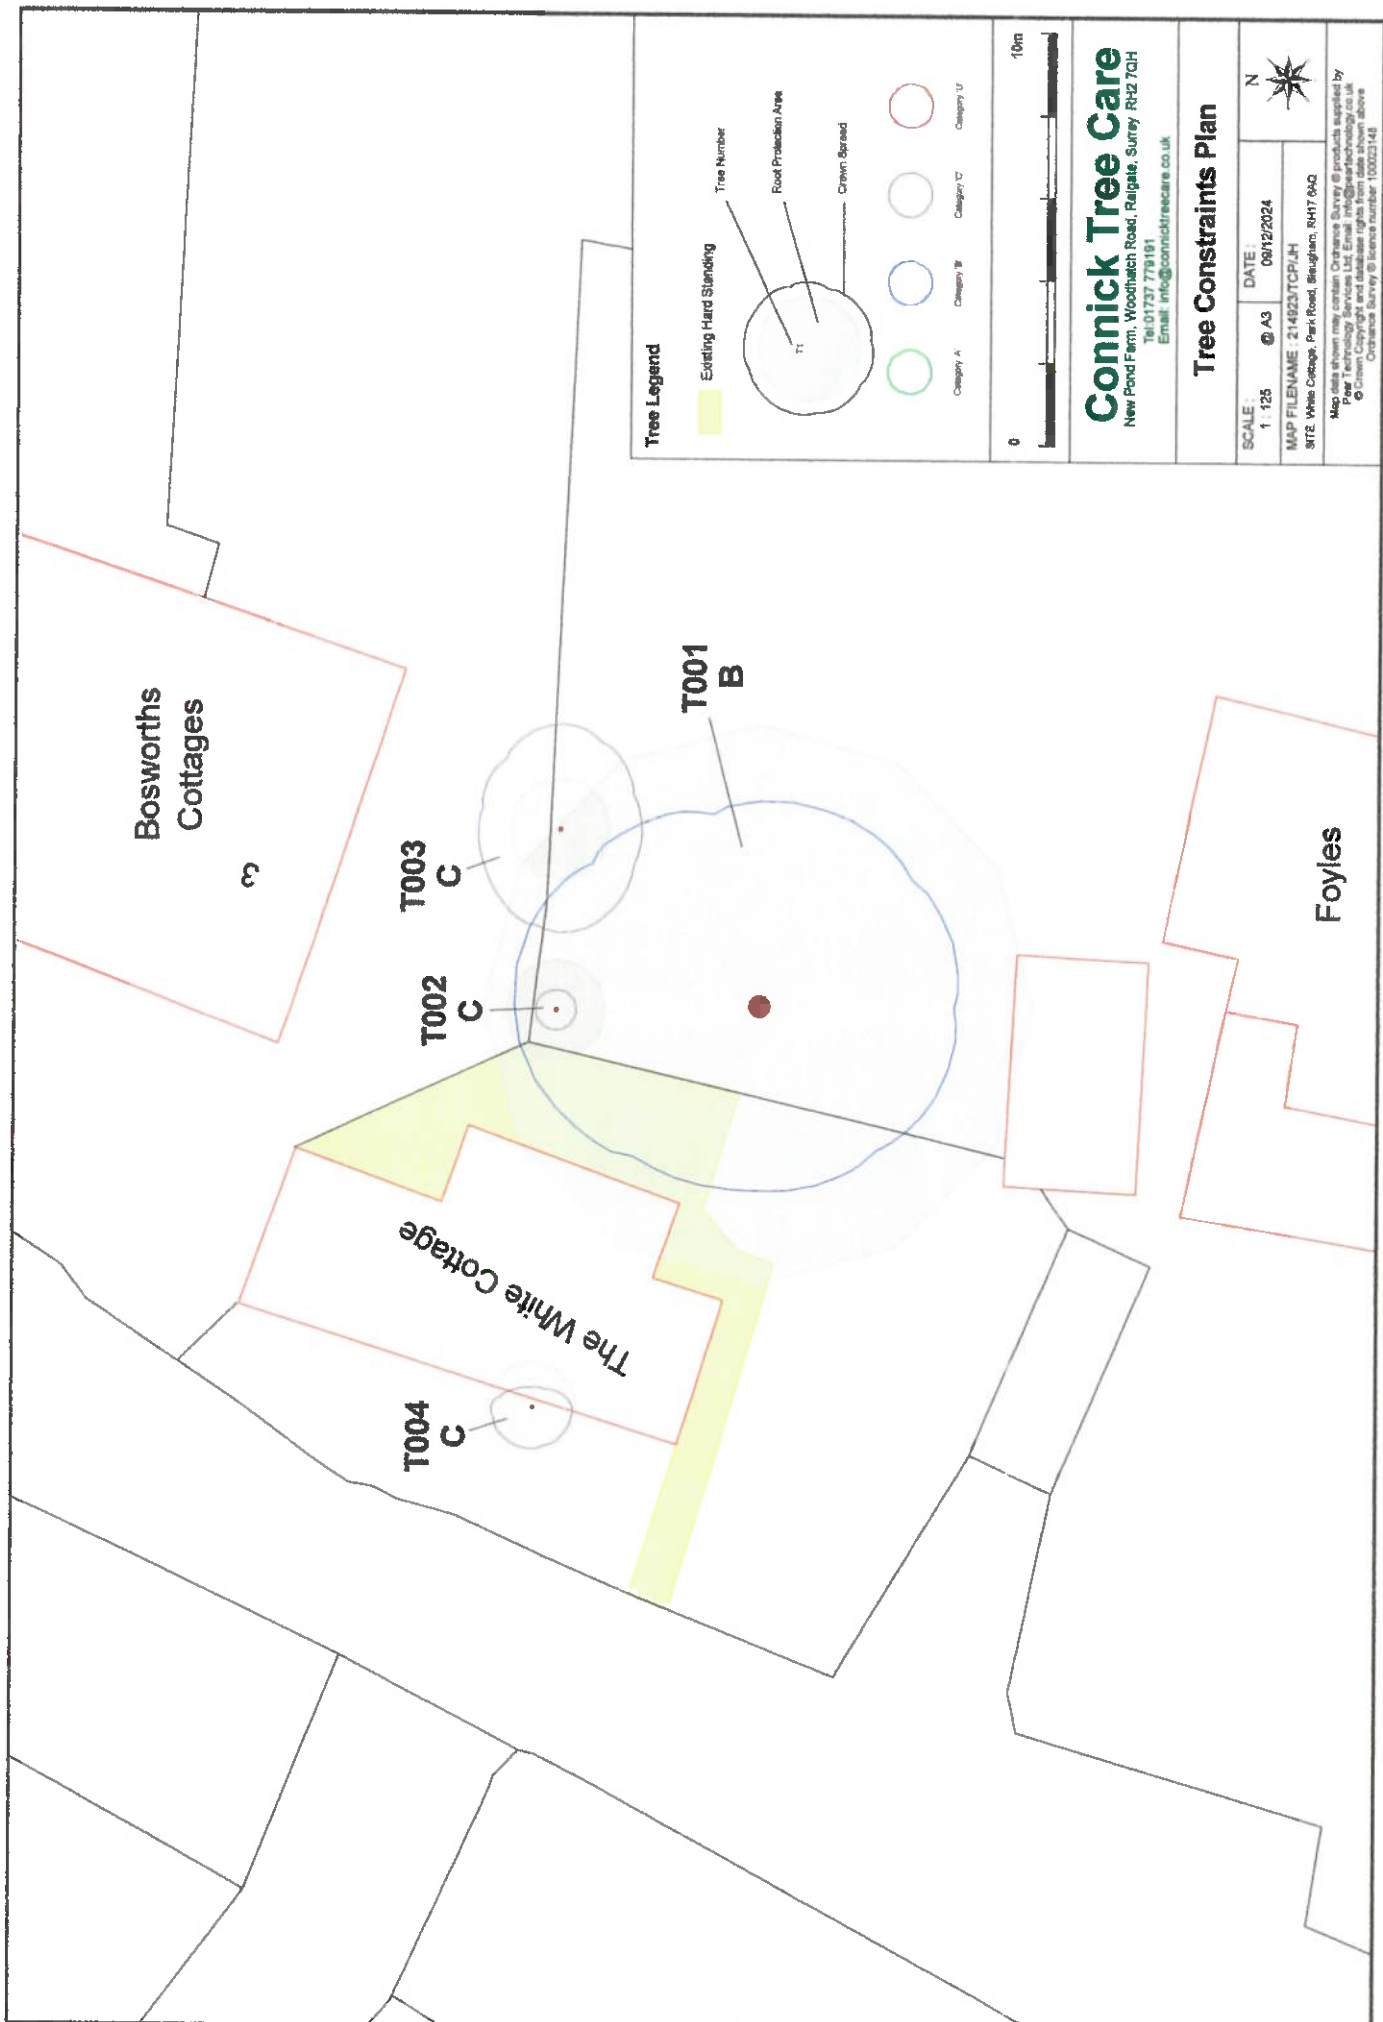
### Tree Retention and Protection Plan

The intrusion into the RPA of T1 to facilitate the construction of the proposed extension is 10sqm which equates to 7.2%. Due to the prominence of the tree and the presence of a TPO, temporary ground protection and arboricultural observations will take place around the area.

The remaining RPA area is covered by ground protection from construction activity by the existing handstanding.

Unrestricted rooting area is evident in the remaining RPA of T1 to the east of the tree

The existing stone boundary wall will be sufficient stem protection, no extra protection fencing will be required.

No disposal of wet materials in RPA's. Materials to be stored on existing hard surfacing.
