# **ARBORICULTURAL IMPACT ASSESSMENT For**

**Acacia Grove  
Copthorne Road  
Copthorne  
Crawley**

**22nd September 2023**

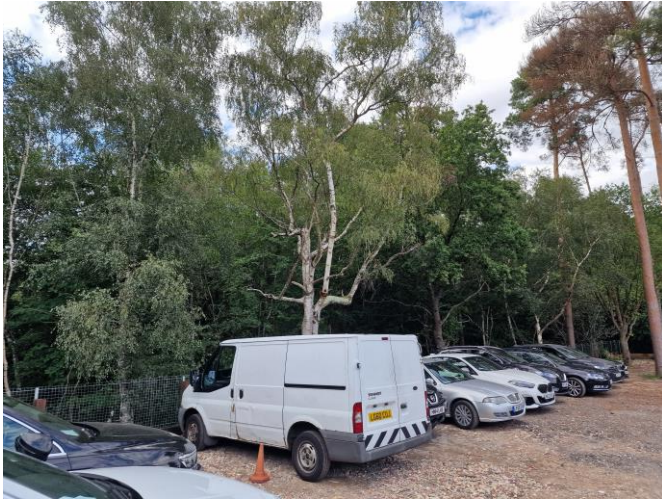
Showing T1 – T3 and existing hard surface

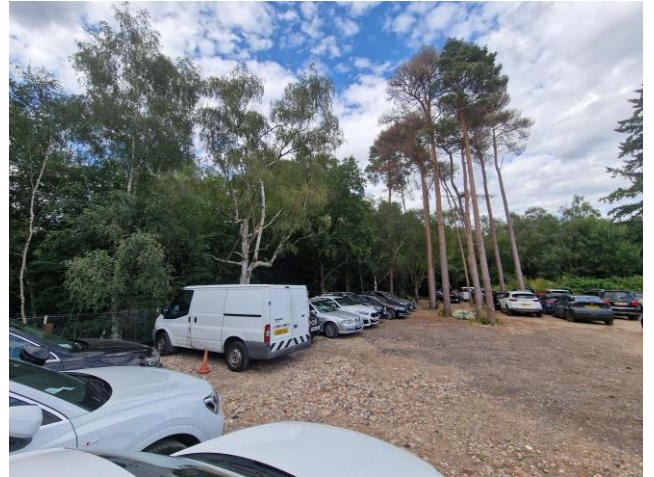
T1, T2, T3, T4, T15 & T16 appear to be in a healthy condition, as do the trees in the adjacent woodland as far as could be assessed from the site. However, T6 – T14 are dead or in terminal decline and should be removed to prevent them causing harm to persons or property if they should fail. These trees are located outside of the application area but have been recorded due to their condition and potential risk to persons or property.

Showing T1 – T16 with existing hard surface

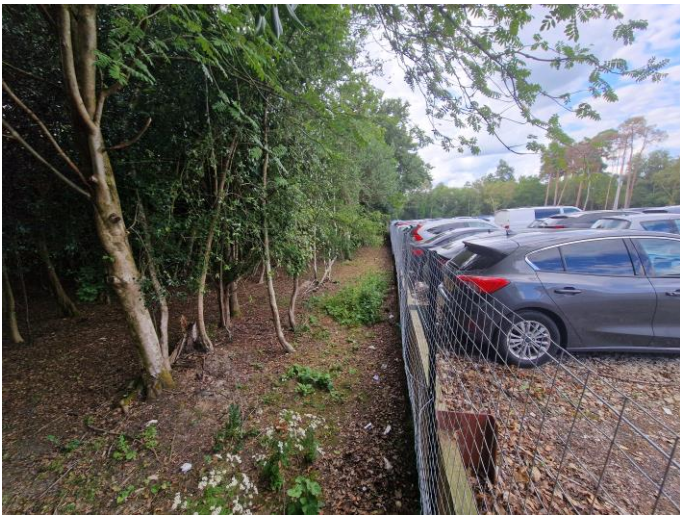
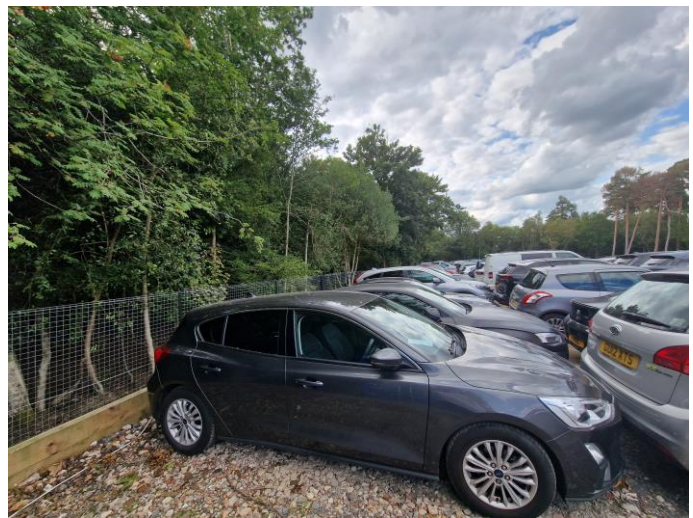
The woodland that runs adjacent to the northern and western boundary will not be impacted by the proposed usage of the site, because the canopy overhang is minimal and what does is high enough where collision damage is unlikely to be an issue. The site is about 2m above the woodland floor, so soil compaction will not be an issue, a high fence runs along the boundary that prevents vehicles accidentally drive over or the trees be impacted in other ways.

Showing the wooded area to the west of the site, the difference in level and space between the site and the trees

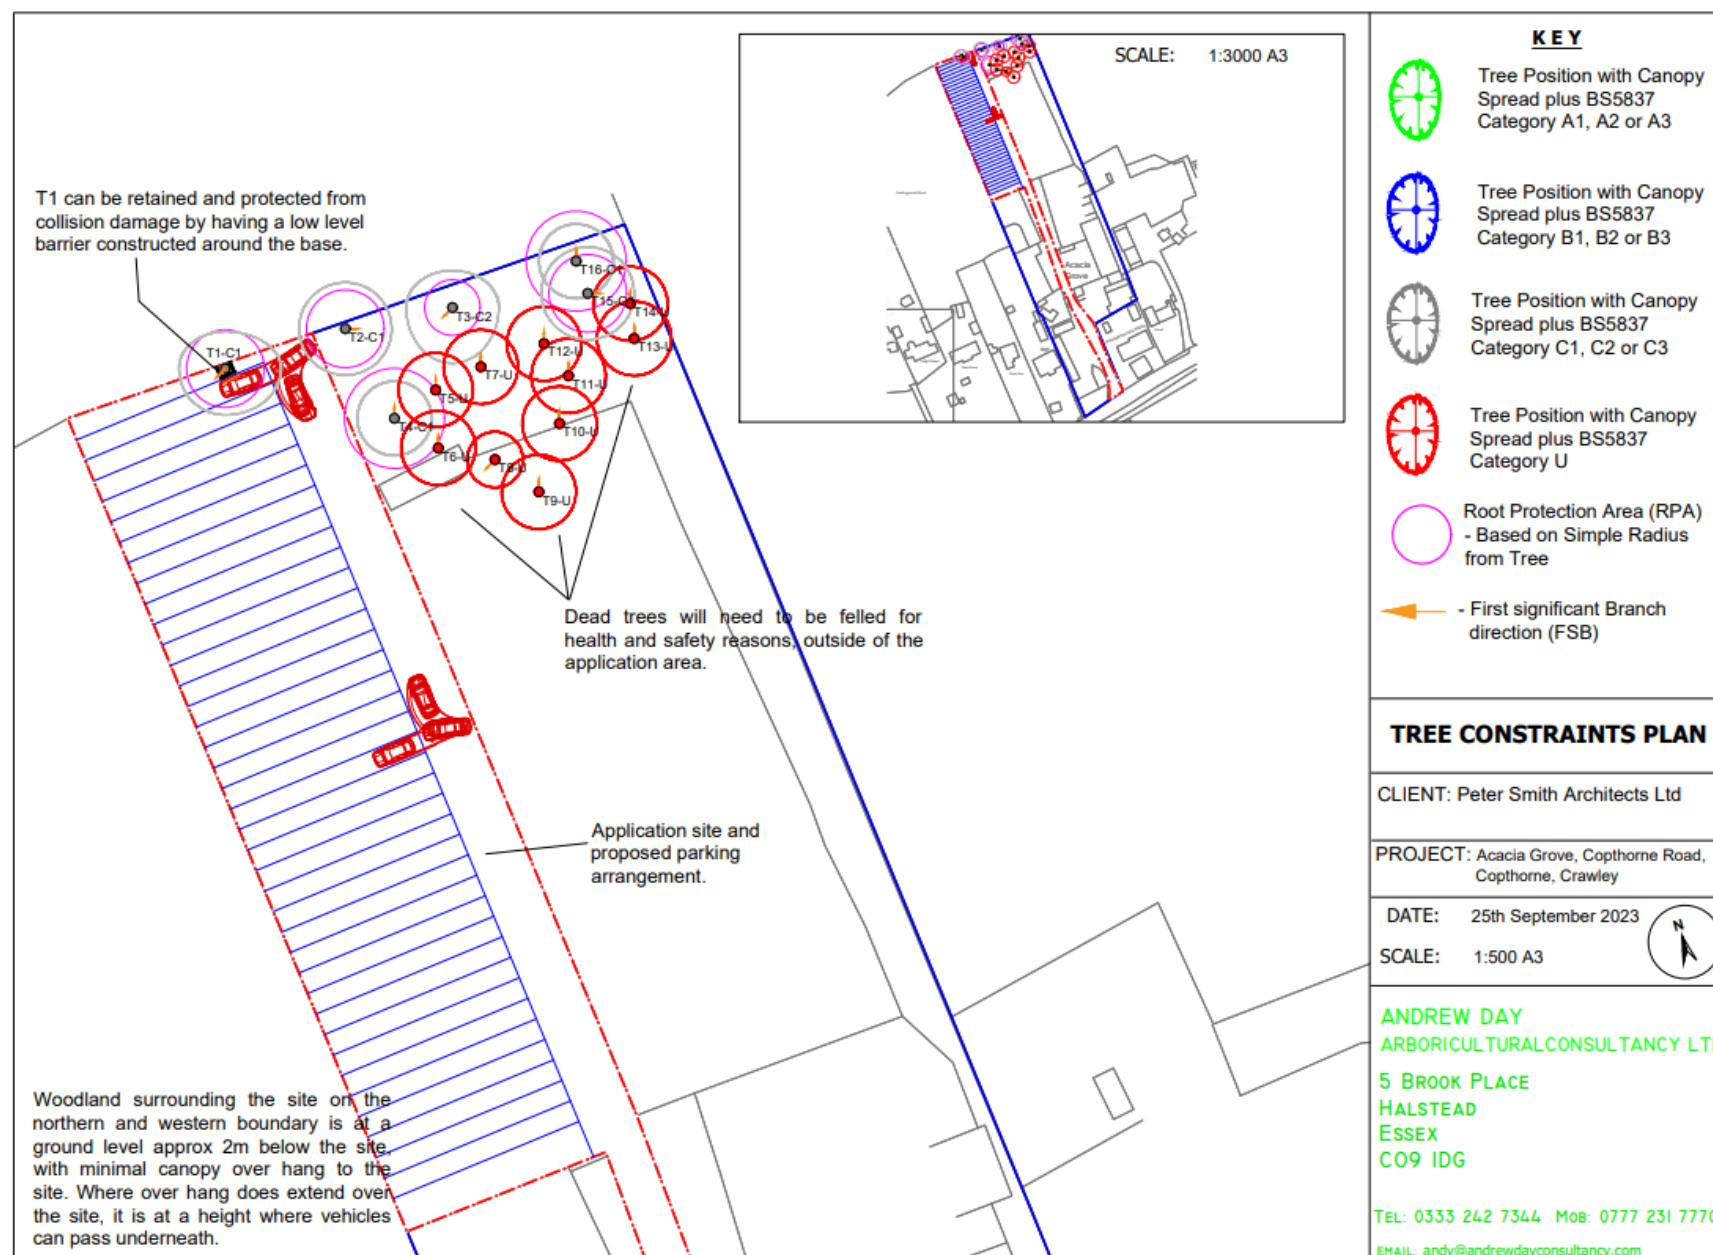
# **TREE CONSTRAINTS PLAN**

The tree constraints plan in **Appendix 4** shows the locations of the trees in relation to the proposed layout. Because the constraints of the trees are already protected by the existing hard surfacing or as with the woodland, on a ground level significantly lower than the site where the trees will not be impacted, no protection measures are required in this case apart from a low wooden barrier installed around the stem of T1 to prevent collision damage.
