# flood risk assessment

PROJECT  
**Crabbet Park (Unit 5), Mid Sussex**

REFERENCE  
**CCE/ZG181/FRA-02**

CCTV Survey  
Report

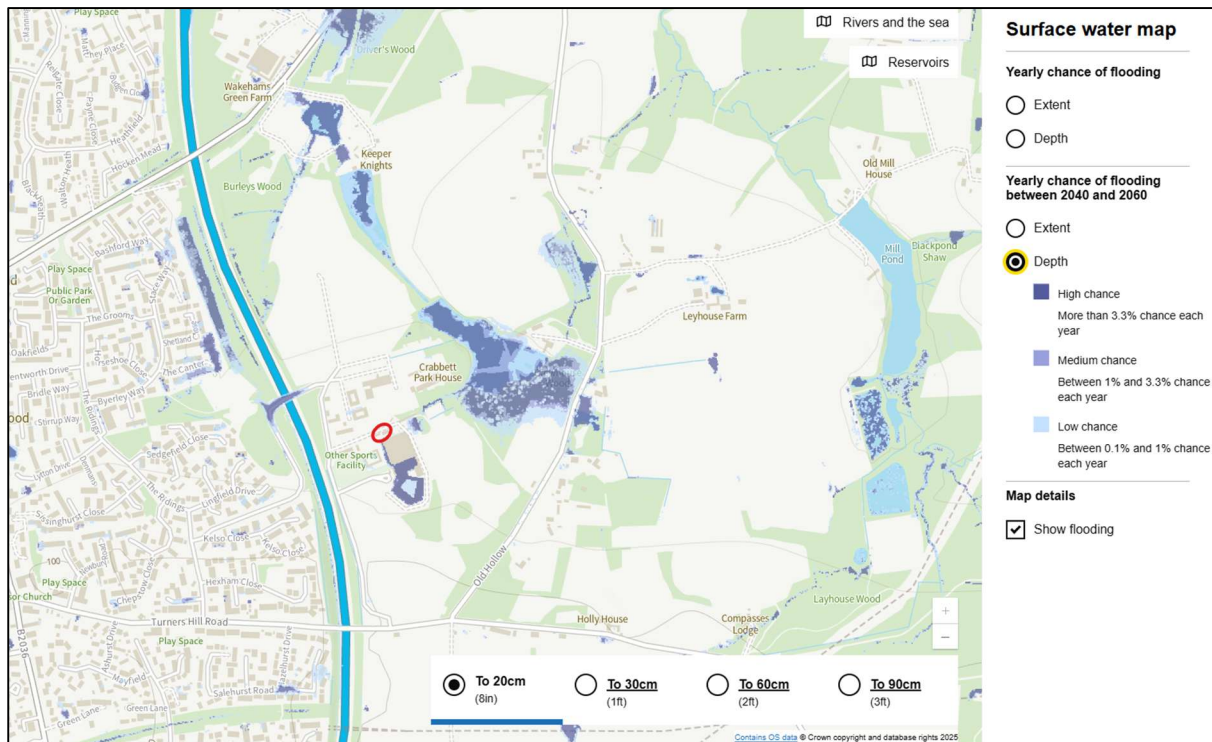
- 2.3 Images 2.1 to 2.3 overleaf show extracts from the 2040-2060 depth of surface water flooding maps. The extracts are from the 200 mm depth and 300mm depth data set. It is worth noting that this is labelled as the “up to 200 mm” depth data set on the web-based mapping but from context (and discussion with the JBA Consulting flood modelling team) it actually shows the likelihood of depths of 200 mm or more occurring. The images overleaf show that only small areas of the site are expected to experience flood depths of more than 200 mm, and none more than 300mm.

Image 2.2 chance of flooding (up to 200 mm) mm 2040-2060, taken from the long term flood risk maps (February 2025) © Crown copyright and database rights 2025 Ordnance Survey 100047325

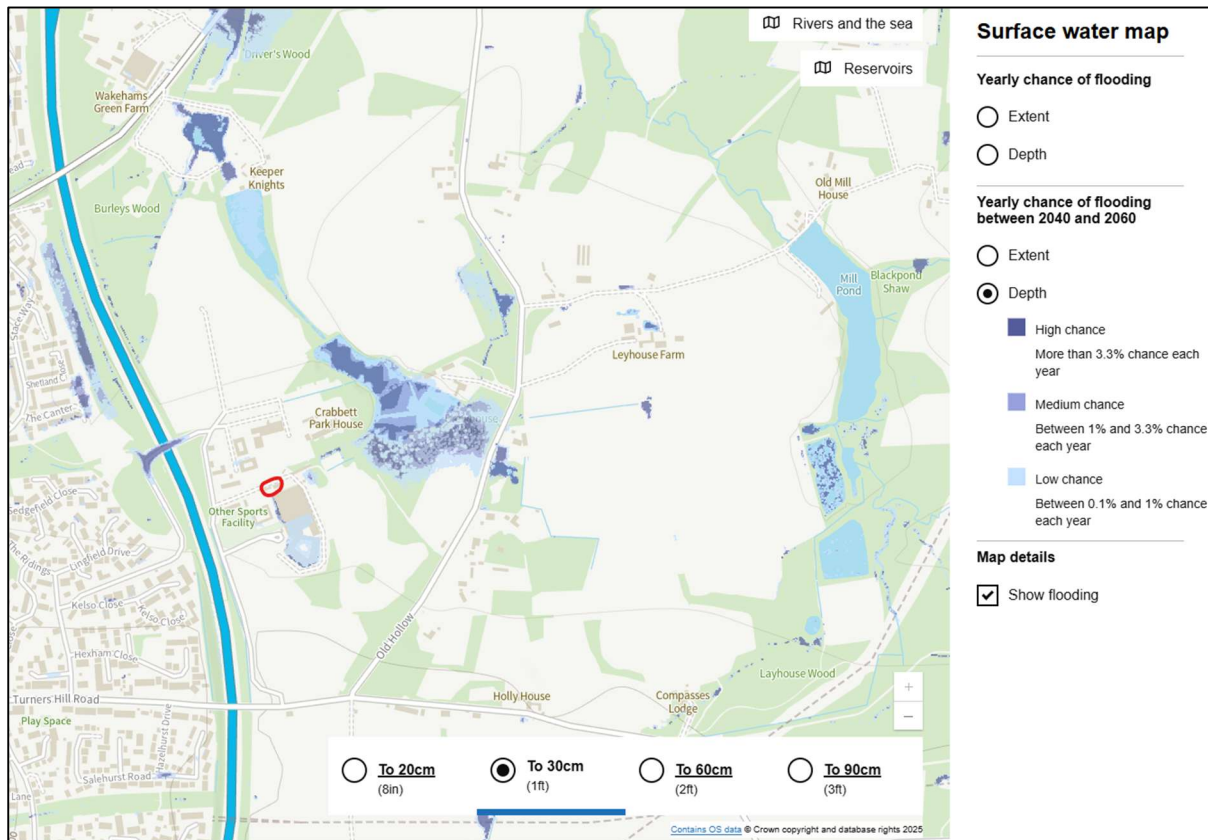
Image 2.3 chance of flooding (up to 300 mm) mm 2040-2060, taken from the long term flood risk maps (February 2025) © Crown copyright and database rights 2025 Ordnance Survey 100047325

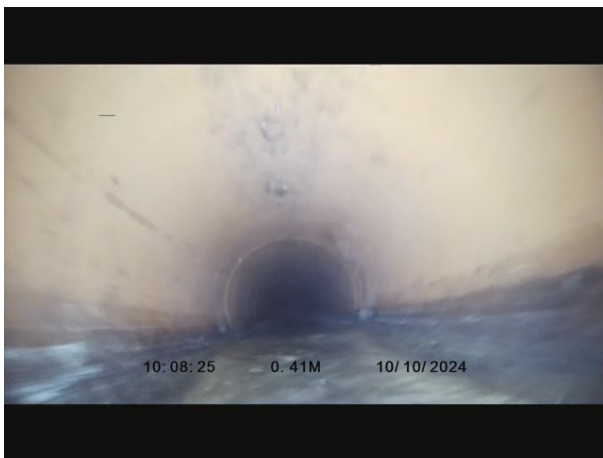
| Item No. | Inspection Direction | PLR | Client's Job Ref | Contractor's Job Ref |
|---|---|---|---|---|
| 2 | Downstream | MH4X | | |

3, 00:00:07, 0.40 m  
Attached deposits, encrustation from 4 o'clock to 8 o'clock, 5% cross-sectional area loss, start

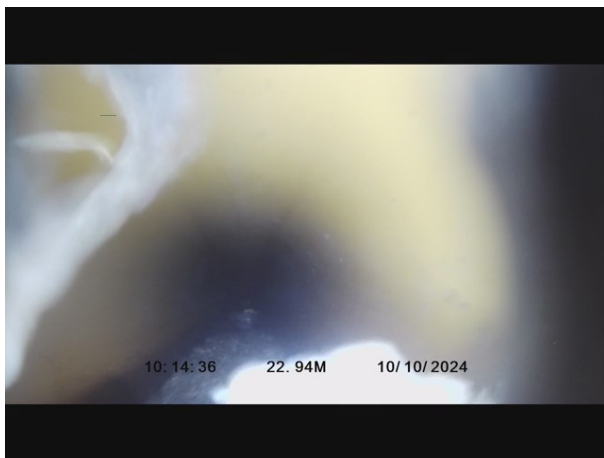
| Item No. | Inspection Direction | PLR | Client's Job Ref | Contractor's Job Ref |
|---|---|---|---|---|
| 3 | Upstream | LATERAL 1X | | |

3, 00:02:06, 22.86 m  
Attached deposits, encrustation from 4 o'clock to 8 o'clock,  
10% cross-sectional area loss, start

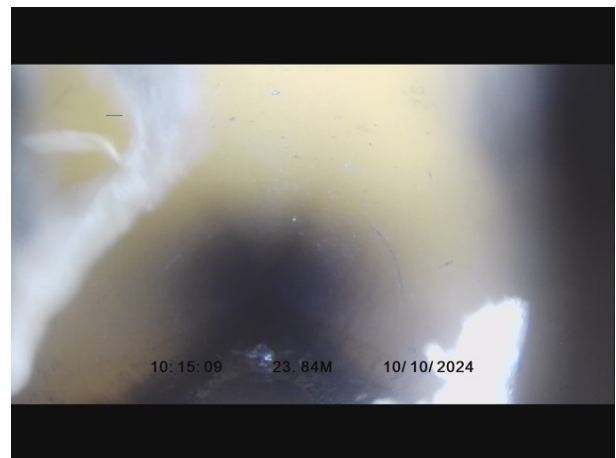
4, 00:02:40, 23.84 m  
Attached deposits, encrustation from 4 o'clock to 8 o'clock,  
10% cross-sectional area loss, finish

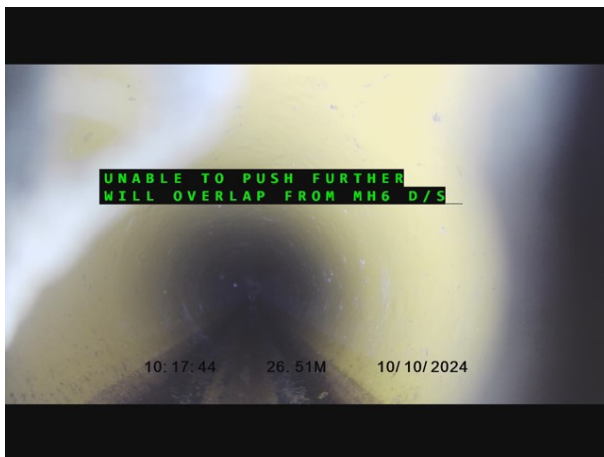
5, 00:03:50, 26.51 m  
Survey abandoned, Unable To Push Further (Overlap With  
MH6 Downstream)

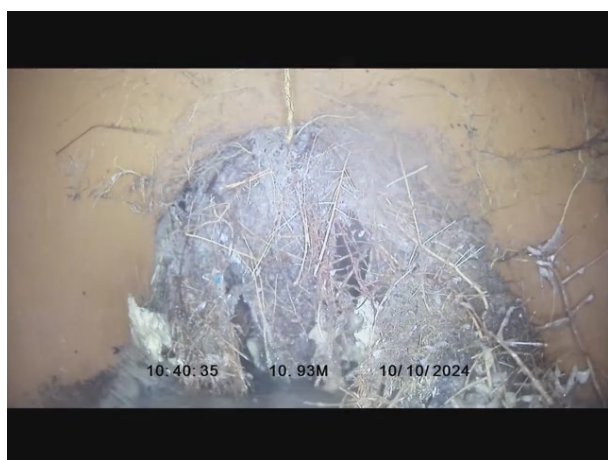
| Item No. | Inspection Direction | PLR | Client's Job Ref | Contractor's Job Ref |
|---|---|---|---|---|
| 5 | Upstream | LATERAL 1X | | |

3, 00:00:53, 10.93 m  
Roots, mass, 80% cross-sectional area loss

| Sheet | Drainage section | Abbreviated Recommendations | Structural (S) or Serviceability/ Maintenance Defect (M) | Recommendation Scale (1-3) | Costs |
|---|---|---|---|---|---|
| 5: | MH5 Lateral 1 Upstream | 1. High pressure water jet and Roots cutting using a combination tanker unit to remove any roots/scale/residual debris.<br>2. Re-CCTV to establish the true condition of the remaining drainage run (with intention to reline, any further works will be quoted accordingly) | S/M | 3 | £375.00 + VAT |
