## IMBERHORNE LOWER SCHOOL, EAST GRINSTEAD

### FOUL SEWAGE & SURFACE WATER DRAINAGE ASSESSMENT

JULY 2026

Ref: 14392/03/HOP/RPT/02

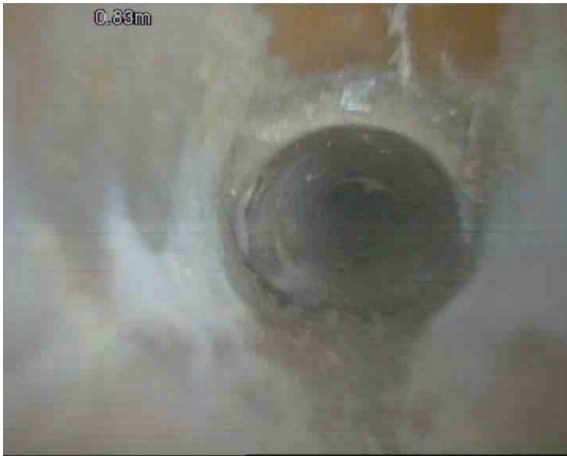
1, 00:00:15, 0.83 m  
Joint displaced, large

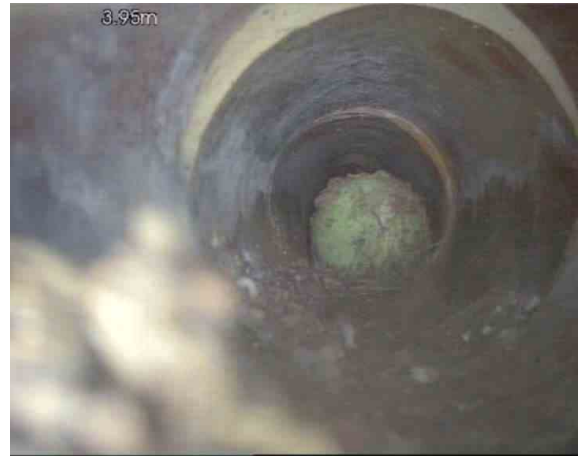
2, 00:00:28, 3.95 m  
Joint displaced, medium

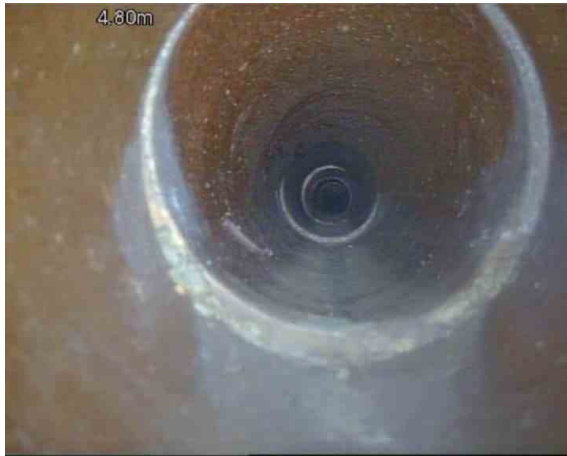
1, 00:00:25, 4.80 m  
Joint displaced, medium

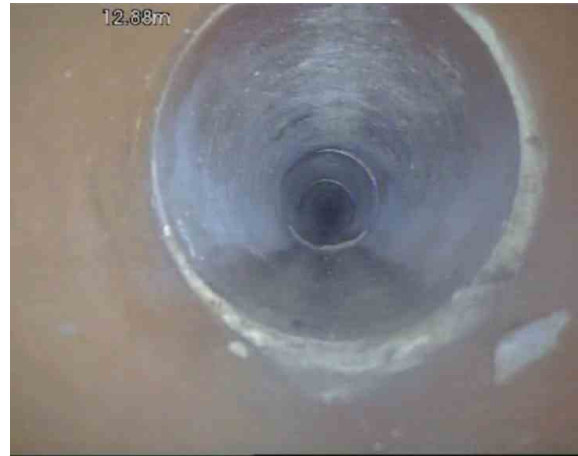
2, 00:00:52, 12.88 m  
Joint displaced, medium

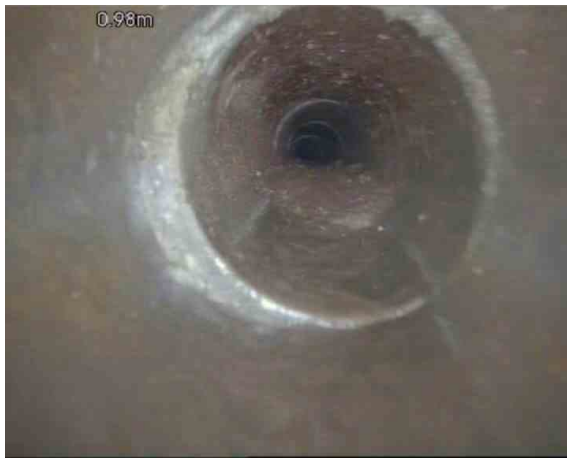
1, 00:00:15, 0.98 m  
Joint displaced, medium

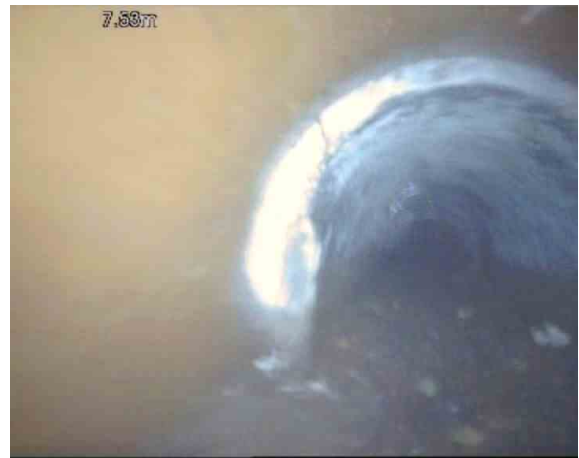
2, 00:00:39, 7.53 m  
Broken pipe at joint at 10 o'clock

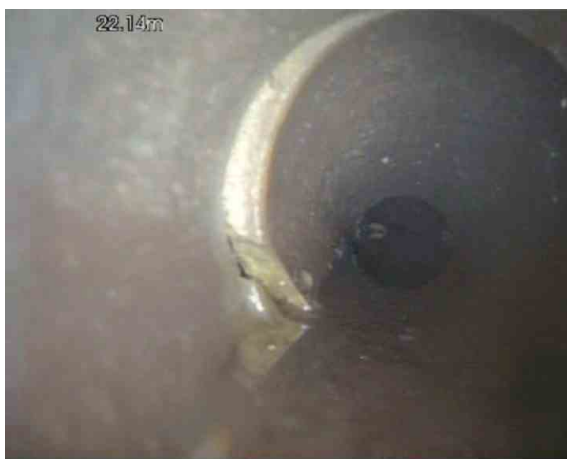
3, 00:01:30, 22.14 m  
Open joint, medium

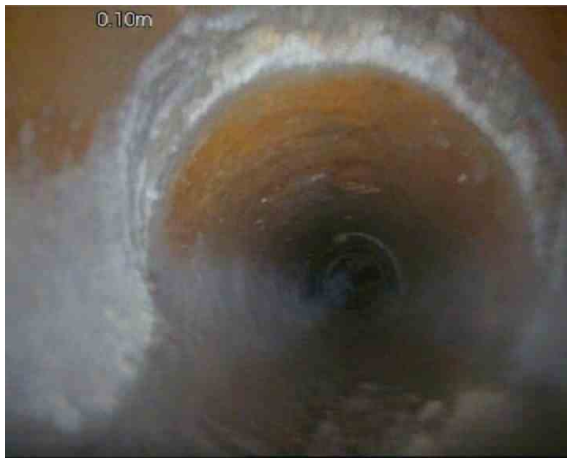
1, 00:00:12, 0.10 m  
Joint displaced, medium

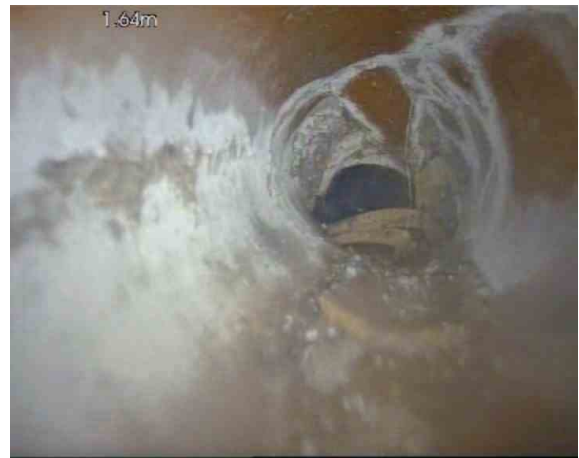
2, 00:00:16, 1.64 m  
Broken pipe from 5 o'clock to 7 o'clock

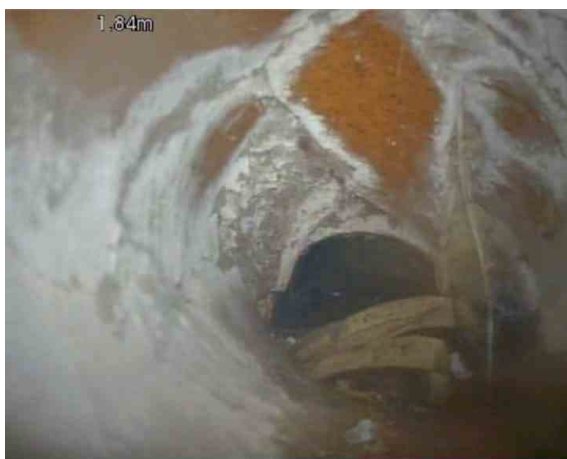
3, 00:00:17, 1.84 m  
Broken pipe from 9 o'clock to 4 o'clock

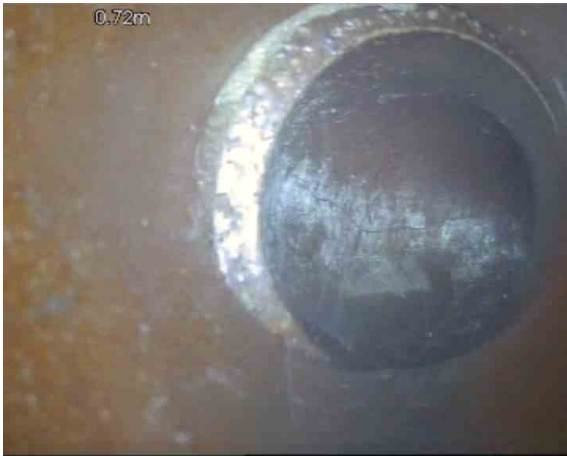
1, 00:00:15, 0.72 m  
Joint displaced, large

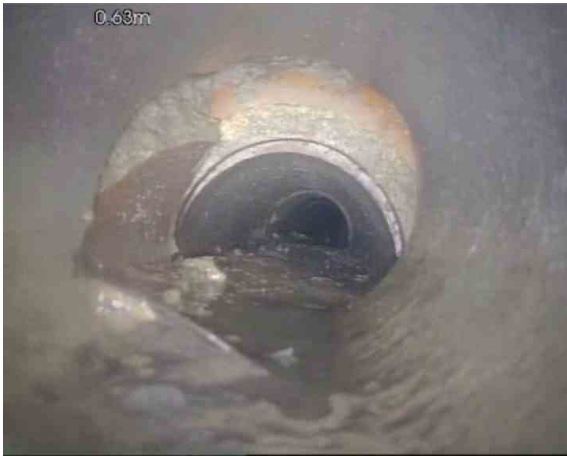
| Scale: | 1:50 | Position [m] | Code | Observation | MPEG | Photo | Grade | | |
|---|---|---|---|---|---|---|---|---|---|
| | | 0.63 | B | Broken pipe from 8 o'clock to 11 o'clock | 00:00:19 | 1 | 4 | | |

1, 00:00:19, 0.63 m  
 Broken pipe from 8 o'clock to 11 o'clock

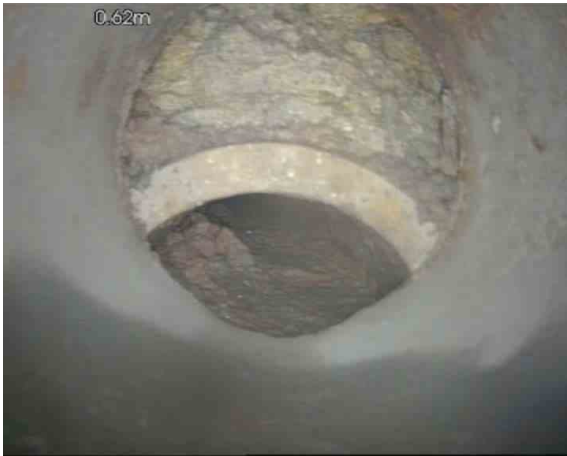
1, 00:00:14, 0.62 m  
Joint displaced, large

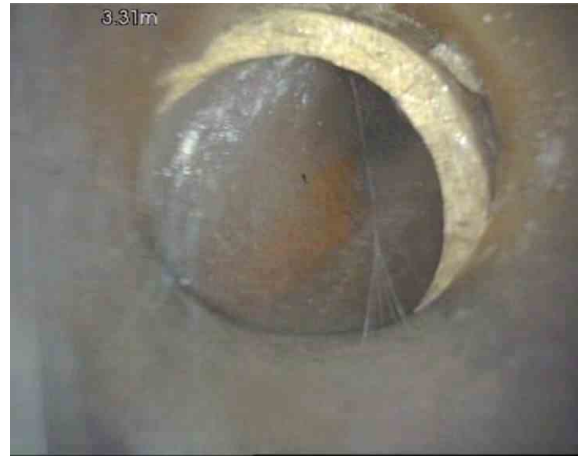
2, 00:00:22, 3.31 m  
Joint displaced, large

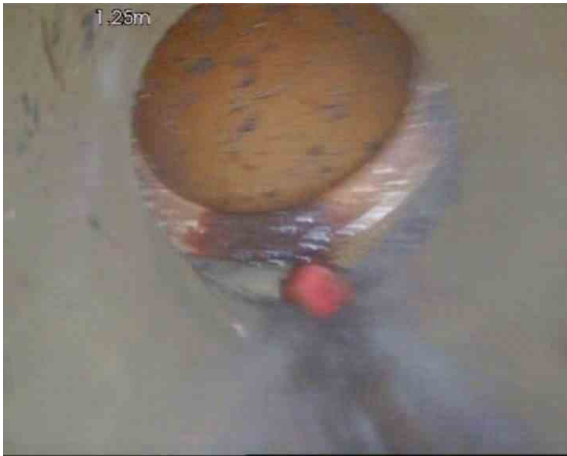
1, 00:00:21, 1.25 m  
Joint displaced, large

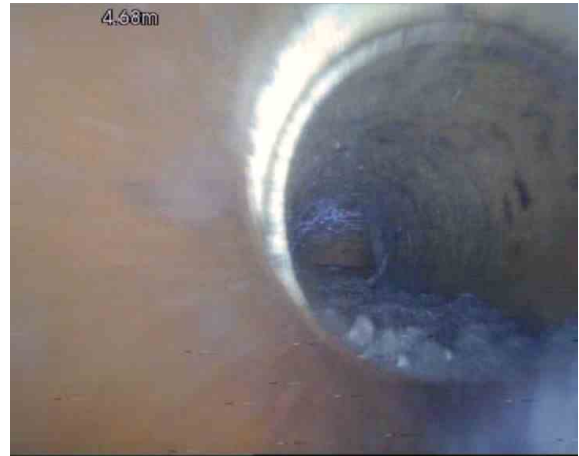
2, 00:00:32, 4.68 m  
Joint displaced, medium

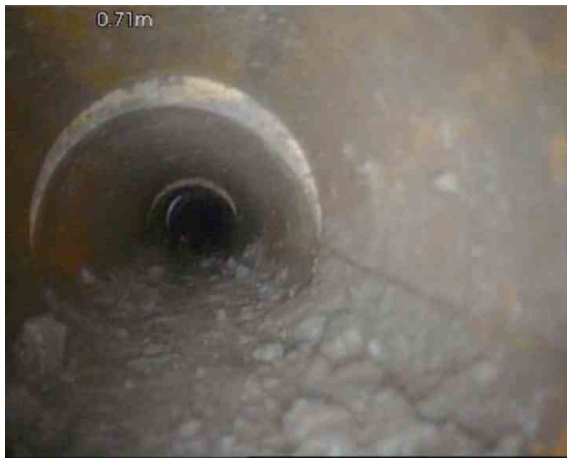
1, 00:00:19, 0.71 m  
Joint displaced, medium

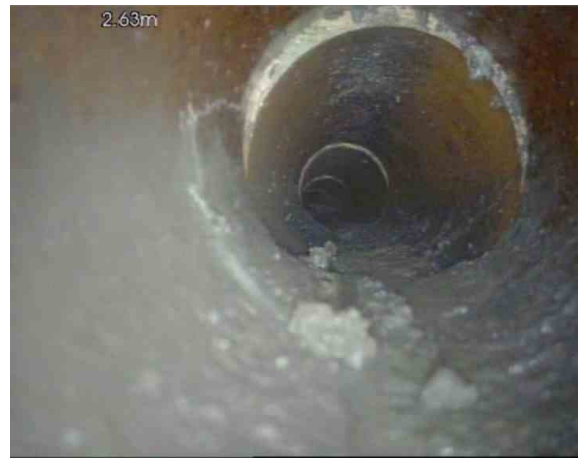
2, 00:00:27, 2.63 m  
Joint displaced, large

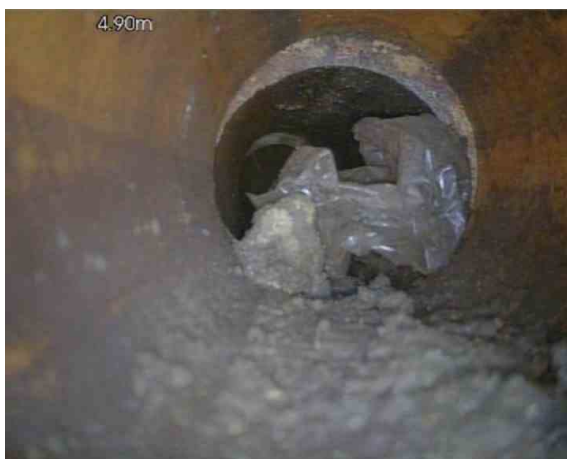
3, 00:00:41, 4.90 m  
Joint displaced, large

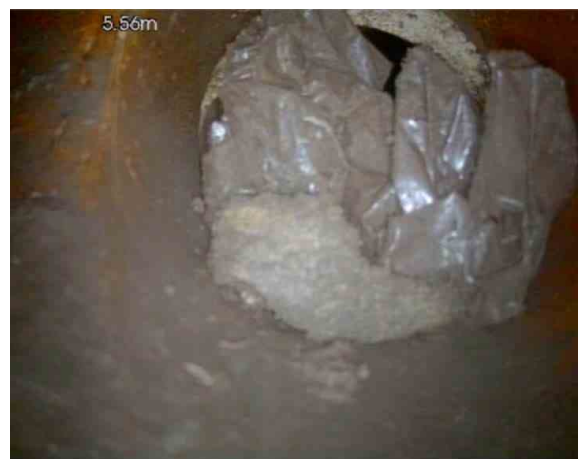
4, 00:01:02, 5.56 m  
Joint displaced, large
