**ARBORICULTURAL IMPLICATIONS ASSESSMENT  
FOR  
PROPOSED EXTENSION AND CAR PORT**

**12 BROOK LANE  
LINDFIELD  
RH16 1SG**

**Tim Laddiman  
BSc.(Hons) M.I.C.For. M.Arbor.A.  
Chartered Arboriculturist**

**Our ref: J67.39  
2<sup>nd</sup> October 2025**

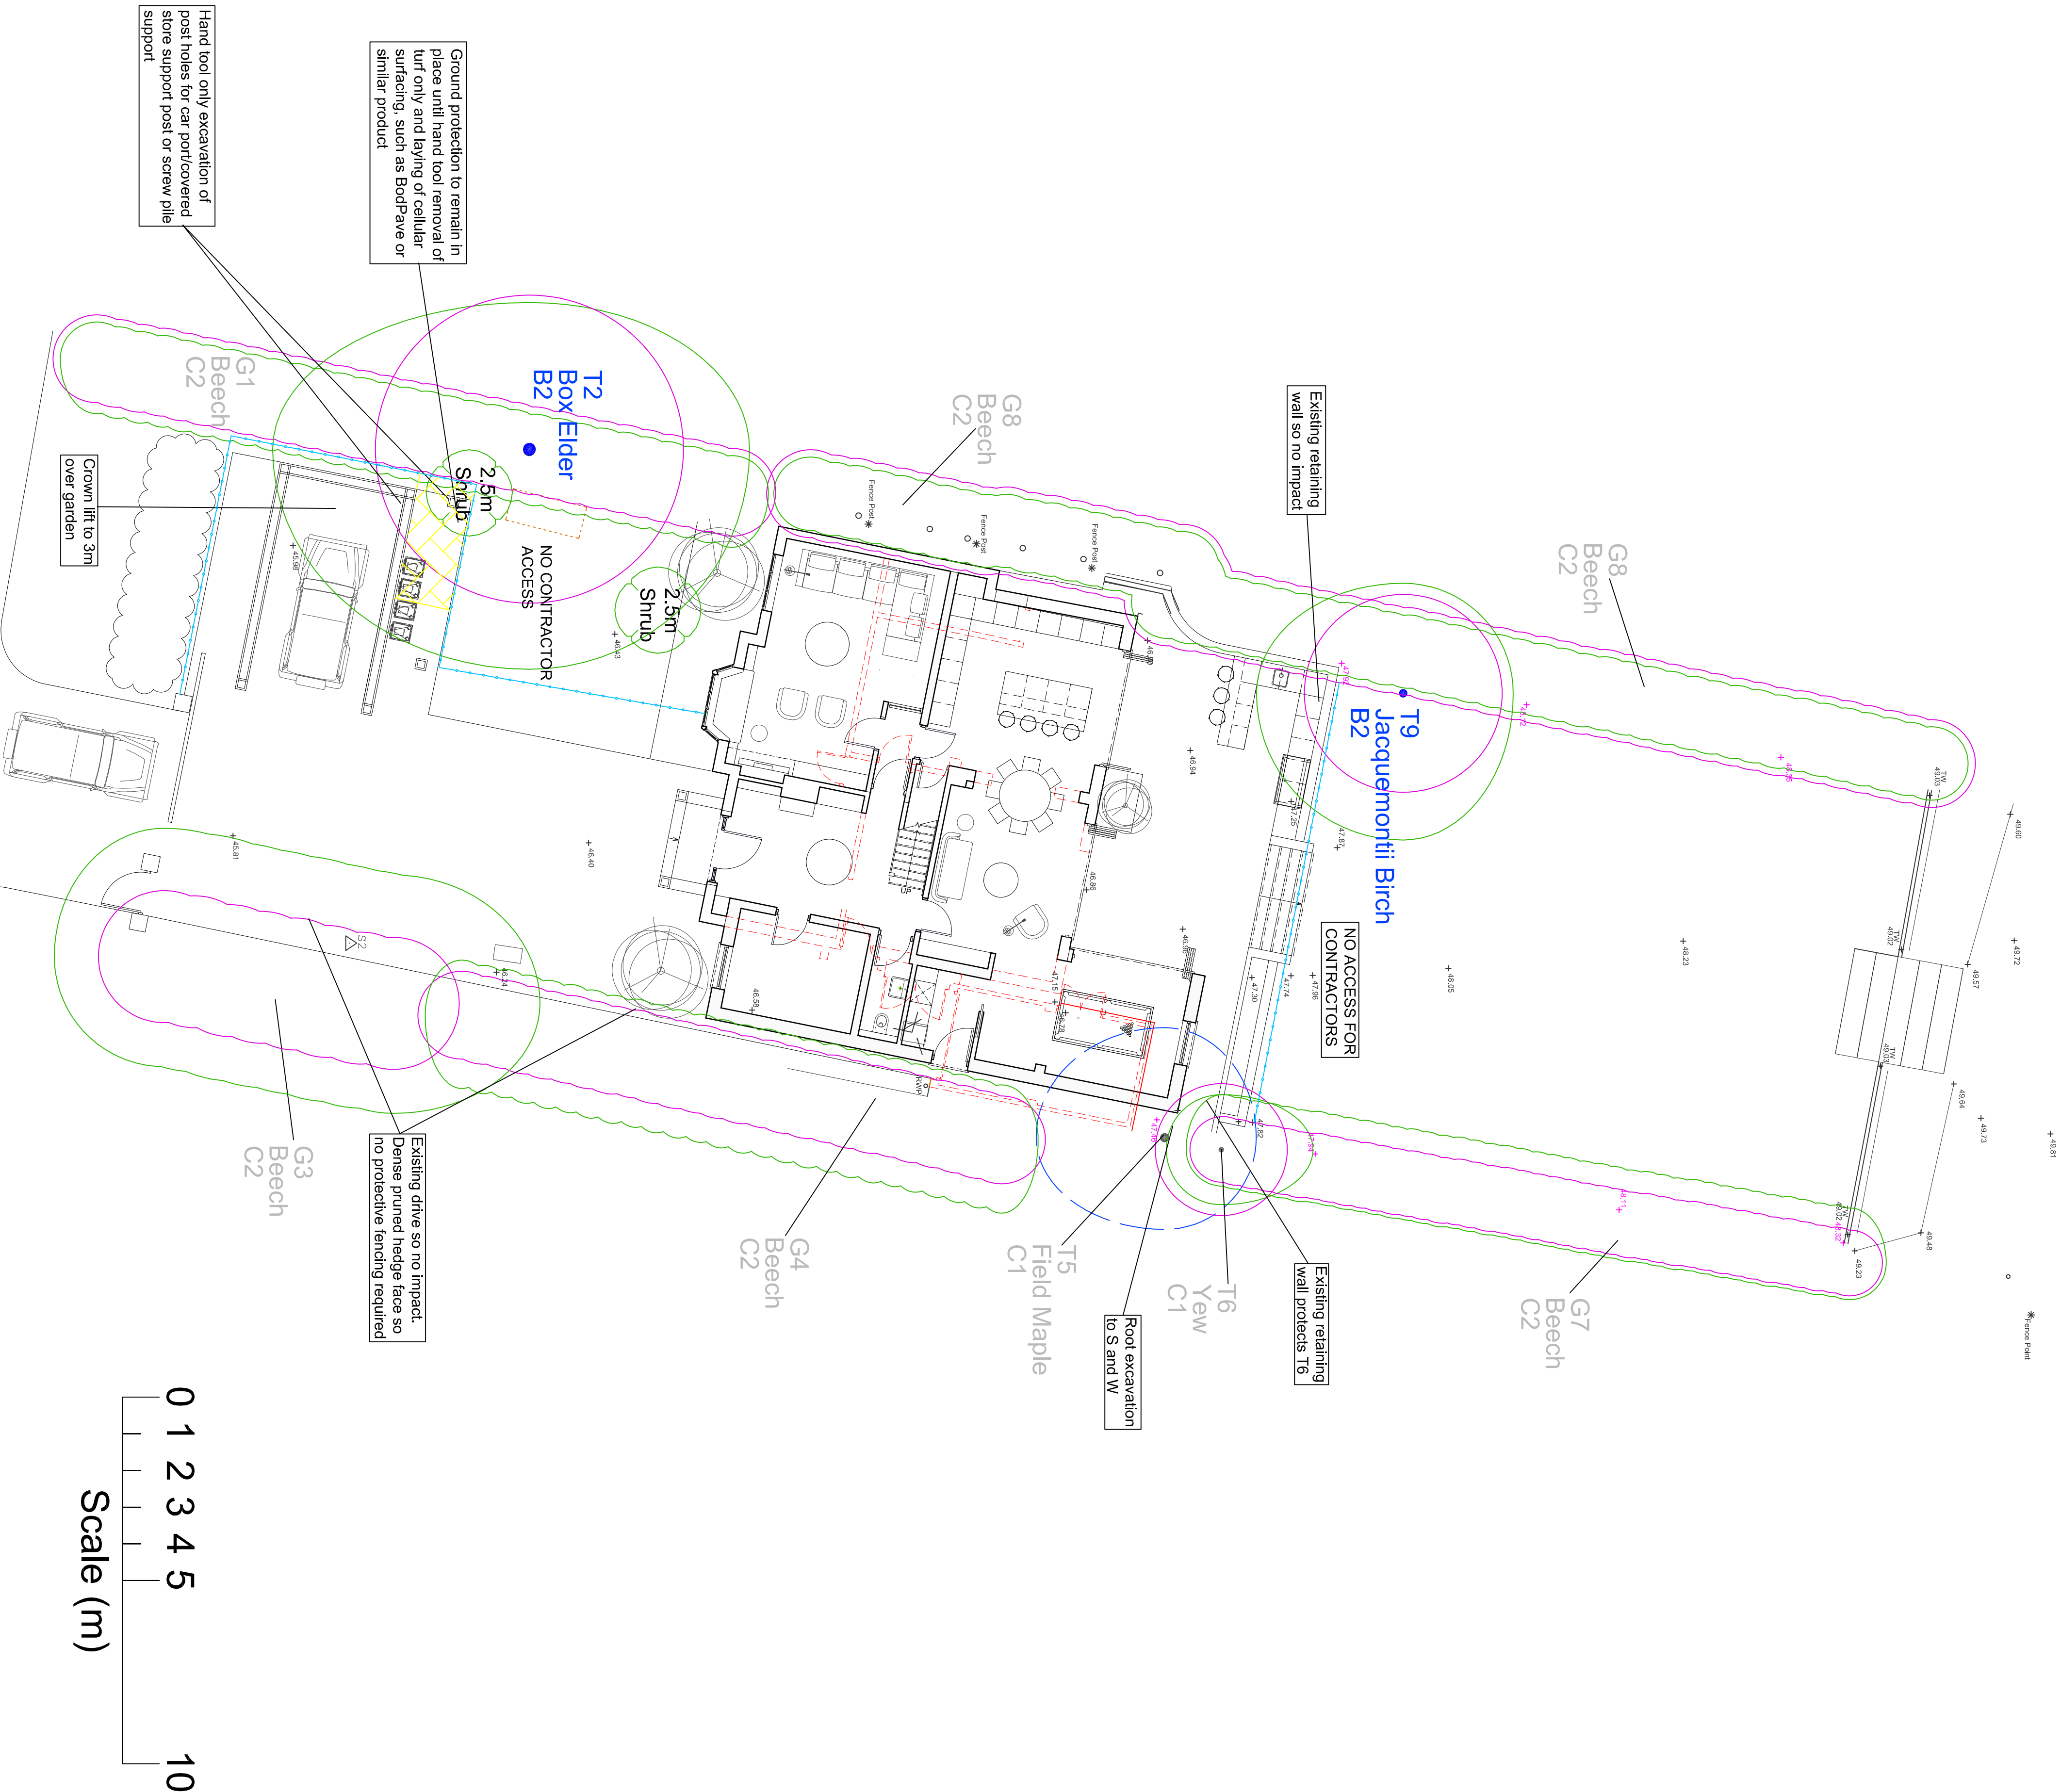
## TREE PROTECTION PLAN

- 10.1 The proposed extension will not impact on any retained tree RPAs.
- 10.2 The proposed car port is a lightweight structure with only one corner post located in the outer RPA of the Box Elder T2 and one post for the covered bin store. This is not a significant overlap and the post hole will either be hand tool excavated or a screw pile utilised. The potential for root damage from such a small excavation is minimal and should not represent a planning constraint. The proposed methodology for minimising any impact is indicated on the Tree Protection Plan.

- 10.3 The proposed area of surfacing for the covered bin store to the north of the proposed car port would overlap with the outer RPA of T2 Box Elder by 3m<sup>2</sup> or just over 5% of the total RPA. To minimise any impact the bin store area will be formed by hand tool only removal of the turf and the laying of a cellular support system, such as Bod Pave or a similar product. This will avoid soil compaction and minimise the excavation depth required. These measures are indicated on the Tree Protection Plan.

- 11.1.1 The Tree Protection Plan indicates the proposed location of protective fencing based on the calculated tree protection areas and space available.

- 12.1 The area shown hatched on the Tree Protection Plan is to be covered in a geotextile, over which 100mm of woodchip is to be placed, topped with minimum 12mm thickness non slip surfaced OSB/plywood boards or side butting scaffold boards.
