**Tree Survey  
Tree Protection Plan  
Arboricultural Impact Assessment  
Method Statement  
For Colwood, Halton Shaws BN6 9QR**

**Client: Mr Chris Webster**

**Author: I. A. Hickinbottom RFS Cert Arb**  
**For Tree Amigos Professional Tree Care**

**Date: 27<sup>th</sup> August 2025**

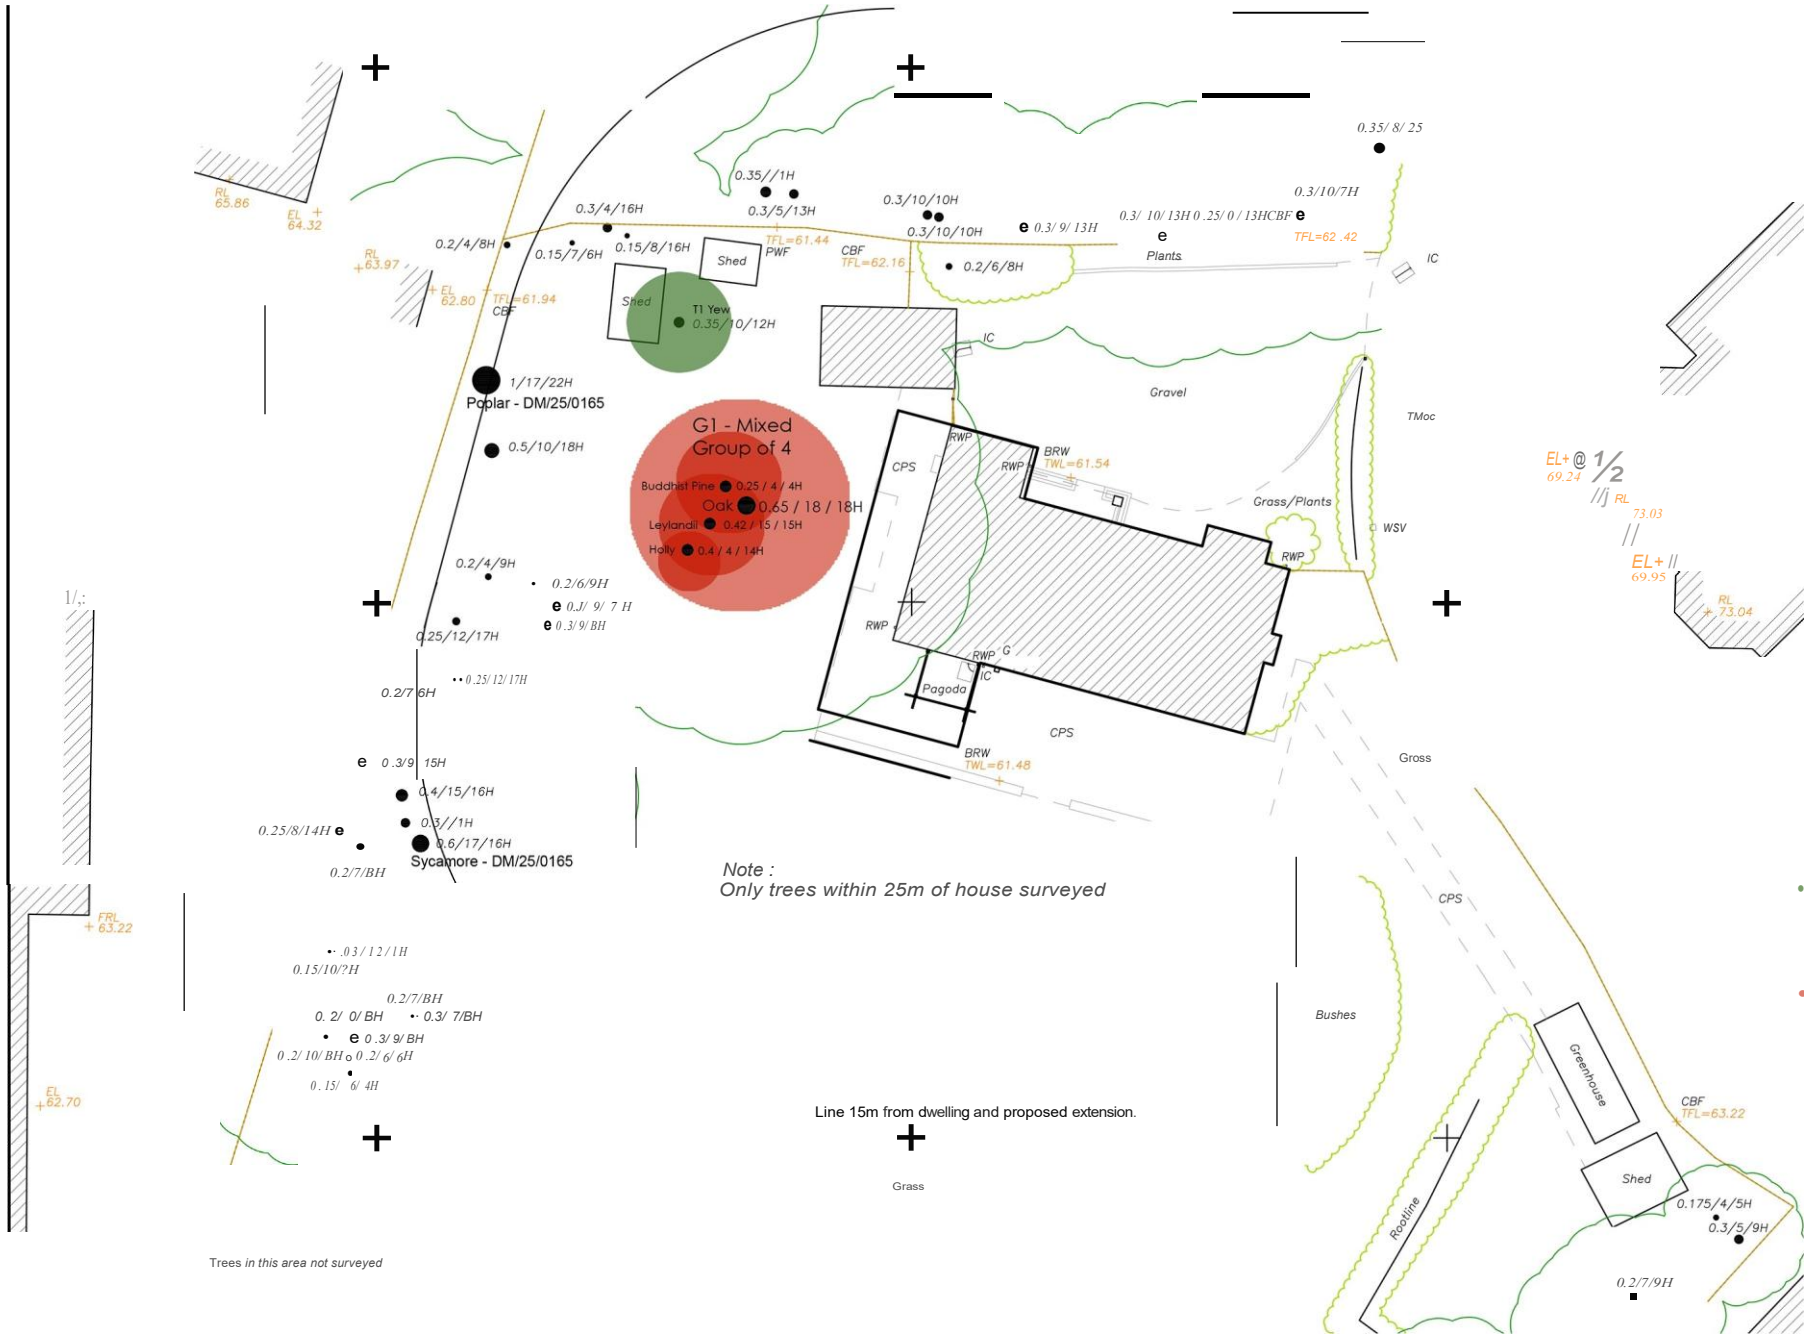
**Appendix A4**  
**Tree Location Plan**

An initial site plan has been used to show the retained tree locations. This is shown in green signifying category A trees. The trees to be removed are shown in red signifying category U trees. (See Appendix A4 – Tree Location Plan).

Four trees forming a group G1 are in category U of BS 5837. These trees are to be removed. Note Permission has already been granted to fell the oak tree.

The yew tree, T1 is a category A tree. This tree is to be retained.

Above ground constraints: The branch spread of the retained tree is shown by a green line on the Tree Location Plan (See Appendix A4). The lower branches constituting the crown break are estimated to be at a height 2.5 meters above ground level. Some lateral limbs branch out Southwards and towards the existing building. These branches are dead and should be removed.

All recommended tree work should be completed before construction work begins. This includes removal of all category U trees in group G1, indicated on the tree location plan.

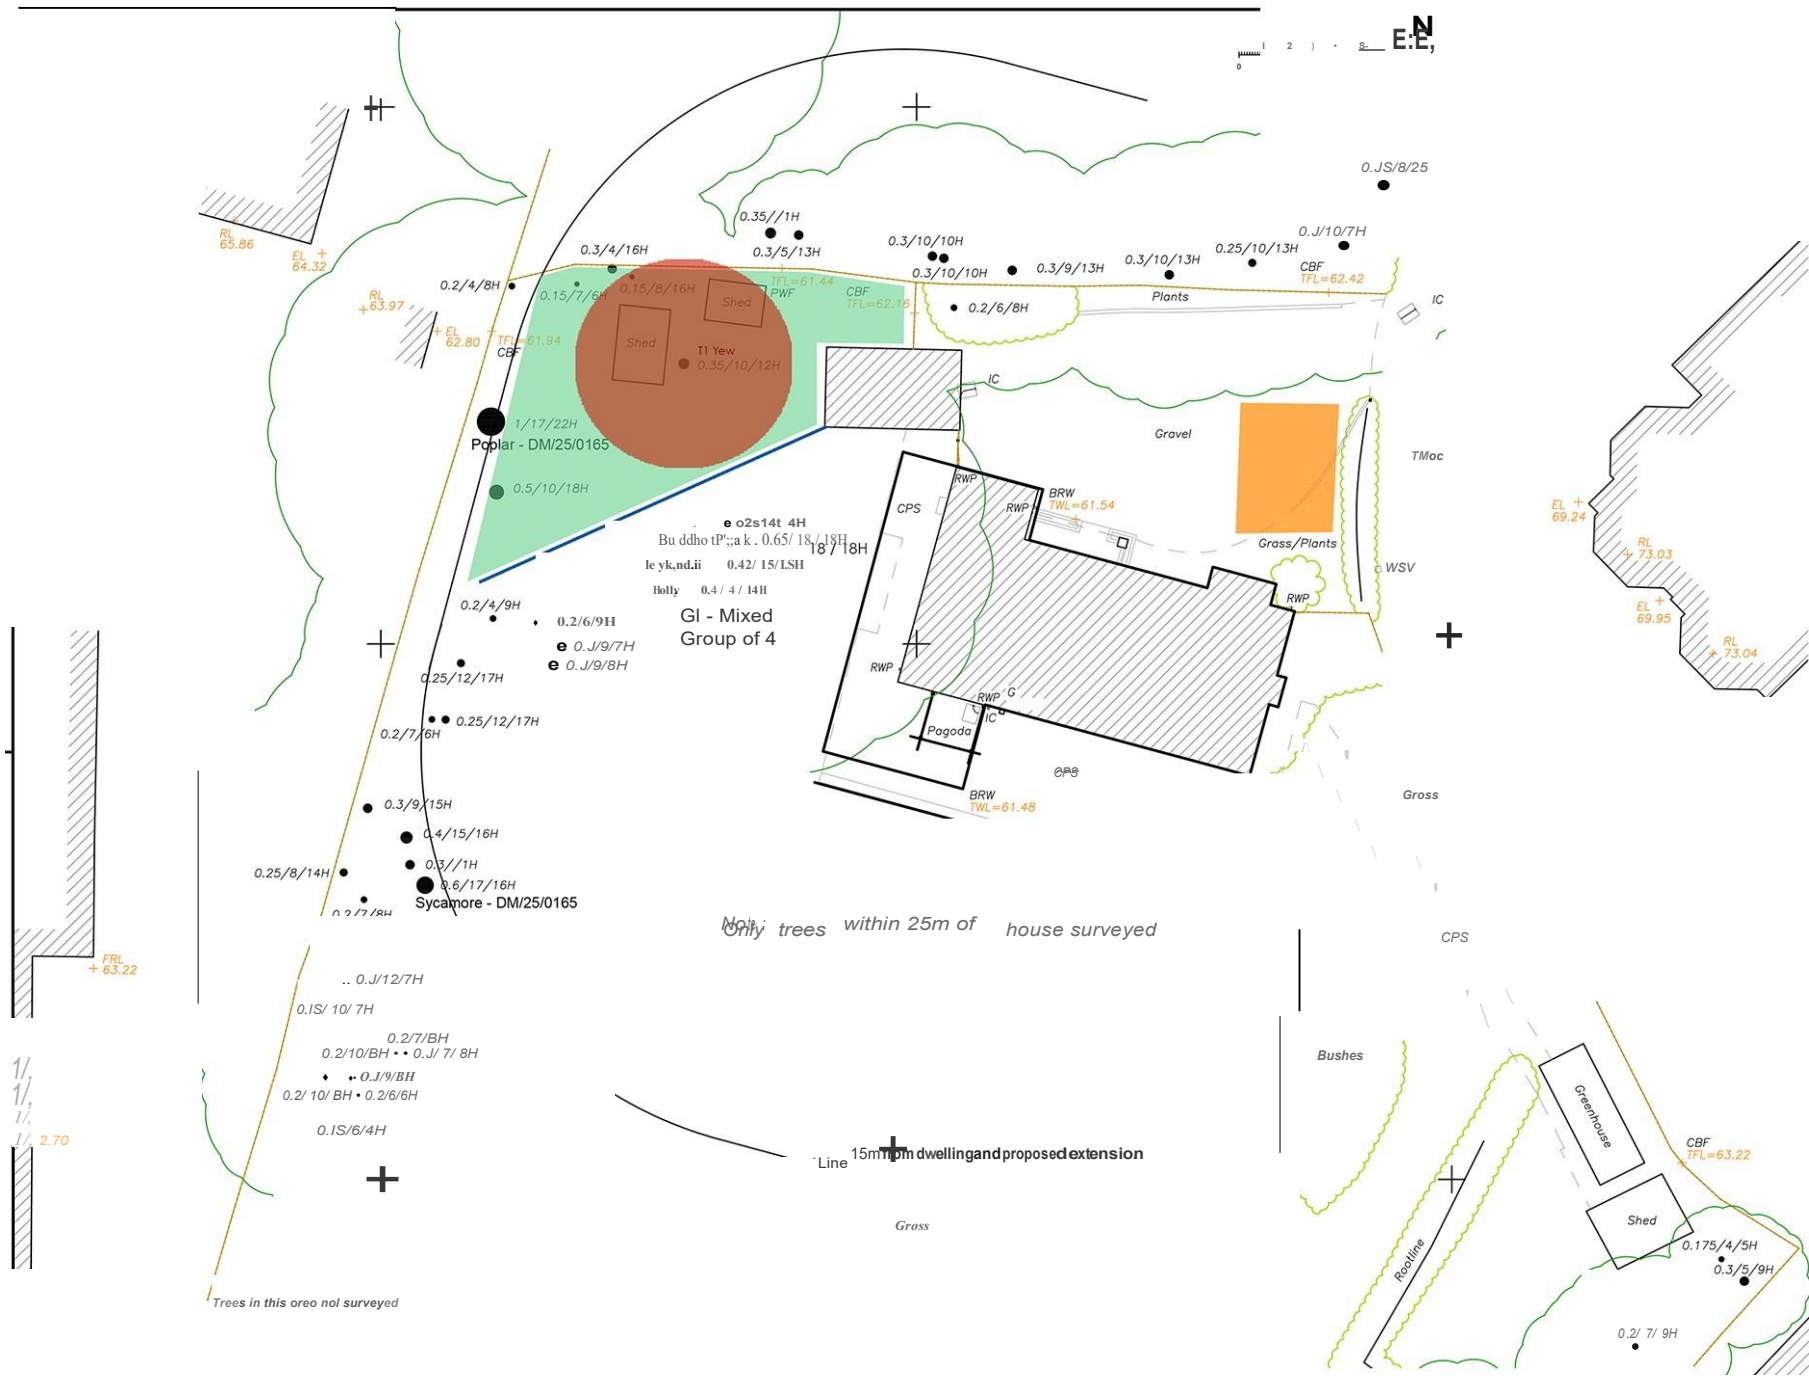
**Appendix A5**  
**Tree Protection Plan**

The Tree Protection Plan shows the calculated Root Protection Area (RPA) for the retained tree, T1, marked in red. This drawing shows there is no potential impact on the retained tree by the new development (See Appendix A5).

Root plate area calculations use the formula of diameter at breast height (DBH) multiplied by 12. The calculated RPA radius is 4.2 meters for the tree T1.

Below ground constraints: The RPA of the retained tree is shown in red on the Tree Protection Plan (See Appendix A5). The RPA will be used to fix the boundaries of any temporary fencing needed to protect the tree during construction forming the Construction Exclusion Zone (CEZ). The CEZ is shown in green.

The Tree Protection Plan shows the detailed location of all protective barriers forming a Construction Exclusion Zone (CEZ) around the retained tree. It also shows the existing hard surface driveway providing ground protection (See Appendix A5). The protective barriers must be implemented before works begin and remain for the duration of the works.

For this site it is recommended that 2 m welded mesh (Heras) fencing with heavy duty rubber feet and anti-tamper fixings are used. At least 2 fixings should be used to connect each fence panel. Fixings should be fitted from the inside and be at least 1 m apart. Stabilizers should be fitted to each panel and pinned into the ground to help support the fence. This fencing should comply with BS 5837:2012 Section 6. (See Appendix A3). The positioning of this fencing should follow the protective fencing shown in the Tree Protection Plan (shown in blue).
