# **Arboricultural Impact Assessment**

## **Renovo House, Whitemans Green**

Report Reference Number: AIA.RH.1019.V2

**Date: 17 March 2026**

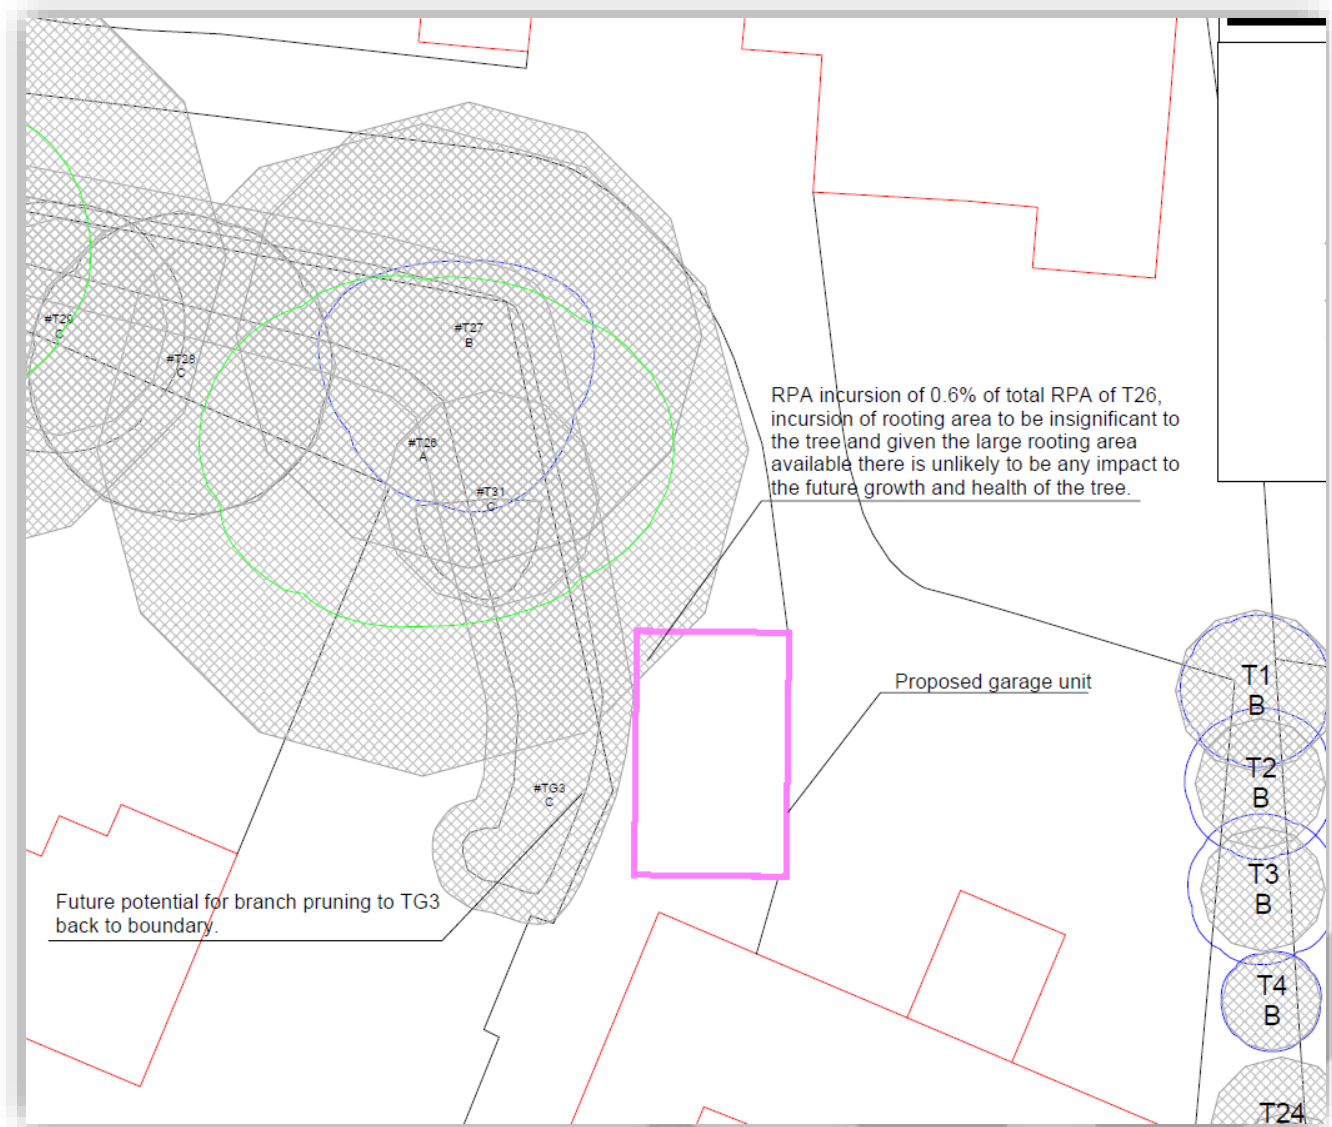
Figure 1 - Extract from Arboricultural Impact Plan – Renovo House [Garage] - AIP.RH.1019.V2

- 9.2. There is an incursion of the Root Protection Areas (RPA) of T26, this will be of 0.6% of the tree's total RPA. This incursion is minimal and the tree has a large unmade area around it available for growth. The unit is unlikely to cause any significant impact to the tree or its future growth potential.

- 9.3. There may be a need, following tree growth, to prune branching on the east of TG3. This will require the reduction of branch length back to the boundary line, this is in keeping with past management. This will be to stop inadvertent tree damage during construction. If undertaken correctly this will be of minimal negative impact to the tree group.

- 9.5. Tree protection measures for the retained trees should be sought in the form of an **Arboricultural Method Statements** and **Tree Protection Plan**. This will ensure sufficient development room shall be available after protection measures are instigated as described within this report. Excavations within retained tree RPAs for construction operations such as; service trenches; changes in levels, foundations excavations and removal of existing hard surfacing are not anticipated and will be avoided where possible.
