## BS:5837 ARBORICULTURAL REPORT

ARBORICULTURAL SURVEY, IMPACT ASSESSMENT &  
METHOD STATEMENT

2 KEYMER ROAD  
HASSOCKS  
WEST SUSSEX  
BN6 8HA

DECEMBER 2023  
Ref: SCD 06169 / 2023

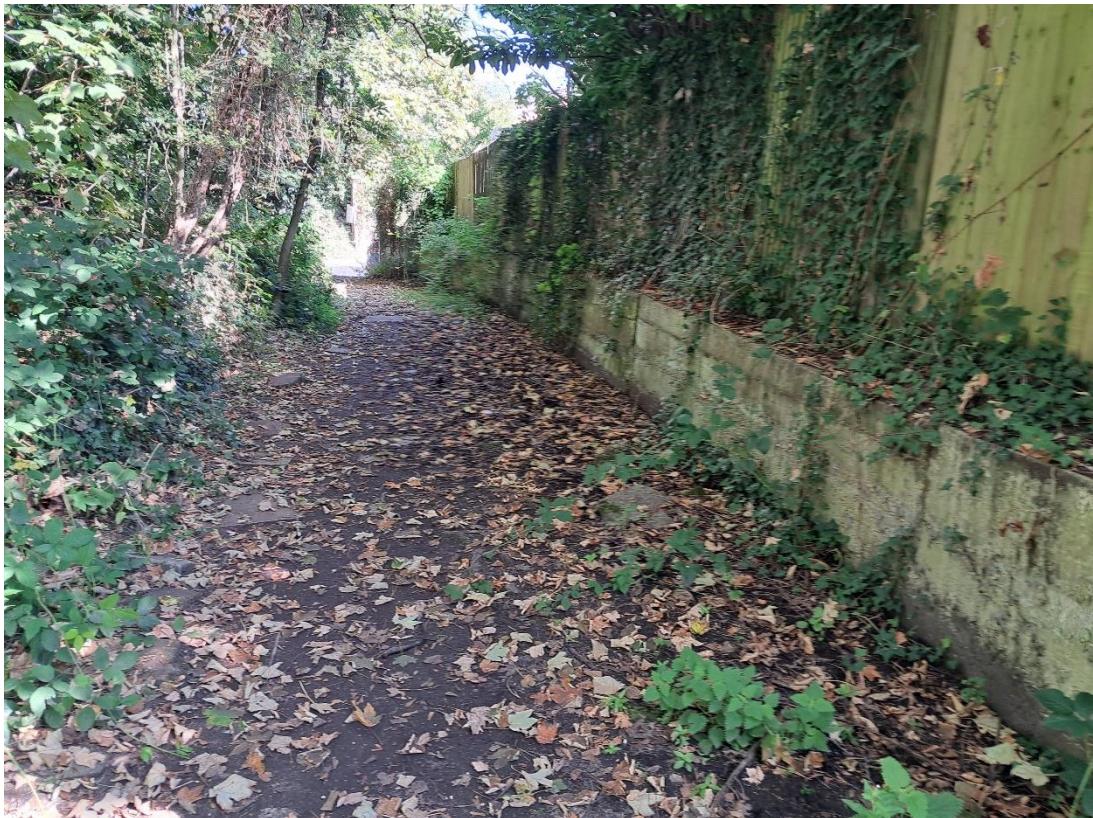
The retaining wall along the western boundary will prevent roots from trees along the western boundary extending into the lawn area at the rear of 2 Keymer Road.

Photo 1. Footpath along the western boundary. The garden of 2 Keymer Road is raised above the concrete retaining wall

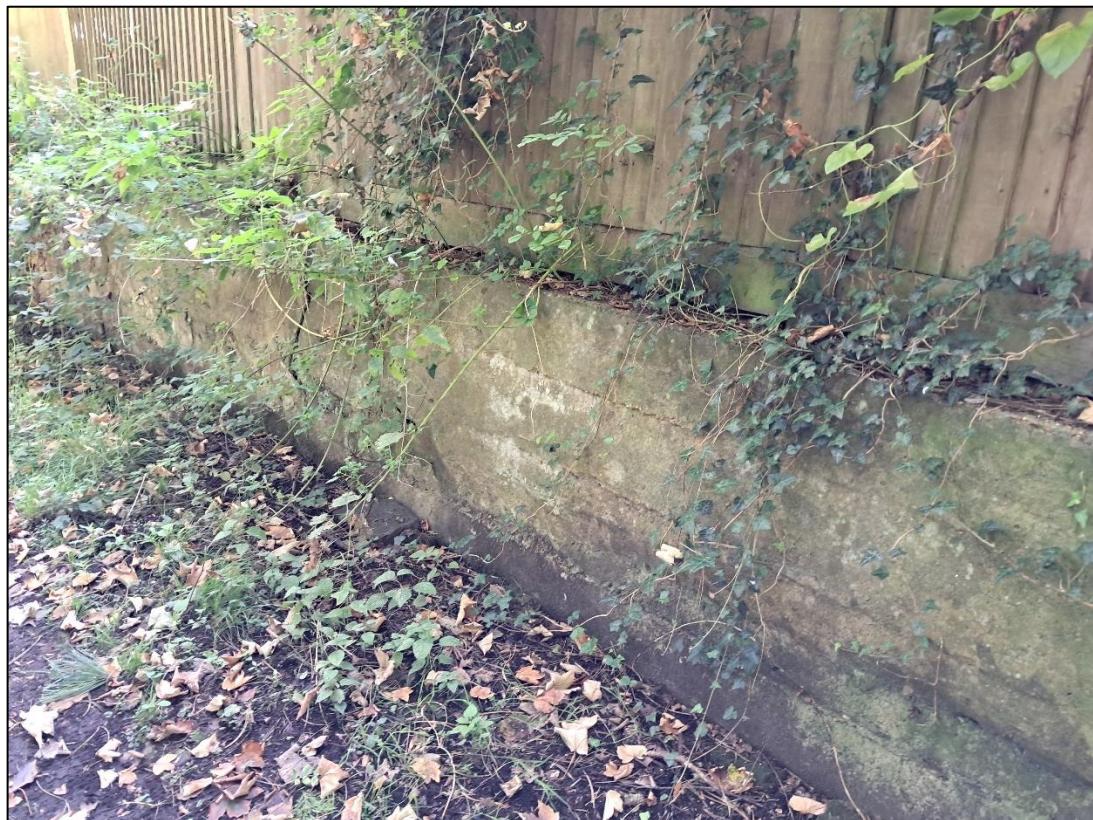
Photo 2. Concrete retaining wall
