**TOWNHOUSE DAIRY,  
TOWNHOUSE FARM, CHURCH  
LANE, ARDINGLY , RH17 6UR  
REMEDICATION METHOD  
STATEMENT  
BENJAMIN ALLEN  
CONSTRUCTION LIMITED**

| Title: | REMEDATION METHOD STATEMENT | |
| Reference: | LS 7477 | |

# **DEMOLITION ASBESTOS SURVEY REPORT**

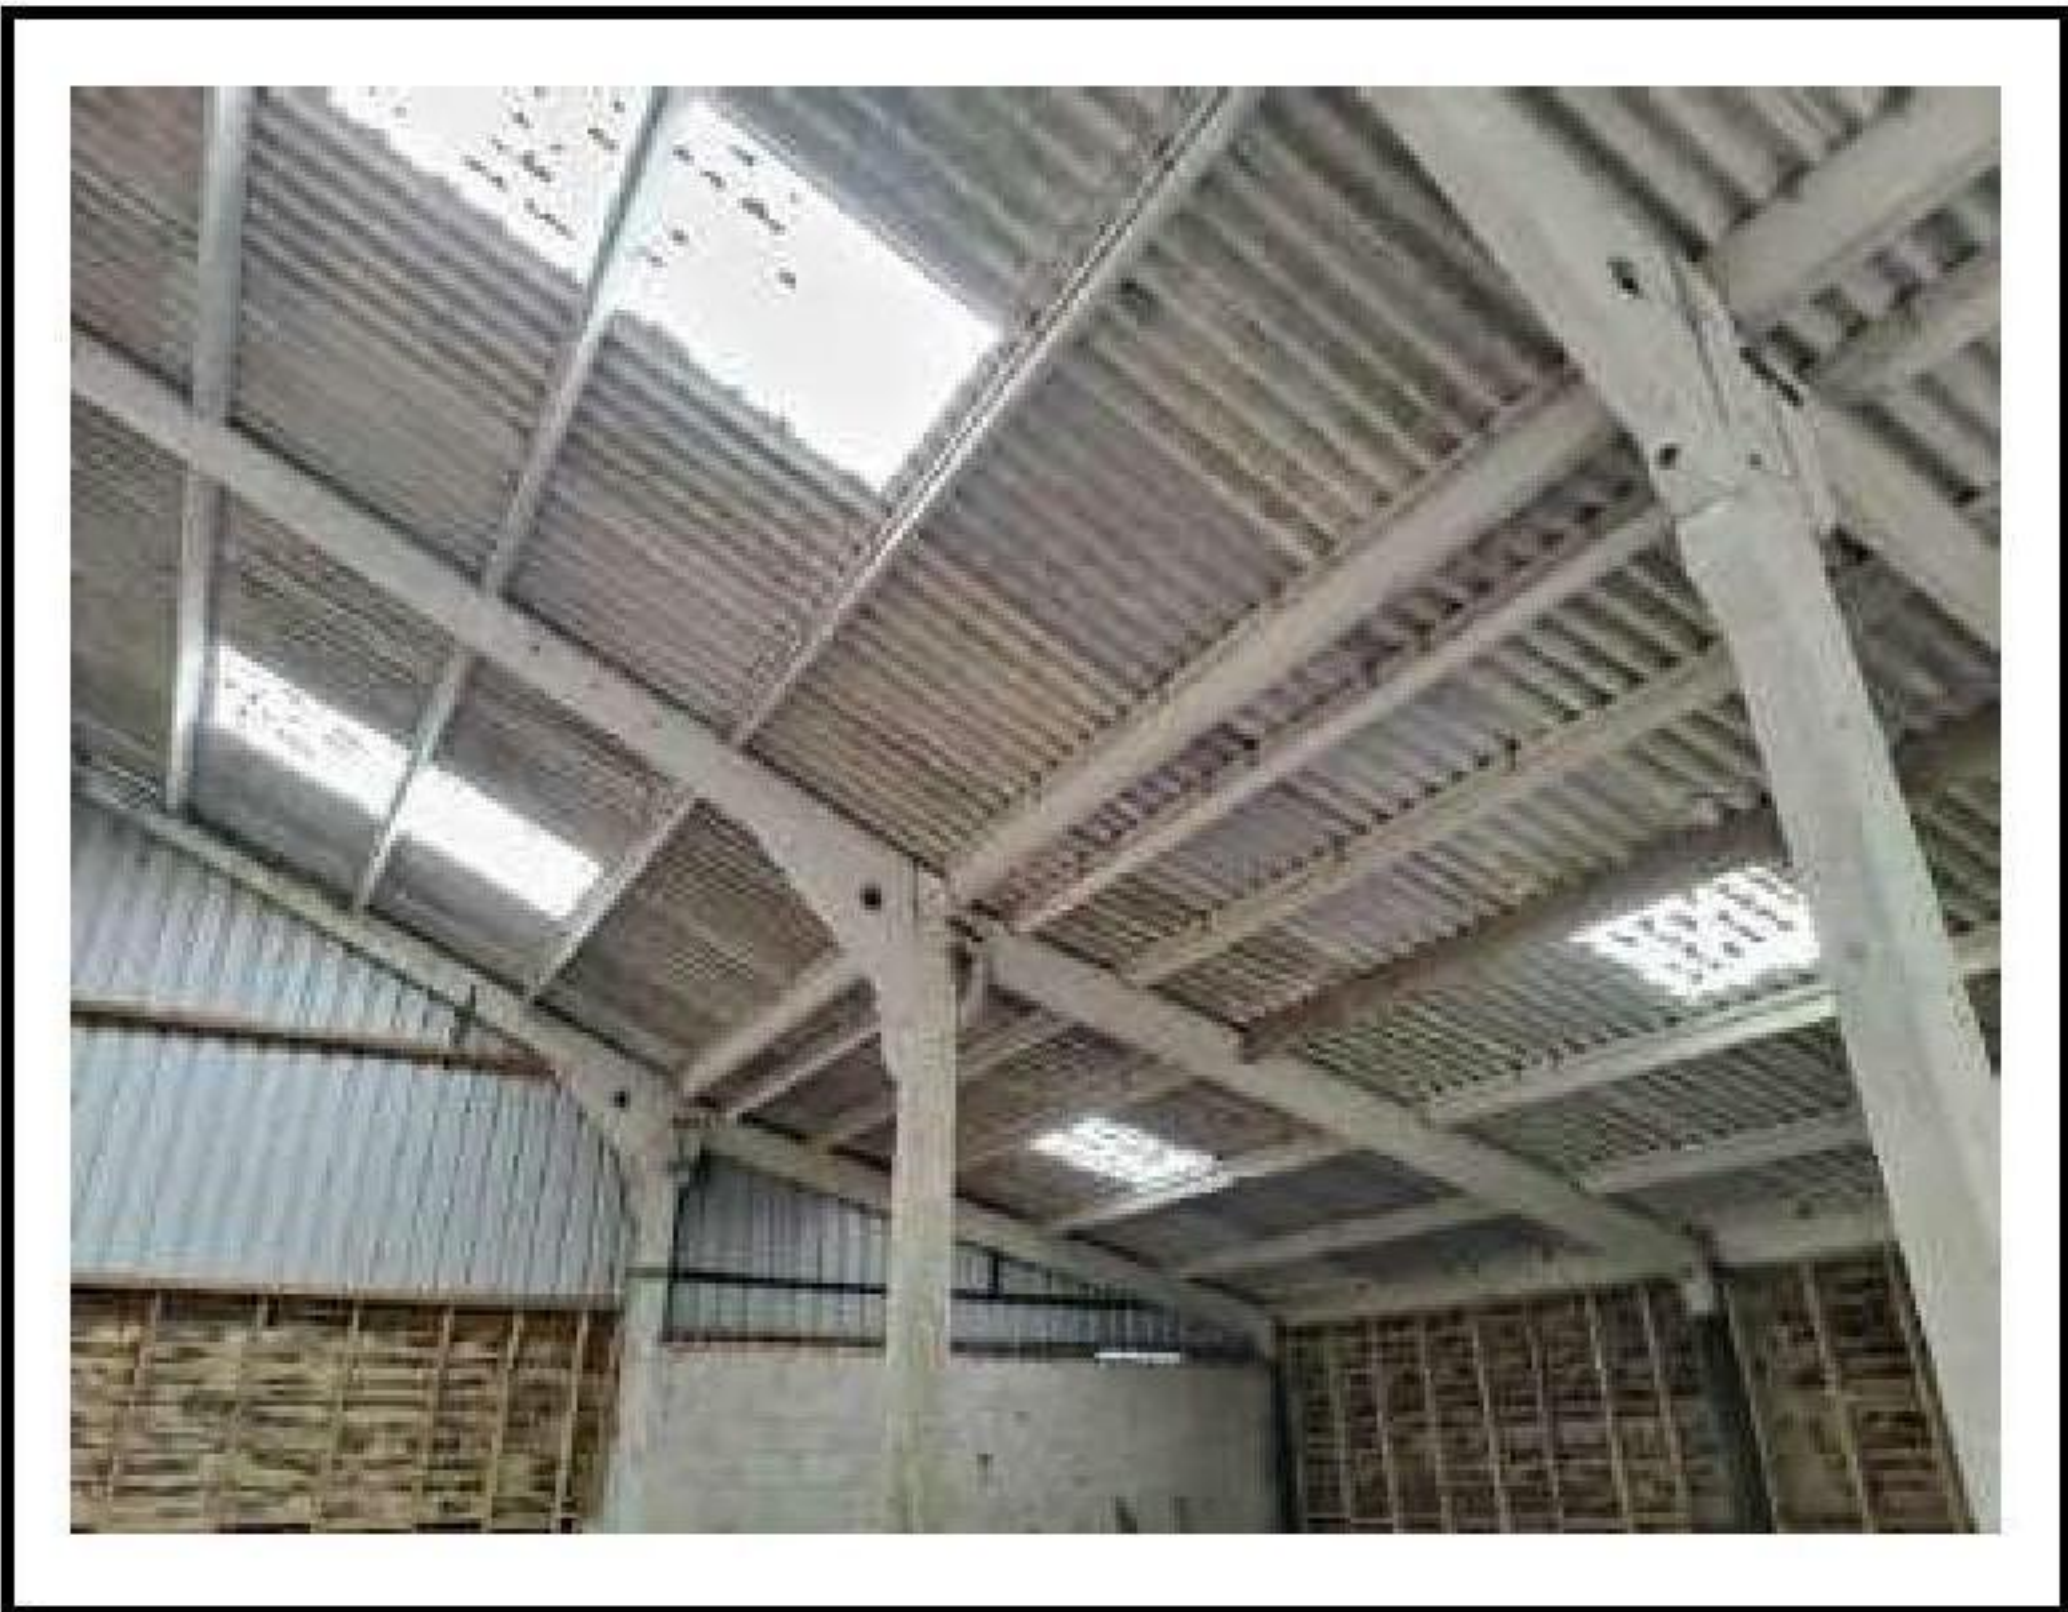
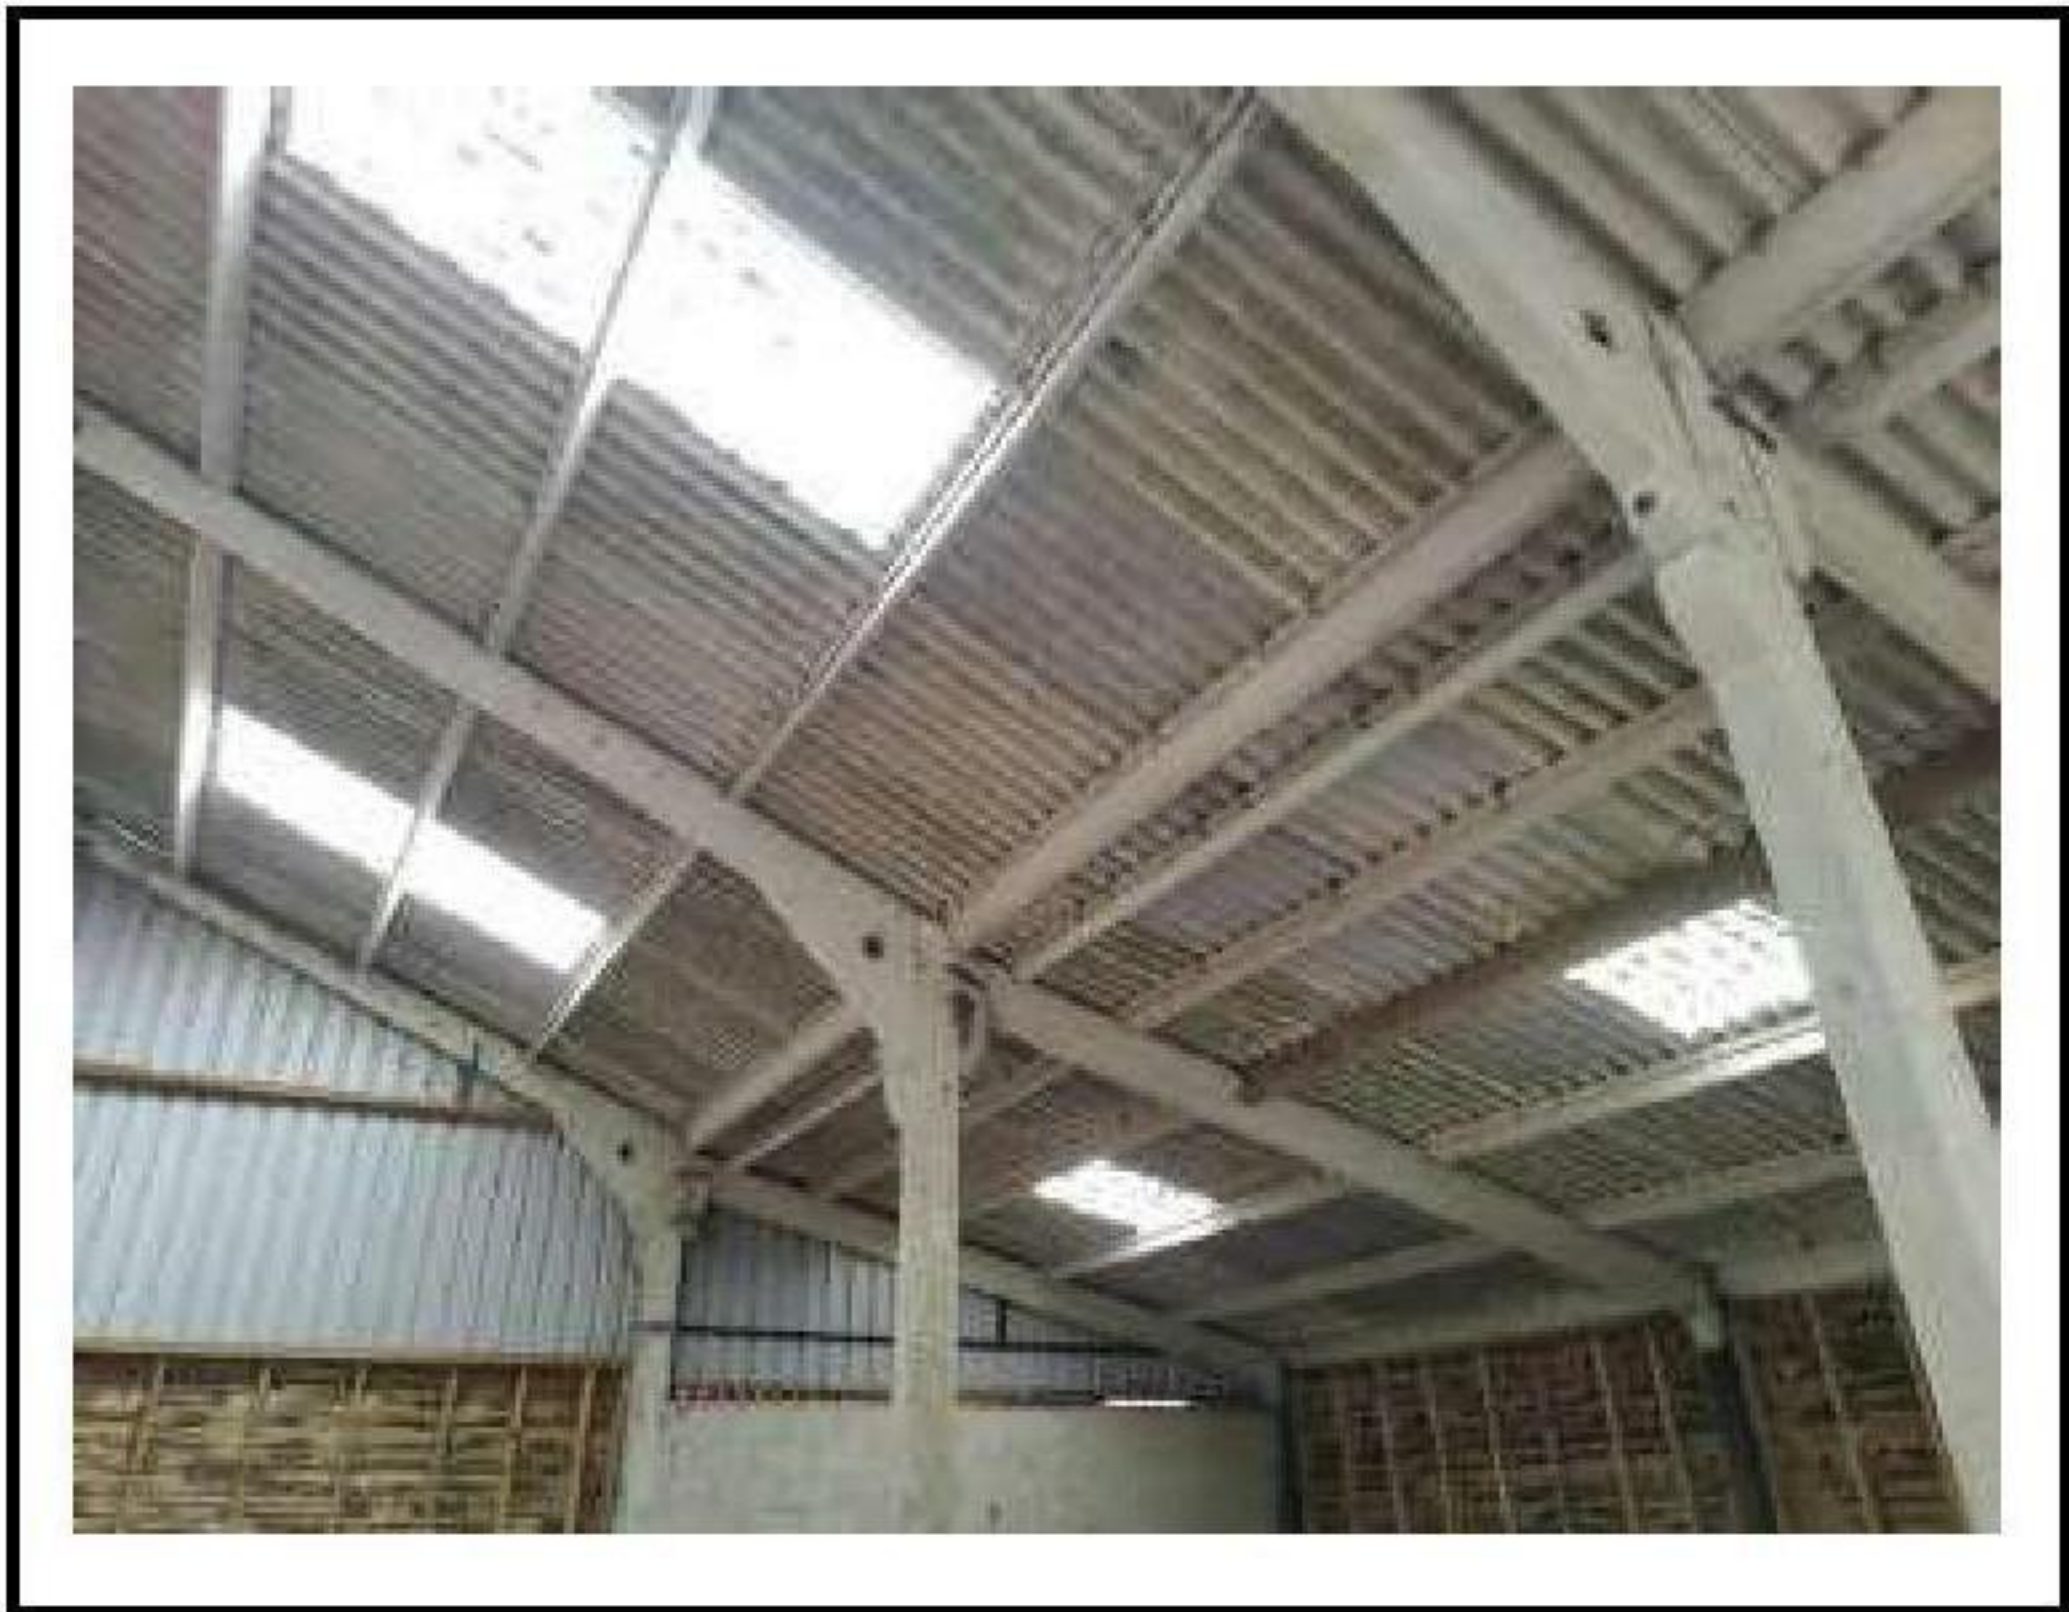
| Level of Identification | Sampled | Sample Ref | S002 |

| Extent | Approx. 210 m² | Accessibility | Difficult |

| Item Notes: | Unsealed. |

| Damage | Low | 1 |

| Recommendation: | Remove prior to refurbishment/demolition (non-licensable works). |

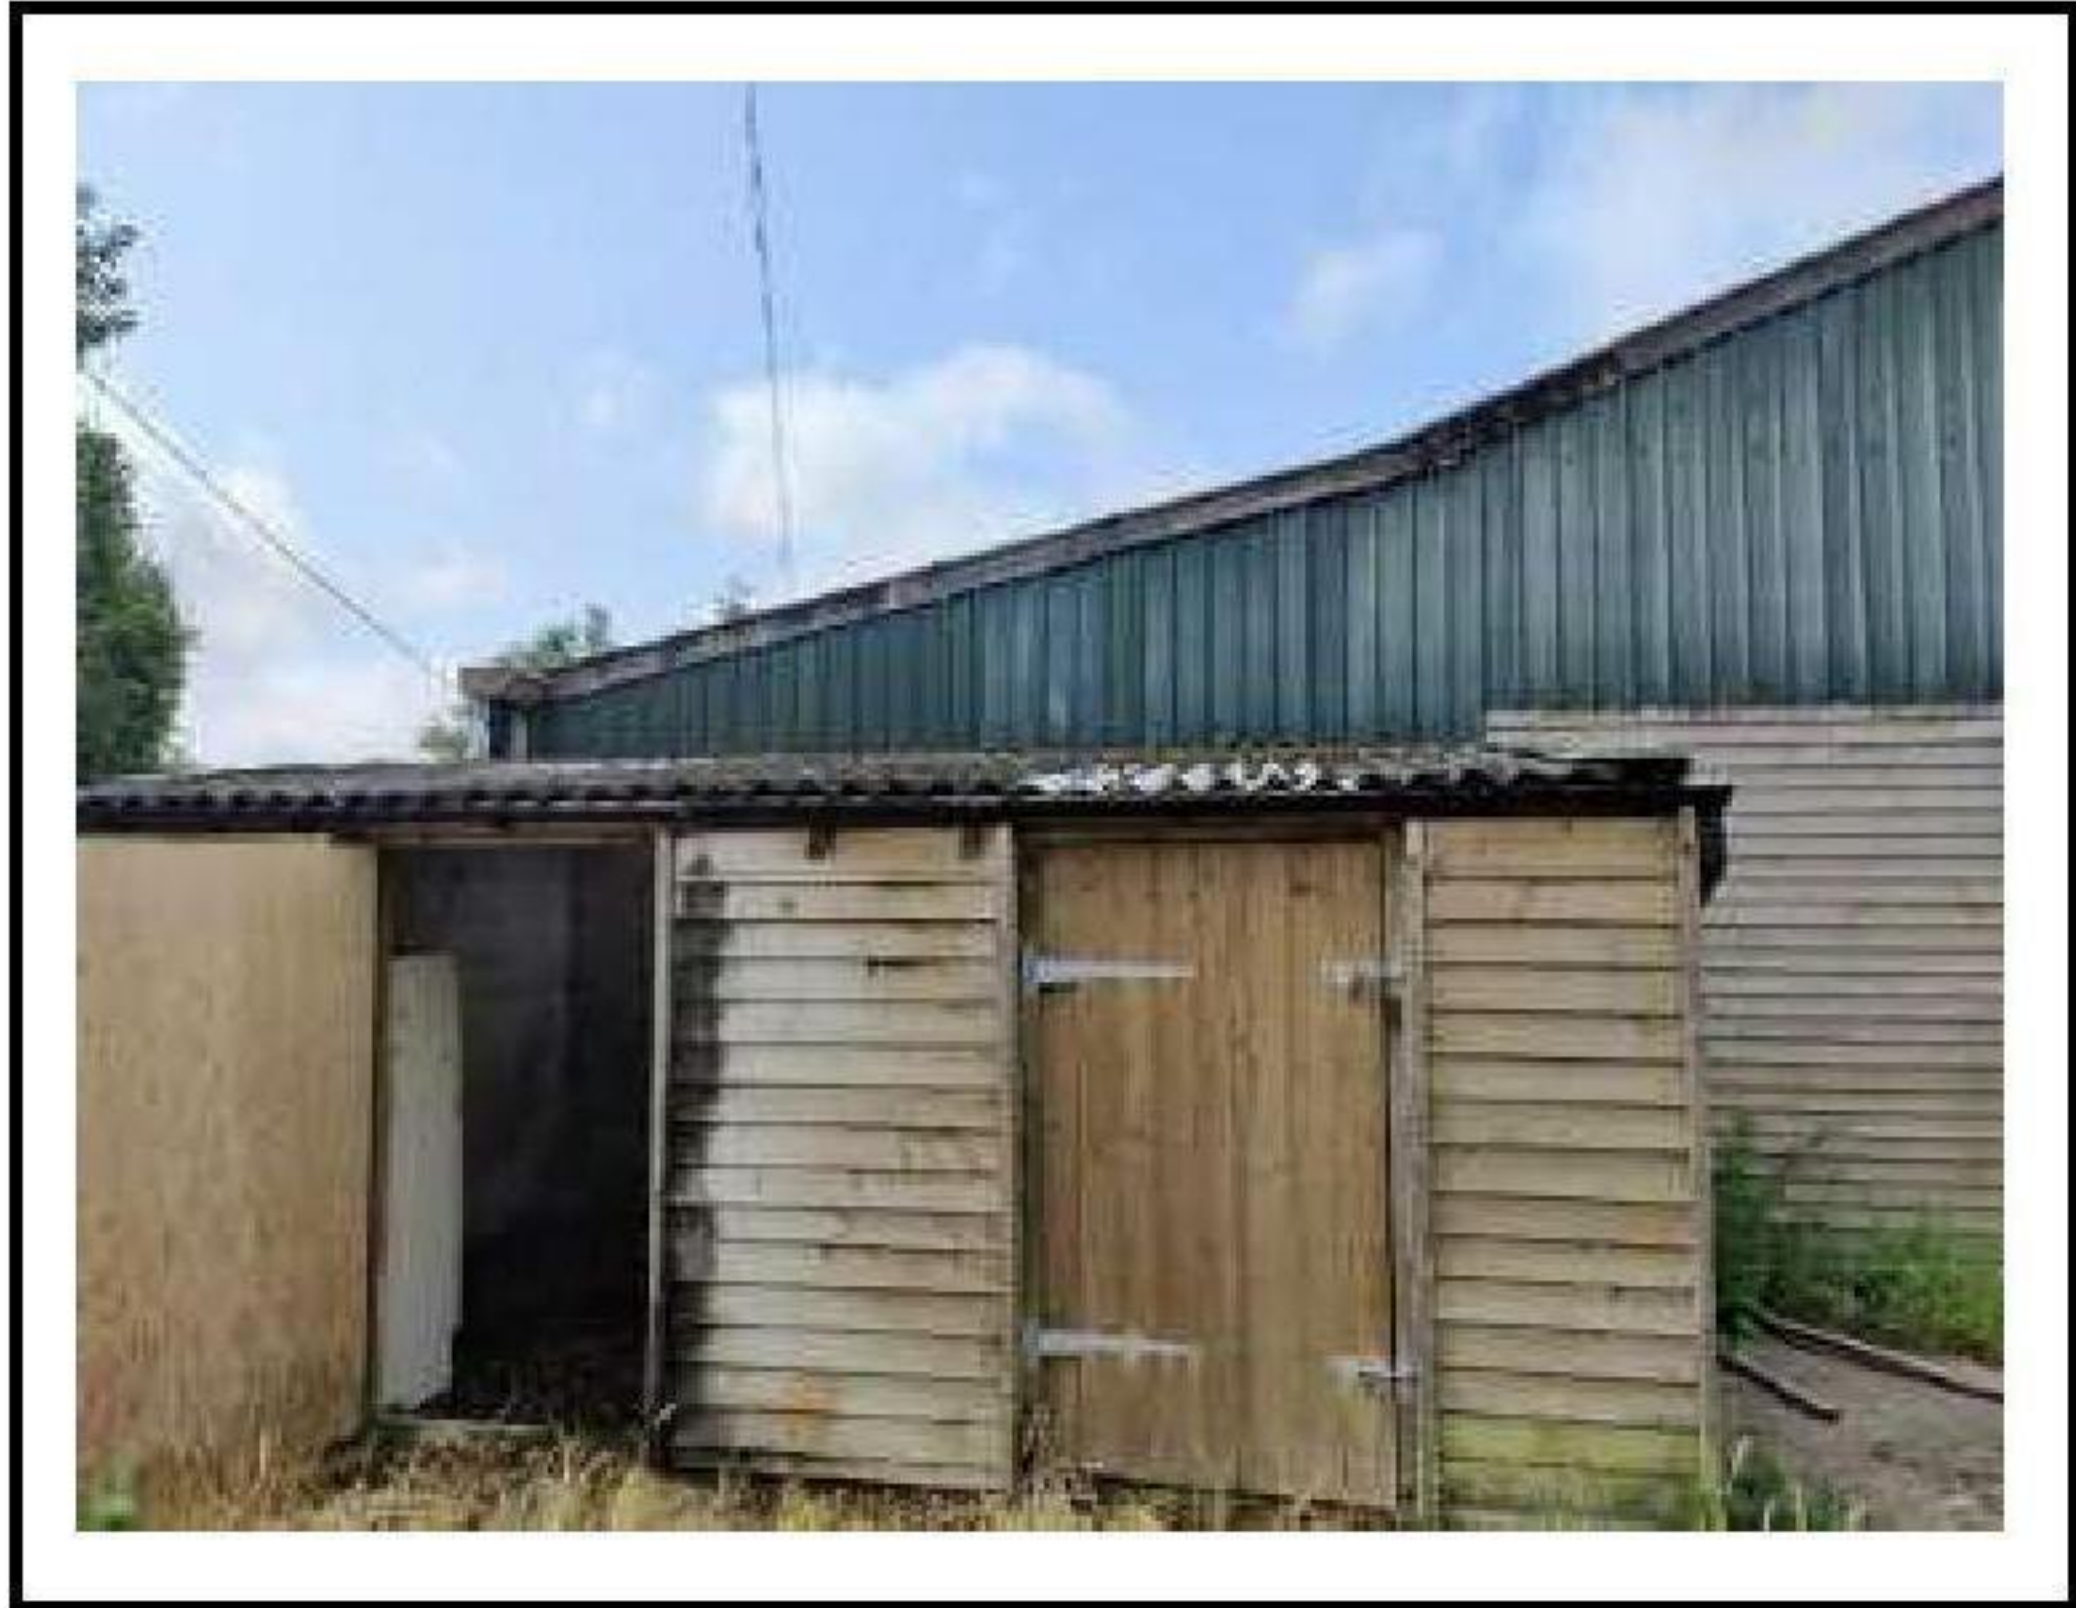
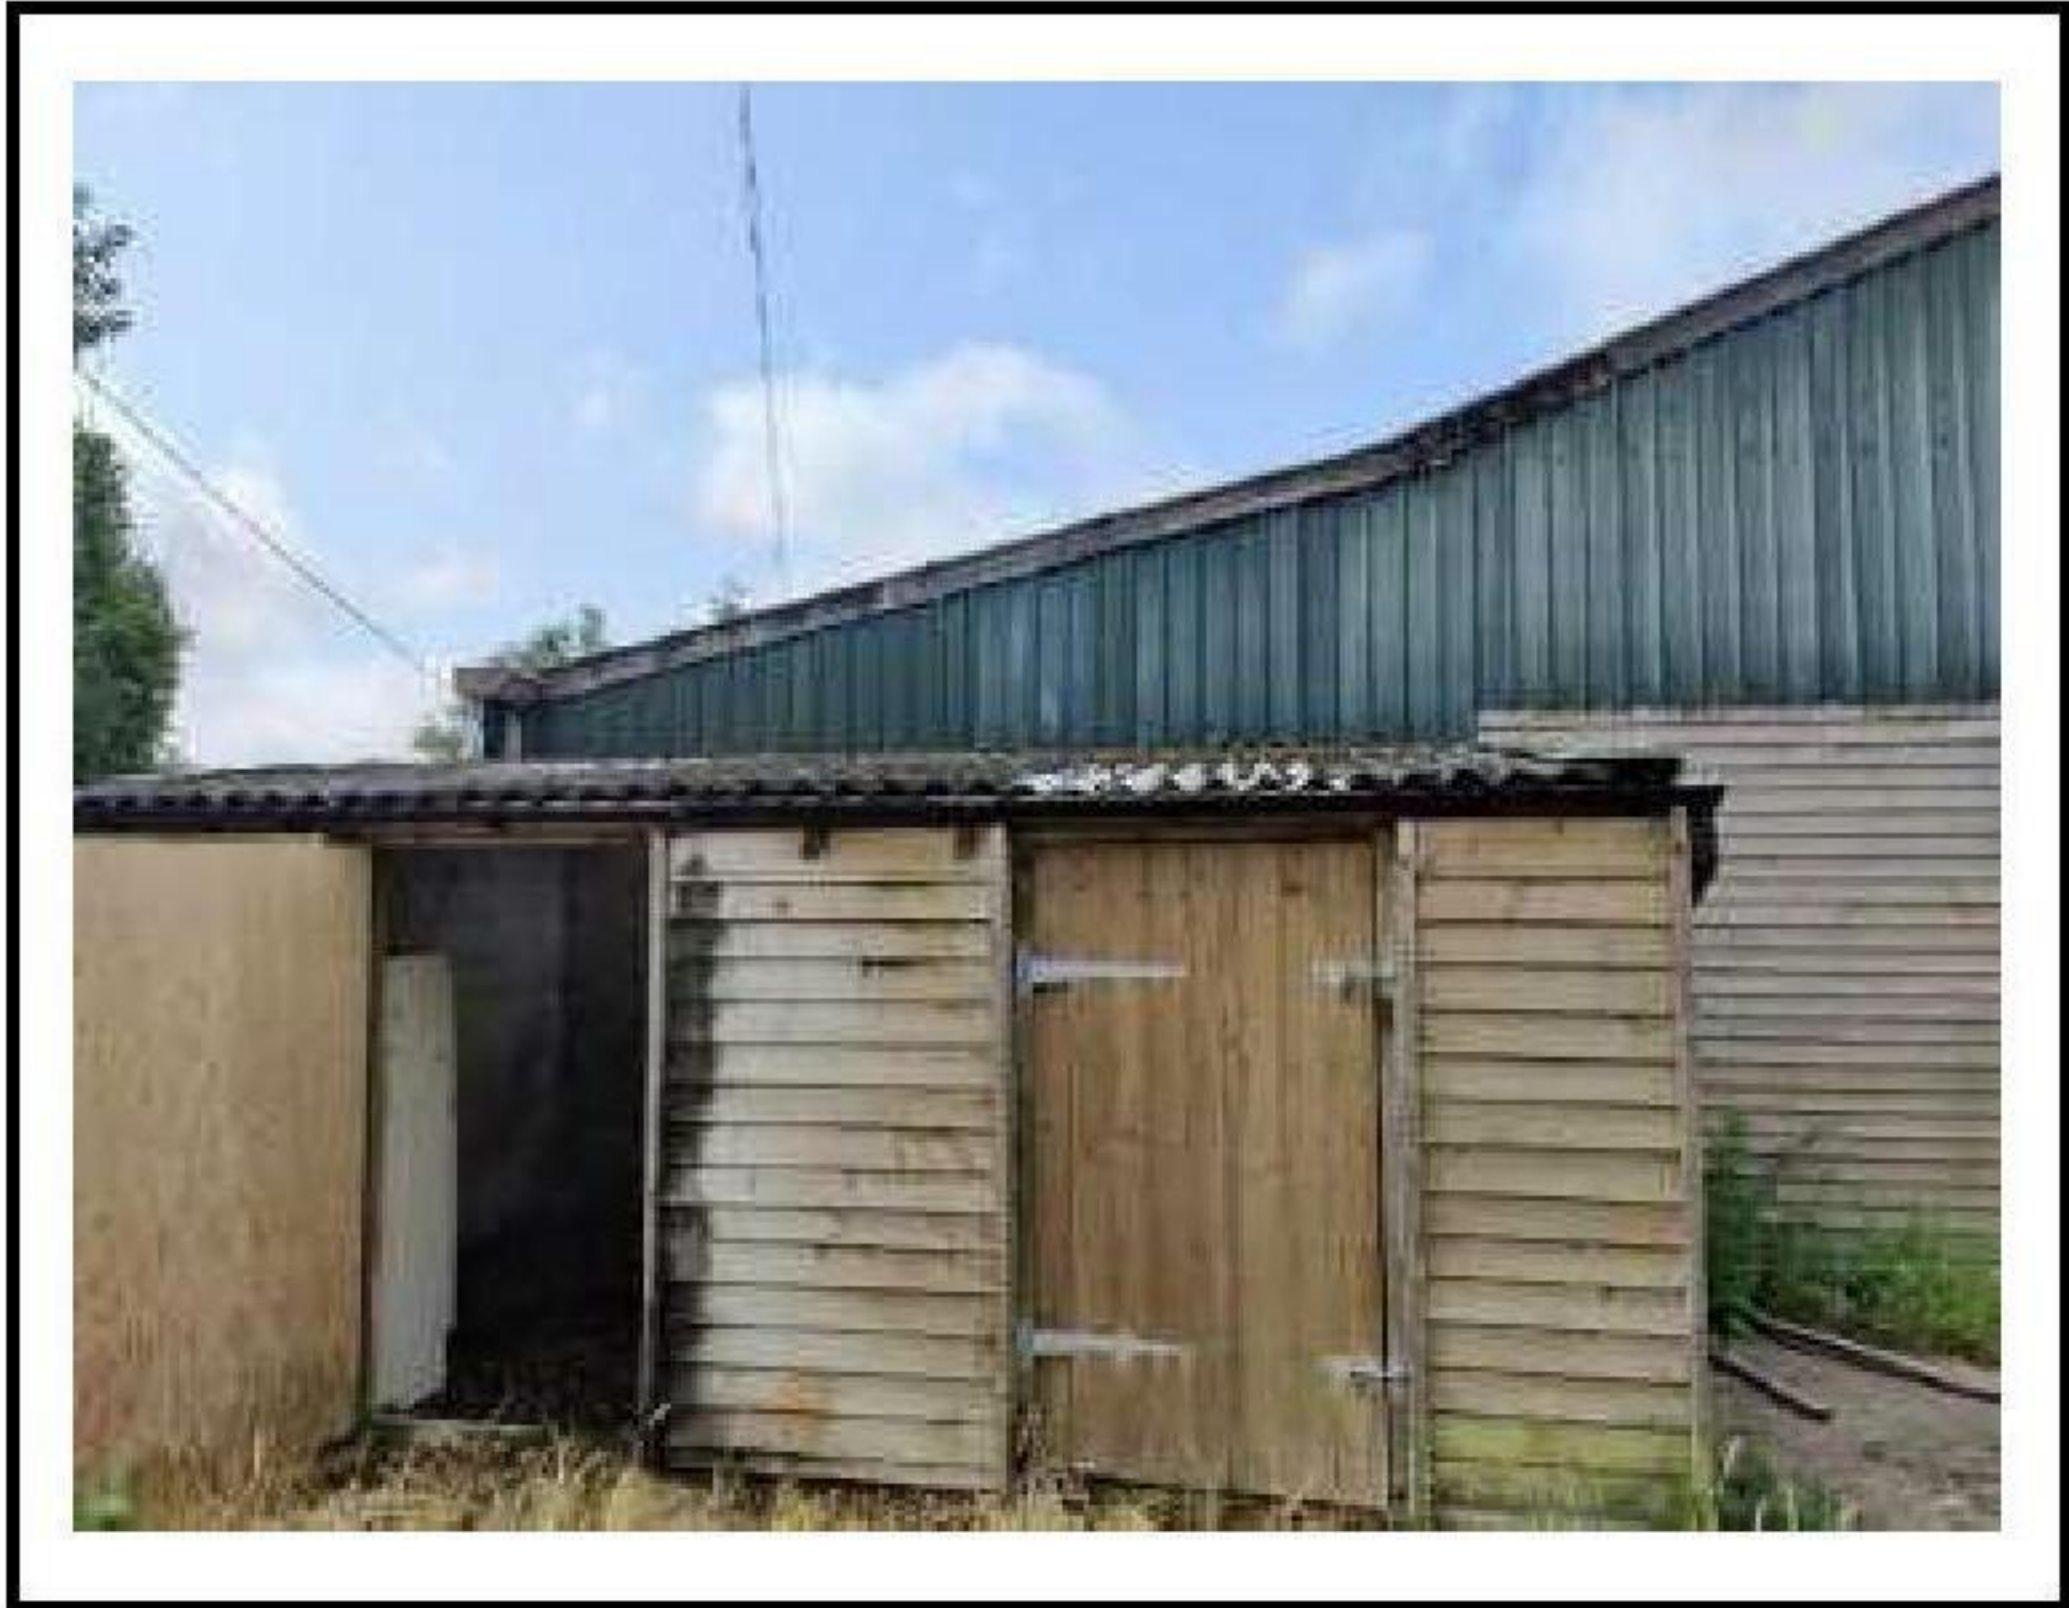
| Level of Identification | Same as | Sample Ref | X002 |

| Extent | 20 m² | Accessibility | Medium |

Item Notes:           Unsealed.

| | | Score |
|---|---|---|
| Damage | No visible damage | 0 |

Recommendation:     Remove prior to refurbishment/demolition (non-licensable works).

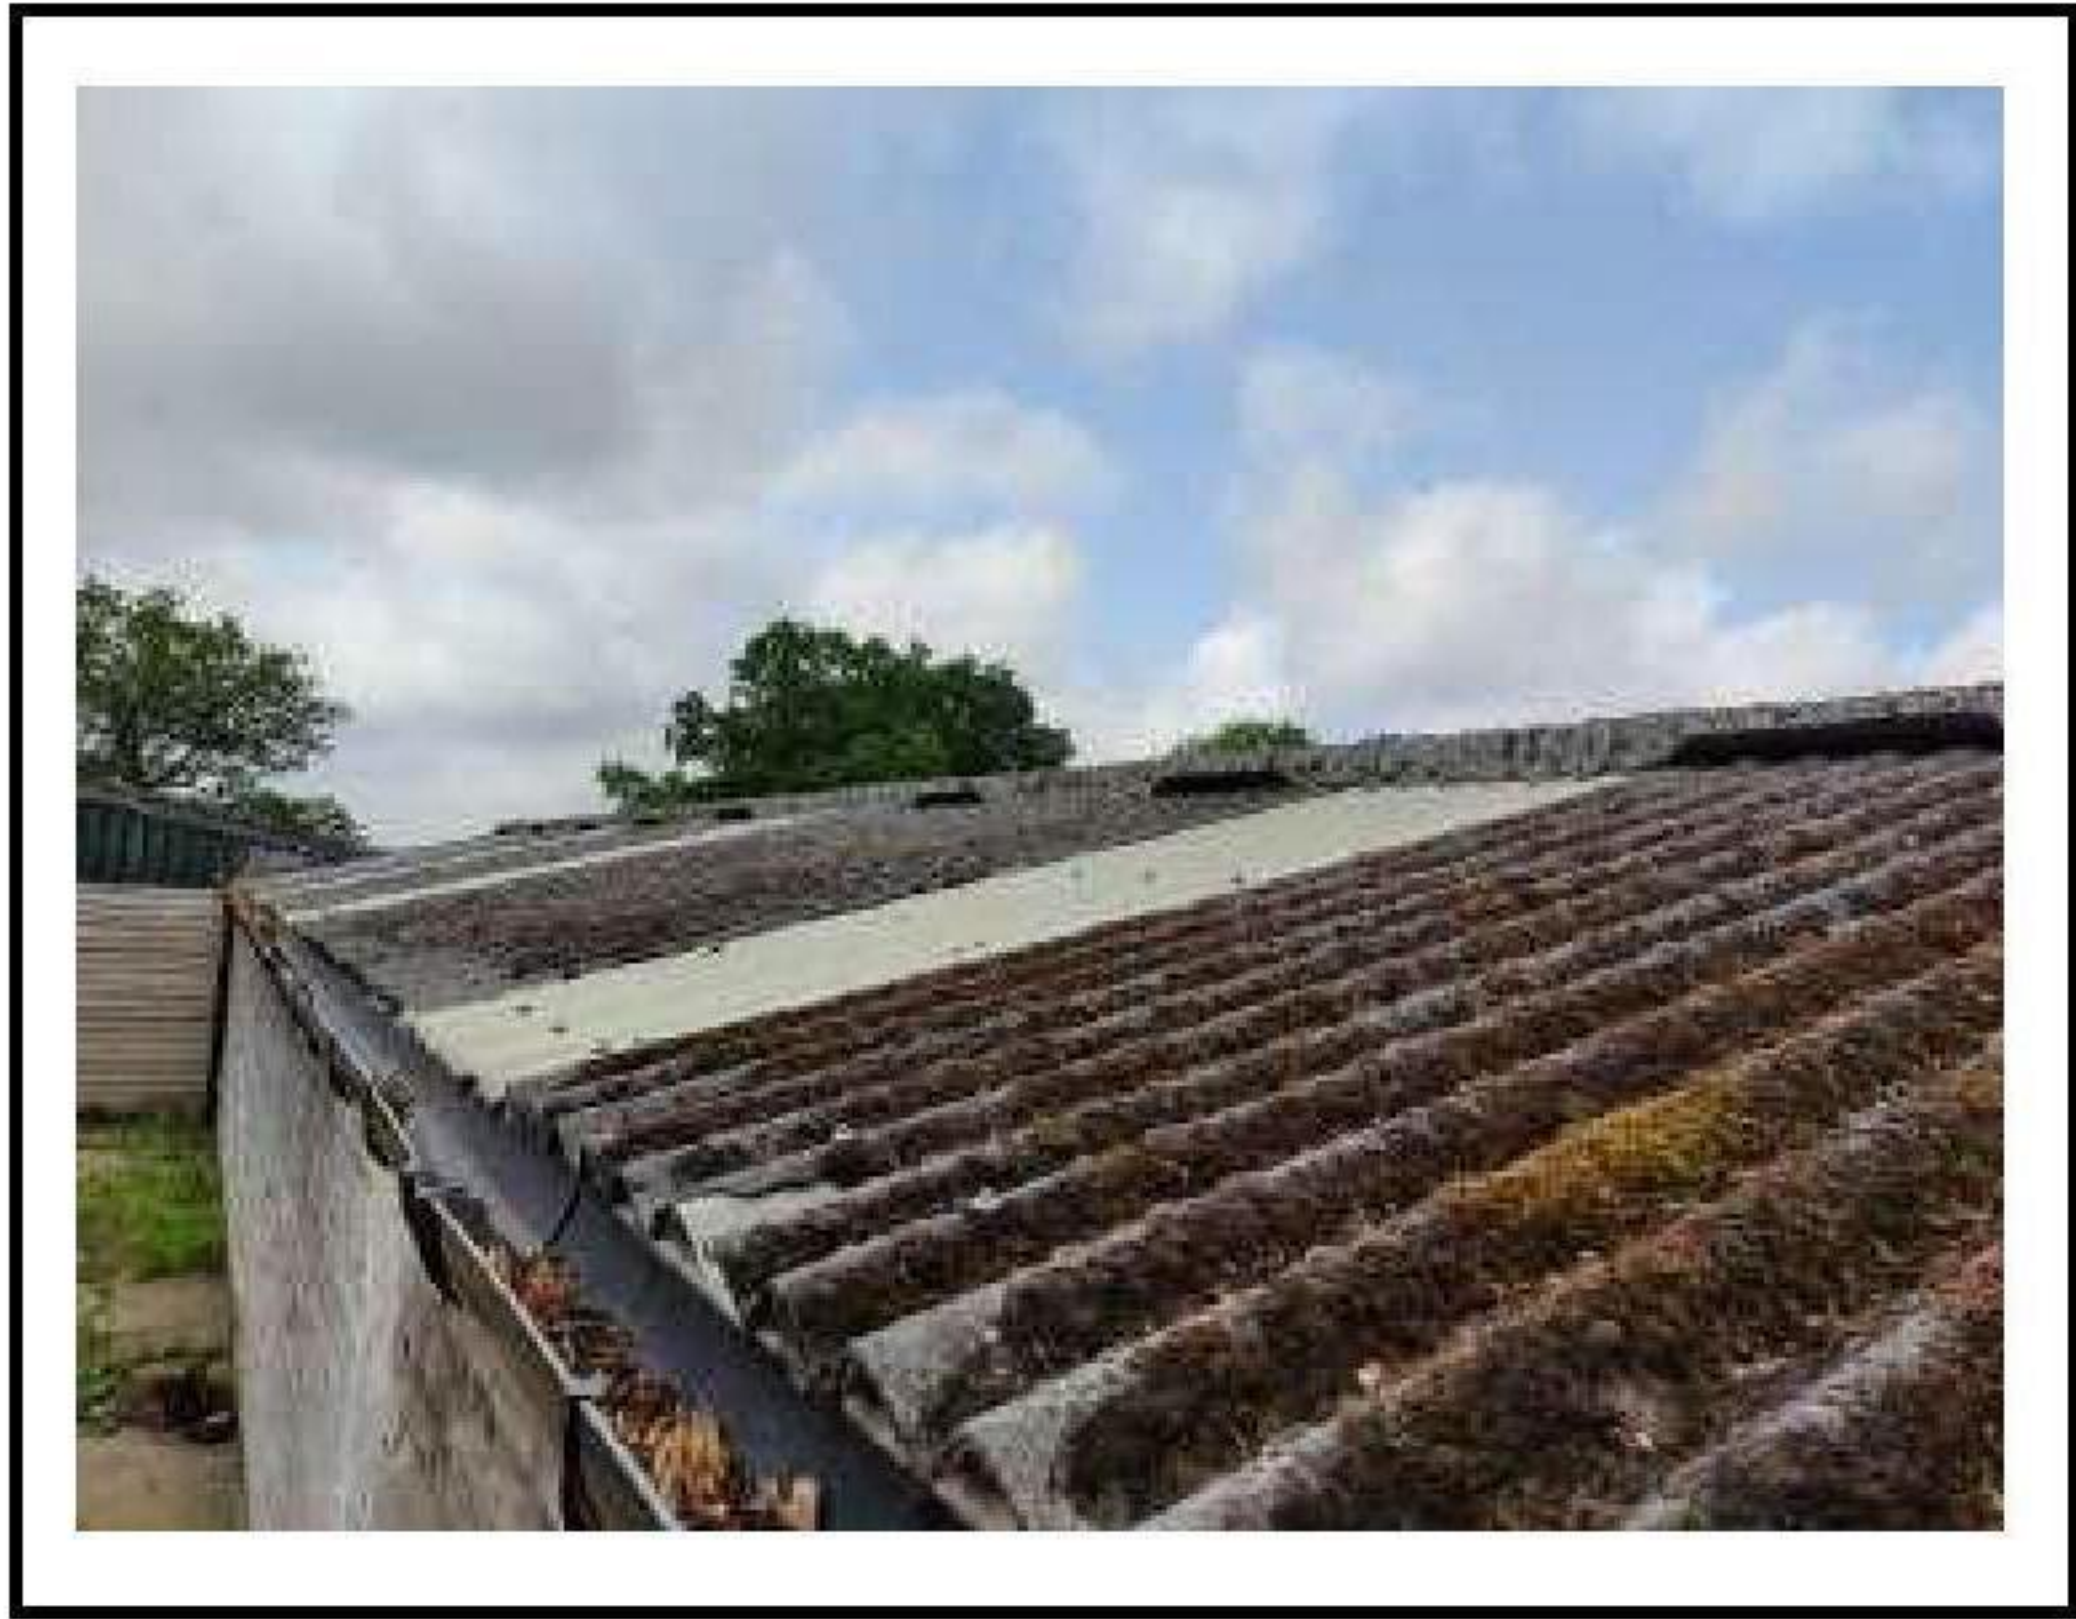
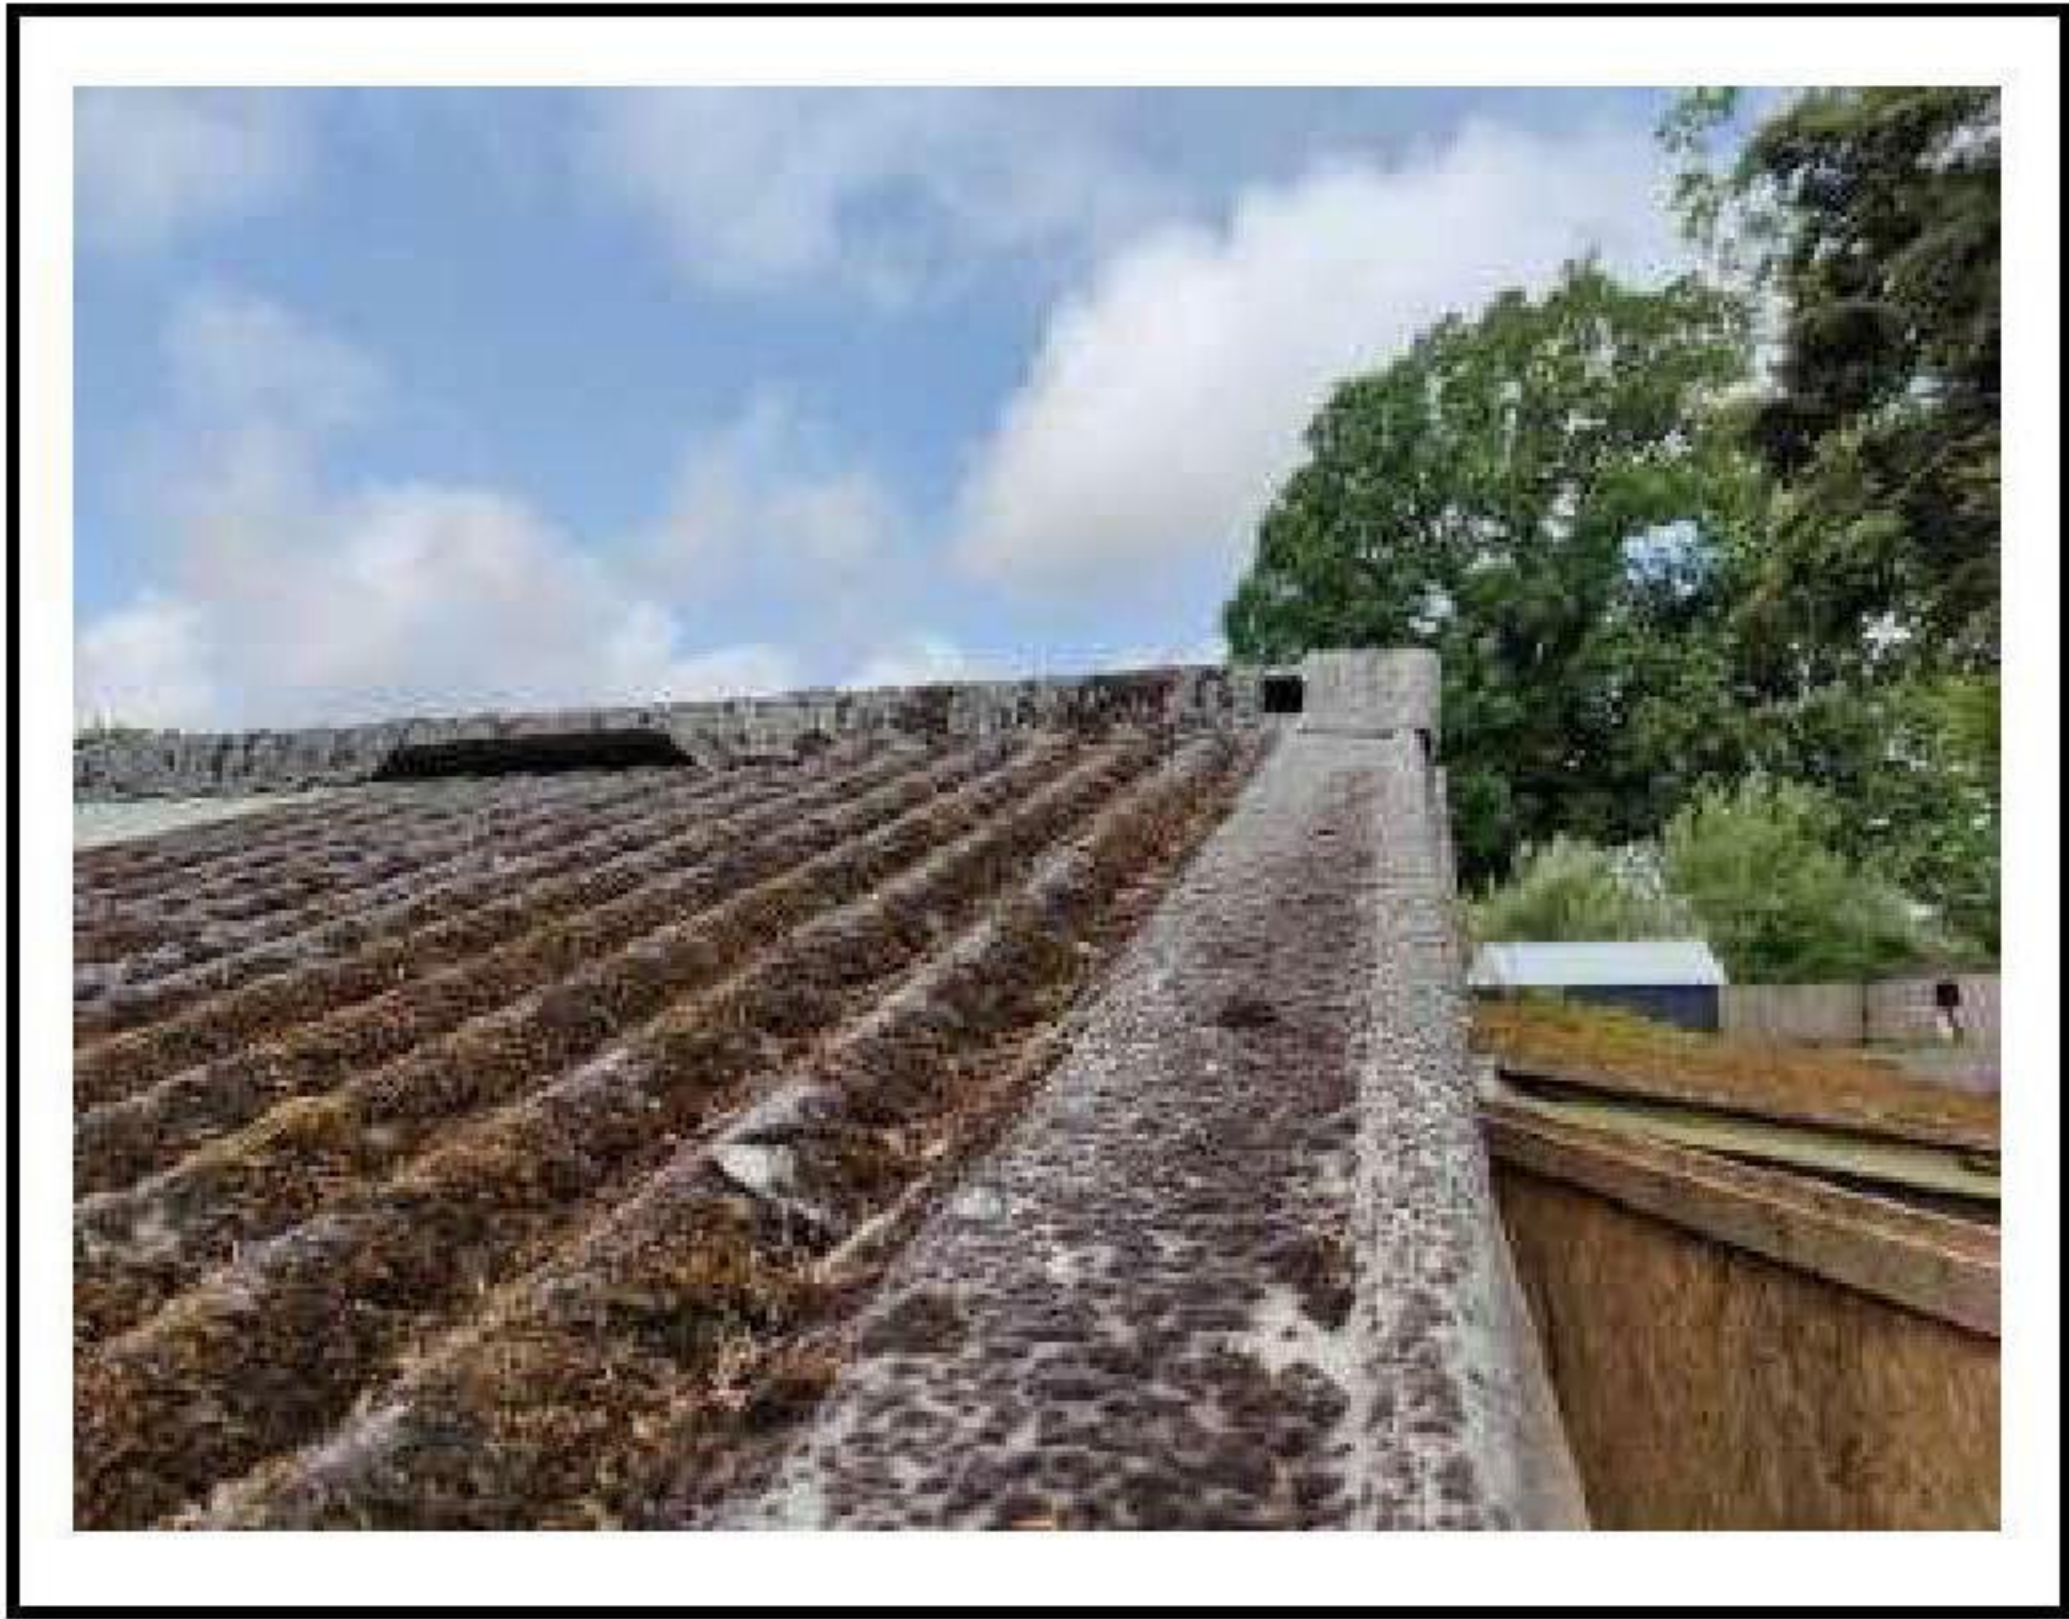
| Level of Identification | Sampled | Sample Ref | S003 |

| Extent | Approx 220 m² | Accessibility | Difficult |

| Item Notes: | Roof sheeting, ridge capping and barge board. |

| | | Score |
|---|---|---|
| Damage | No visible damage | 0 |

| Recommendation: | Remove prior to refurbishment/demolition (non-licensable works). |
